Report on the investigation of
the foundering of the fishing vessel

Purbeck Isle

9 miles south of Portland Bill, England

on 17 May 2012

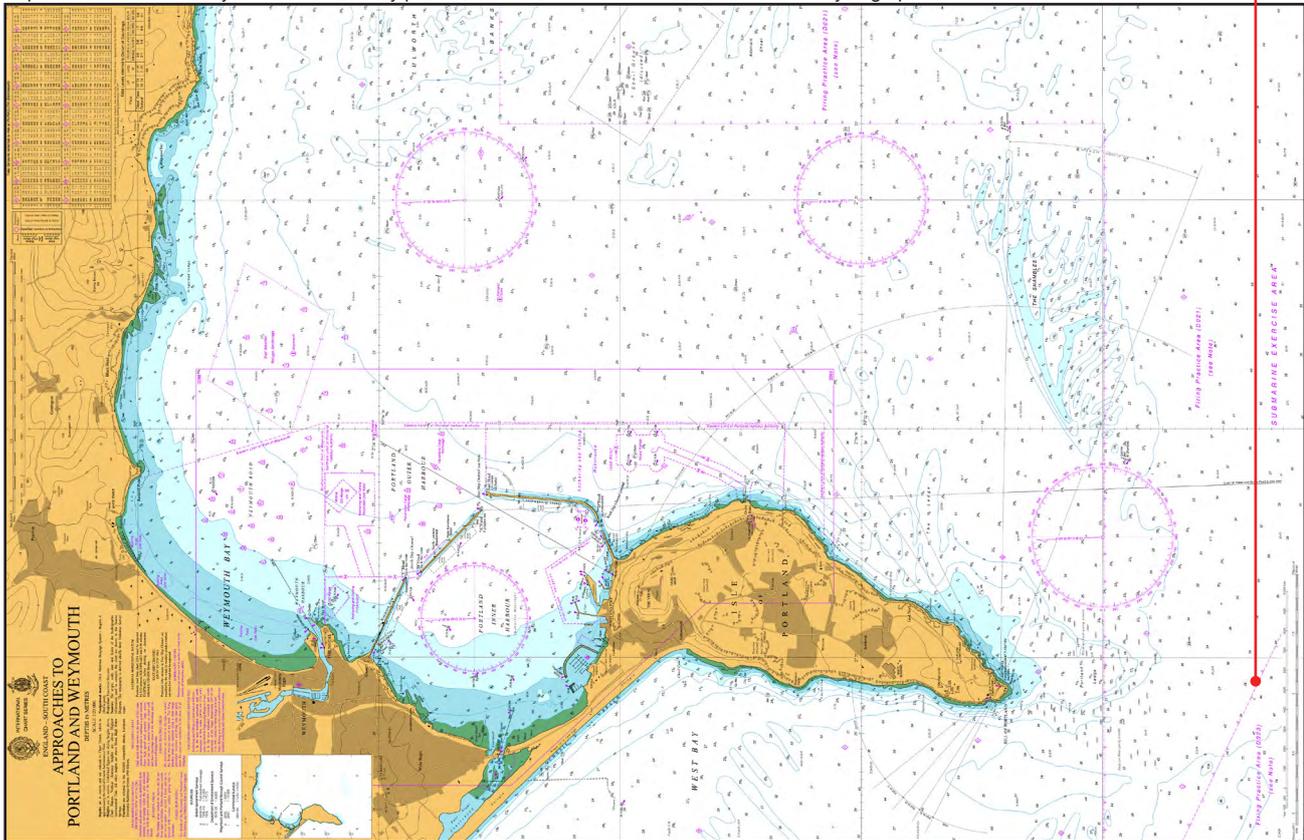
Figure 4: Cluster of marker buoys from Purbeck Isle spotted 9 miles south of Portland Bill

Cluster of buoys
 N50° 21.6' W002° 29.35'
 approx. 9nm south of the Bill

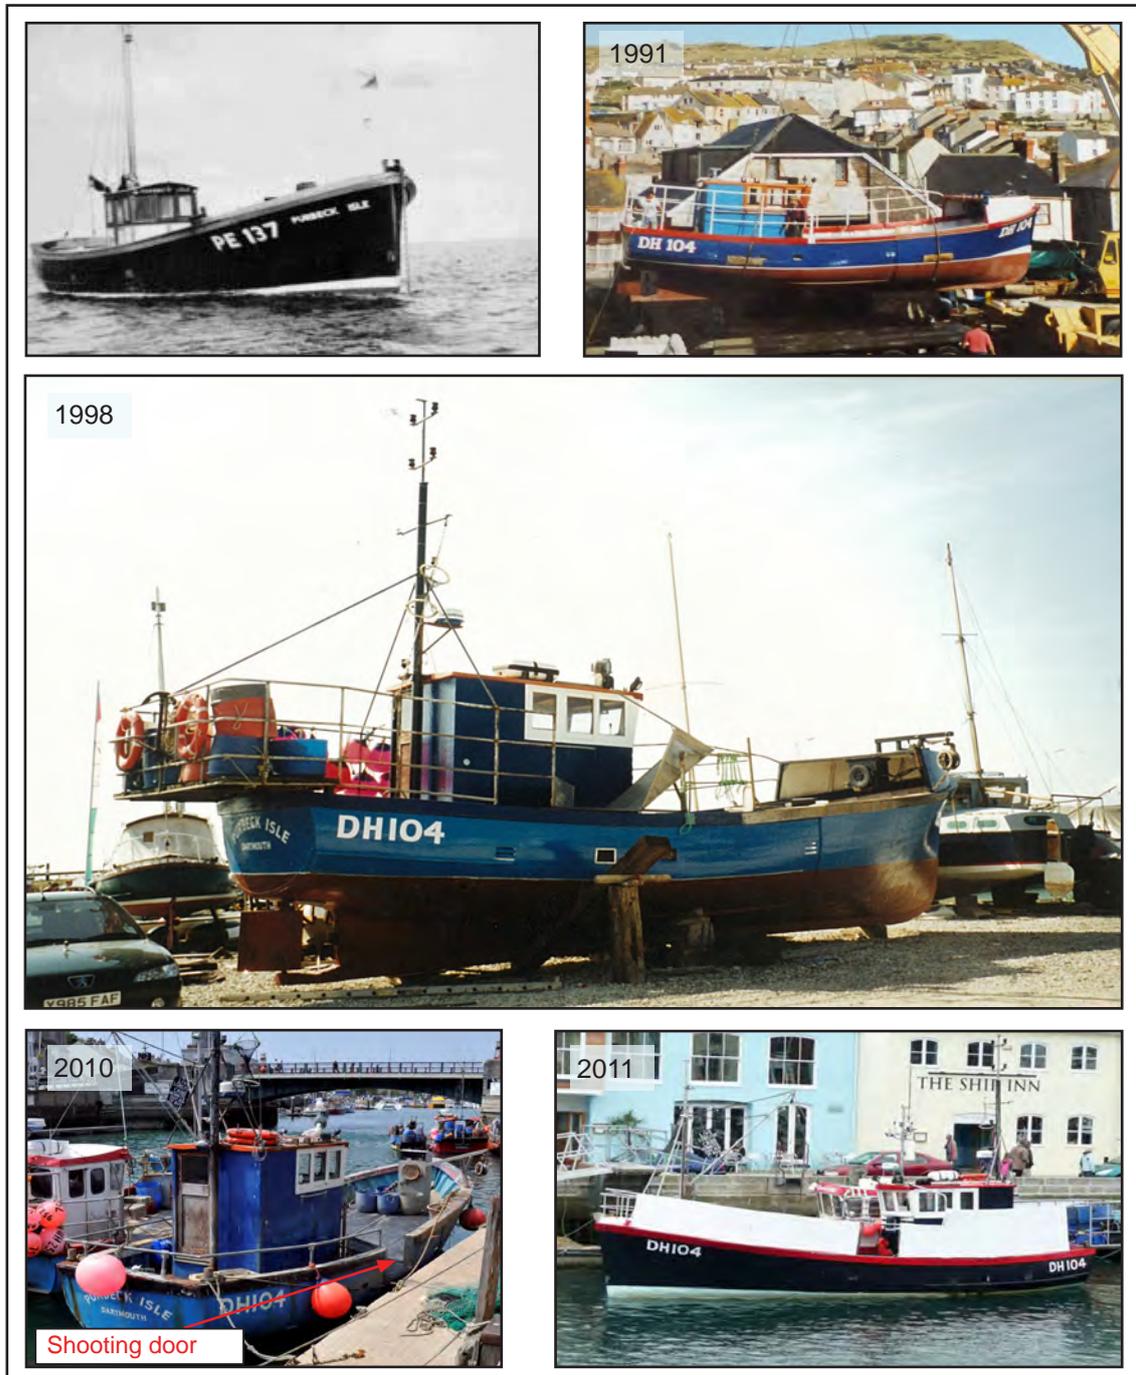
Figure 9: *Purbeck Isle* construction alterations and modifications

A review of *Purbeck Isle*'s known maintenance and repair history identified that several structural modifications and upgrades had been made to the vessel over the 21-year period prior to the accident (**Figure 9**). During a major refit at a local Portland boatyard in 1991, her deck and wheelhouse were completely renewed, and a steel whaleback⁶ and steel guardrails were bolted to the top of her gunwale⁷.

When Maverick (Weymouth) Ltd bought the vessel, its owner fabricated and fitted a steel stern rack. At that time, the vessel was rigged to shoot its pots over the gunwale via a steel shooting ramp (**Figure 9**) located on the starboard side of the deck.

In 1998, the owner removed the vessel's original engine and fitted the Perkins Sabre engine. In order to do this, the wheelhouse was raised several centimetres off the deck and the engine's original access hatch and its deck coaming⁸ were removed. The hole left in the deck in front of the wheelhouse by the removal of the access hatch was covered by an aluminium plate (**Figure 6**). The aluminium plate was bolted flush to the deck and sealed using a silicon-based marine sealant.

In 1999, the majority of *Purbeck Isle*'s deck planking was renewed, but the deck's plywood base and the outer edge of its planking were not. The following year, a hole was cut into the bulwark⁹ on the starboard side of the deck just in front of the wheelhouse to allow a steel shooting door to be fitted (**Figure 6** and **Figure 9**). In 2008, the steel whaleback and the stern rack were removed, and a new hauling winch was fitted.

In the spring of 2011, the skipper had a new set of steel guardrails and a stern rack bolted on to the top of the vessel's gunwale. In order to provide some protection from the prevailing environmental conditions for the crew on deck, white plastic sheeting was attached to the outside of the guardrails (**Figure 9**). A steel rail was also fitted to the deck adjacent to the hauling winch to allow the crew to tightly stack the pots on the port side of the winch, to prevent them sliding about the open deck.

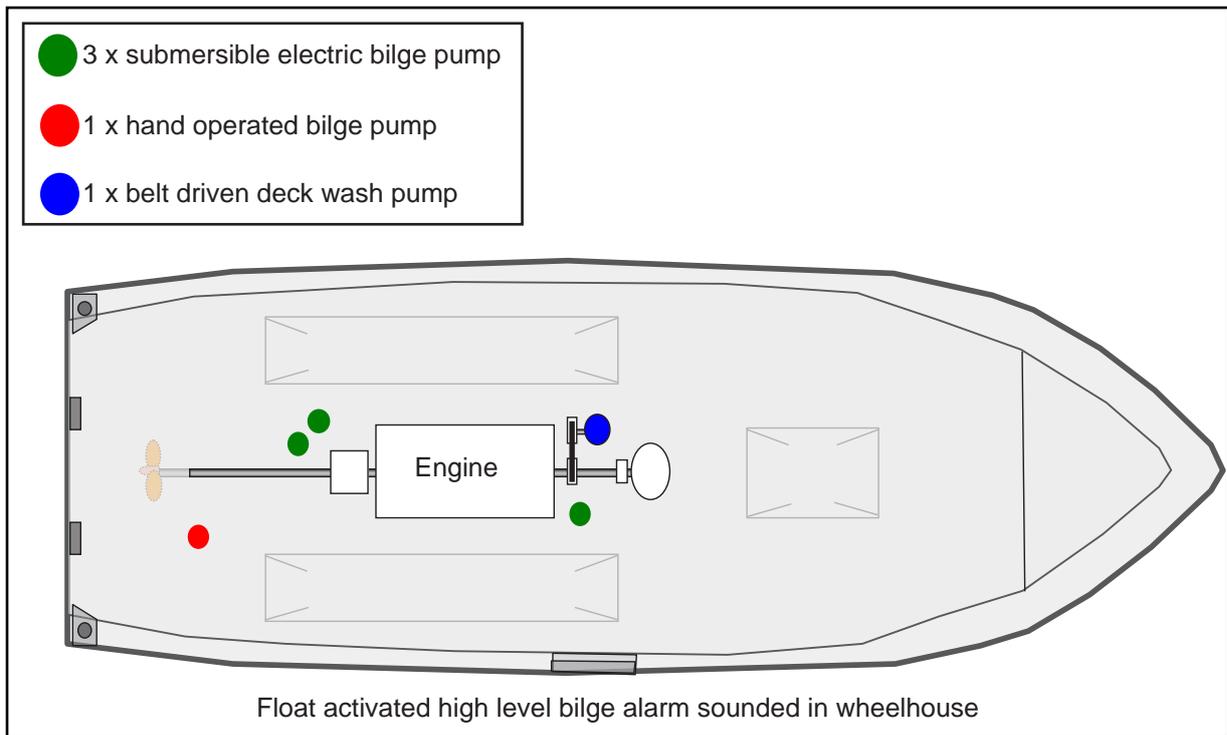
Figure 13: Bilge pump arrangements

Purbeck Isle had three electric bilge pumps and one hand-operated emergency bilge pump (**Figure 13**). A float-activated high level bilge sensor connected to an audible alarm and warning lamp located in the wheelhouse was fitted in the machinery space. The electric bilge pumps were each capable of removing about 5t of water from the machinery compartment per hour and could be started manually from the wheelhouse. One of the pumps was electrically connected to a float switch, allowing for automatic operation. This bilge pump was normally left in its automatic mode at all times, even when the vessel was berthed alongside overnight. The hand-operated emergency bilge pump was fitted to the aft bulkhead of the wheelhouse. It had not been operable for some time as its suction pipework had been disconnected.

Purbeck Isle also had an engine-driven deck wash pump that could be re-configured to pump the bilges overboard in an emergency. In order to do this, a crewman was required to enter the machinery compartment and go to the forward end of the engine to turn the pump's sea suction valve to its bilge suction position. As a result of the failure of the electric bilge pumps, often due to a build-up of sand and silt in the bilges, or because of the amount of water ingress, it had been necessary for previous crew members to wade through high levels of bilge water to change the deck wash pump's suction valve to bilge suction on several occasions during the 18-month period prior to the accident.

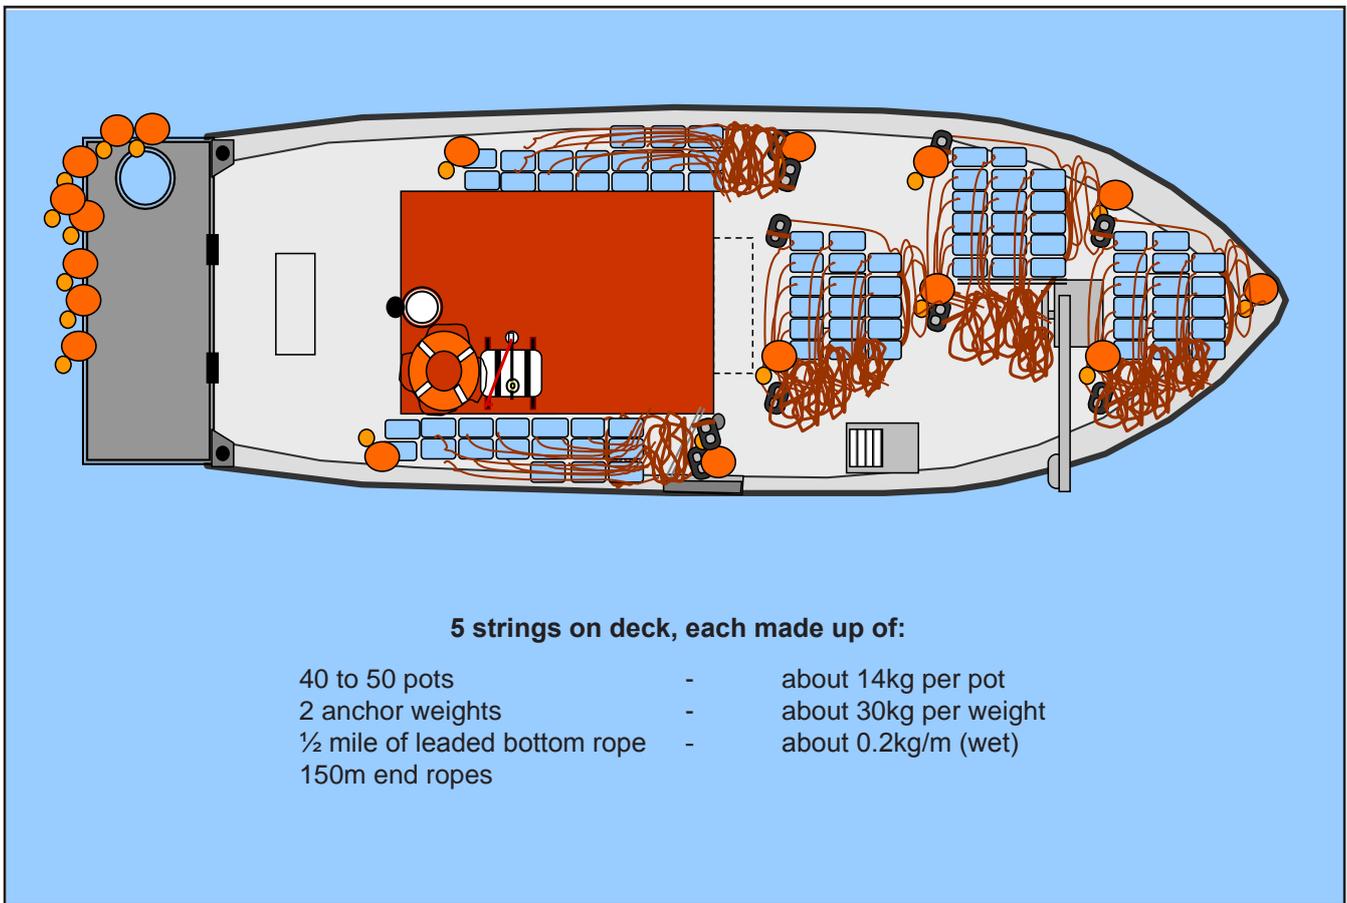
Figure 17: Method adopted for the stacking of pots on deck when gear was relocated during the previous season (2011)

When the pots were moved from one set of grounds to another, the entire string was recovered inboard. To allow the gear to be relocated faster, several strings of pots were stacked on deck at the same time. During the previous season, the crew had carried five strings (about 250 pots) on the deck at a time. To achieve this, one string was stacked in the bow, two on the deck in front of the wheelhouse and one on either side of the wheelhouse (**Figure 17**). With five strings on deck, the crew could not open the shooting door and had to shoot the first string (the one blocking the door on the starboard side of the wheelhouse) over the gunwale.

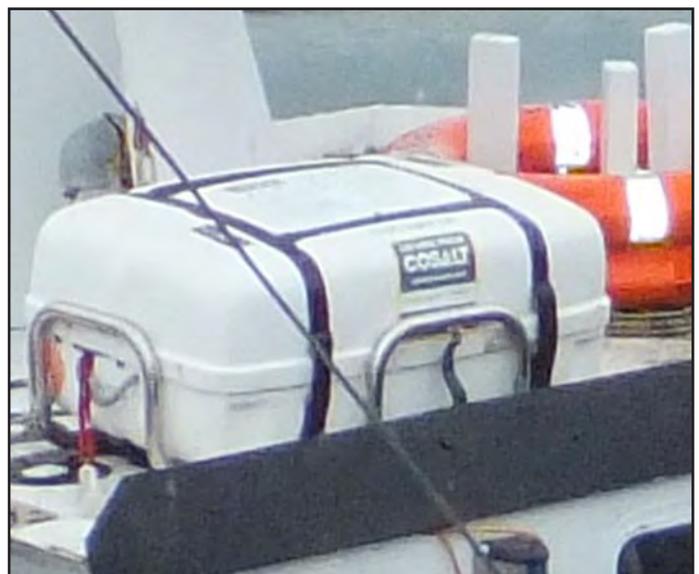
Figure 31: Random inspection of fishing vessel liferaft securing arrangements

Liferaft rigged to float free
