Fire on board the fishing vessel **ONWARD**

**60nm off the north coast of Scotland
resulting in the loss of the vessel
11 April 2012**

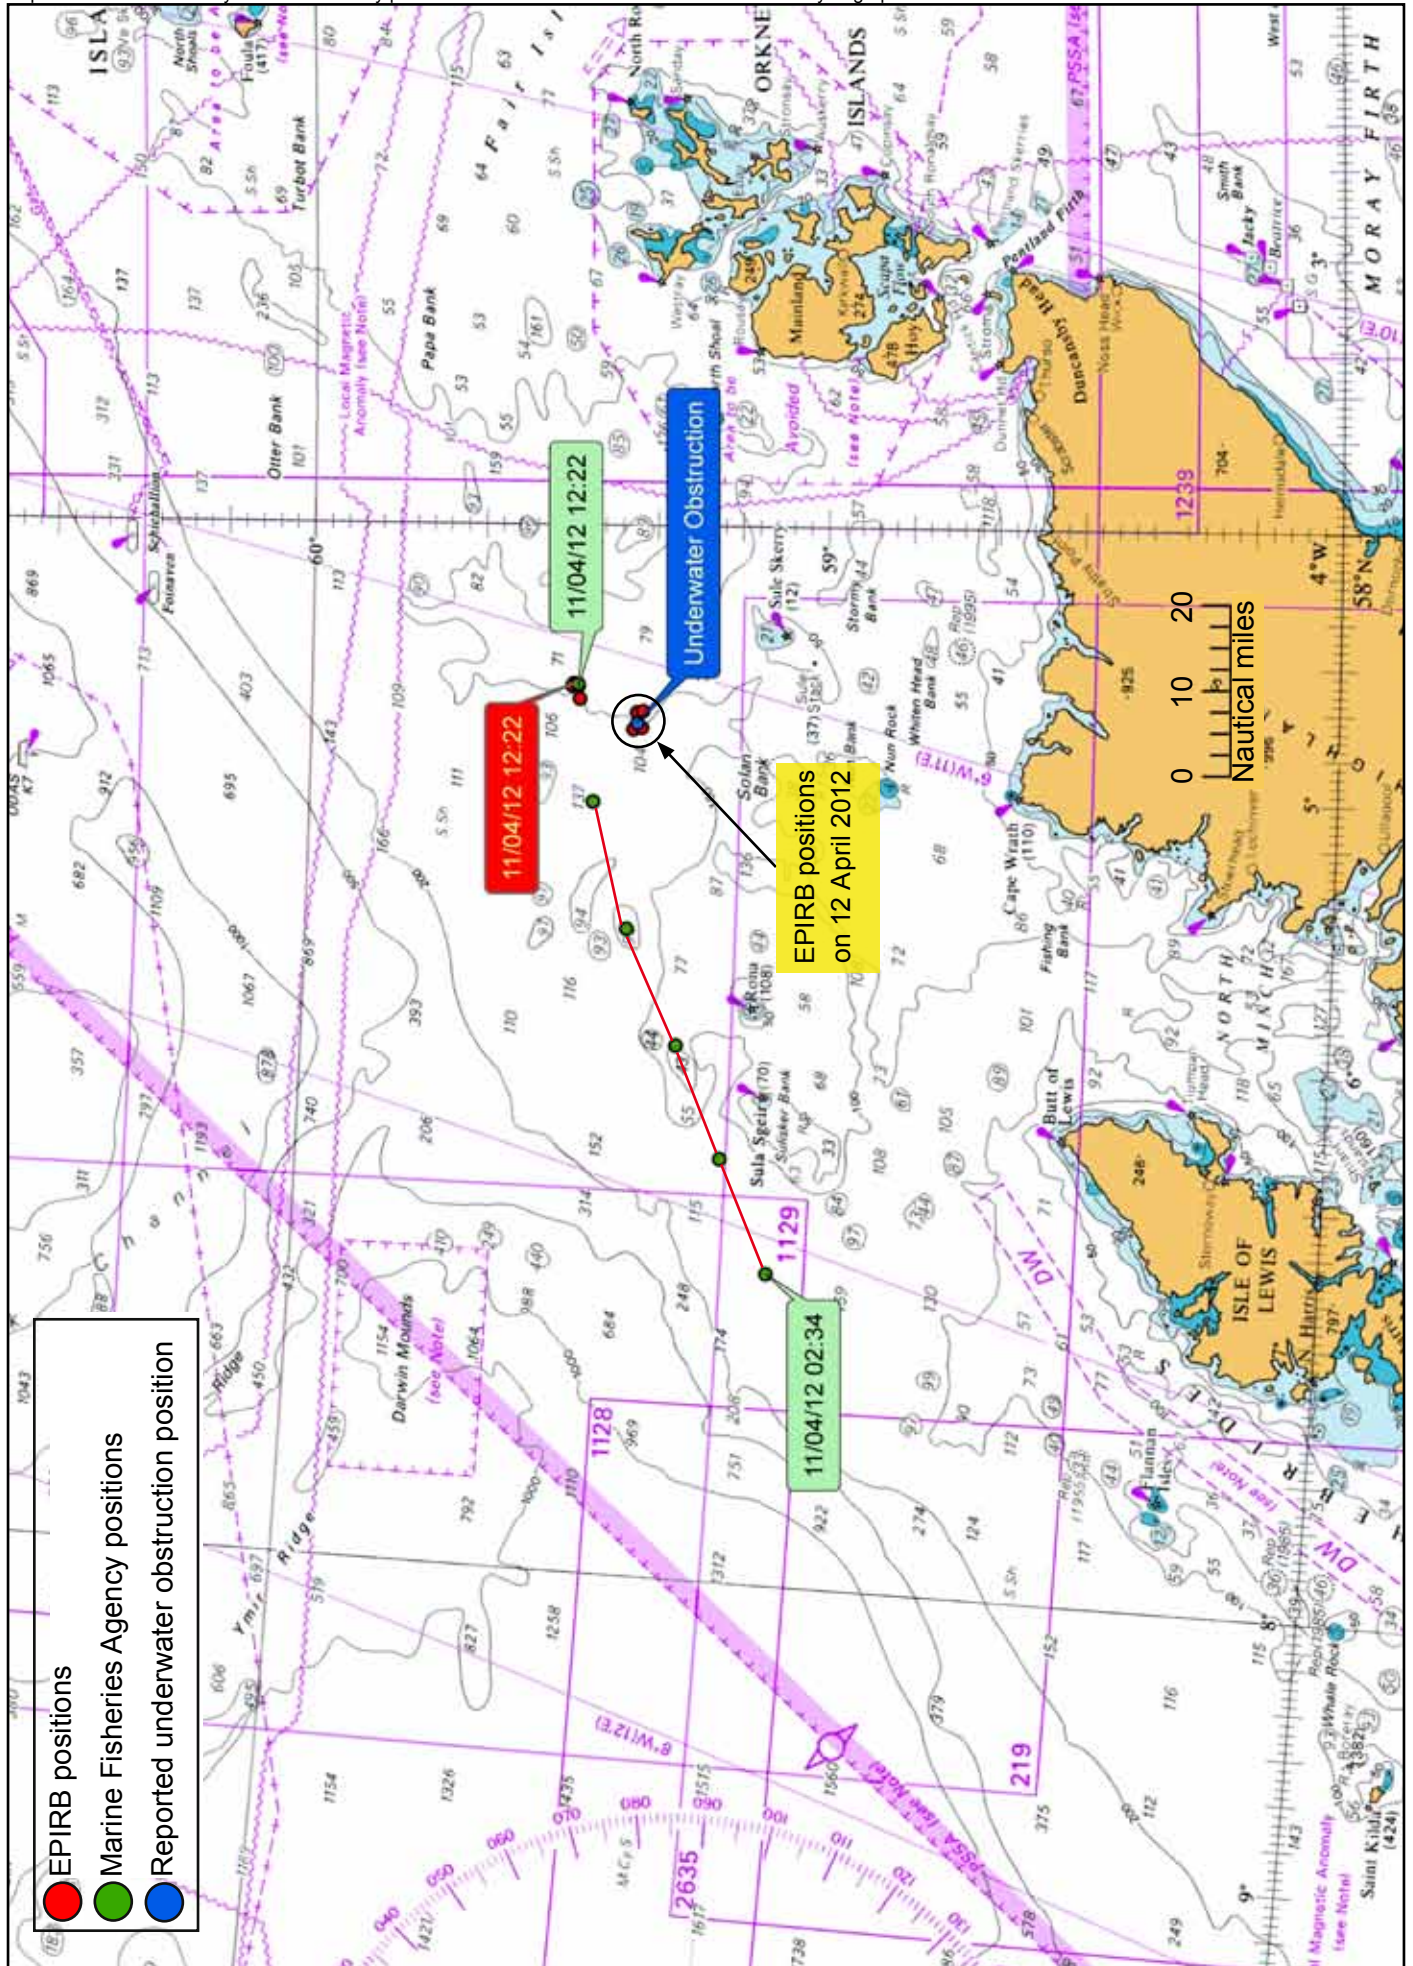
Figure 1: Vessel and EPIRB positions (times on this chart are UTC)

The Emergency Towing Vessel (ETV) *Anglian Sovereign* arrived on scene later the same night but, although one of the two liferafts was recovered, neither *Onward* nor the EPIRB were found. In June 2012, a fishing vessel reported snagging her nets on a previously unknown underwater obstruction in position 59°22N 004° 45W (**Figure 1**).

In view of the intensity of the fire (**Figure 3**) and the vessel's wooden construction, *Onward* would have continued to burn until foundering. The proximity of the underwater obstruction discovered in June 2012 to the vessel's last known position, and the positions of the EPIRB on 12 April 2012 (**Figure 1**), suggests that the obstruction could be the wreck of *Onward*.

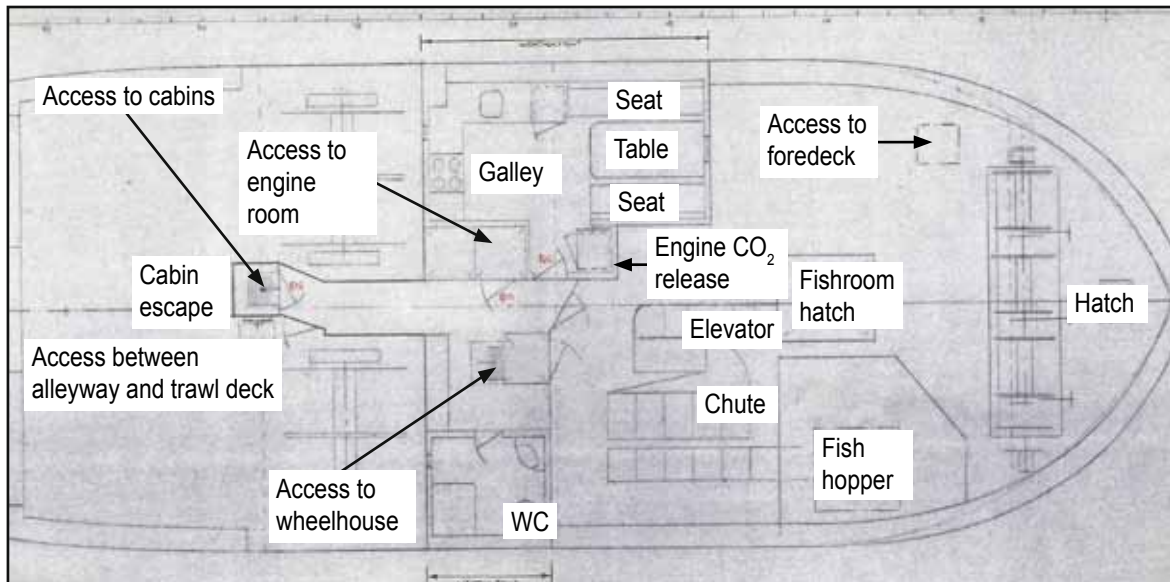
Figure 2: General arrangement (Accommodation deck)

Access to the engine room was via a door sited next to the galley door on the port side of the main alleyway (Figures 2 and 4). The compartment's bulkheads, deckhead and access door had a fire insulation rating of B15¹. The engine room access door was kept closed when the vessel was at sea, but it did not provide a tight seal. The engine room had a single exhaust fan leading to a vent to port of the wheelhouse (Figure 5). A closed circuit television (CCTV) system enabled the engine room and trawl deck to be monitored from the wheelhouse.

The combined galley and crew mess was sited on the vessel's port side, immediately aft of the forward shelter deck (**Figures 2 and 4**). To insulate against the spread of fire, the compartment bulkheads and deckhead were rated to A30² and the door was rated to the B15 standard. The furniture inside the galley was mainly wooden.
