Saga Sapphire

## SYNOPSIS

At 1020 on 29 March 2012, two crewmen fell 22m into the water from *Saga Sapphire's* No 5 lifeboat while the ship was secured port side alongside in Southampton. They sustained minor injuries.

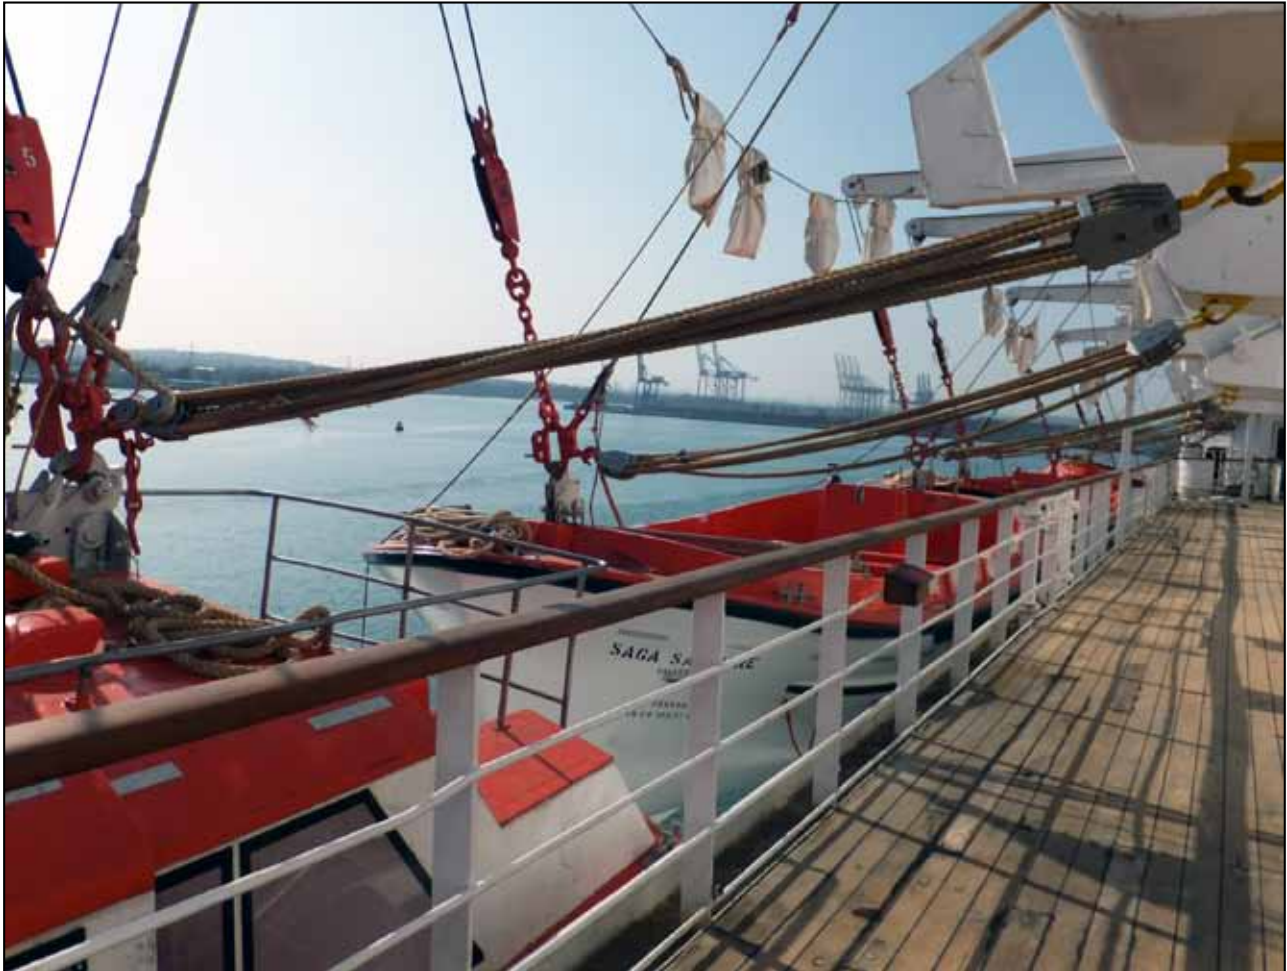
**Figure 1: Starboard boat deck**

In the meantime, the crew were sent to crew alert stations and the master instructed the fourth officer to proceed to the starboard side of deck 9 (**Figure 1**) to oversee the lifeboat preparations. As the lifeboat preparation teams and "soul counters" arrived, the bosun lowered the two tenders and three lifeboats, which were automatically held at deck level by their respective tricing pennants (**Figure 2**). The two-man lifeboat and tender preparation crews then started to rig their respective fore and aft bousing tackles. This was done under the instructions of the bosun and fourth officer, in readiness to release the tricing pennants, embark the simulated passengers, lower the boats to the water, and release the "on-load" hook to enable the boats to proceed away from the ship under their own power.

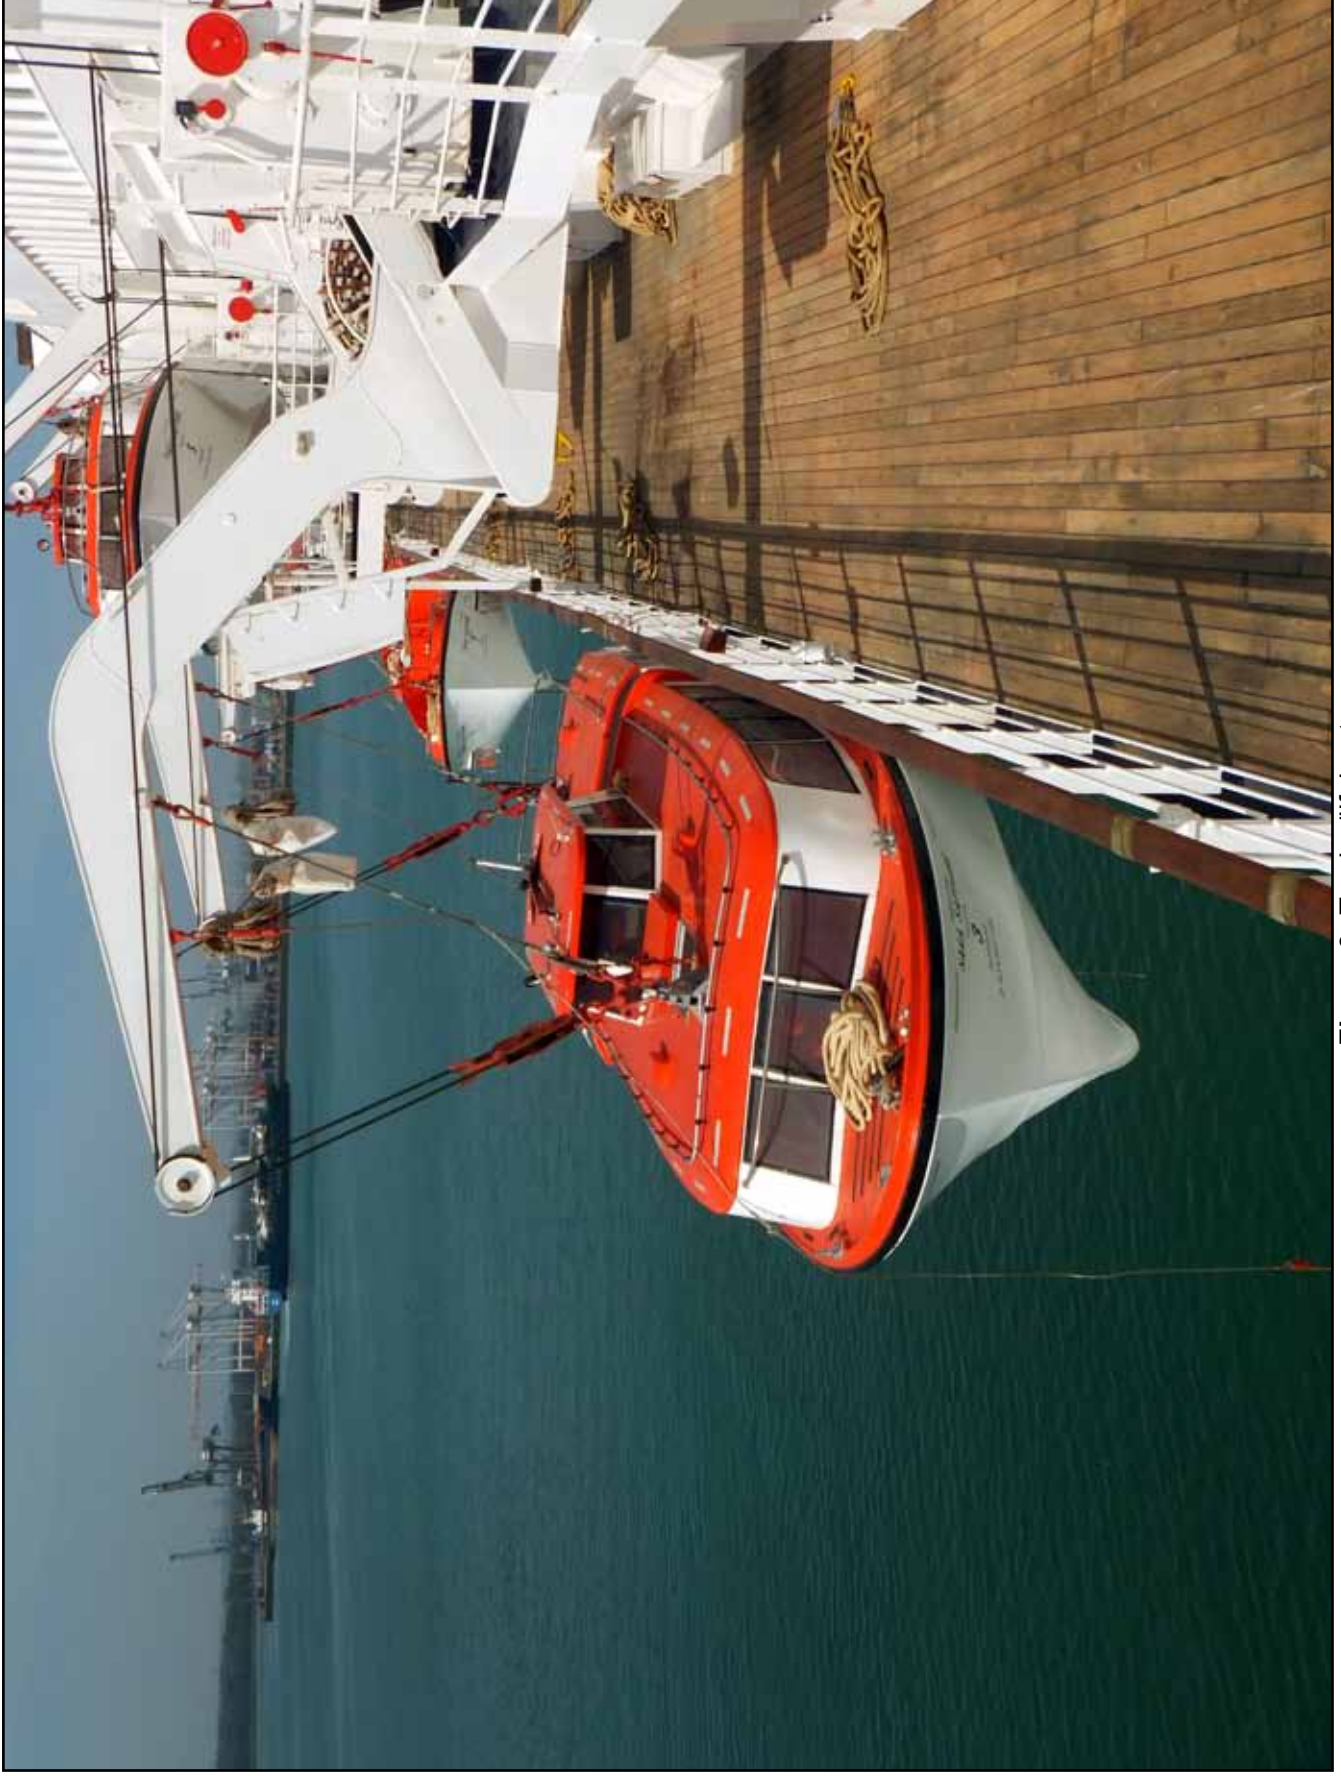
**Figure 9:** Tender/lifeboat

*Saga Sapphire* was equipped with four, 11.5m enclosed tenders/lifeboats<sup>2</sup> (**Figure 9**), designated Nos 3, 4, 5 and 6 lifeboats<sup>3</sup>. Nos 4, 5 and 6 lifeboats were built by Robert Hatecke GmbH based in Drochtersen, Germany. Although of the same dimensions as the other tenders, No 3 tender was built by Fritz Fassmer GmbH, also of Germany, but to a Robert Hatecke GmbH design. However, it was of a slightly different construction and was heavier than the others. In addition to their life-saving

role, the tenders were also designated for passenger transfer use. The four tenders were fitted with fore and aft ventilation hatches to the coach roofs. The hatches were positioned adjacent to the “on-load” release hooks.

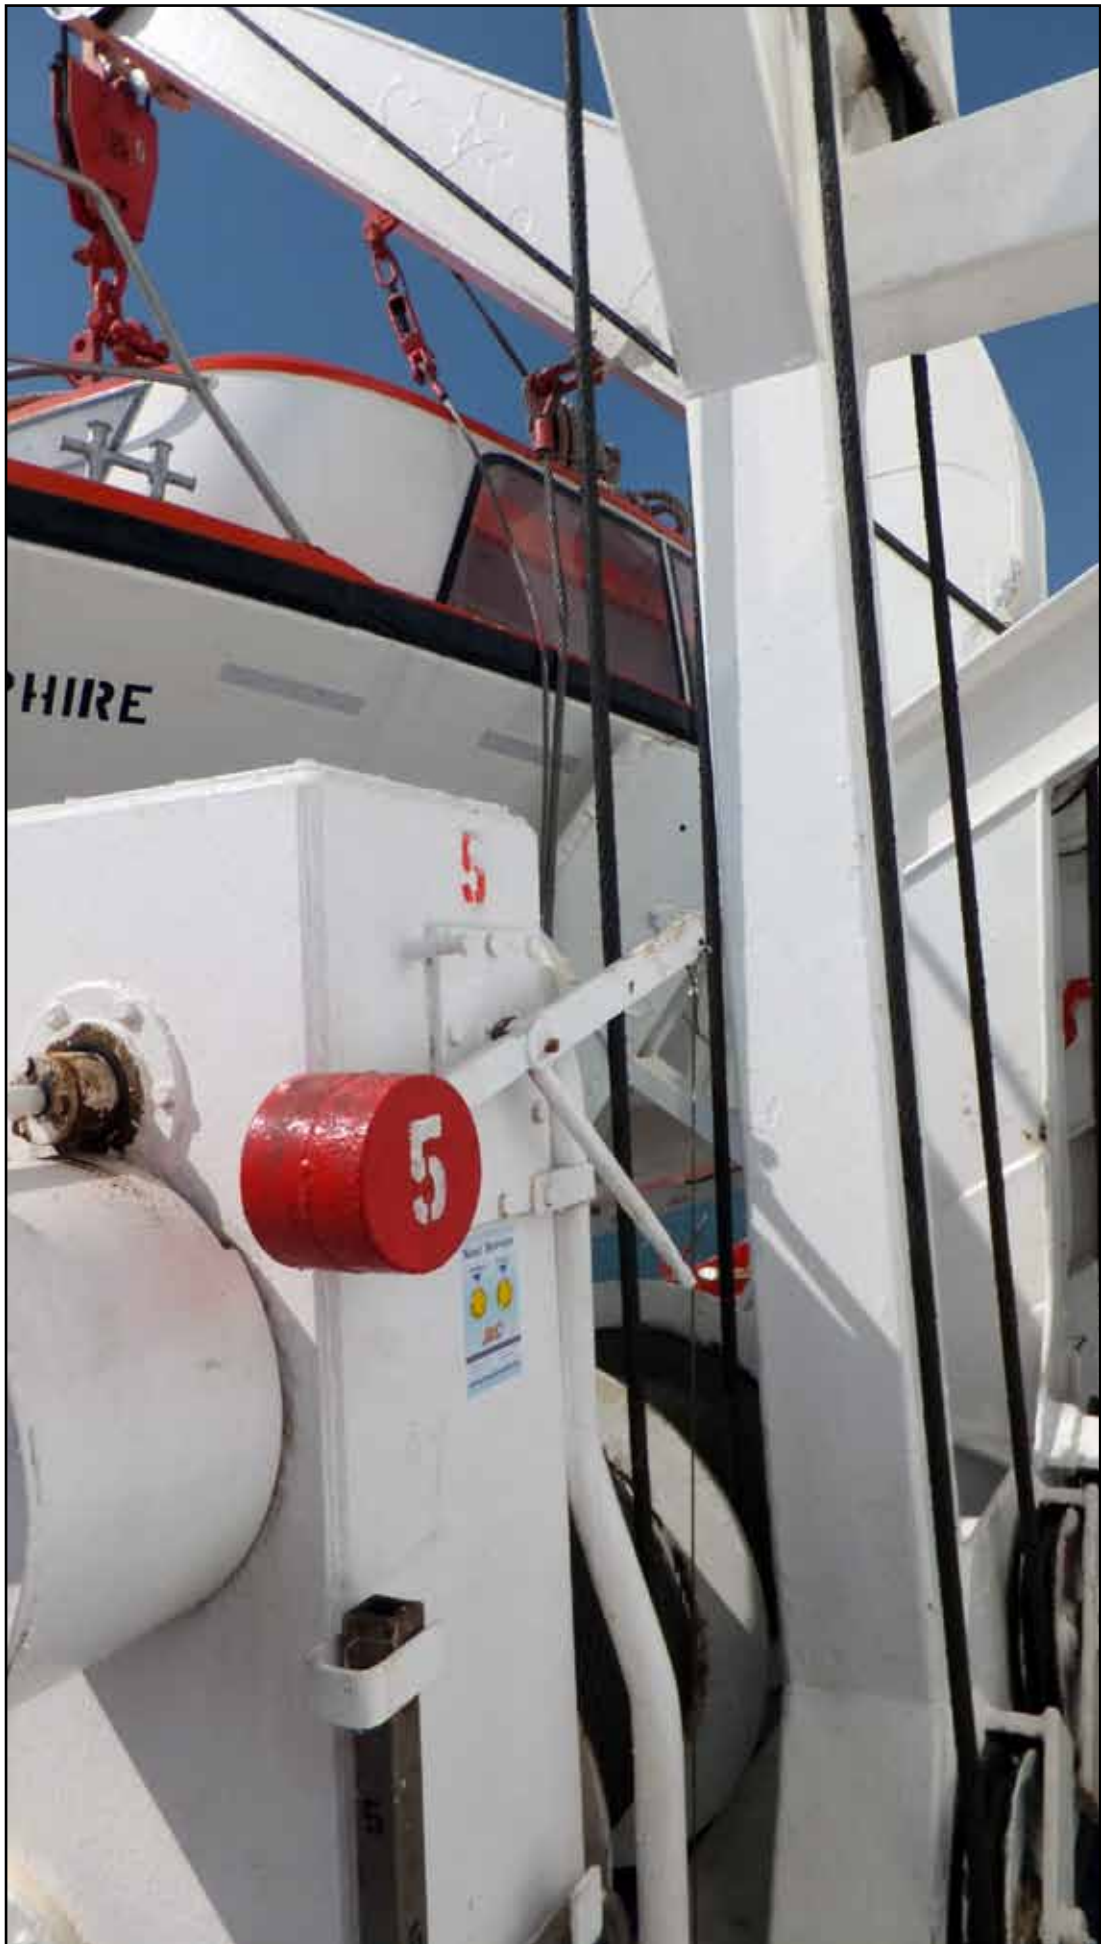
**Figure 10:** Davit control position on the winch deck

The davit winch control positions for the lifeboats were on deck 10, the winch deck. Each position was equipped with a lifeboat launching operation instruction poster. The lifeboats could be lowered under power or under gravity using a “dead man”, counter-balance centrifugal brake control lever fitted to the end of the brake disc shaft. Both the power and gravity controls were duplicated on an extension sponson situated above each boat. The davit winch controls are shown at **Figures 10 and 11**.

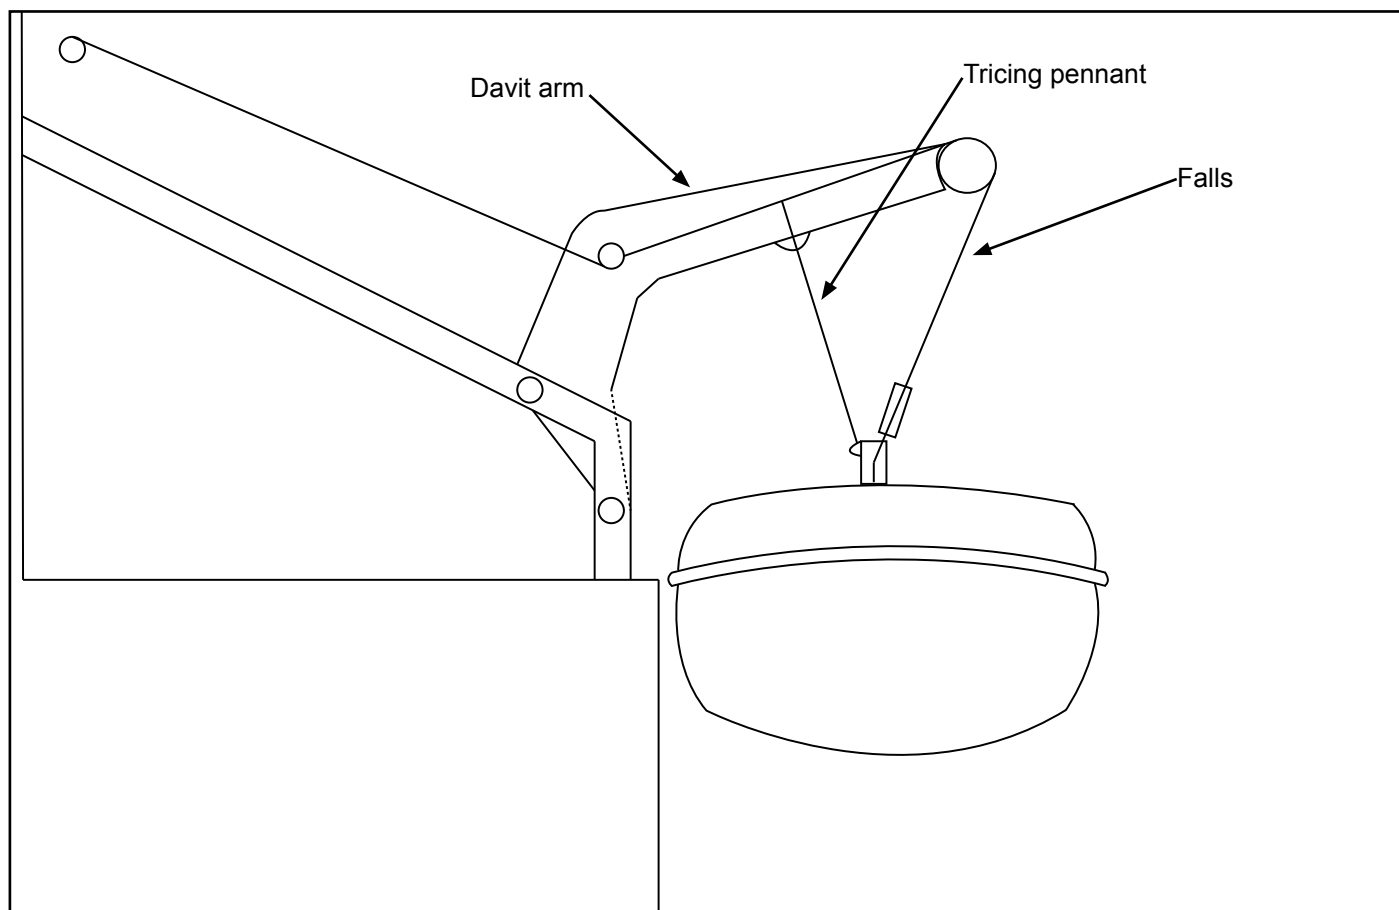
**Figure 12:** Schematic showing lifeboat held against the deck by action of the tricing pennant

Schematics illustrating the operation are at **Figures 12 and 13**.

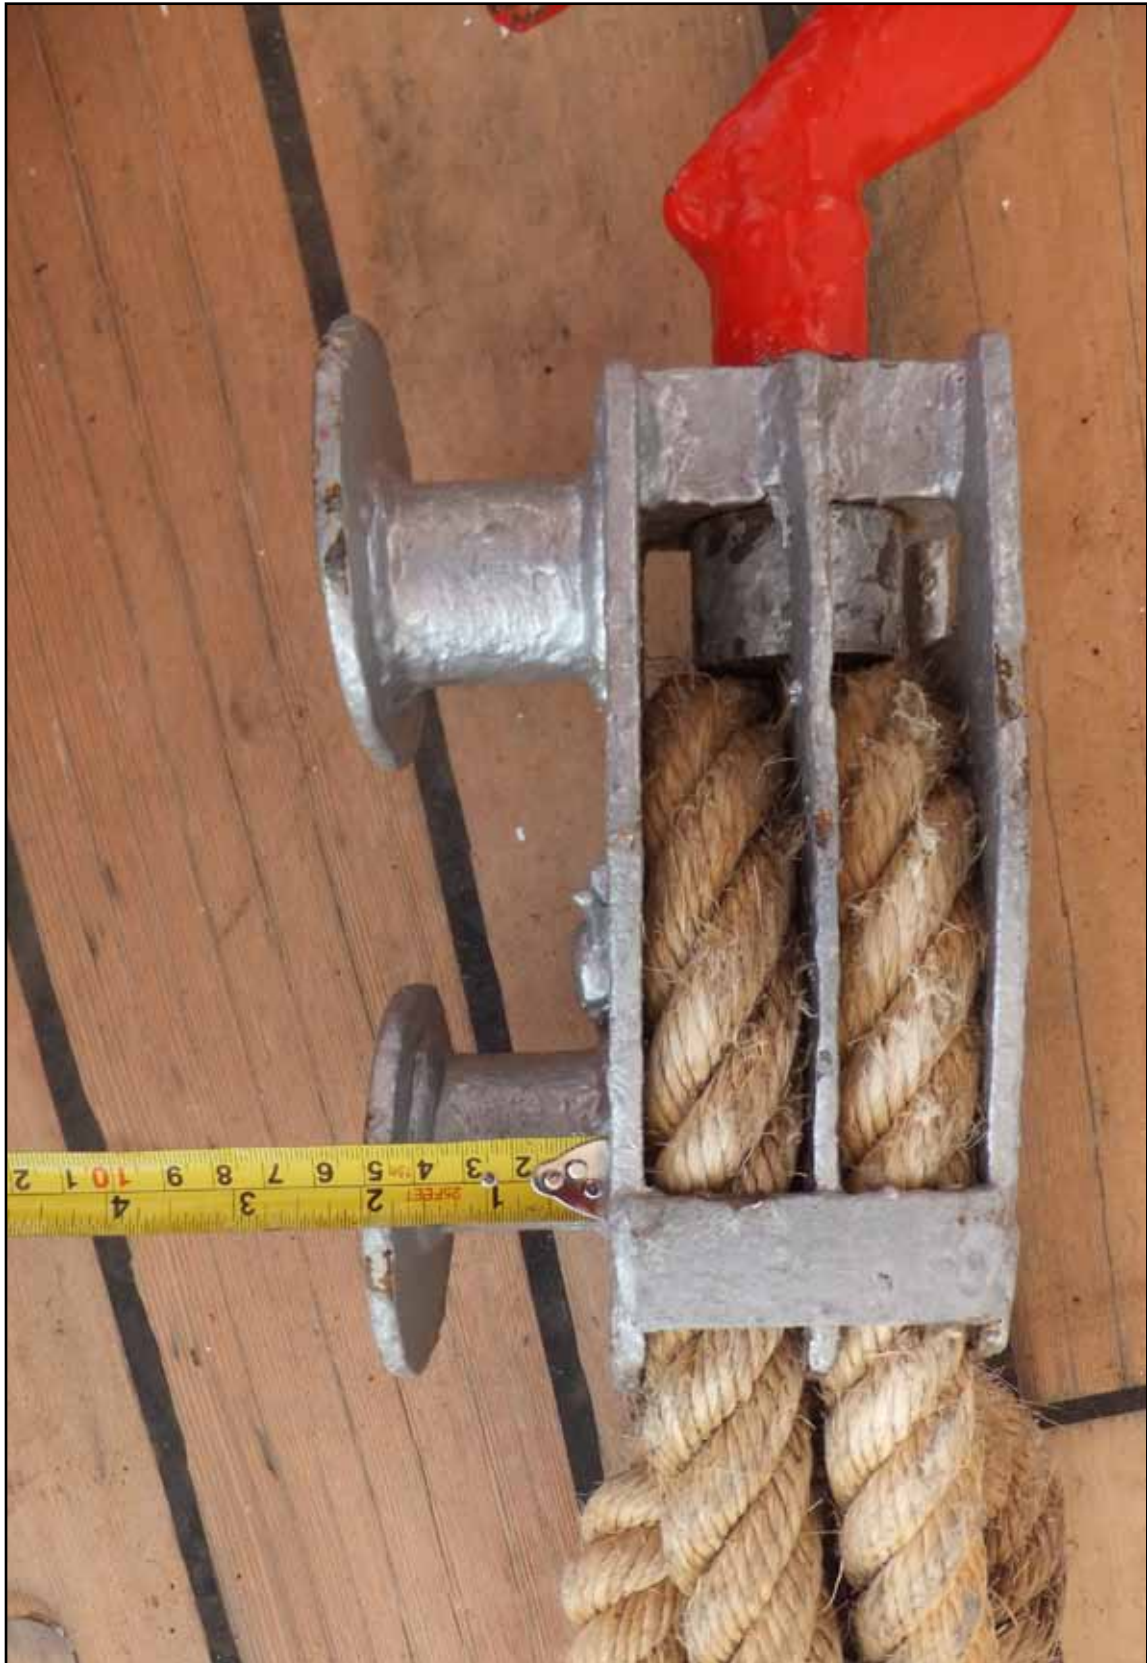
**Figure 16:** Height of bitts

Securing and control of the bowsing tackle ropes was managed by the lifeboat crew and preparation teams from on board the lifeboats. Once sufficient tension was applied to hold the lifeboat alongside deck 9, the rope was secured in figure-of-eight turns around the bitts welded to the block hooked to the boat's lifting plate link. The bitts were 50mm high from their base to the underside of the cap, and the distance between the inner faces was 80mm. The bitts' dimensions are shown in **Figures 16 and 17**.

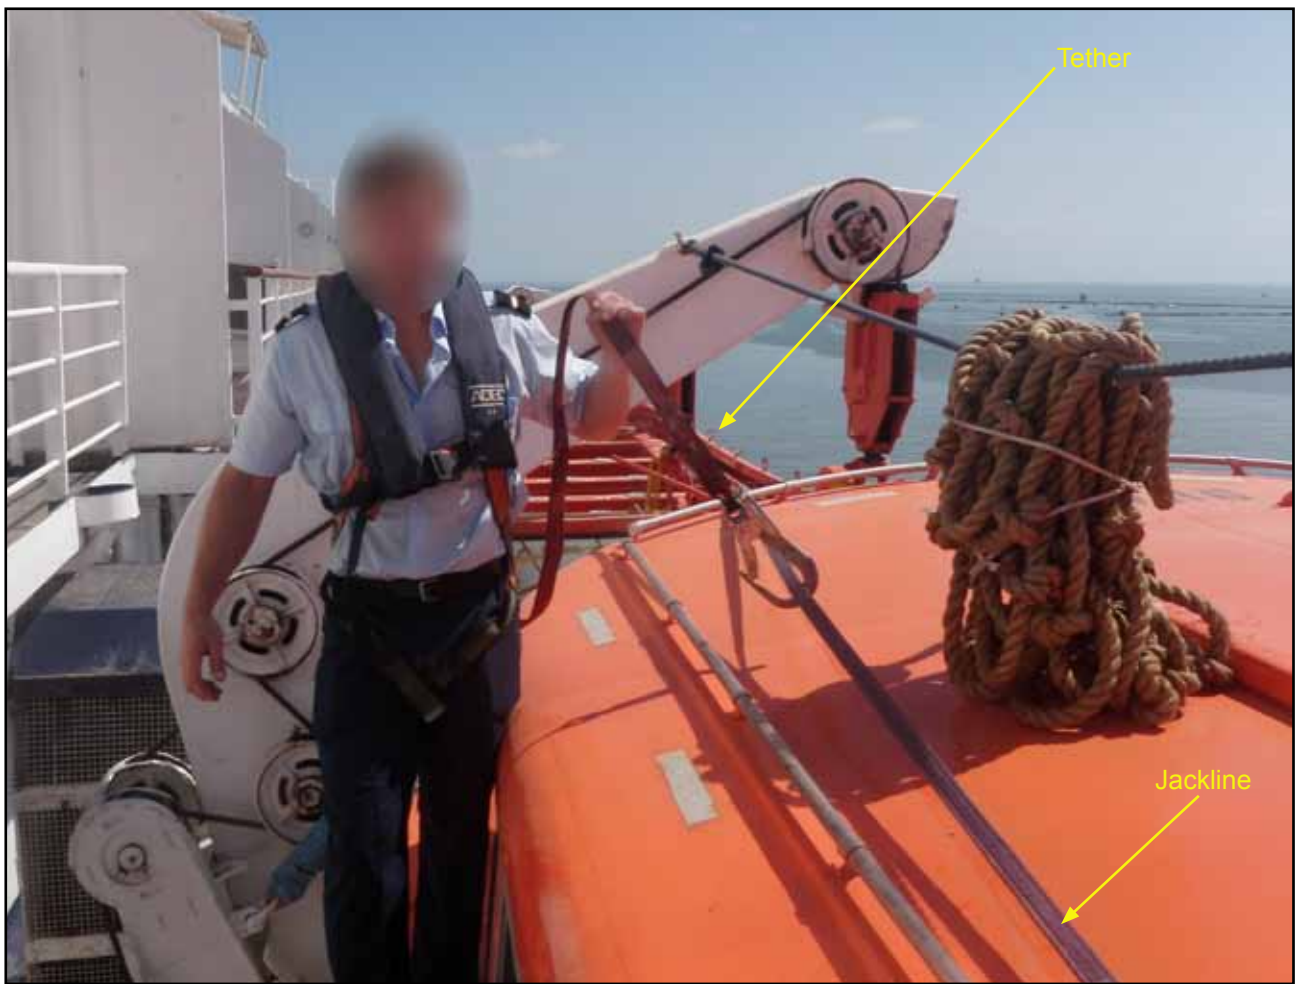
**Figure 21:** *Saga Ruby's* tender jackline and tether arrangement

Access to the bowsing tackle arrangements fitted to the tenders/lifeboats on board *Saga Ruby* required the lifeboat preparation/ lifeboat crews to climb onto the coach roof. There were no readily accessible strong points on the lifeboats/tenders to which to attach a safety harness tether. To overcome this, webbing jacklines, running fore to aft, were fitted to the glass reinforced plastic (GRP) coach roof to which a safety tether was attached (**Figure 21**). The jacklines were secured to shackles fitted to eyebolts which passed through the roof. The shackles were fitted to the eyebolts with, what appeared to be, a standard nut and bolt arrangement which had been prevented from slackening by a split pin (**Figure 22**). The issues relating to this arrangement are discussed at Section 2.10.
