Report on the investigation of the collision between

Seagate

Timor Stream

on 10 March 2012 at 0540 local time

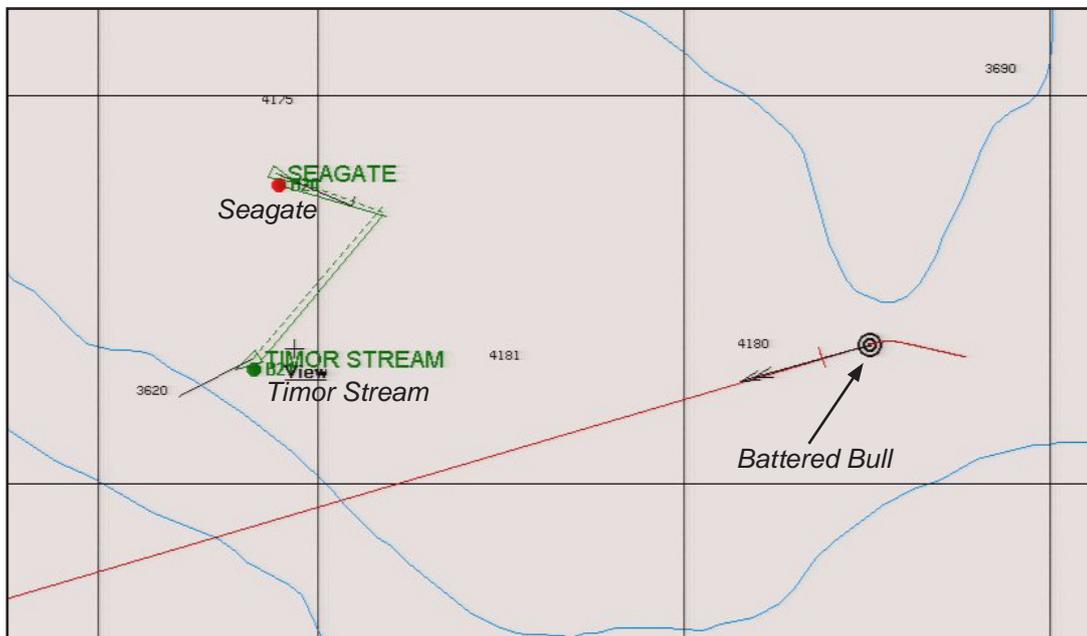
Figure 5: Battered Bull's ECS display at 0533

By 0532, *Seagate* and *Timor Stream* were 2.8nm from each other on a collision course (**Figure 4**); *Battered Bull* was 8.5nm from *Seagate*. *Battered Bull's* chief officer altered course 24° to port to avoid the developing situation with both *Seagate* and *Timor Stream* (**Figure 5**).

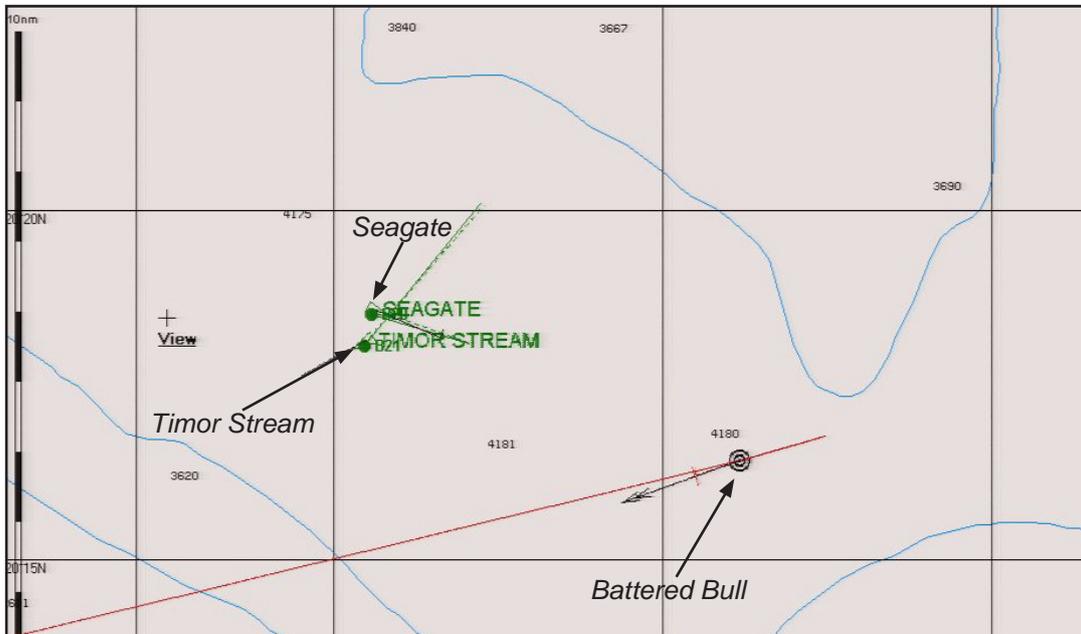
Figure 6: Battered Bull's ECS display at 0539

At around 0535, *Seagate's* lookout again told the chief officer about the other ship on his starboard side. As the distance between the two ships further reduced, the lookout yet again alerted the chief officer to the presence of the other ship. At 0539 (**Figure 6**) the chief officer started to alter *Seagate's* heading slowly to port; he predicted that this adjustment would increase the passing distance of the two ships. Shortly afterwards the lookout shouted at the chief officer to “do something”. The chief officer reported that he saw *Timor Stream* turn to port towards *Seagate* and, when he realised that a collision was imminent, he put the steering controls into manual mode and turned the helm hard to port.

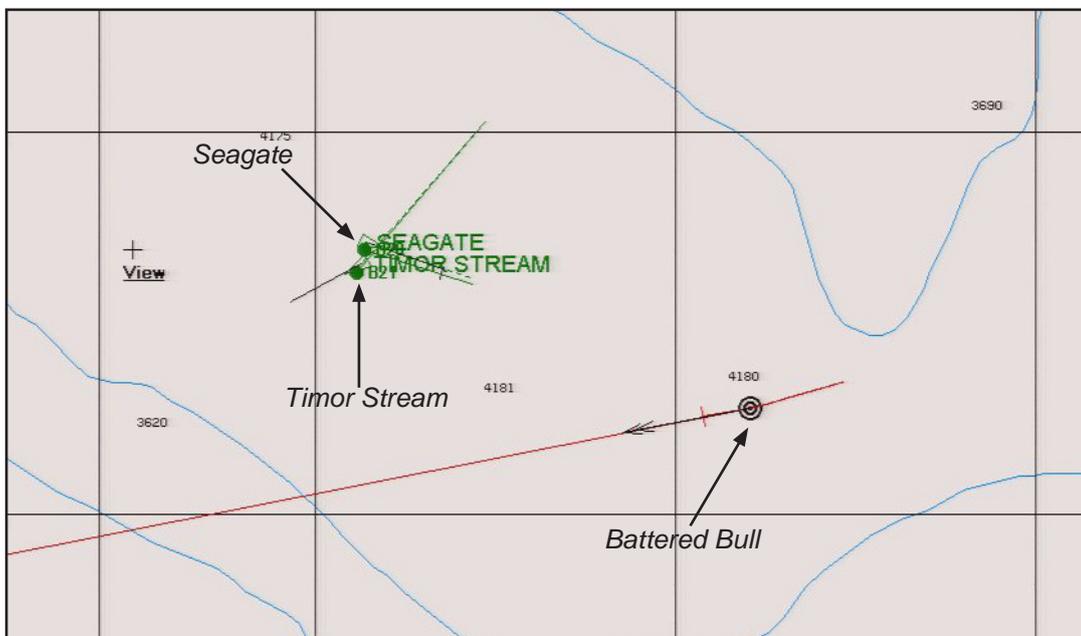
Figure 7: Battered Bull's ECS display at 0540

Timor Stream's master first saw a ship very close on his port bow at 0540 (**Figure 7**). He was unable to take avoiding action prior to the collision in the short time available to him.

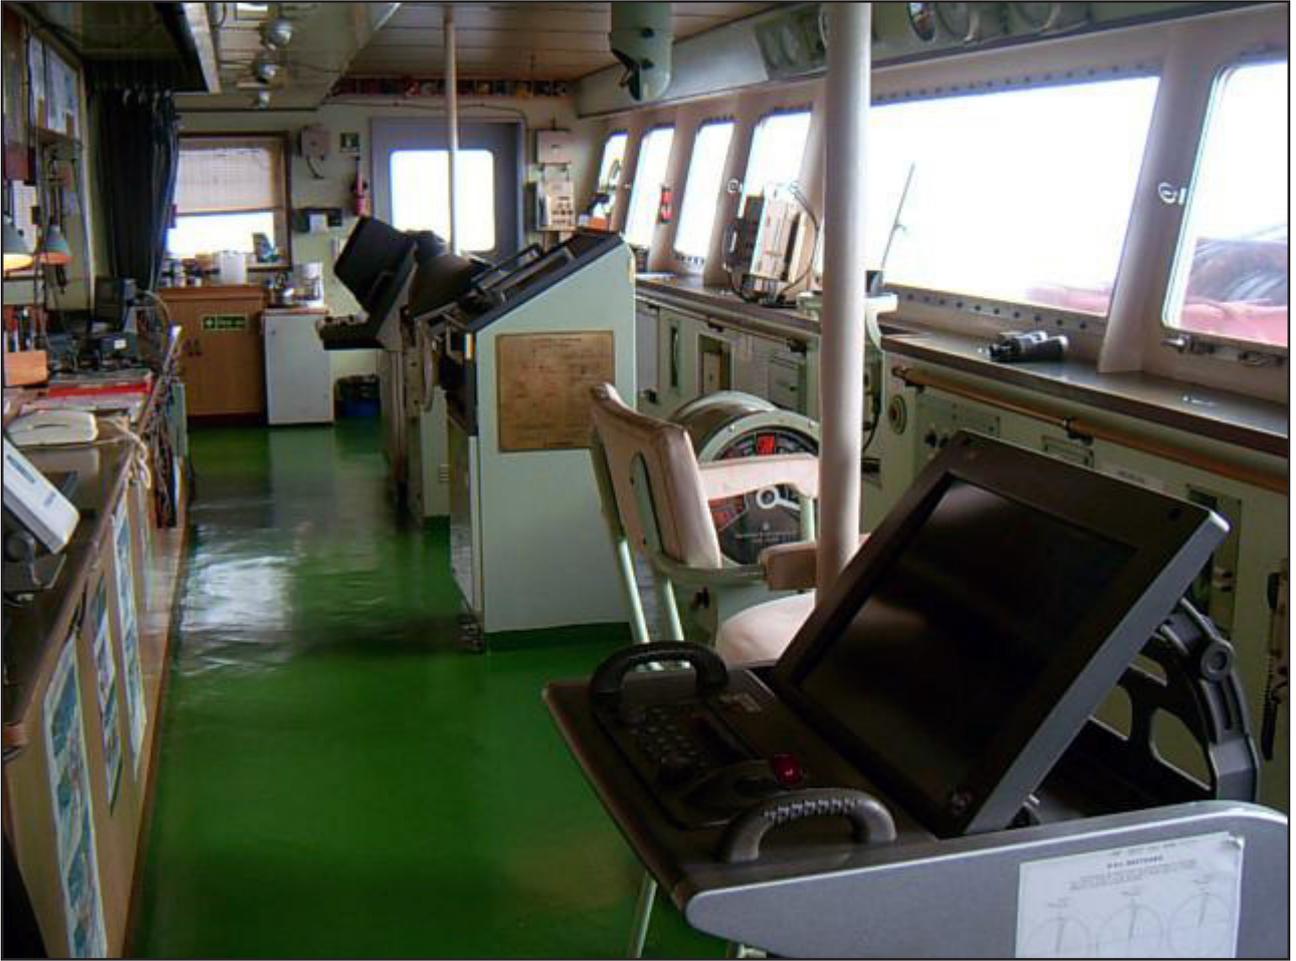
Figure 17: Seagate's bridge

Seagate's bridge (**Figure 17**) was fitted with two X band (3cm wavelength) radars, one on each side of the bridge. Both radars were fitted with an automatic radar plotting aid (ARPA). The starboard radar was also capable of displaying AIS data overlaid onto radar targets. At the time of the accident, it was reported that there was a fault with the system and, consequently, the radar was not able to display the AIS data.

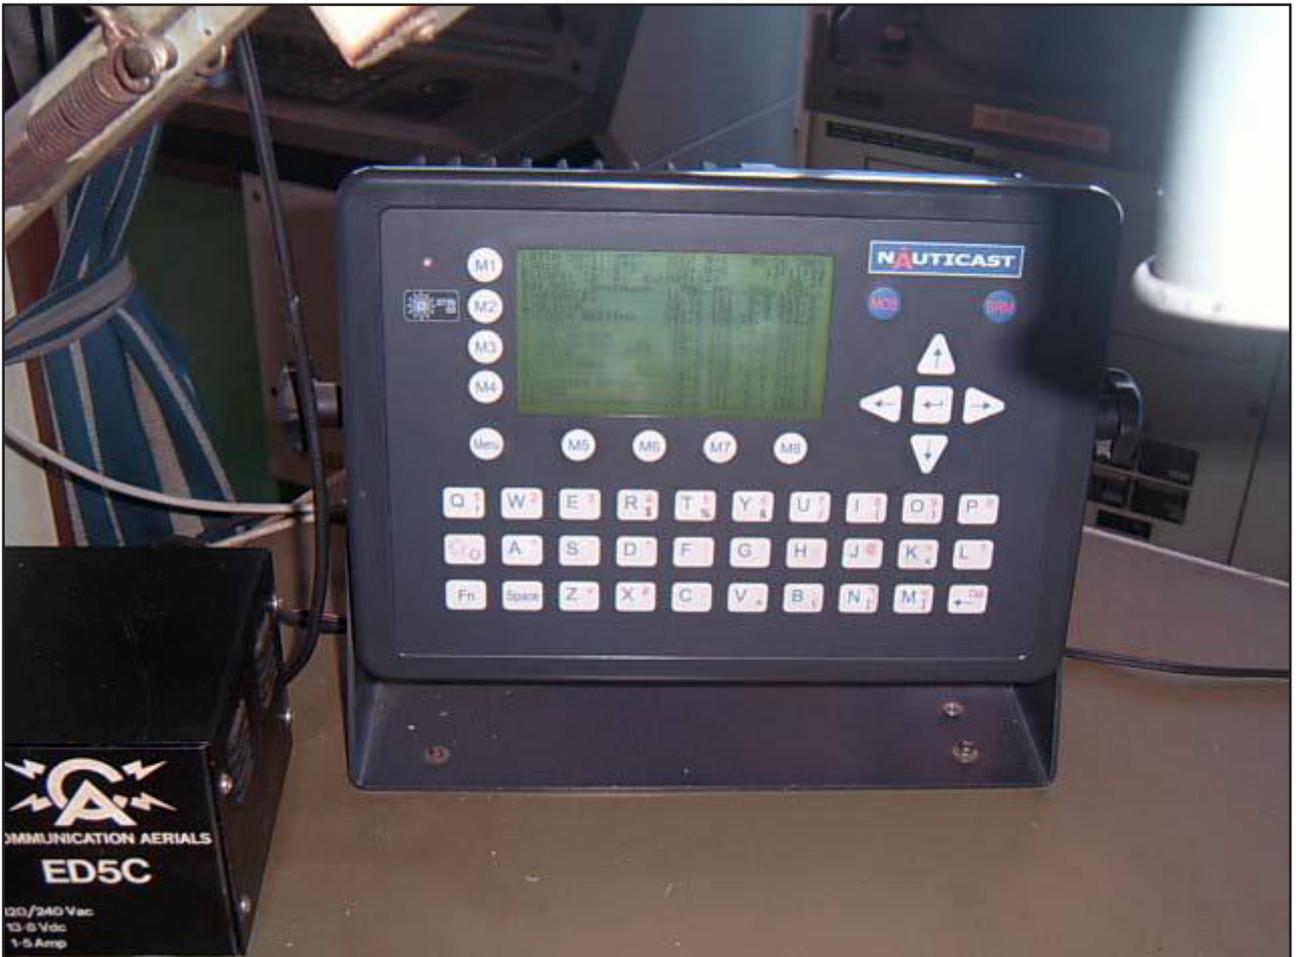
Figure 18: Seagate's AIS unit

A Nauticast AIS unit was located in the chart room (**Figure 18**). The AIS display screen was small and showed vessels' ranges, bearings, and names, in the form of text lists.

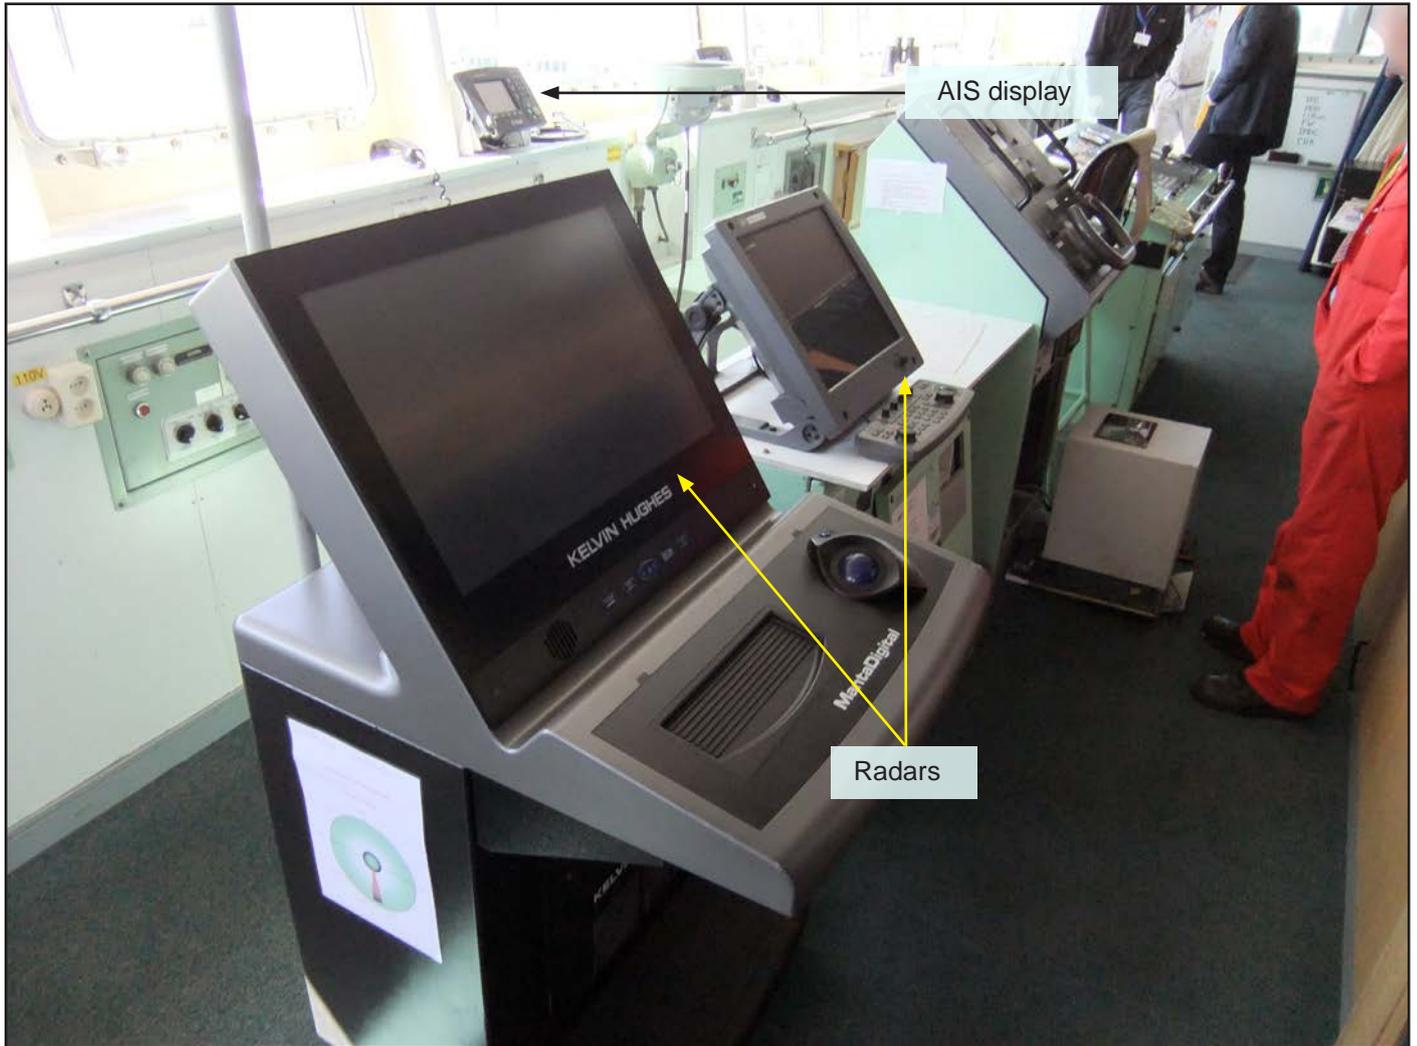
Figure 19: *Timor Stream's* bridge – radars and AIS display

The primary means of navigation was with British Admiralty paper Standard Nautical Charts. Two X band (3cm wavelength) ARPA radars were located on the port side of the bridge (**Figure 19**). The AIS unit (**Figure 19**) was located by the centre bridge front window. A pilot chair was provided on the centre line and, although the view ahead was partially obstructed by the deck cranes (**Figures 20**), it was still possible to obtain a good view ahead by changing position on the bridge. A watch alarm was provided, but was not in use at the time of the accident.

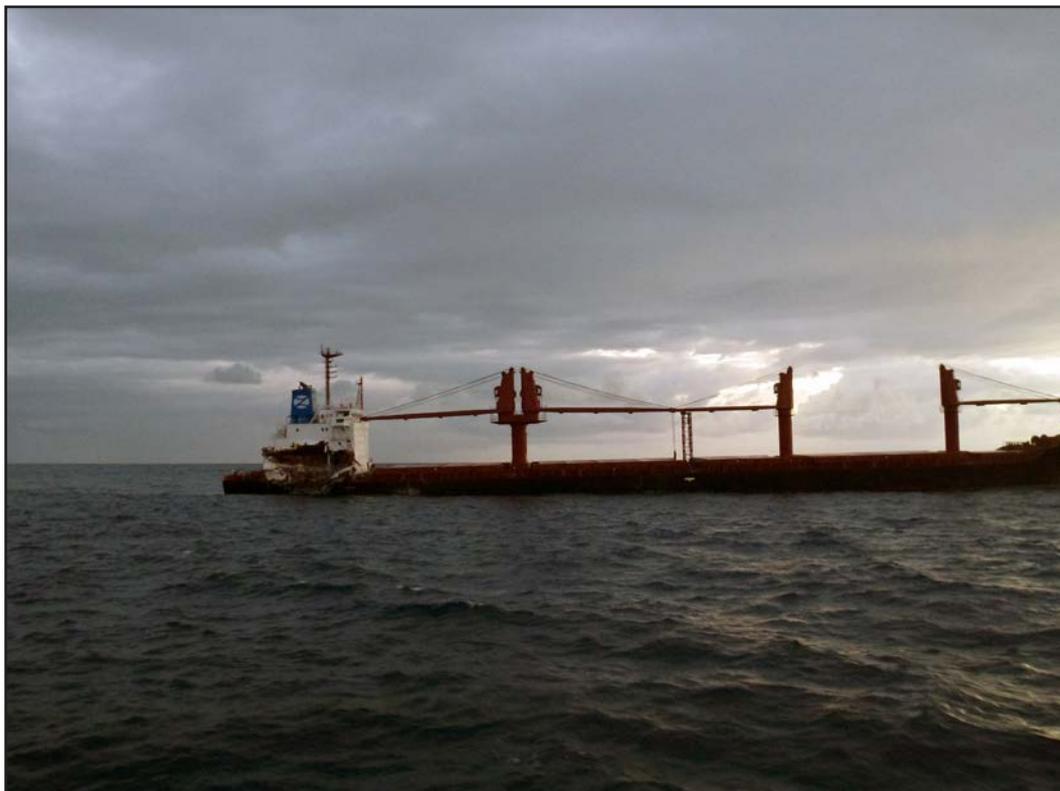
Figure 23: Environmental conditions shortly after the collision

- Cloudy, with occasional light isolated rain showers
- Wind: north-east, Beaufort Force 3
- Swell: north-east, height 1.5m (**Figure 23**)
