Report on the investigation of
a fatal manoverboard from the fishing vessel

Zenith (B 470)

29 miles south-east of Kilkeel

on 29 January 2012

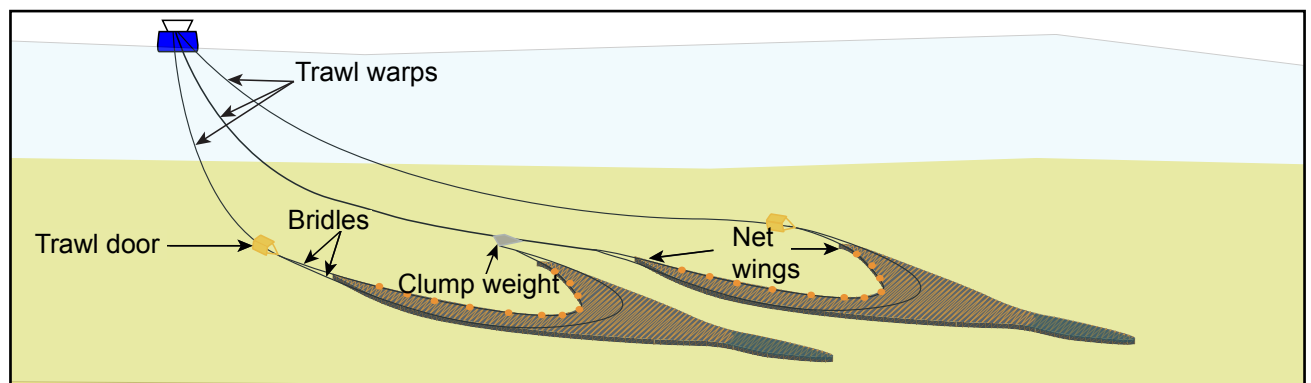
Figure 1: Diagrammatic representation of twin rig trawling

When fishing, *Zenith* towed two nets on the seabed (twin-rig trawling), connected to the vessel by three trawl warps or wires (**Figure 1**). The port and starboard wires led to otter boards, or trawl doors, which kept the mouths of the nets open by spreading the net wings apart. A third central wire was shared by the inner wing of each net and was fastened to a heavy chain weight, known as a clump, that kept the middle of the arrangement on the sea bed. Aft of the trawl doors and clump, the wing ends of the nets were attached by bridles which dragged over the sea bed, guiding the catch towards the nets.

It was not uncommon for bridles and nets to build up unevenly and collapse upon themselves while being wound onto the drums, causing them to subsequently become entangled during shooting. To prevent this build-up, the skipper would either steer *Zenith*'s stern into the nets, or two deckhands would manually push the bridles and wing ends apart for the first three or four turns of the net drums, monitored by the net drum controller. This operation required the deckhands to place themselves abaft the net drums and work with their arms at full stretch over their heads. However, when the weather permitted, it had become the custom for them to make access to the gear easier by standing on the transom bulwark top rail to spread the bridles and net wing ends apart.

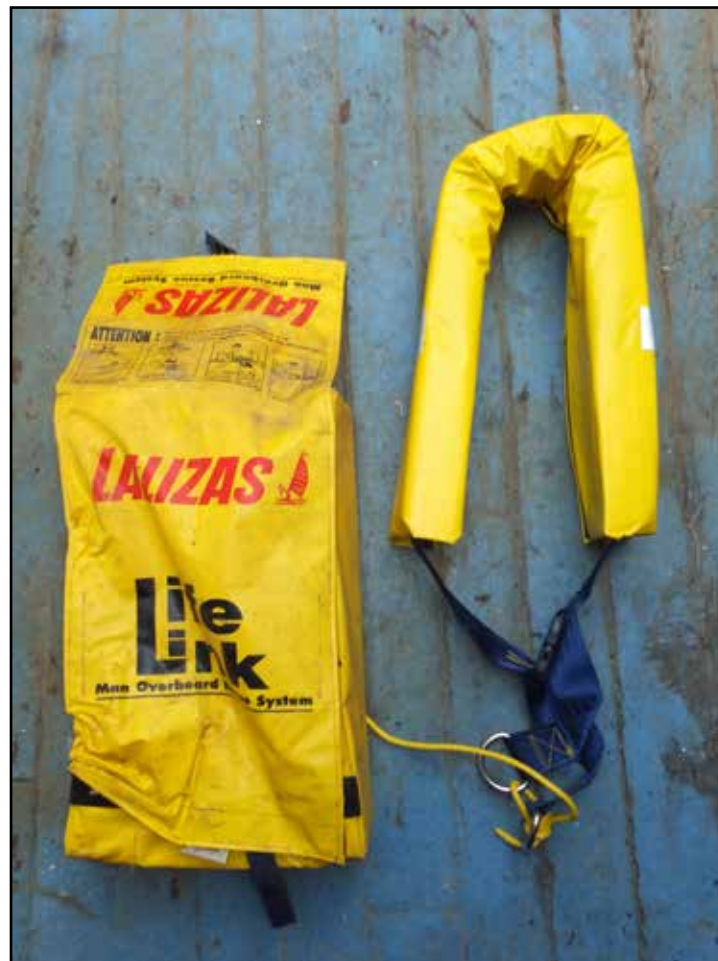
Figure 7: Lalizas manoverboard recovery equipment

Antares underwent UK Fishing Vessel Certificate (UKFVC) surveys in 1996, 2000 and 2004 during which the modifications of 1996 went unnoticed by the attending surveyors. The 2004 UKFVC renewal survey was protracted as *Antares* was detained for several weeks for having numerous serious defects, including the lack of manoverboard (MOB) retrieval equipment. During this period her name was changed to *Zenith*, her current skipper became an owning partner and he took over operational management of the vessel. The vessel was released from detention once the deficient items had been brought up to the standard required by the survey. This included the fitting of a *Lalizas* MOB retrieval system (**Figure 7**).

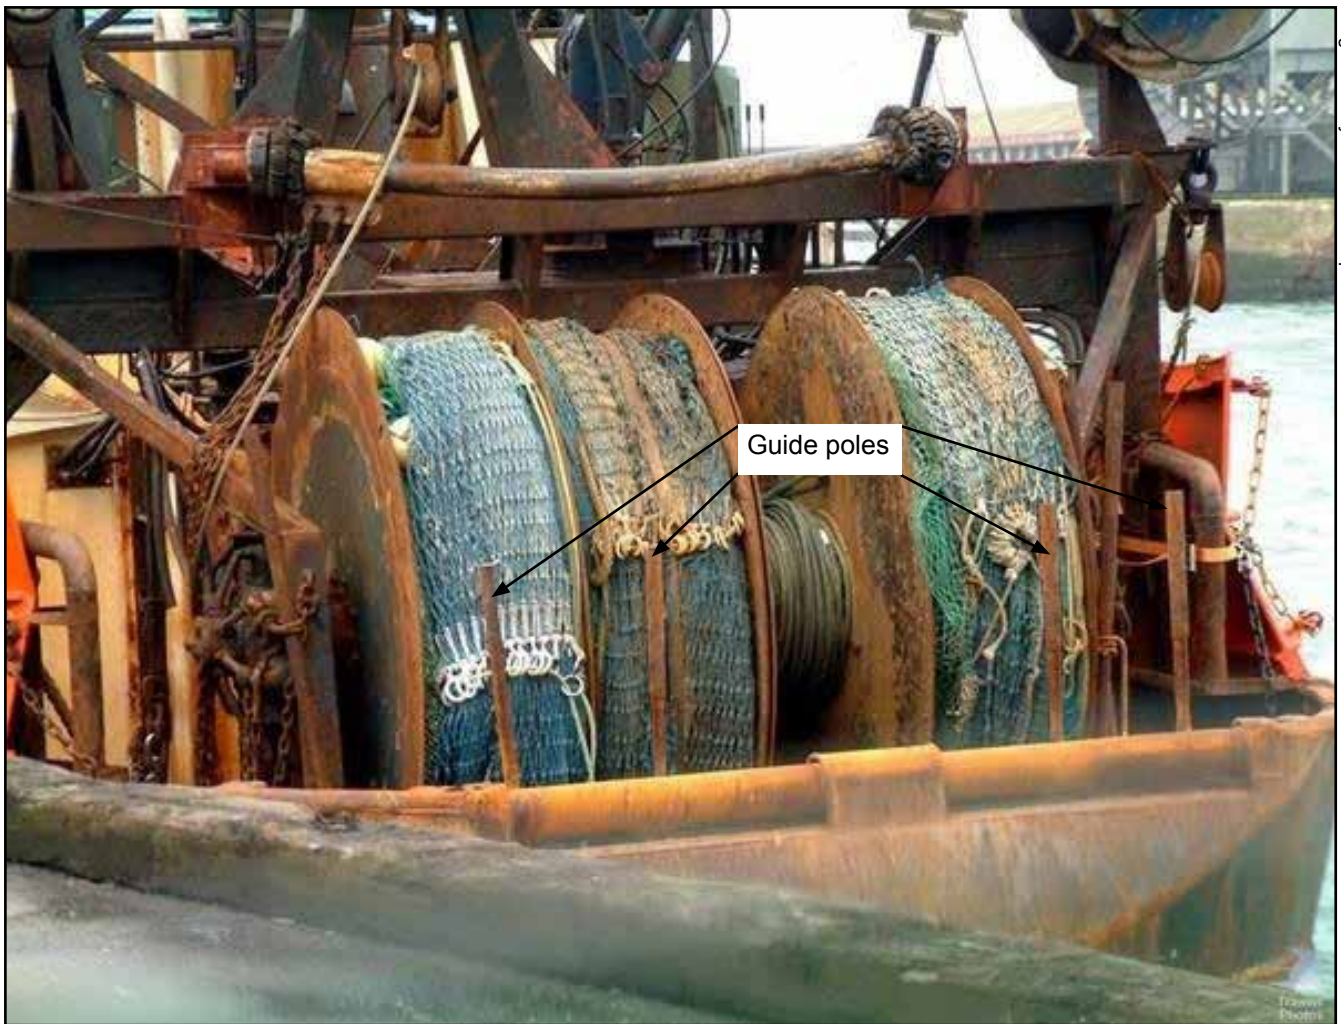
Figure 9: Stern trawler showing example of a deck mounted net drum with guide poles in place

In 1987, *Zenith*'s deckhouse had been extended aft. Consequently, there was insufficient space to fit a net drum on the deck, and in 1996 when the vessel was converted to stern trawling the net drum was positioned above the deck, on supporting legs. As a result of the height of the net drums and the short aft deck, the height of the bridles and nets during retrieval was well above the bulwarks. This prevented the use of vertical guide poles to initially guide the gear onto the drums, as used by many other vessels with lower drums (**Figure 9**). Nevertheless, there are many examples of similar arrangements whereby skippers manoeuvre their vessels during retrieval in such a way as to ensure that nets feed onto the drums evenly without the need for manual intervention by the crew. It was unsafe for a man to stand on the bulwarks to feed the bridles and nets onto the net drum, and an alternative system, that did not require manual intervention, should have been devised.

Zenith's six-man crew had a great deal of experience of working with her fishing gear. The vessel had operated without significant incident since the vessel's conversion to twin rig trawling in 1996. Getting onto the top rail to spread the bridles was a practice that crews had evolved since 2004 to reduce the possibility of uneven build up of the gear on the drums and the risk that the unbalanced turns

would subsequently collapse and entangle the nets, causing subsequent delays during shooting. Although standing on the top rail to guide the bridles and net wings onto the drums was the deckhands' chosen way of working, it was known about and condoned by the skipper. There was no need to stand on the top rail to push the gear apart, but it made the task somewhat easier than when the crew attempted to do so from the deck.
