Report on the investigation of
the loss of a crewman from the fishing vessel

***St Amant* (BA 101)**

off the coast of north-west Wales

on 13 January 2012

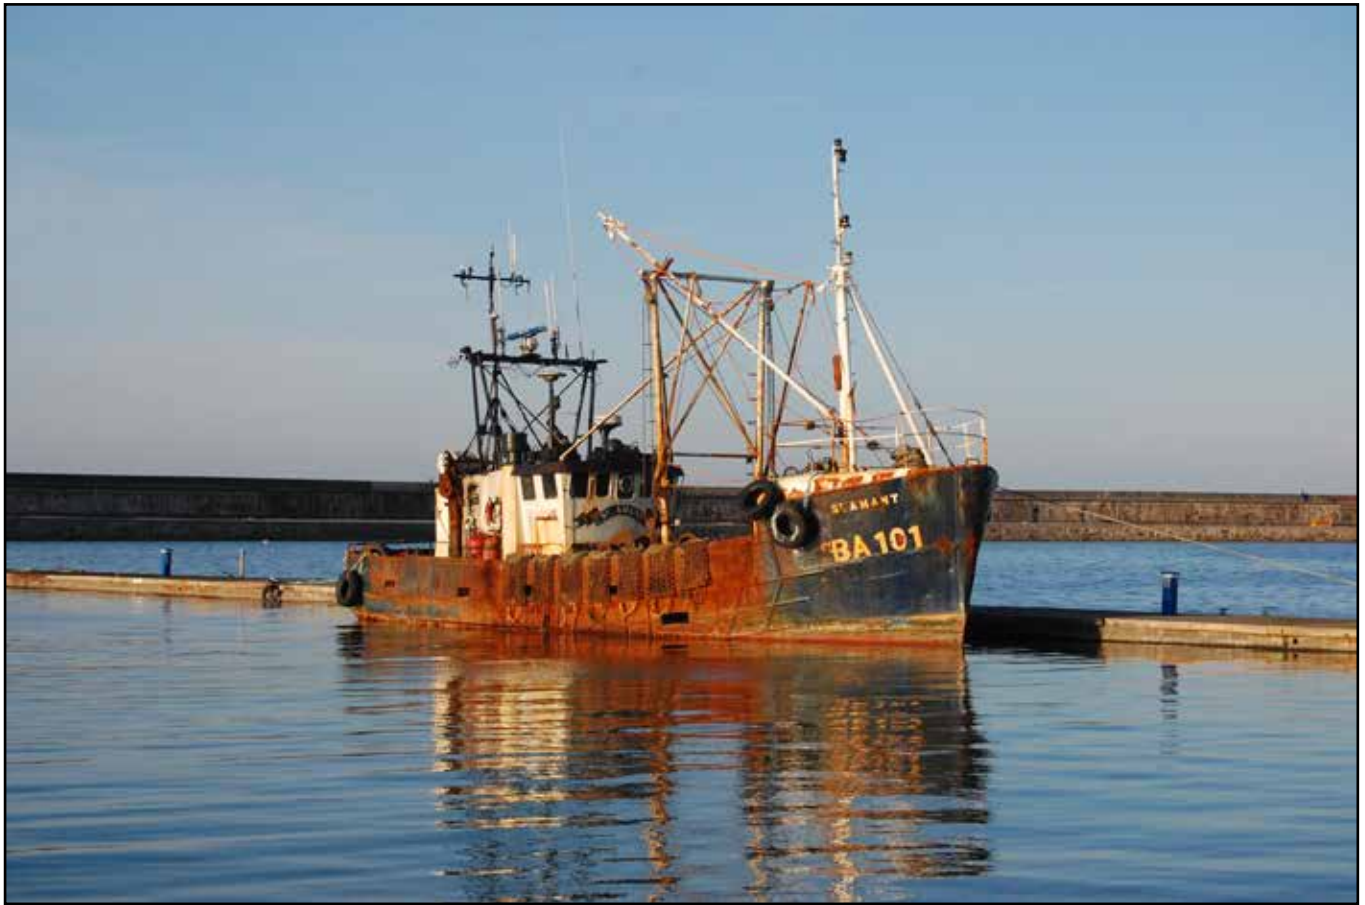
Figure 1: *St Amant* following this accident

St Amant was a UK-registered scallop dredger with a length overall (LOA) of 17.8m as depicted at **Figure 1**. The vessel's general arrangement is shown at **Figure 2**. Although *St Amant*'s home port was Kirkcudbright in the south-west of Scotland, the crew of four generally worked on board the vessel for up to 10 days, operating from various ports around the UK coastline. In late 2011, the vessel had been operating off the west coast of Scotland and had returned to Kirkcudbright for the Christmas and New Year holiday period.

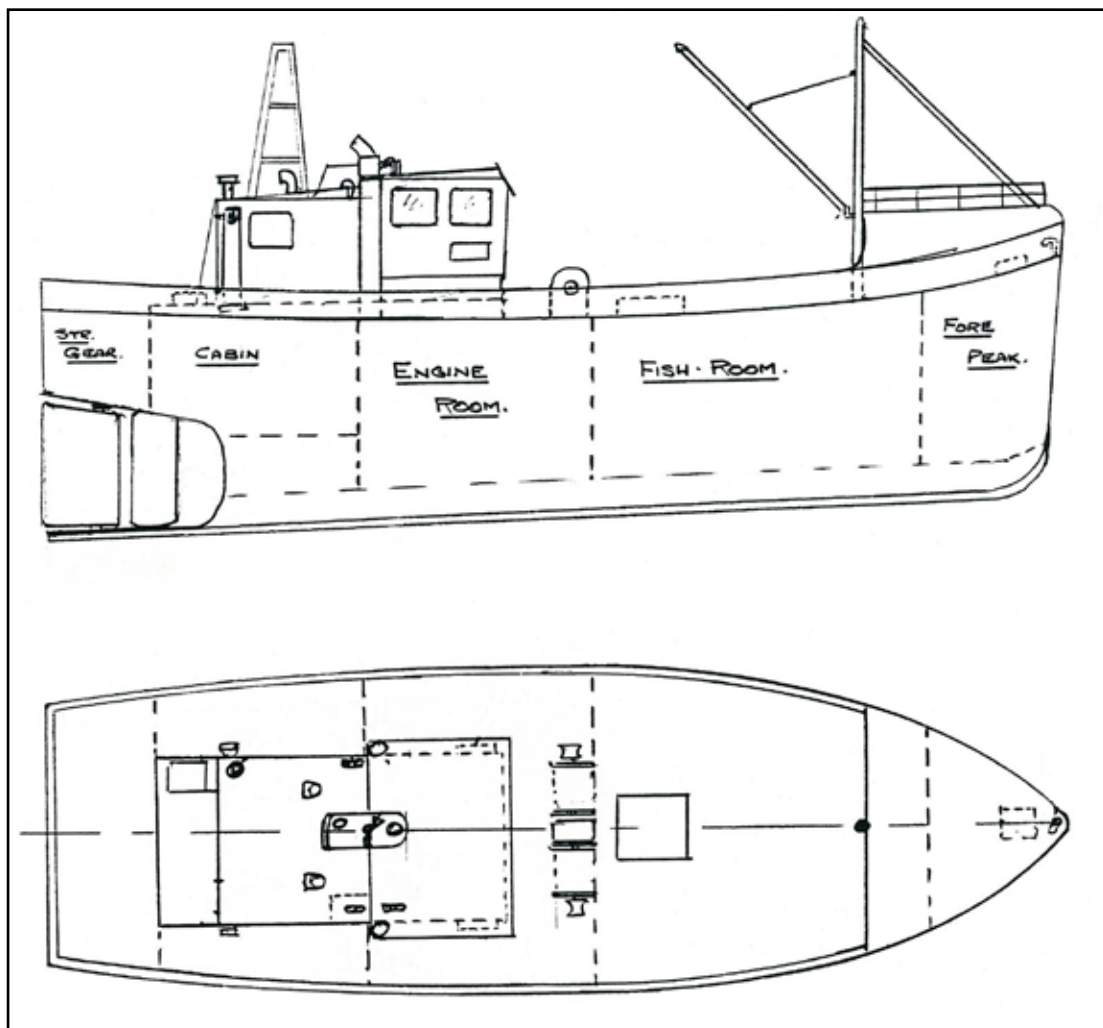
Figure 2: General arrangement of *St Amant* at time of accident

The layout of *St Amant* at the time of the accident is at **Figure 2**. The vessel was of steel construction, with predominantly wooden planked decks; these were reported as not being slippery at the time of the accident.

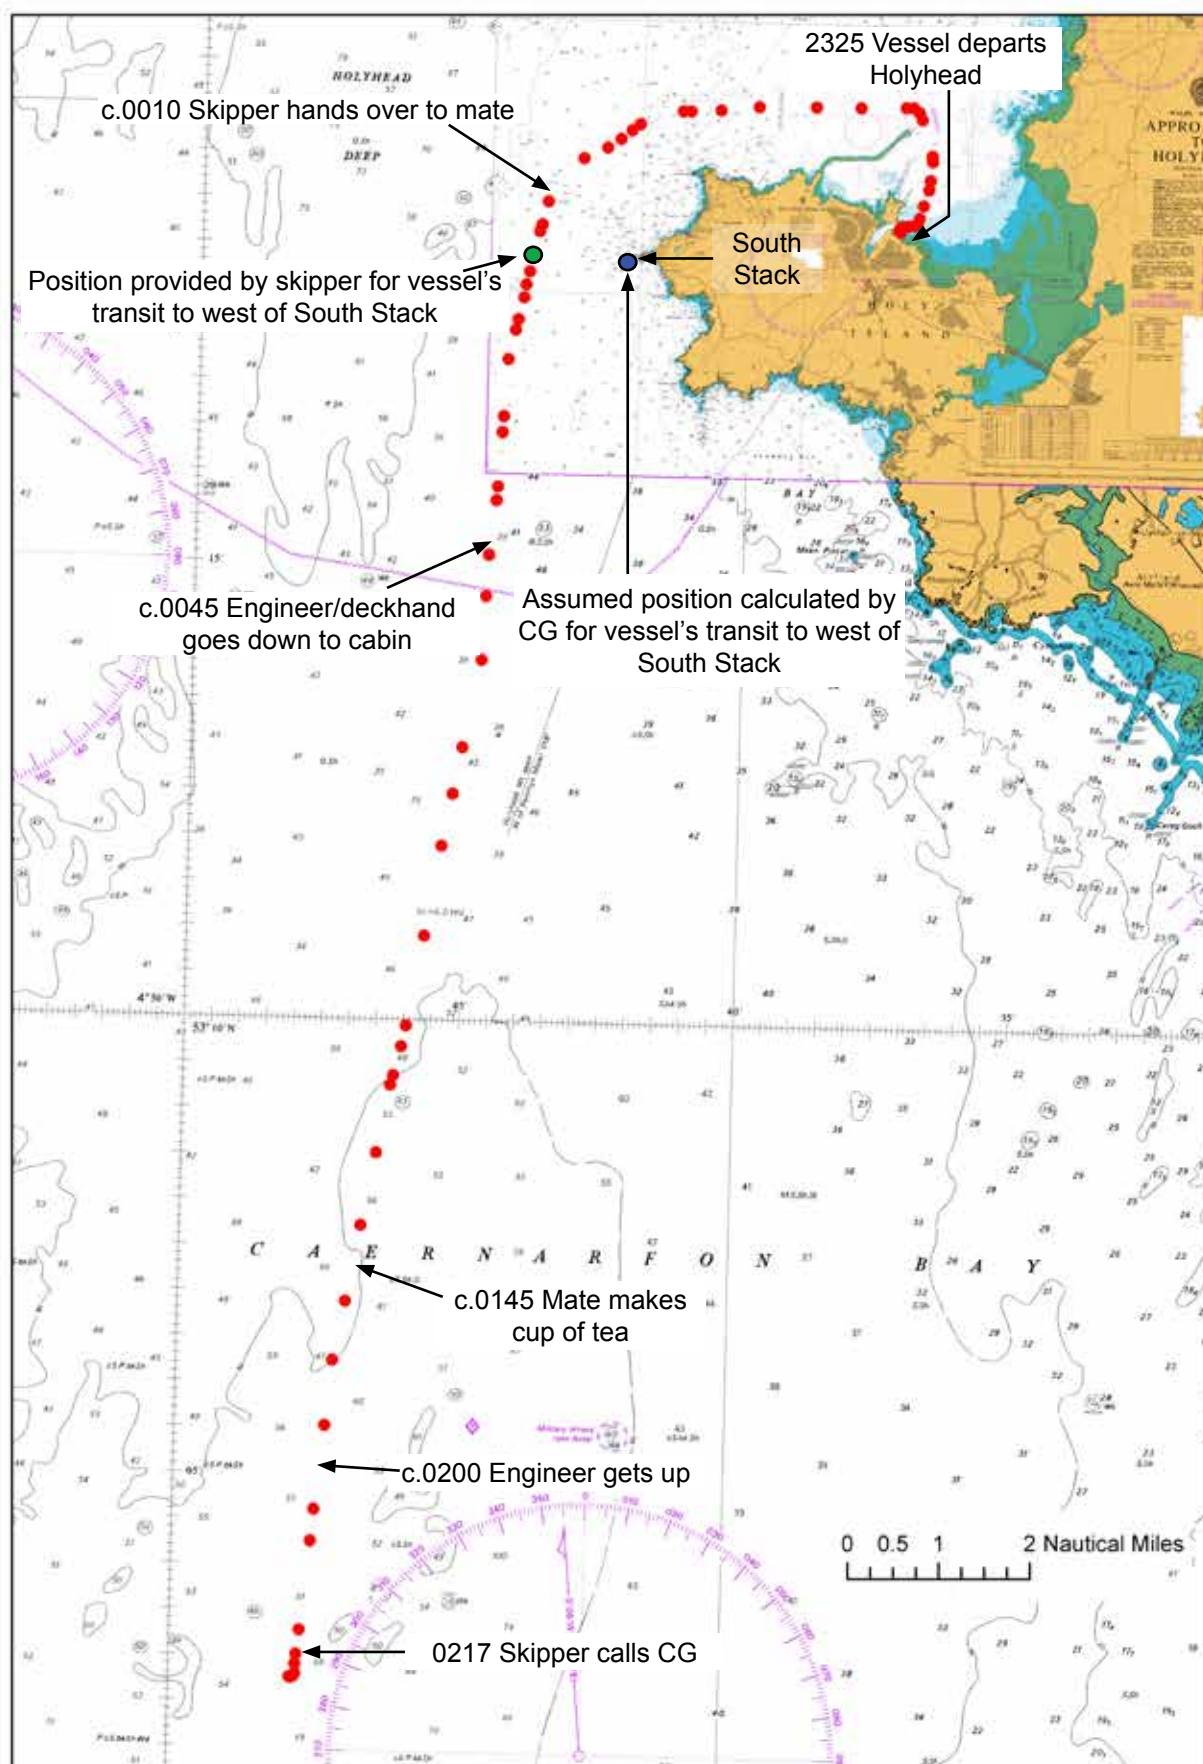
Figure 3: Chart showing track of *St Amant* (all times UTC)

The skipper navigated the vessel around the northern coast of Anglesey. He steadied the vessel (on an autopilot-controlled heading) onto a course over the ground of about 190°, making directly for the intended fishing grounds (**Figure 3**). At about 0010 on 13 January the skipper handed the watch over to the mate and went down to the cabin (**Figures 6a and b**) to rest.

At 0253, the skipper confirmed that *St Amant* had earlier passed South Stack at position 53° 18.47'N 004° 43.995'W (**Figure 3**), about 1nm to the west-north-west of the position previously assumed by the MRCC. During the subsequent conversation, the MRCC also queried the course details that had been provided with the skipper, who suggested that the 205° course would have been approximate, due to a possible discrepancy with the autopilot.

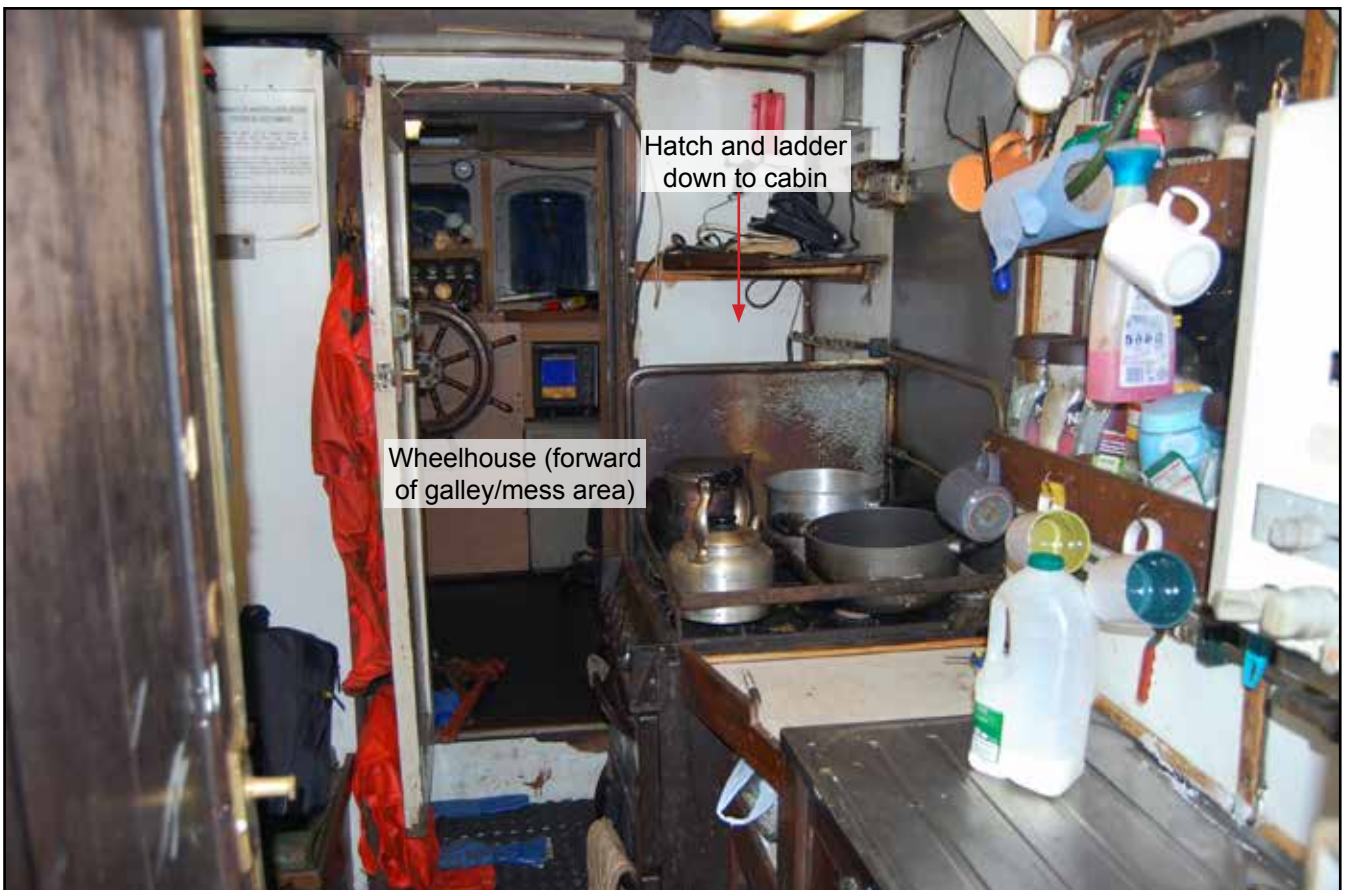
Figures 5b: Galley/mess area on *St Amant* looking forward

Access to the superstructure was via an aft facing door from the quarter deck into the galley/mess area (**Figures 5a and b**). Forward of this was the wheelhouse, containing a typical arrangement of navigational equipment for a fishing vessel, including an OLEX chart plotter.

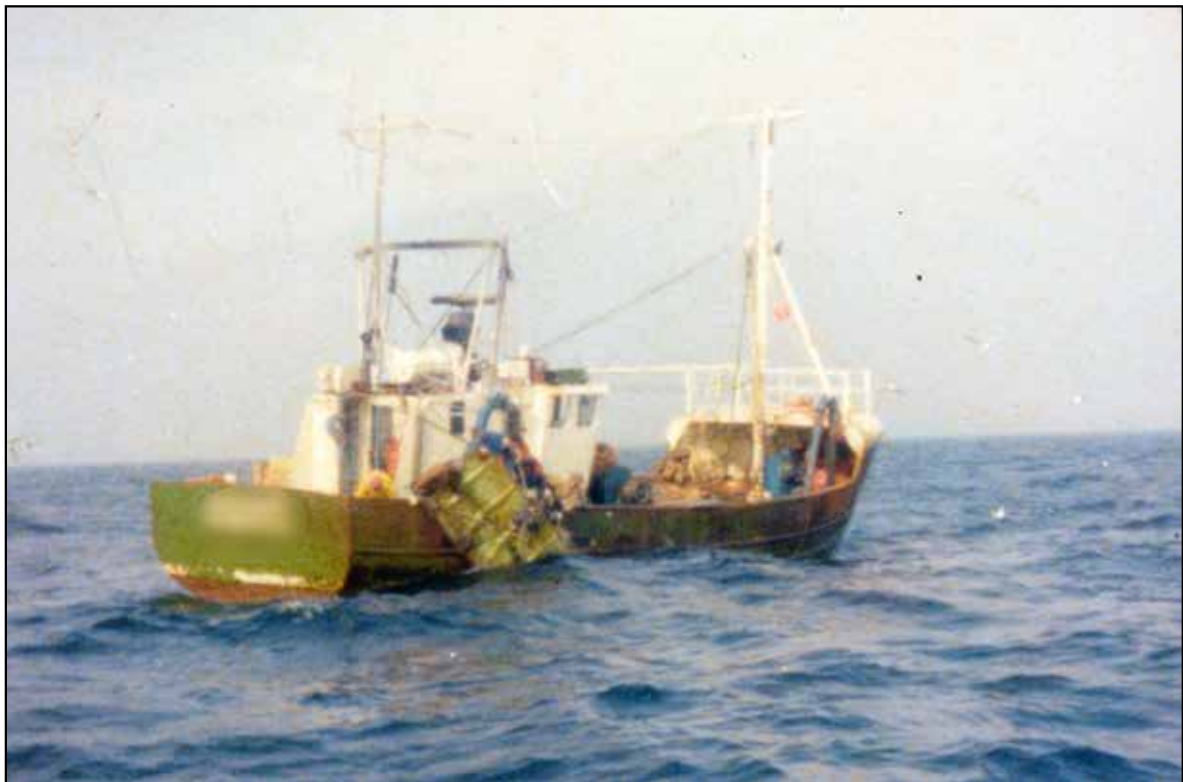
Figure 7: Vessel operating as a side trawler in the 1970s

The vessel's keel was laid in March 1974, and she entered service in 1975 as a side trawler or "sidewinder" (**Figures 7, 8a and b**) on the east coast of England. She was later renamed *St Amant* following a change of ownership. In 1984, a major fire on board the vessel caused severe damage to the accommodation and wheelhouse. Extensive repairs were undertaken, including replacement of the upper steelwork and bulwarks⁵, and in 1985 the vessel re-entered service as a scallop dredger.

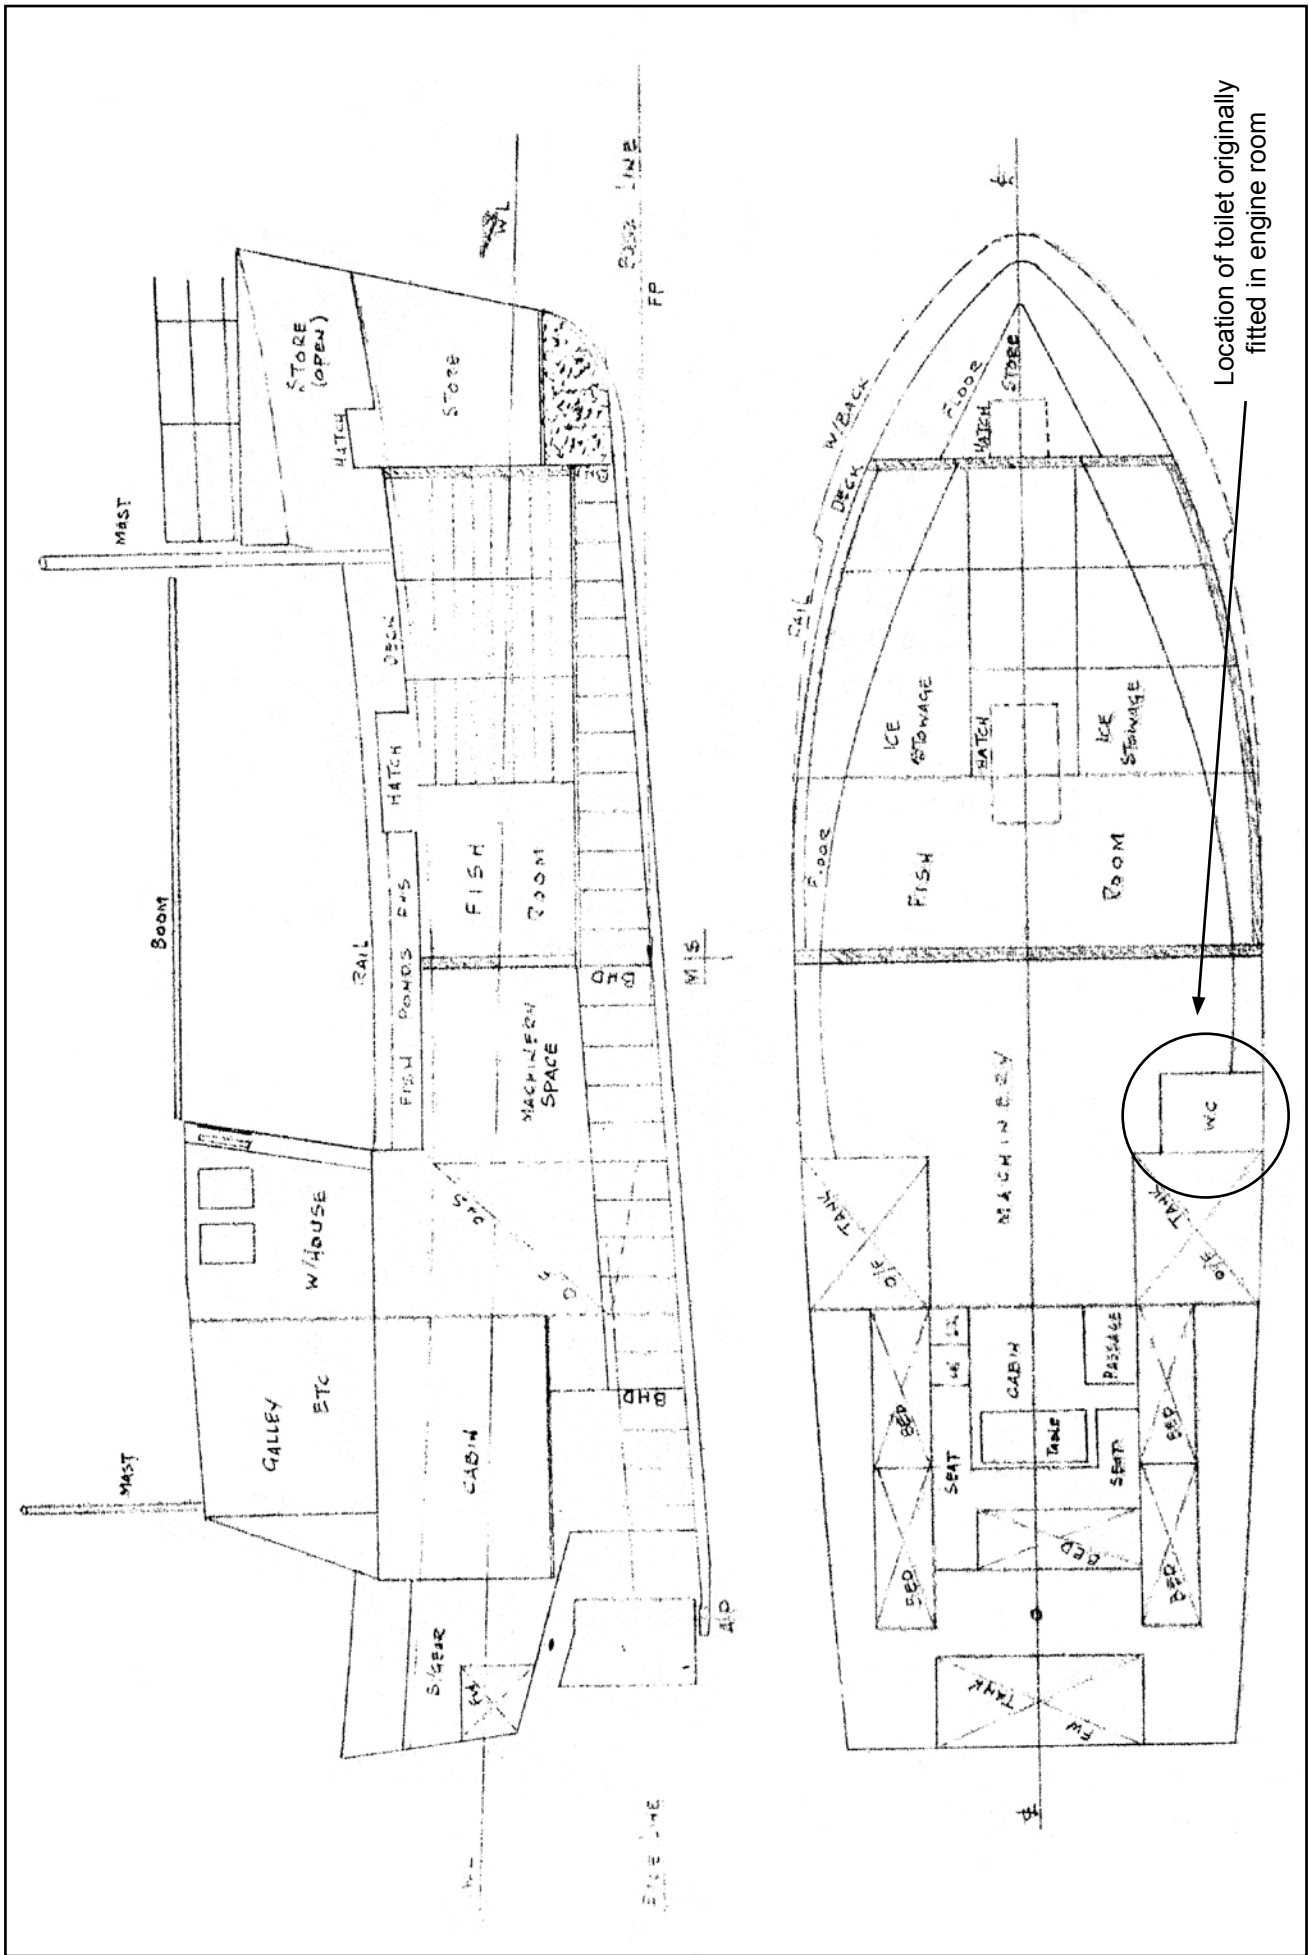
Figure 8a: General arrangement of vessel as built

Although the vessel had originally been built with a toilet in the engine room (**Figure 8a**), this had been removed at some stage after 1985. There was no toilet fitted on board at the time of the accident.

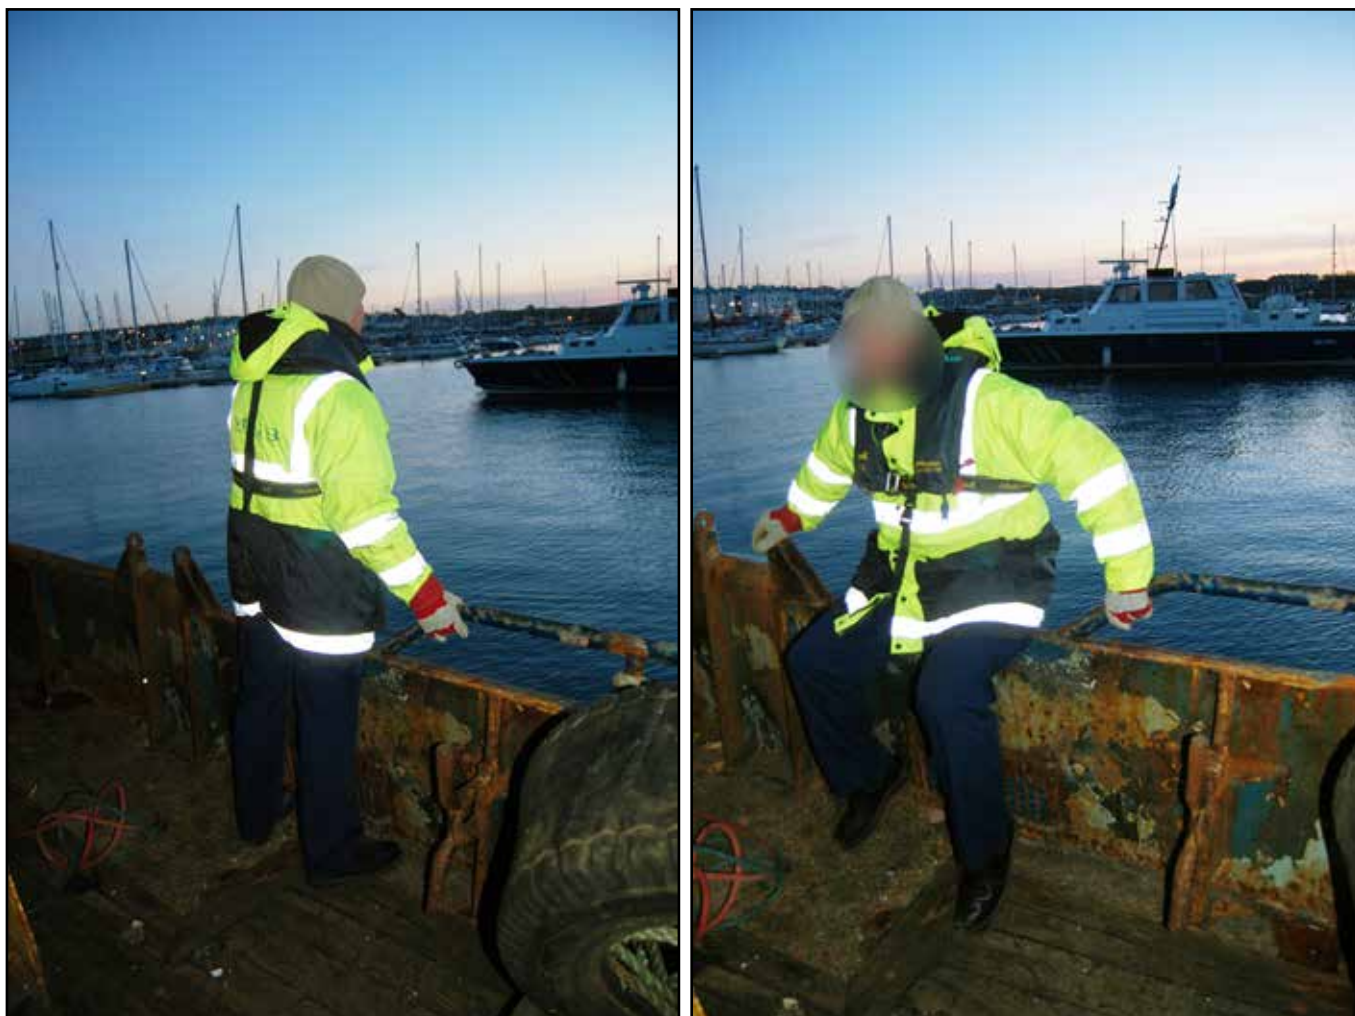
Figures 12a and 12b: Photos of demonstration of crewman relieving himself or defecating over the bulwarks aft of the starboard outrigger

A basic chemical toilet, incorporating a bucket with an attached toilet seat, was reported to have been previously kept in the fish hold. However, at the time of the accident, the crew either relieved themselves overboard or into an ordinary bucket which was kept on top of the storage area at the stern (**Figure 11**). If the bucket was required, the accepted procedure on board was to use it on the open deck at the stern. However, if the weather was poor, crewmen would take the bucket down into the fish hold, where the catch of scallops and fresh provisions were stored, to provide more shelter. Steven was reported to have preferred to use the bucket. Others opted to sit over the side, partially supporting themselves on the outrigger (**Figures 12a and b**). The bucket was in its normal position when Steven was discovered missing.

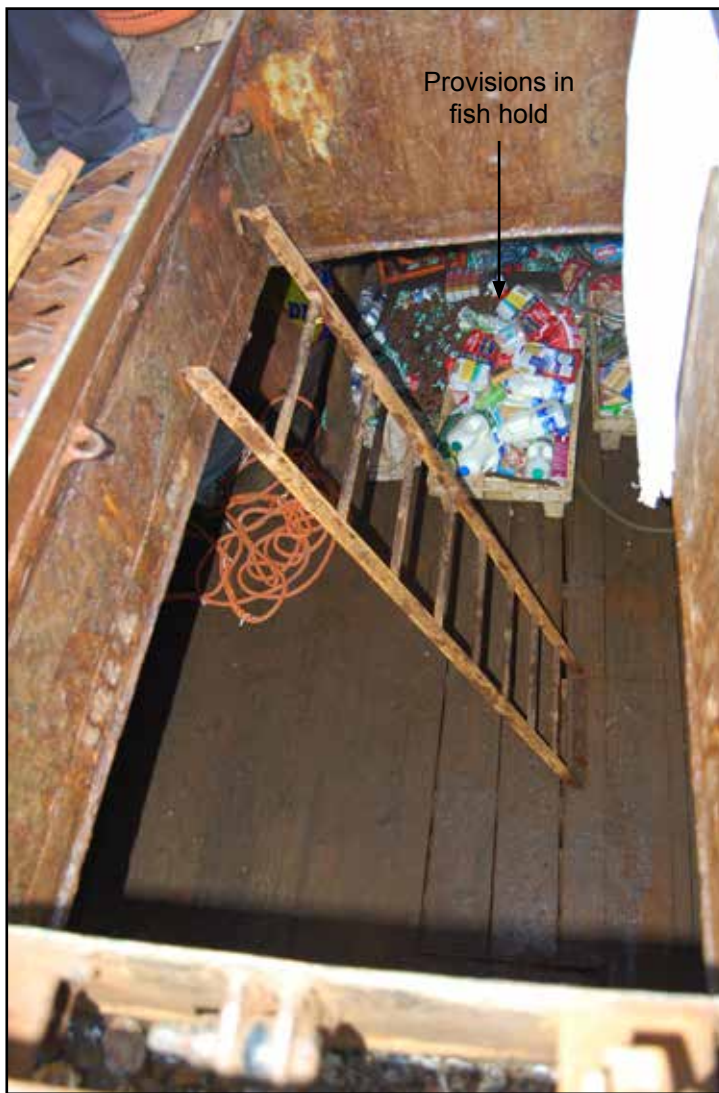
Figure 13: Photo looking down into the fish hold

The vessel had no refrigeration facilities for provisions. These were either stowed in the aft open storage area or in the fish hold (**Figure 13**). The sink in the galley/mess offered the only food preparation and washing facilities for the crew (**Figure 5a**).

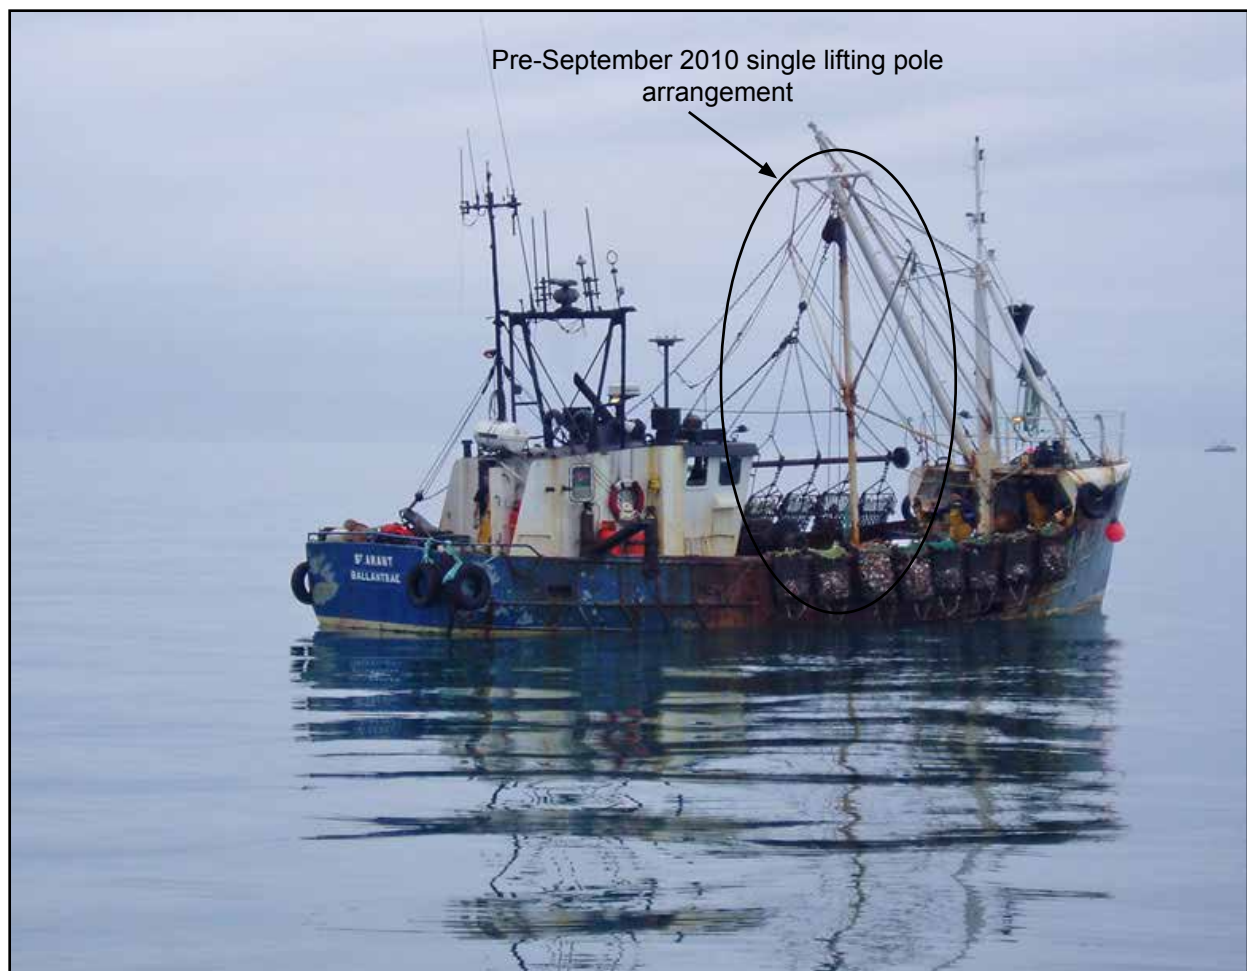
Figure 16a: Lifting arrangement on *St Amant* before modification in 2010

In early September 2010, the MCA became aware of modifications being made to *St Amant*'s lifting equipment: a new ‘goalpost’ type arrangement for the dredging gear was being fitted (**Figure 16b**) to replace the previous single lifting pole (**Figure 16a**). The MCA wrote to the skipper requesting that details of the modification be forwarded for approval.

During an MCA inspection on 29 September 2010, an action code 16 deficiency (requiring rectification within 14 days) was raised for details of these modifications to be forwarded to the Marine Office. There was no record on the CM files or SIAS (**Annex J**) of this deficiency being followed up.
