Report on the investigation of

the capsize and foundering of the fishing vessel

Heather Anne (FY 126)

REPORT NO 2/2013

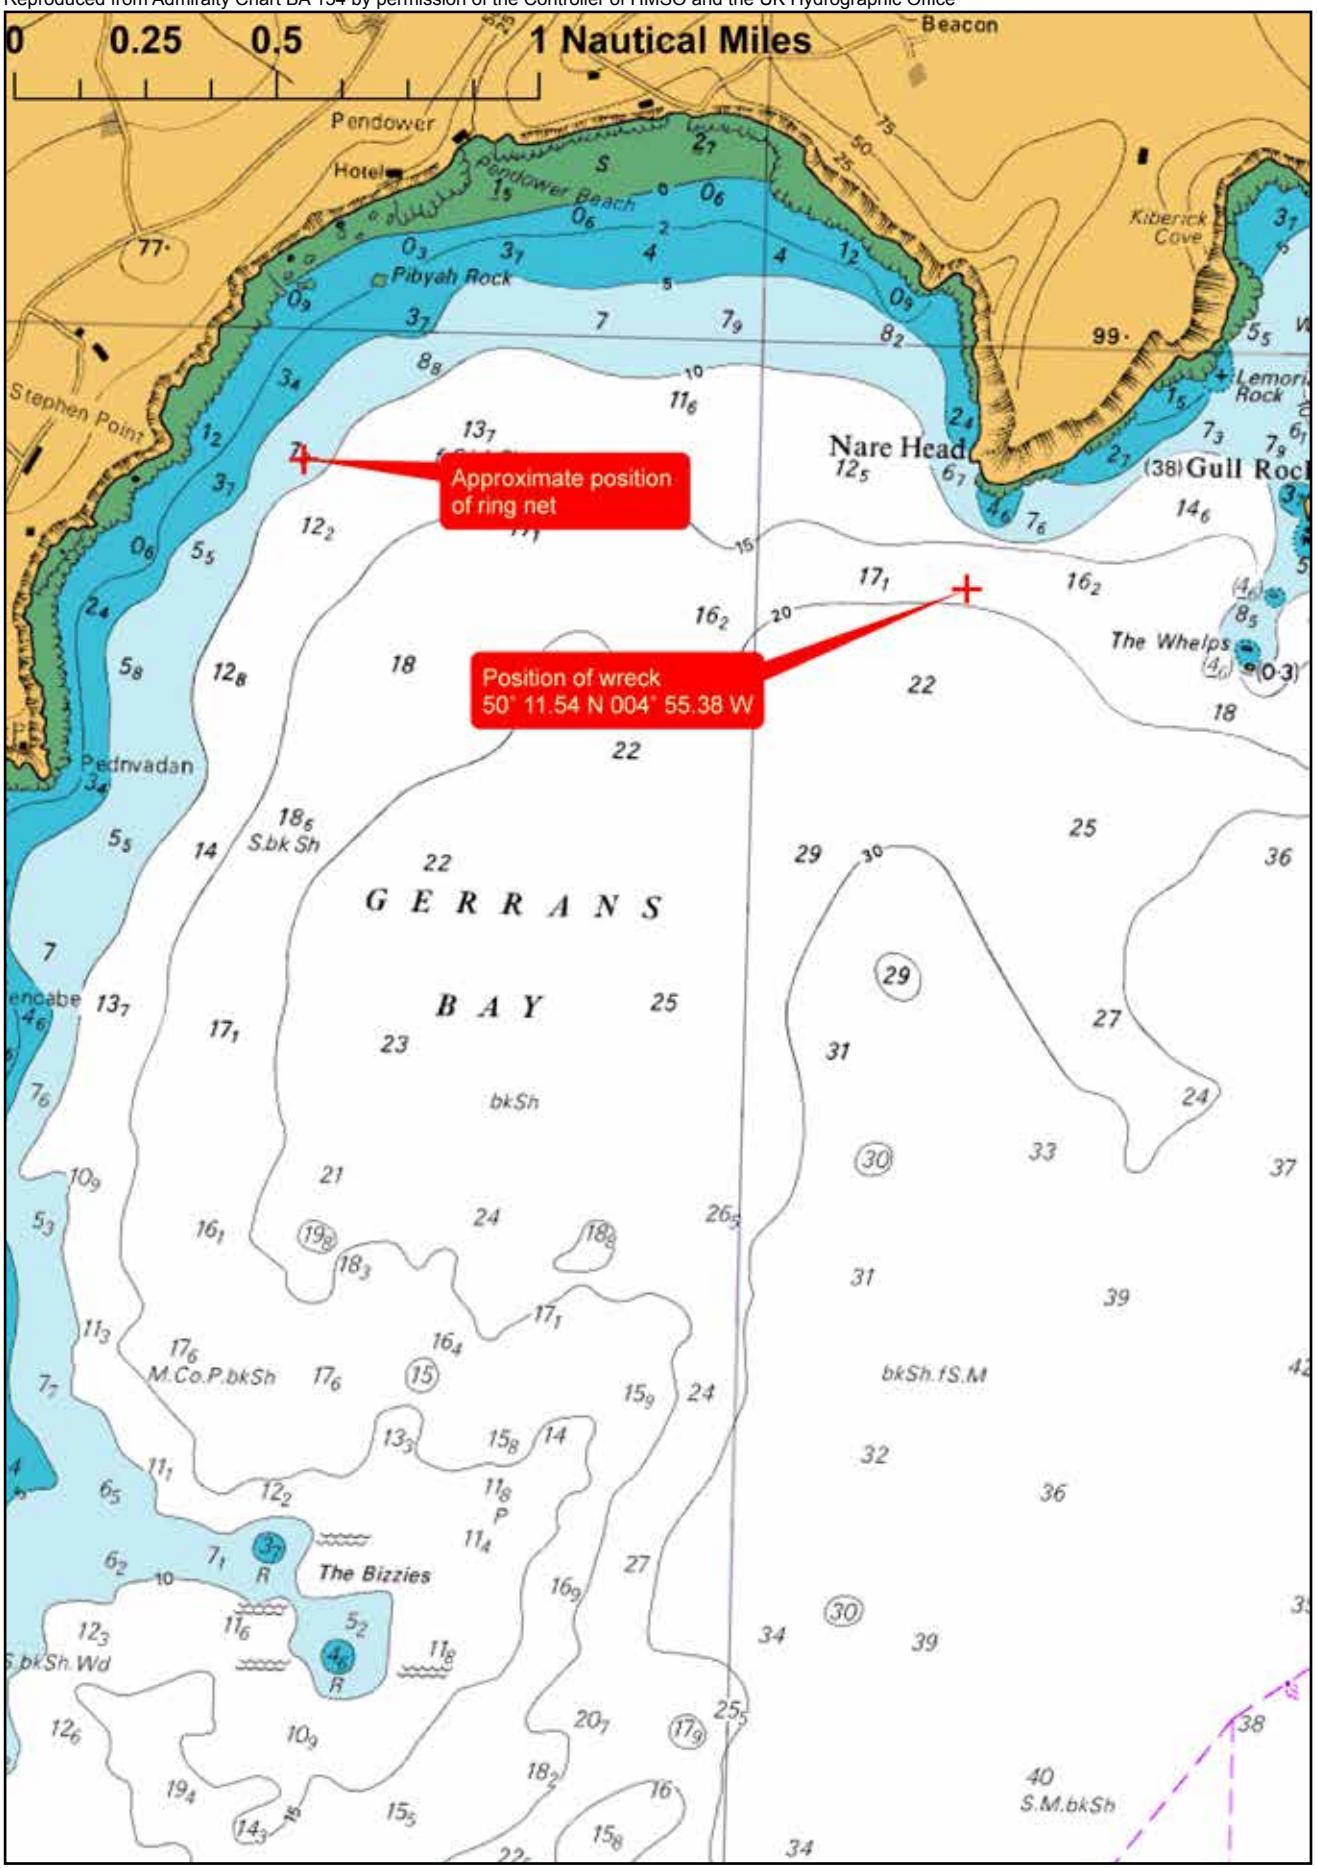
Figure 2: Extract of chart BA 154

Heather Anne sailed to Gerrans Bay, about 14 miles south-west of Mevagissey **(Figure 1)**, in company with *Leonora*². At about 1700, as darkness approached, *Heather Anne*'s skipper detected a shoal of Cornish sardines (pilchards) by sonar approximately 5 cables off the shore **(Figure 2)**. To catch the fish, a dhan buoy was dropped and the ring net was shot as the skipper turned the vessel to starboard and encircled the shoal. The two ends of the net were then drawn together and *Leonora* was secured to *Heather Anne*'s port side with 30m of towline.

On 22 December 2011, the Maritime and Coastguard agency (MCA) established a Temporary Exclusion Zone (TEZ) covering a radius of 200m around the wreck position (Figure 2).

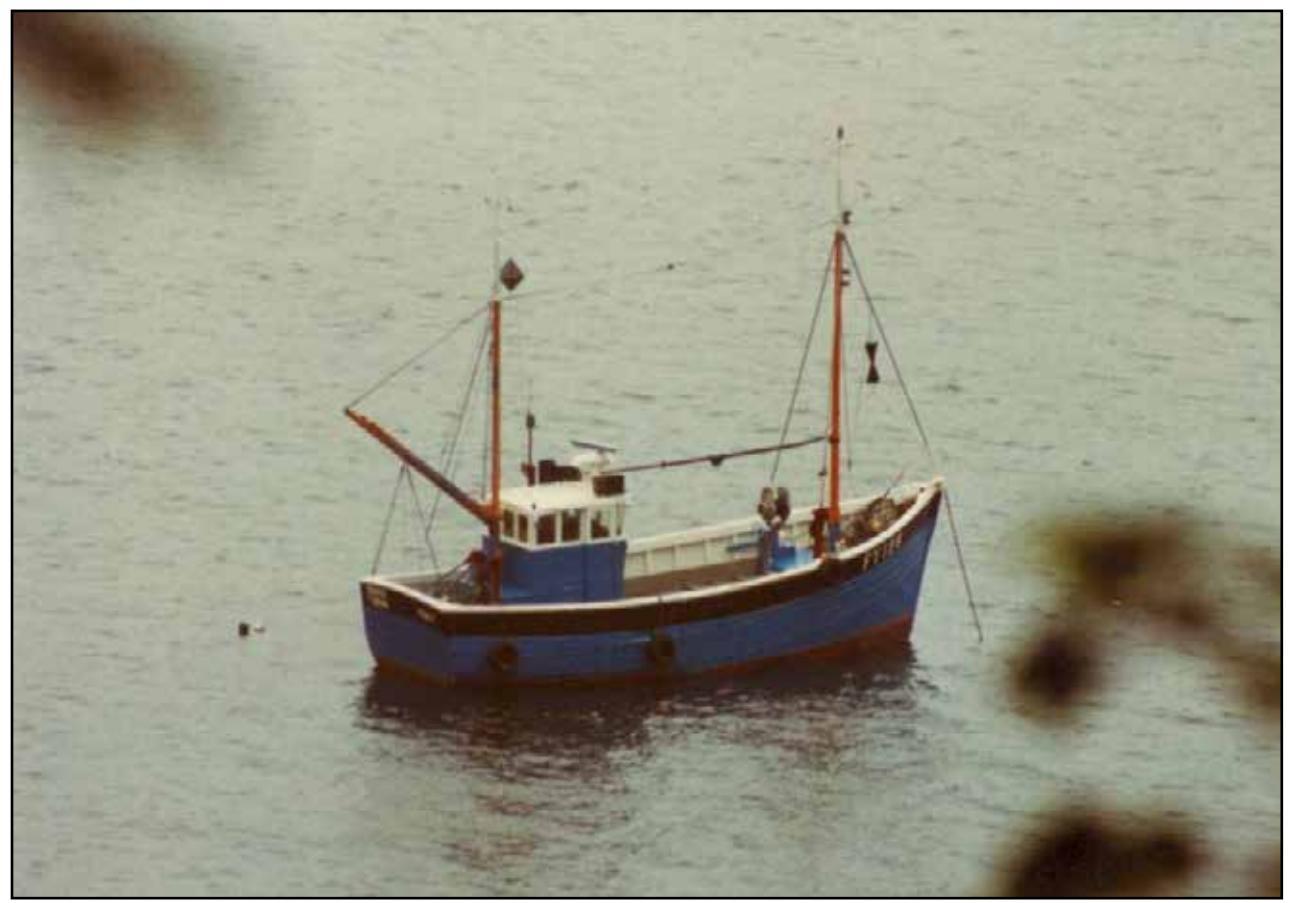
Figure 4: Photograph of Aquarius of Cawsand in 1972 (later re-named Heather Anne)

Heather Anne was originally designed as a netter and, although not specified, her loading capacity was expected to be about 5 tonnes; 4 tonnes stowed in the fishroom and 1 tonne stowed on the deck. She was built in 1971 by G Percy Mitchell & Sons, in Port Mellon, Cornwall and was originally named *Aquarius of Cawsand* (Figure 4).

The comparison of **Figures 4** and **Figure 15** clearly shows that since build in 1971, *Heather Anne* had been extensively modified. Such changes added significant weight on the upper and lower decks. As a result, when the vessel was inclined in March 2012, her lightship displacement had increased from an estimated 15.7 tonnes at build to 23.9 tonnes, an increase of over 50%.

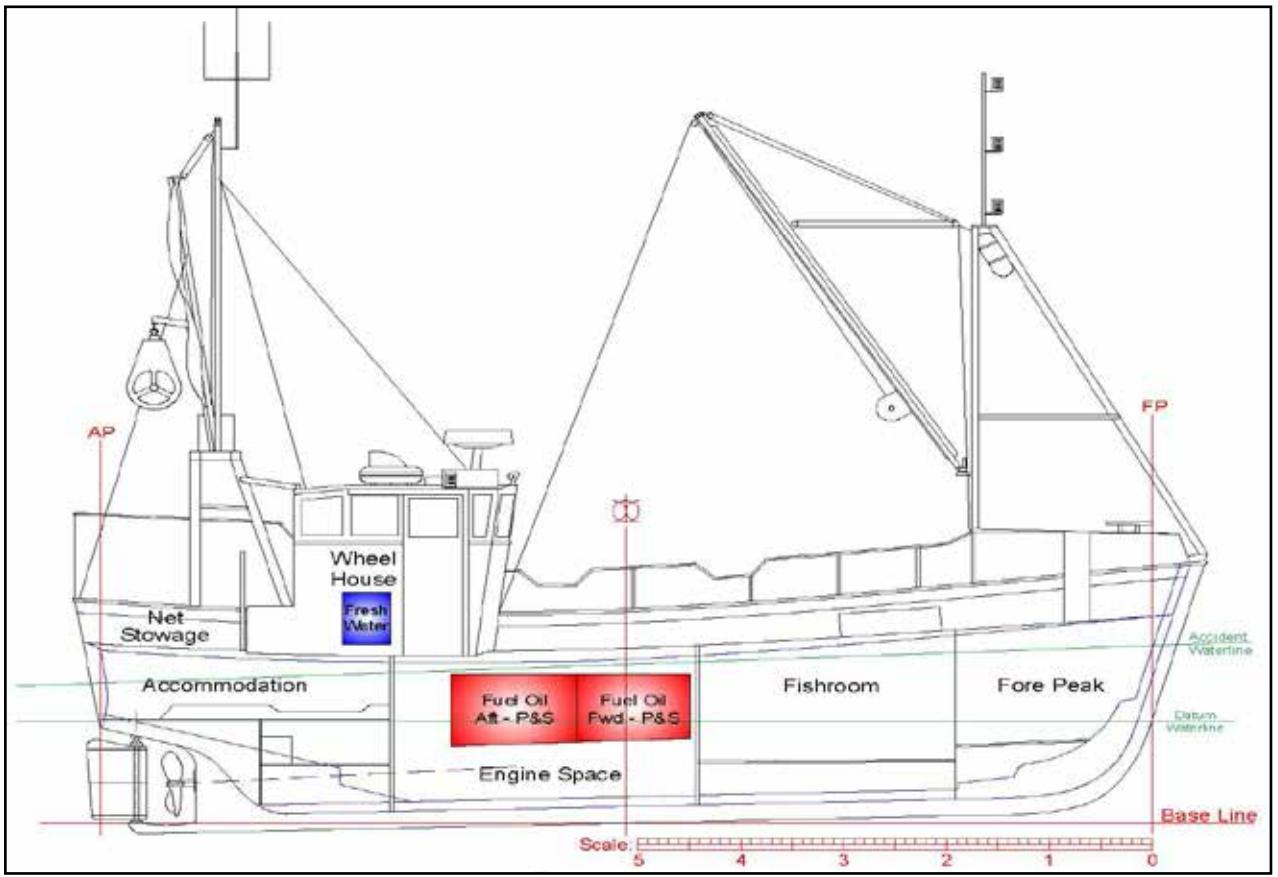
Figure 5: General arrangement

Heather Anne was constructed of oak frames and larch hull and deck planking attached with iron fastenings. Her length overall (LOA) was 11.05m, and her registered length (L) was 10m. A general arrangement of the vessel is shown at **Figure 5**.

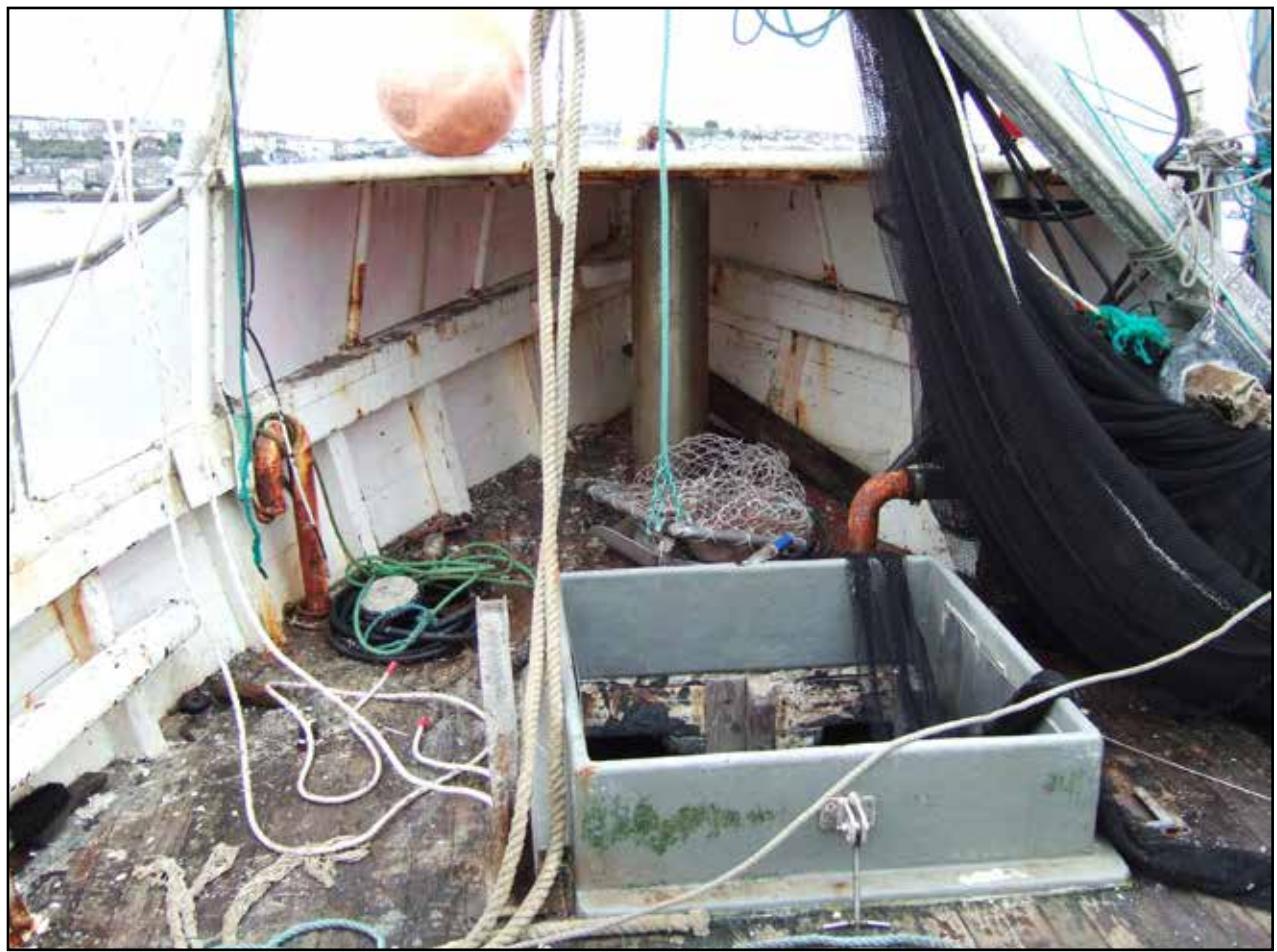
Figure 6: Fishroom hatch

The vessel's internal spaces (fishroom, fore peak, engine room, and accommodation) were separated by non-watertight bulkheads. Access to the fishroom was via a hatch on the foredeck (**Figure 6**) covered by a reinforced fibreglass coated plywood cover which was secured by two hinged 'dog' clips. Access to the accommodation and engine room was via the fibreglass wheelhouse. A sliding door was fitted on the starboard side of the wheelhouse which led to the deck. A net stowage area was sited aft of the wheelhouse.

• The fishroom hatch was missing and a substantial quantity of fish remained within the hold.

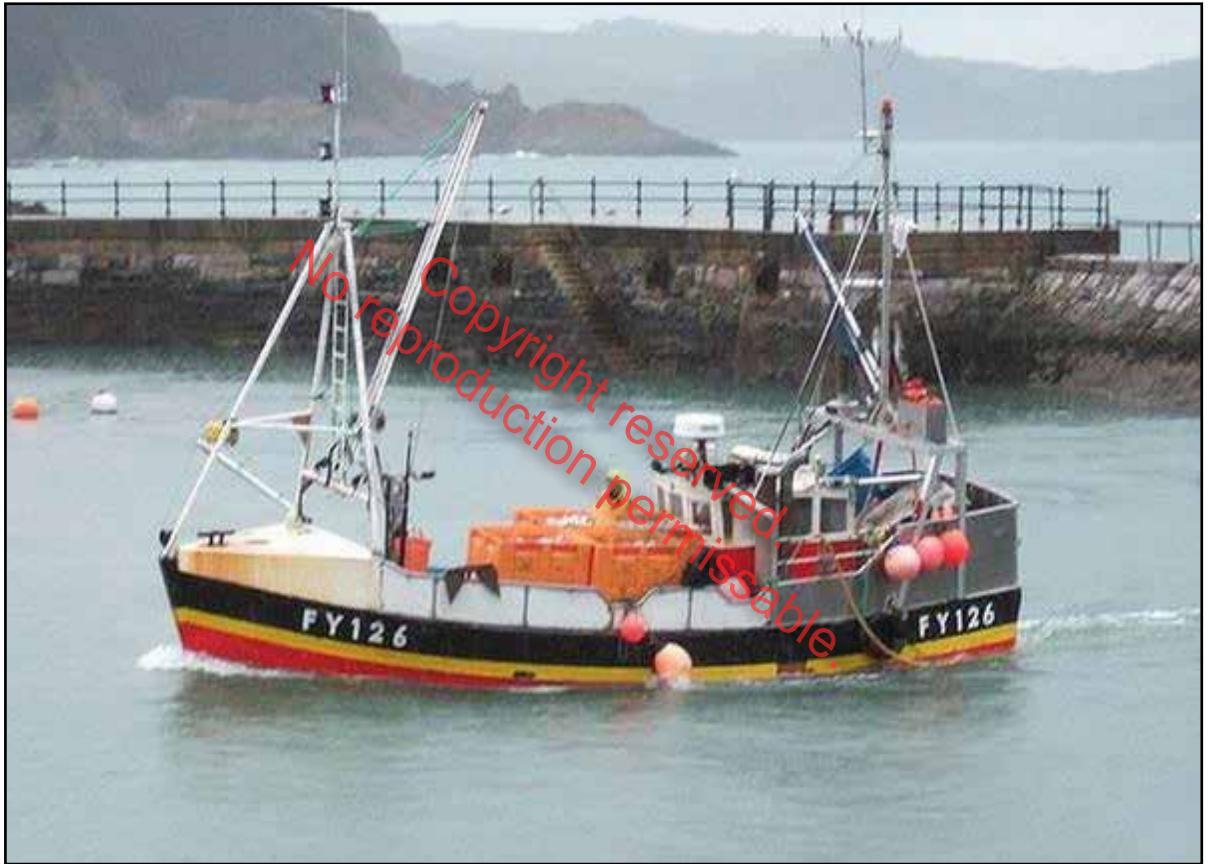
Figure 10: Heather Anne returning to Mevagissey on 19 January 2011, carrying 10.1 tonnes of Cornish sardines [Publication pursuant to section 259 (2) of the Merchant Shipping Act 1995 - Permission witheld by copyright holder]

Figures, 9, 10 and **11** show *Heather Anne* returning to Mevagissey from a fishing trip on 19 January 2011 with 10.1 tonnes of Cornish sardines on board. The vessel carried 12 bins (7 bins on the deck with 4 bins on top and 1 bin on the fish hatch) (**Figure 11**). Each bin was 1.15m wide, 0.96m deep and 0.6m high, and could hold approximately 450kg of fish. Several, smaller blue bins were also carried. It was not uncommon for *Heather Anne's* freeboard to reduce by between 70cm and 80cm when carrying a good catch.

There is no doubt that *Heather Anne* had been at an increased risk of capsize since her conversion to ring-netting in 2010. Indeed, when the vessel was loaded with 10.1 tonnes of fish on 19 January 2011 (**Figures 9, 10** and **11** and **Table 1**) her stability condition was only marginally better than on 20 December 2011 (**Table 4** in **Annex B**). It is possible that capsize was only avoided on that occasion due to better sea conditions and the fact that the larger tarpaulin had not yet been fitted in the fishroom.

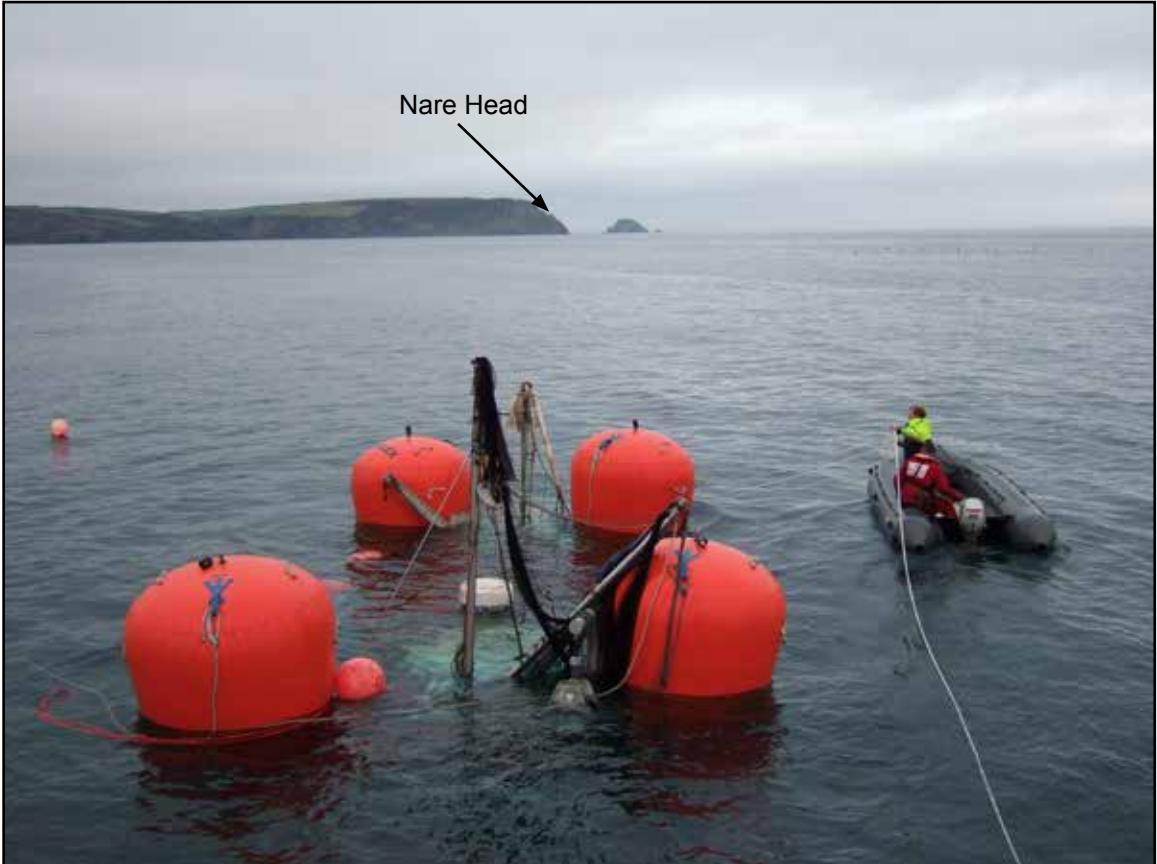
Figure 13: Heather Anne being refloated

On 23 February 2012, *Heather Anne* was lifted to the surface using air bags (**Figure 13**). The vessel was then towed to shallower water to enable the hull condition to be verified. The following day, *Heather Anne* was towed to Queens Jetty, A&P Falmouth, where lifting strops were placed under the hull.

Given that the planks in way of the damaged area on the vessel's starboard side (Figure 16) had been replaced in 2010, and the probability that the damage was caused by the vessel's movement on the seabed (Annex A) or by a lifting strop when the vessel was raised (Figures 13 and 14), it is unlikely that the capsize was initiated by flooding resulting from a sprung plank in this area. In addition, as the discharges overboard were relatively high on the vessel's side (Figure 8), it would not have been possible for seawater to enter the hull via this pipework during passage, even with the vessel's very low freeboard. Nonetheless, had the vessel started to flood for whatever reason, the skipper would not have been alerted because the bilge alarm was muted. In any event, the time available to take any action would have been minimal due to the vessel's low freeboard and low reserve of stability.

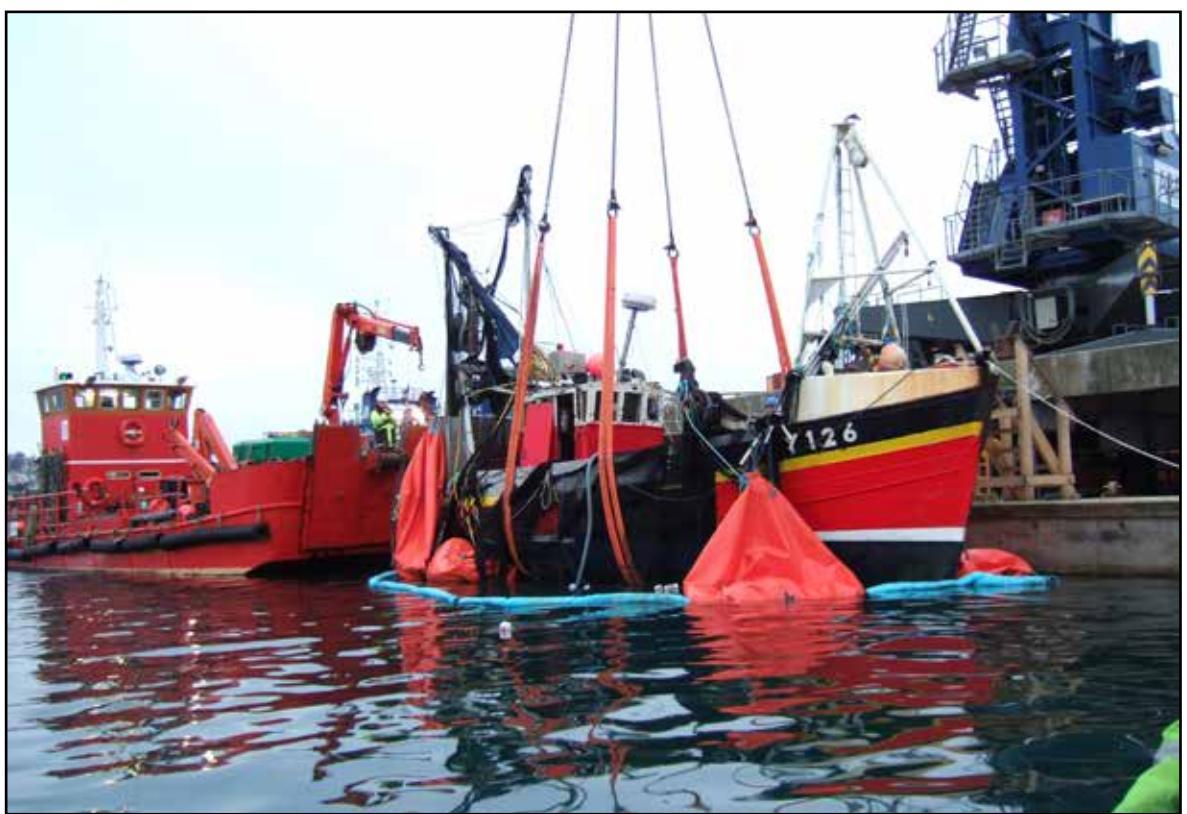
Figure 14: Heather Anne being lifted out of the water

The vessel was then lifted out of the water by a shore crane (Figure 14). Water entrapped within the hull was then pumped out before the vessel was lowered and chocked (Figure 15).
