Report on the investigation of the collision between

ACX Hibiscus

Hyundai Discovery

at 0756 local time on 11 December 2011

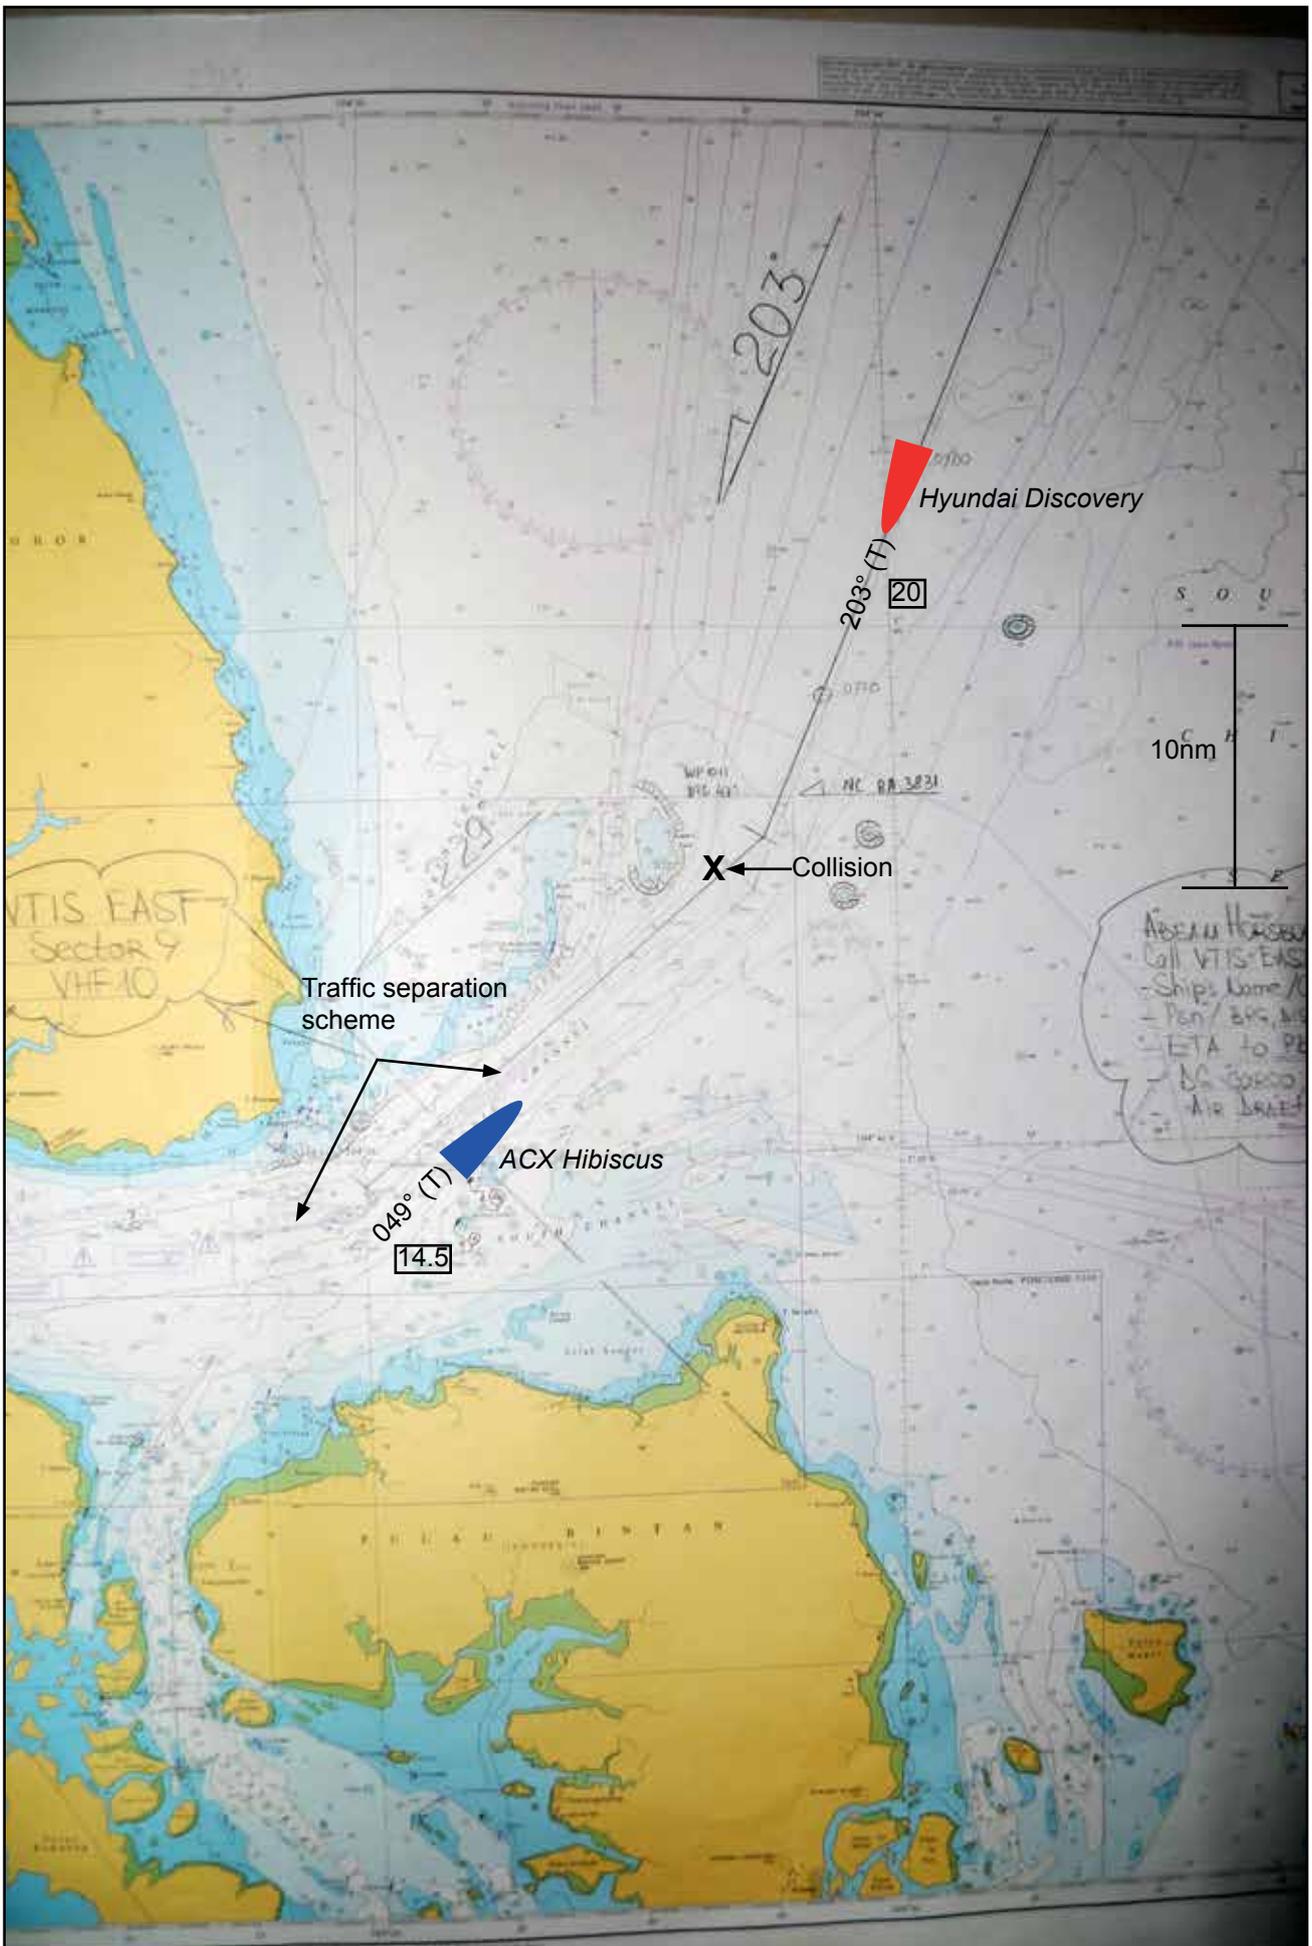
Figure 1: Hyundai Discovery's chart with the positions of ACX Hibiscus and Hyundai Discovery at 0700 superimposed

By 0740 *Hyundai Discovery's* chief officer had seen and acquired, using ARPA, the radar targets of four vessels that were out-bound from the Singapore Strait TSS. The vessels' positions were fine on his starboard bow. It was reported that heavy rain had reduced the visibility on *Hyundai Discovery's* port side to approximately 5 miles at around this time.

At about 0740 *Hyundai Discovery's* cadet looked at the AIS information that was displayed on the Electronic Chart System (ECS) and saw that one of the vessels was *ACX Hibiscus*. The cadet told the chief officer that he thought *ACX Hibiscus* would pass clear down *Hyundai Discovery's* port side. At 0741 the master returned to the bridge; the chief officer mentioned the recent rainfall to the master. The master instructed the chief officer to inform the on-watch engineer at 0800 that the main engine should be available to manoeuvre by 0900. At 0744 *Hyundai Discovery's* chief officer used the autopilot control to alter course to starboard to a new heading of 209° (**Figure 2**). During the turn *ACX Hibiscus* was lost from sight.

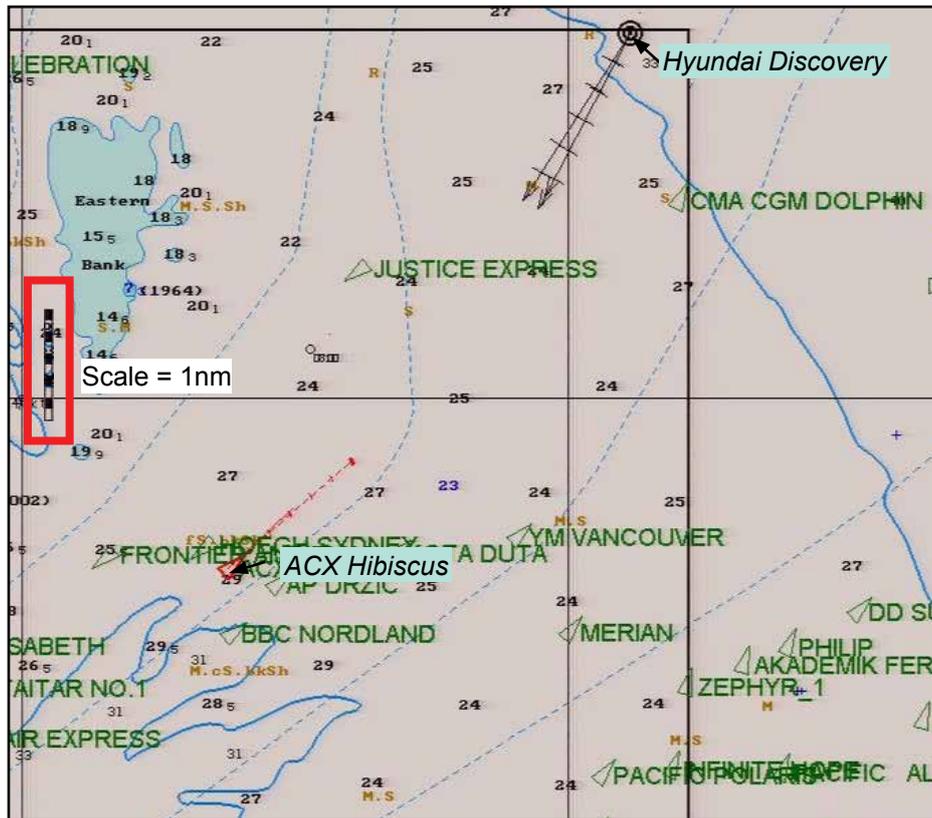
Figure 3: Position of ACX Hibiscus and Hyundai Discovery at 0747

At 0747:00 the ARPA radar display on board *Hyundai Discovery* showed that *ACX Hibiscus* was 5nm right ahead of *Hyundai Discovery*. The radar plot indicated that the ships would be passing close, but clear, down each other's port sides (**Figure 3**). The chief officer on *Hyundai Discovery* used the autopilot control to turn to starboard to a heading of 216° to converge onto his next charted course of 229° and to increase his passing distance from *ACX Hibiscus*. At 0748:30, once close to the charted course, the chief officer turned further to starboard onto a heading of 229°.

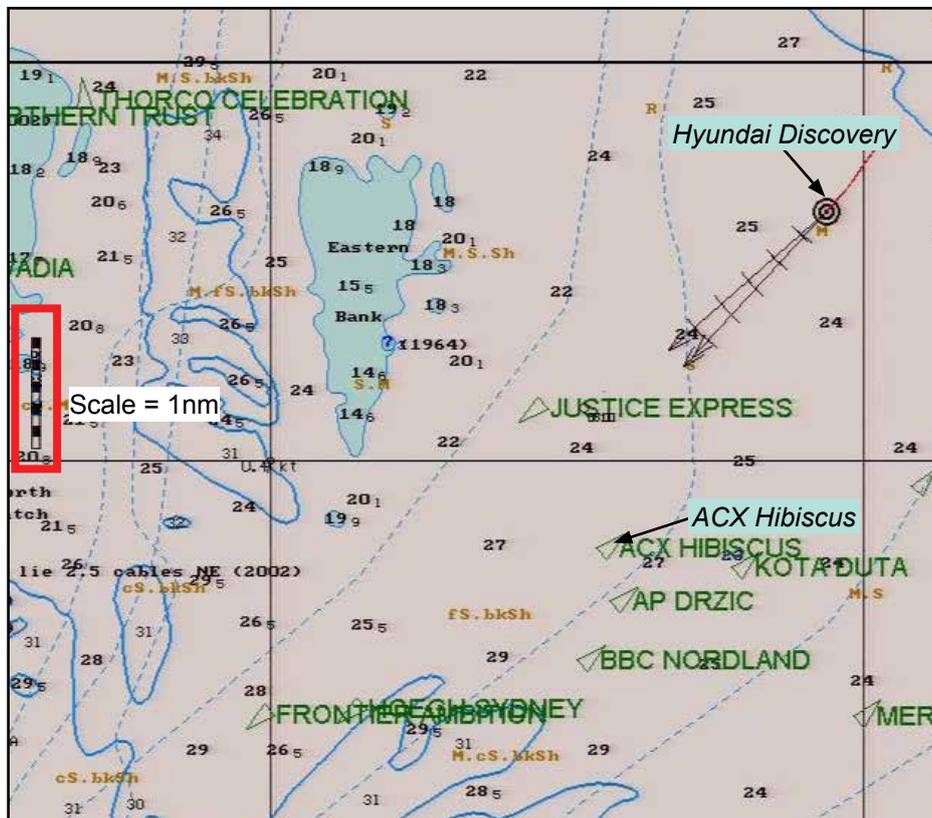
Figure 4: Position of ACX Hibiscus and Hyundai Discovery at 0750

By 0750:00 *Hyundai Discovery* was steady on a heading of 229°, with *ACX Hibiscus* about 15° on the port bow at a range of 3.5nm (**Figure 4**). The ARPA on *Hyundai Discovery* indicated that *ACX Hibiscus*'s closest point of approach (CPA) would be approximately 7 cables on the port side. *Hyundai Discovery*'s chief officer placed the radar's electronic bearing line (EBL) over *ACX Hibiscus*'s radar target to confirm that its bearing was opening to port as he was expecting.

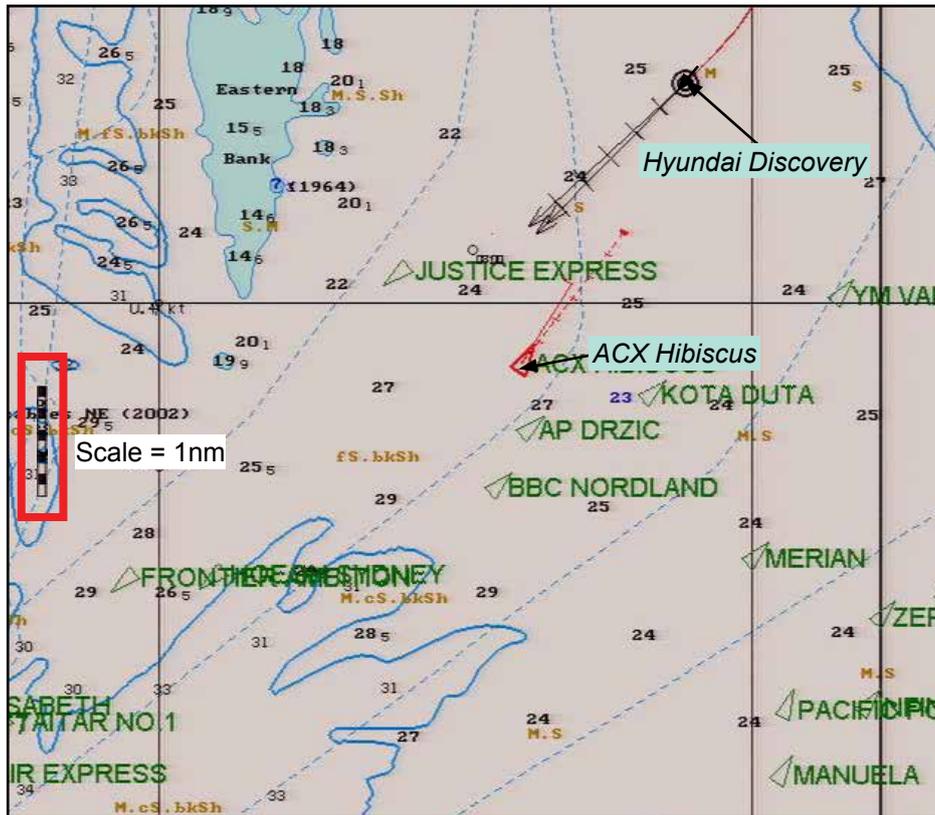
Figure 5: Position of ACX Hibiscus and Hyundai Discovery at 0751:30

ACX Hibiscus's third officer arrived on the bridge at around 0750 ready to take over the watch at 0800. At 0751:30, *ACX Hibiscus*'s chief officer started to alter his vessel's course to port by adjusting the desired heading on the autopilot to turn the ship incrementally onto the next planned track of 350° (**Figure 5**). It was reported that the third officer looked at the radar display and found that radar targets were not seen due to clutter, and that he informed the chief officer about the situation.

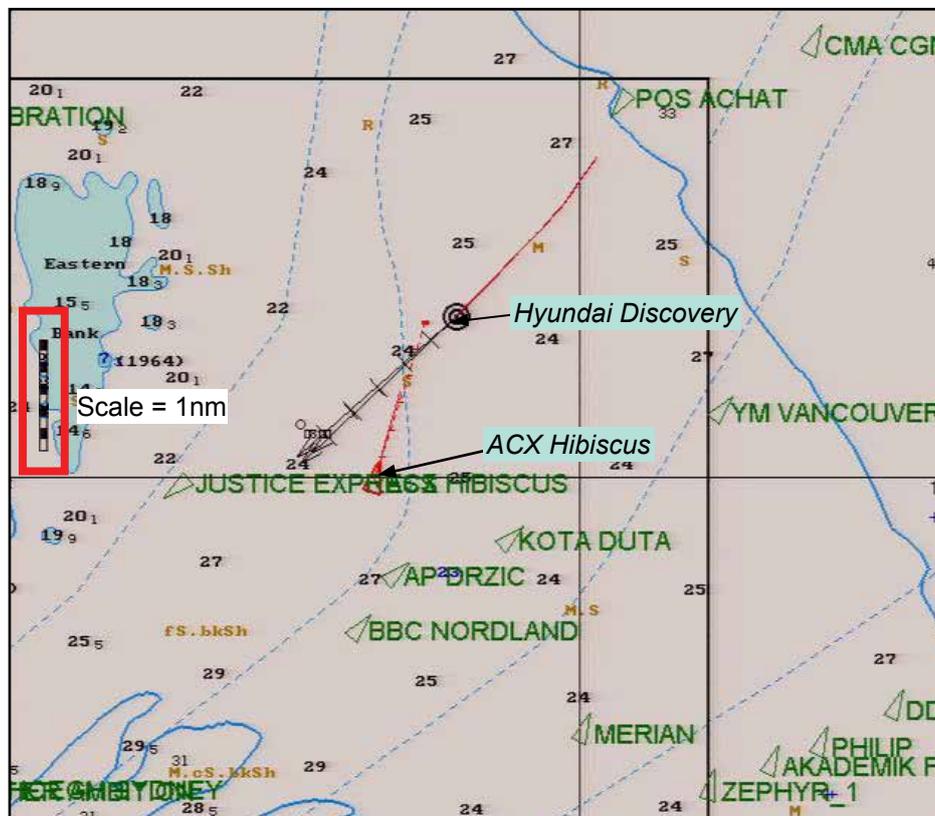
Figure 6: Position of ACX Hibiscus and Hyundai Discovery at 0753:30

At 0752, with about 2.2nm distance between the vessels, *Hyundai Discovery*'s chief officer noticed that the radar trail of *ACX Hibiscus* changed direction towards his vessel. The trail was set to display its motion relative to *Hyundai Discovery* and showed that *ACX Hibiscus* was altering its course to port. The chief officer checked the AIS information on the ECS and confirmed that the vessel turning to port was *ACX Hibiscus*. At 0753:15, and again at 0753:30 (**Figure 6**), *Hyundai Discovery*'s chief officer called *ACX Hibiscus* by VHF radio using the distress and calling channel, channel 16. Once communication was established, both officers changed their VHF radios to a working channel, channel 6.

At 0754:00 *Hyundai Discovery*'s chief officer asked *ACX Hibiscus*'s third officer 'why are you altering course to port side?' The response from *ACX Hibiscus* was unclear, but it was apparent that the third officer said that his vessel was turning to the north. *Hyundai Discovery*'s chief officer continued... 'Do not cross my bow ...the visibility

is zero you must alter course to starboard'. At 0754:20 *Hyundai Discovery*'s chief officer told *ACX Hibiscus*'s third officer to alter course to starboard and create a minimum CPA of 3 cables. He then asked '*the visibility is zero, what are you doing?*'

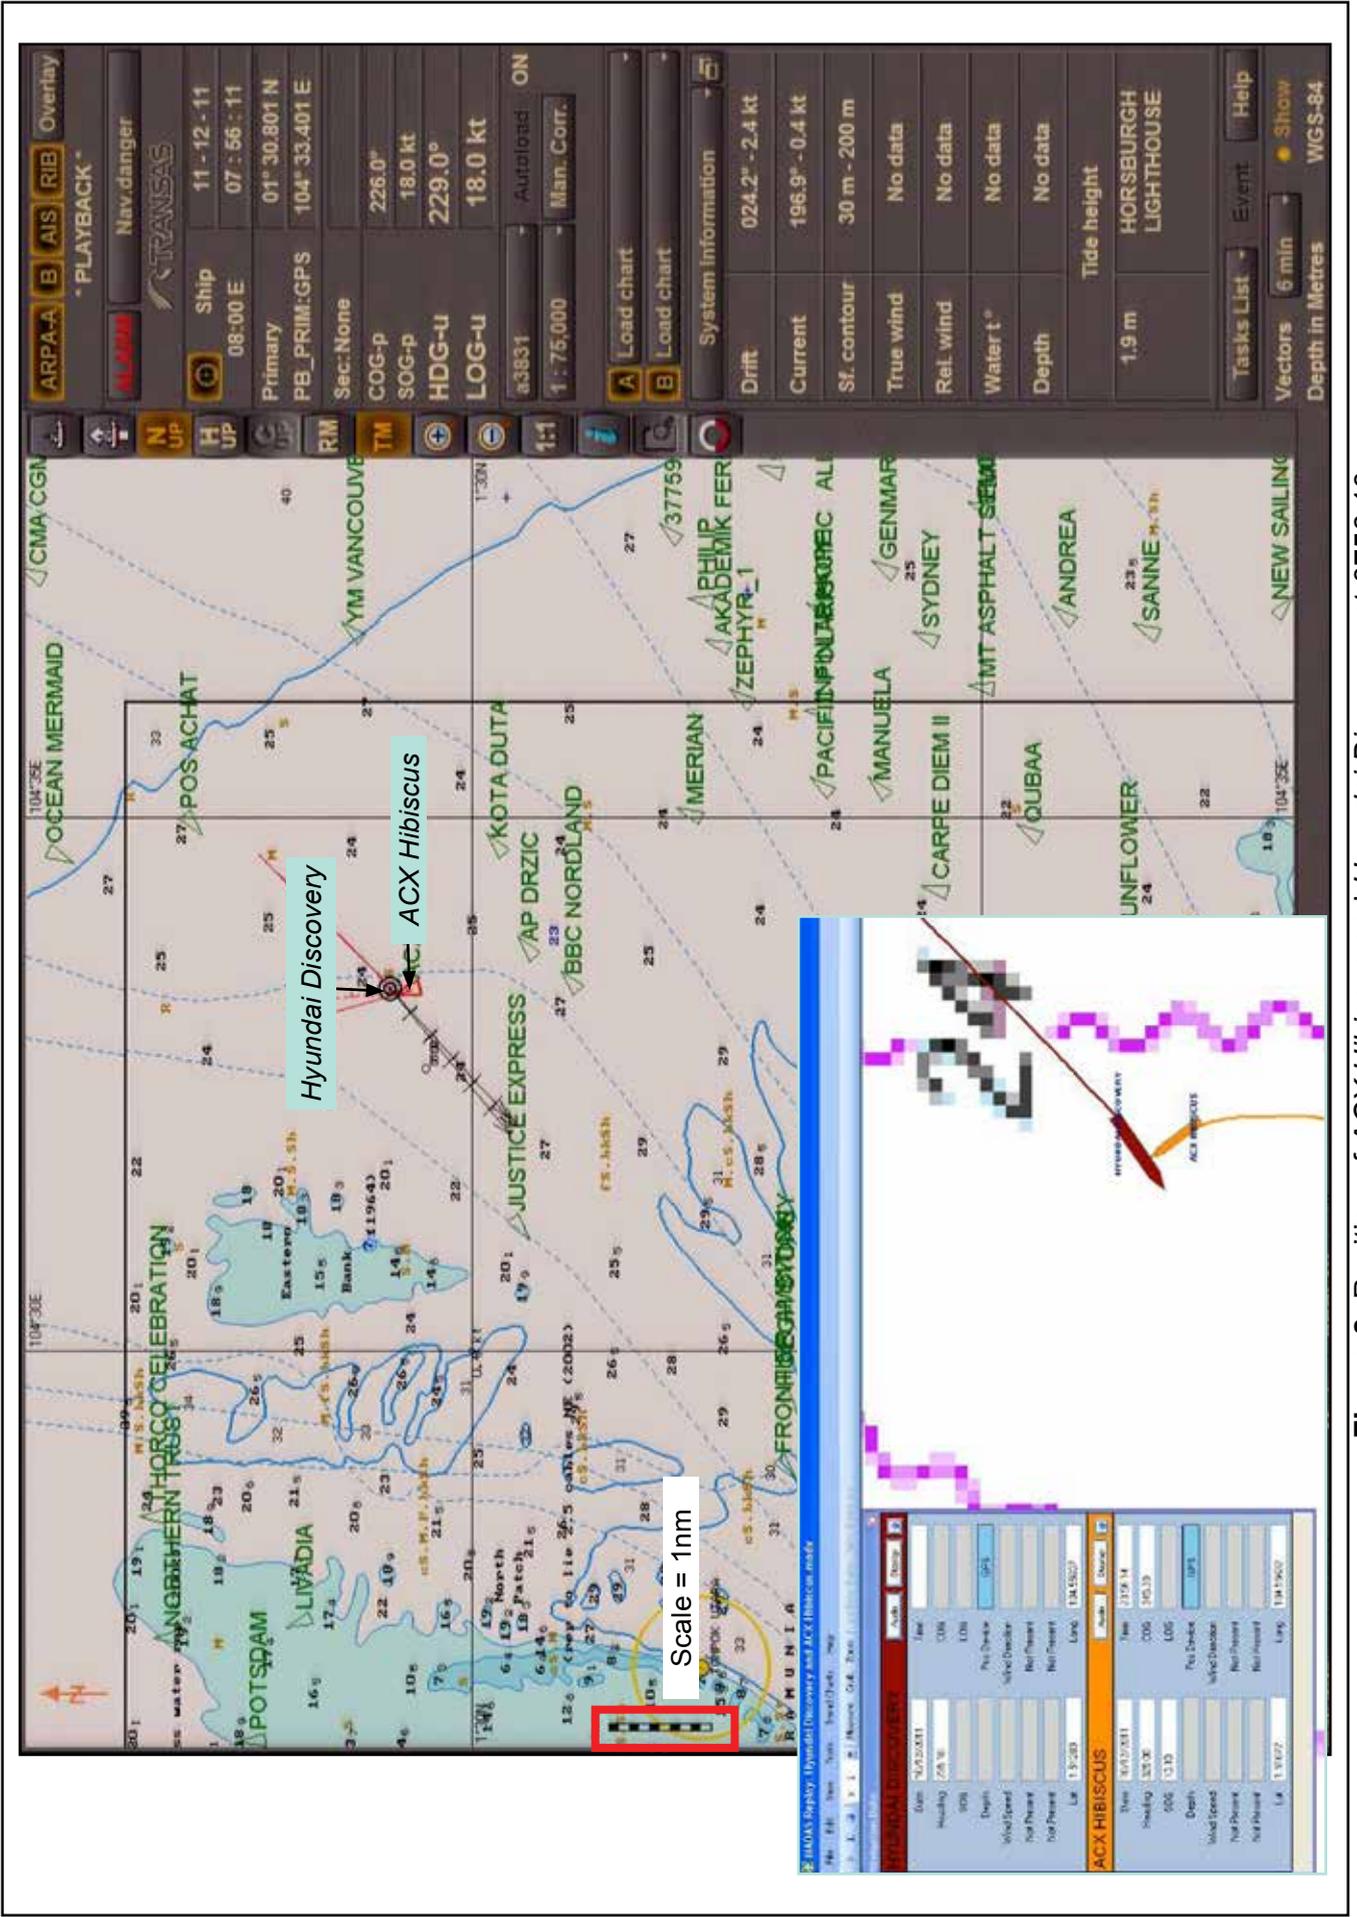
Figure 8: Position of ACX Hibiscus and Hyundai Discovery at 0756:10

Hyundai Discovery listed to port due to the flooding of the empty No.2 wing ballast tank. *Hyundai Discovery*'s master called *ACX Hibiscus* on VHF radio to establish the condition of the other vessel, but the reply from *ACX Hibiscus* was unclear.

ACX Hibiscus's master mustered his crew on the bridge and then instructed them to sound the tanks and bilges to check where the hull had been breached. *ACX Hibiscus* was flooded in the fore peak tank and took on a list to starboard. Water also flooded into the forward hold. At 0830 the master advised the Malaysian Coastguard about his ship's damaged status by VHF radio. Following this, the master turned *ACX Hibiscus* to head west at slow speed with the intention of beaching the vessel if necessary to prevent it from sinking. At 0920 the master, satisfied that *ACX Hibiscus*'s condition was stable enough to resume passage, navigated his vessel back to Singapore's outer anchorage at slow speed.

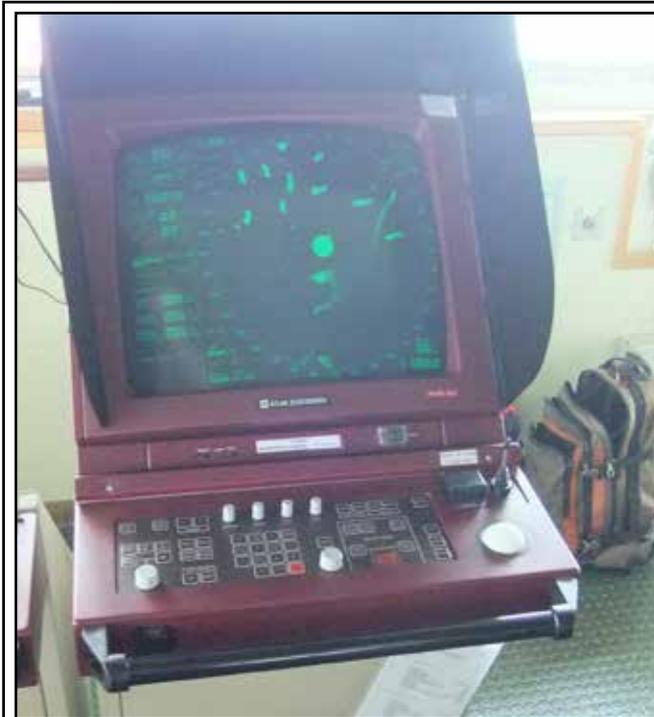
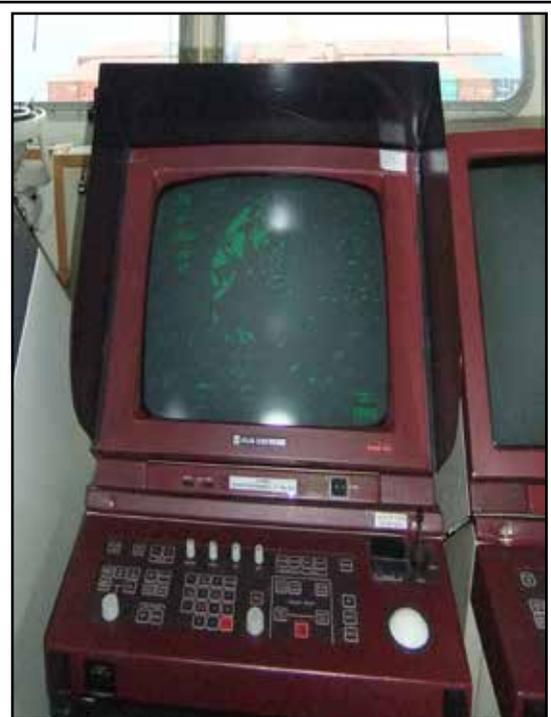
The bridge had two radars, both fitted with ARPA: an 'S band' (10cm wavelength) radar and an 'X band' (3cm wavelength) radar. While both radar displays worked effectively, due to the age of the equipment neither was capable of showing AIS data (**Figures 16a** and **16b**).

At the time of the accident, the chief officer primarily used the S band radar for collision avoidance, alternating between the 12 and 6 mile range scales. The 'own ships' position was offset from the centre of the radar screen to increase the area of the display available for monitoring traffic ahead. The predicted paths of radar targets were displayed with vectors whose length represented the distance travelled in 6 minutes. This gave an indication of each target vessel's true course and speed. Each target's track history was displayed with vector trails representing the distance moved in the last 6 minutes. The trails showed each target vessel's movement relative to *Hyundai Discovery's* track. The chief officer suppressed the interference caused by the rain to the radar picture by adjusting the rain clutter control manually.

The X band radar was operated mainly on the 12 mile range scale. Radar targets were displayed with predictive vectors and historic trails that showed target vessels' true courses and speeds.

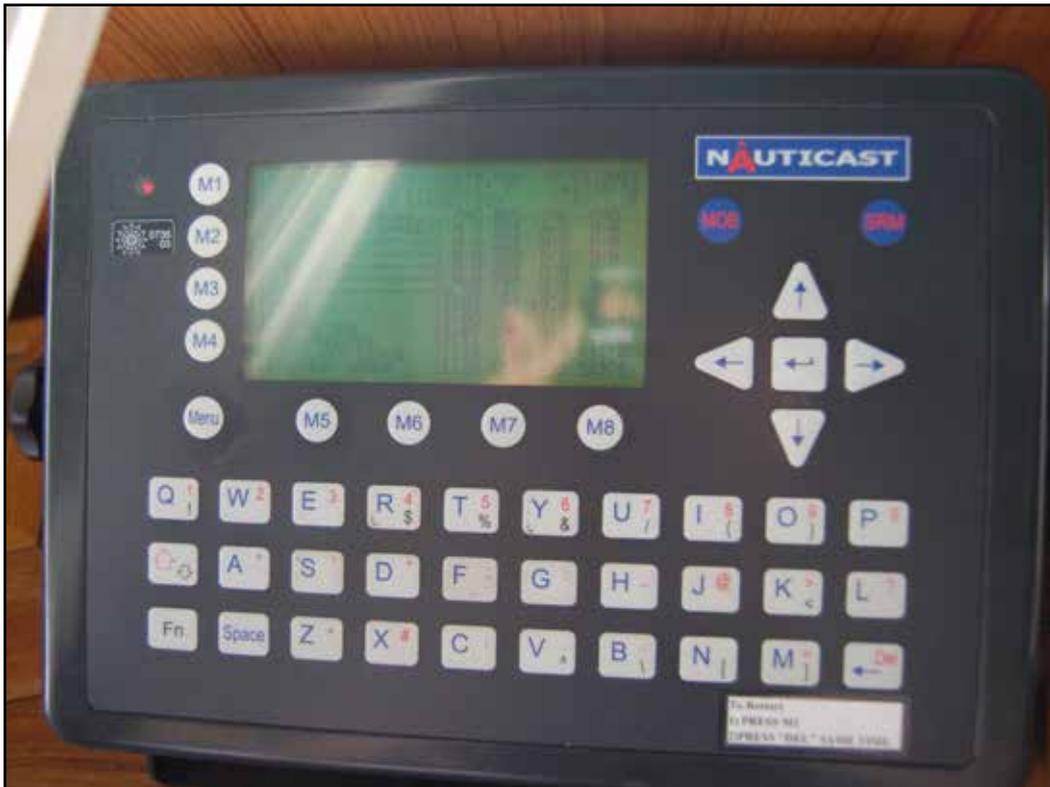
Figure 17: *Hyundai Discovery's* AIS unit

AIS data was shown on a display unit located near the chart table at the front of the bridge (**Figure 17**). The AIS information was also displayed on an Electronic Chart System (ECS) located by the communication station at the aft of the bridge on the port side by the communications desk (**Figures 18a** and **18b**). The ECS displayed the ship's Global Positioning System (GPS) position and the AIS data for nearby vessels on an electronic navigation chart. The ECS had not been approved as a primary means of navigation and was provided to help the bridge watchkeepers improve their situational awareness. There were no instructions provided on how watchkeepers should use the combined ECS and AIS displayed information.

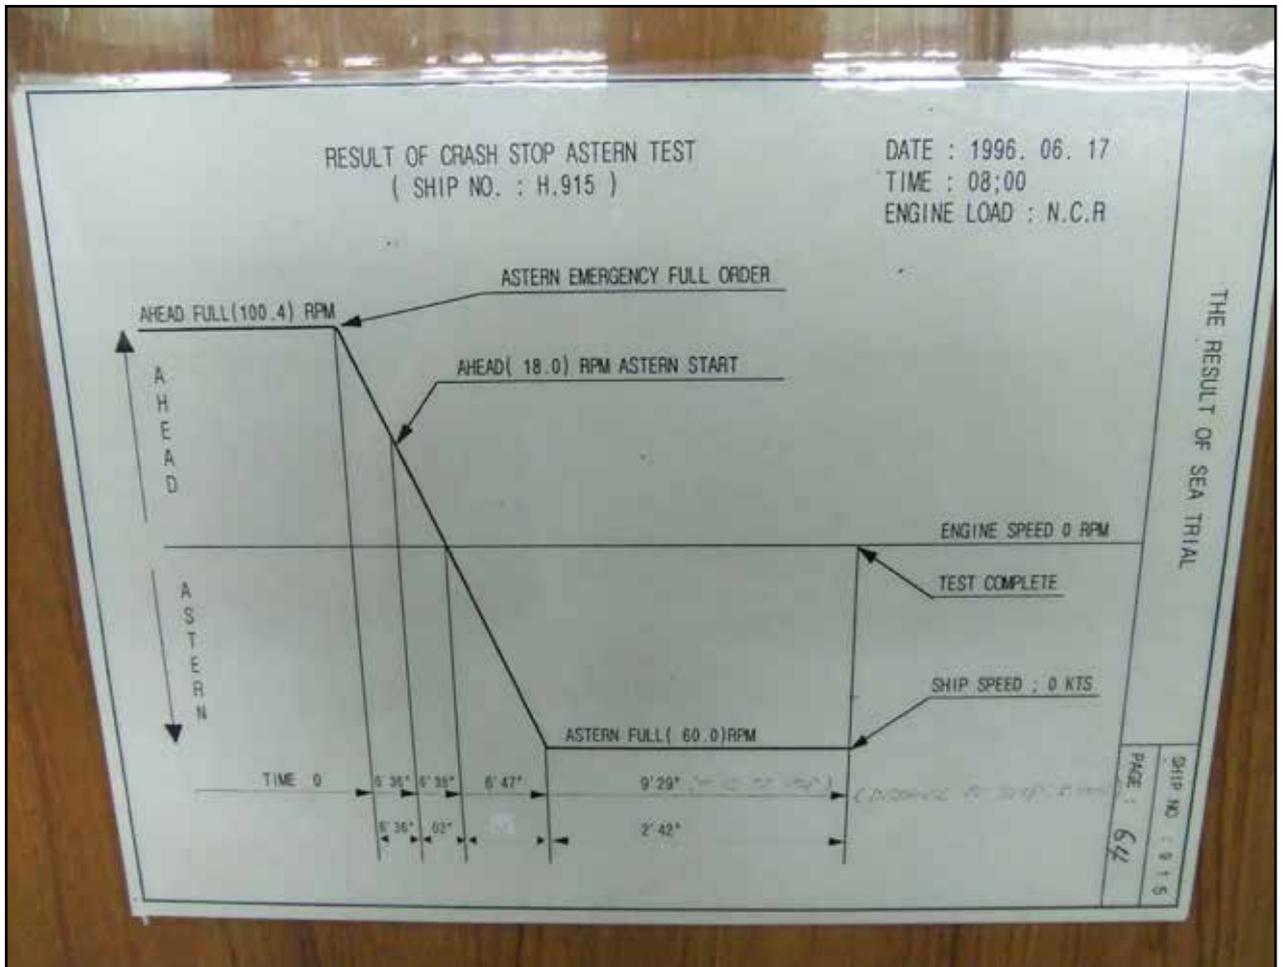
Figure 20: Hyundai Discovery's crash stop test results

The results of a crash stop test were also posted on the bridge (**Figure 20**). The diagram showed that from full speed (100 RPM), astern propulsion would be started in 6 minutes and 38 seconds. Full astern propulsion would be achieved after 6 minutes and 47 seconds with the vessel brought to a stop after 9 minutes and 29 seconds.
