**Marine Weather Legal Report  
Vessel: MV SWANLAND**

MV *Swanland* Review of Structural History, Survey and Repair Records following the Structural Failure and Foundering on 27th November 2011, Braemar report, dated 31 May 2013

### REVIEW OF STRUCTURAL HISTORY, SURVEY AND REPAIR RECORDS FOLLOWING THE STRUCTURAL FAILURE & FOUNDING ON 27<sup>th</sup> NOVEMBER 2011

**Report No.: 312835.1R v3.5**  
**31<sup>st</sup> May 2013**

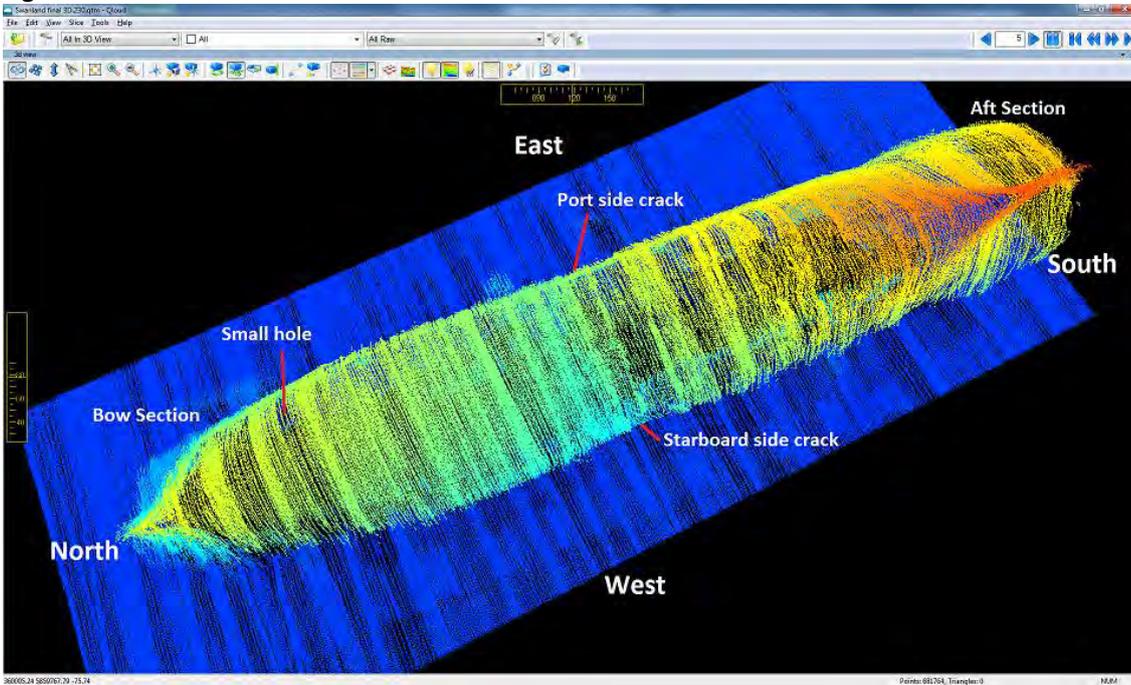
**Fig 1**

The Swanland was found to be upside down, the vessel was laying on the seabed in a North to South orientation. The Bow of the vessel is located to the North.

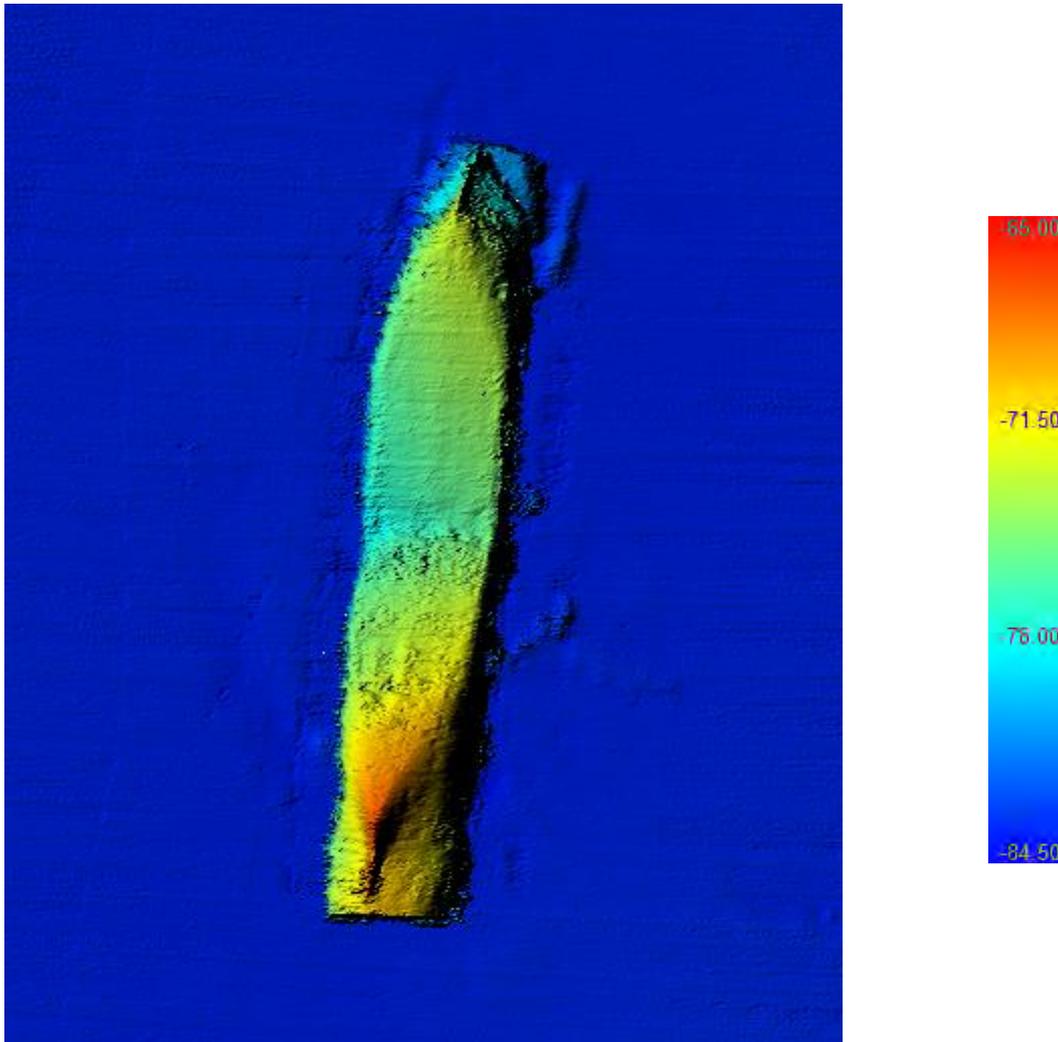
Figure 1 Swanland\_2D\_0.2m

Fig. 1 displays final processed MBES data gridded to a 0.2m x 0.2m bin (area of seabed represented by one pixel). Shading has been applied to provide 3D aspects to the wreck. This image is North orientated, with the bow of the Swanland offset to the North. The smooth surface and features at the stern of the Swanland indicate that the wreck is upside down, with the keel facing up. Due to this orientation of the vessel, the Port side is in the East, and Starboard side in the West.

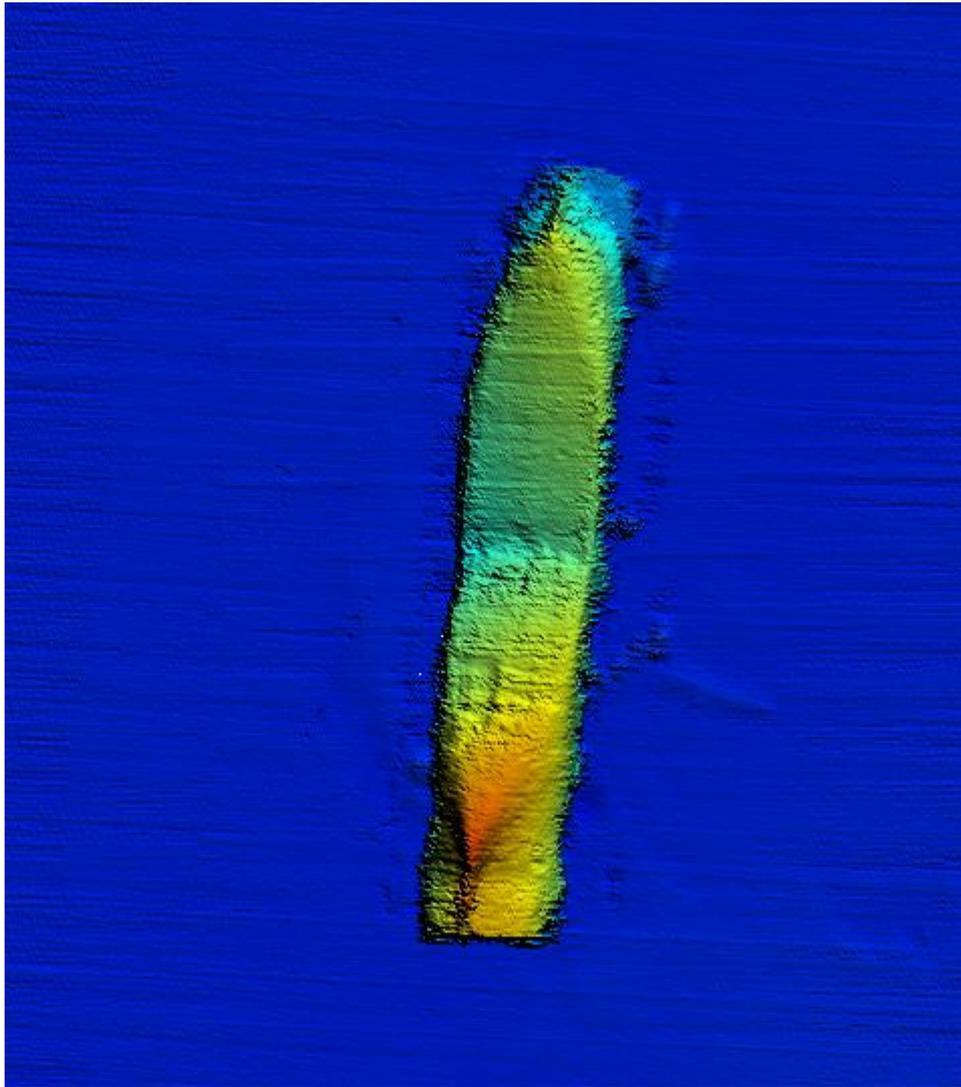
**Figure 2 Swanland\_2D\_0.2m\_2**

Fig. 2 shows the same data, with the illumination angle used to provide the shading altered. This is designed to provide an alternative aspect to the image, and highlight features which may not have been as apparent in Fig. 1. Again Fig. 2 is at a 0.2m bin, with a scale of -65m to -84.5m.

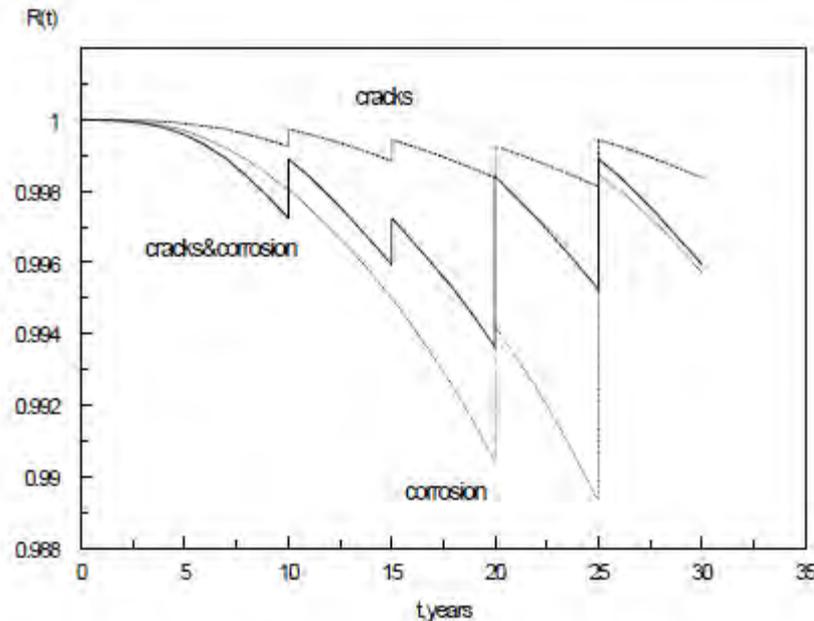
Figure 8—Loss of Structural Reliability with time after Cumulative Repairs

- 5.2.10. For example, replacing a segment of tank-top plate adjacent to one that has corroded but is still within the accepted limits, creates a relative weak point and potentially enables corrosion to develop adjacent to the seam due to the plate thickness differences (unless suitably faired). So, even though substantial parts of the vessel have been gradually repaired or replaced, its overall strength is still only as good as its weaker points. Figure 8 shows how the structural reliability of a vessel can degrade over time (Reference 2) following the cumulative effect of repairs over time. The variable R(t) shown in the graph is a reliability function

describing the ability of the ship's primary structure to resist the forces placed upon with the influence of corrosion and cracks.

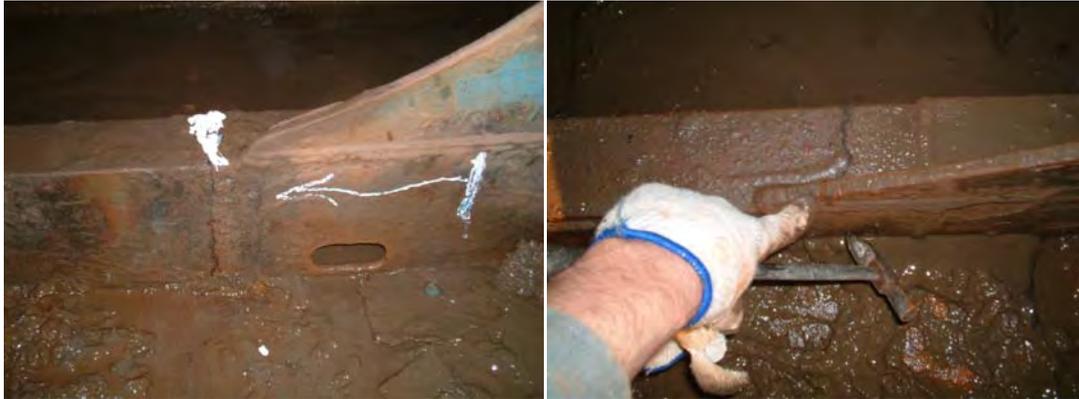
Figure 8 - Examples of Cracks in Bottom Longitudinal Members (Not MV SWANLAND)

- 5.2.35. The cracks in longitudinal members connected to the bottom shell in regions close to the midships are of high significance. As soon as a crack reaches the shell plating it propagates rapidly due to the high bending moments imposed in that region, eventually creating a serious structural failure. The fact that the cracks were reported to be due to wear and tear and not misalignments or localised stresses increases the concern as any other cracks not evident at the time of this survey may soon have appeared subsequently and quickly become serious. Figure 8 shows examples (not of MV SWANLAND) of cracks in longitudinal stiffeners in way of the bottom shell plating.
