FV *MOYUNA*

Grounding at the entrance to Ardglass Harbour, Northern Ireland 21 November 2011

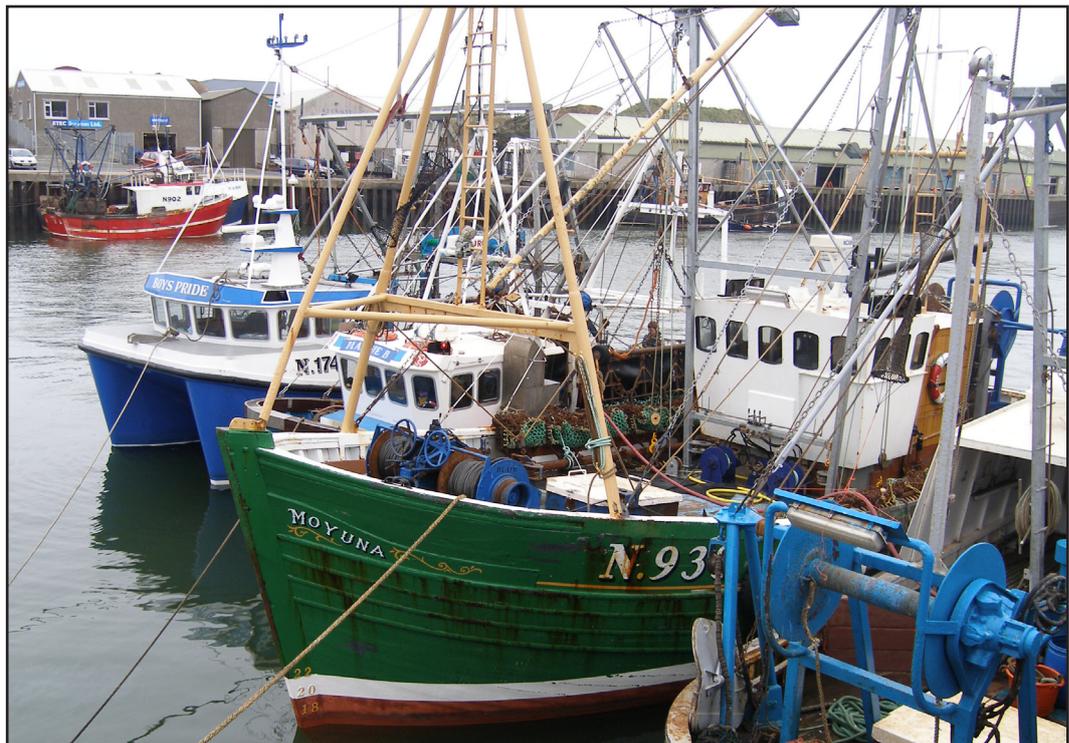
Figure 1: *Moyuna*

At 2330 (UTC) on 21 November 2011, the UK registered fishing vessel *Moyuna* (**Figure 1**) grounded, at slow speed, while entering Ardglass Harbour. The vessel started to list and the skipper and three crew abandoned to a liferaft. They were successfully rescued, having suffered no injuries, and the vessel refloated on the rising tide. She had sustained only minor damage, resulting in no water ingress or pollution.

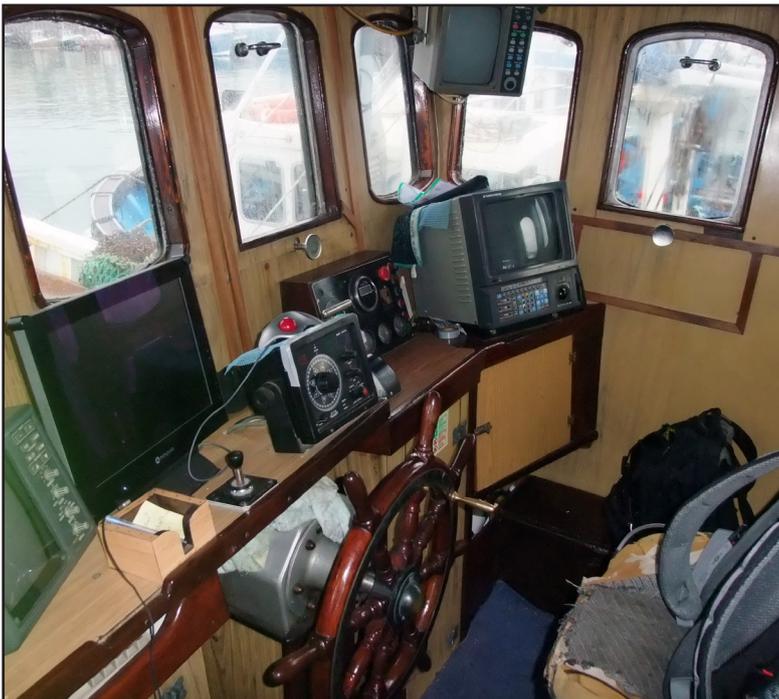
Figure 2: Wheelhouse

The wheelhouse (**Figure 2**) was well-equipped with duplication of some systems. Two GPS units each independently fed one of two track plotters. There were two VHF radios in addition to a digital selective calling (DSC) VHF radio, and a radar was located on the starboard side. *Moyuna* was not fitted, nor required to be fitted, with Navtex.
