Serious injury to a chief officer **CAMERON**

Crosby Channel, Liverpool

21 November 2011

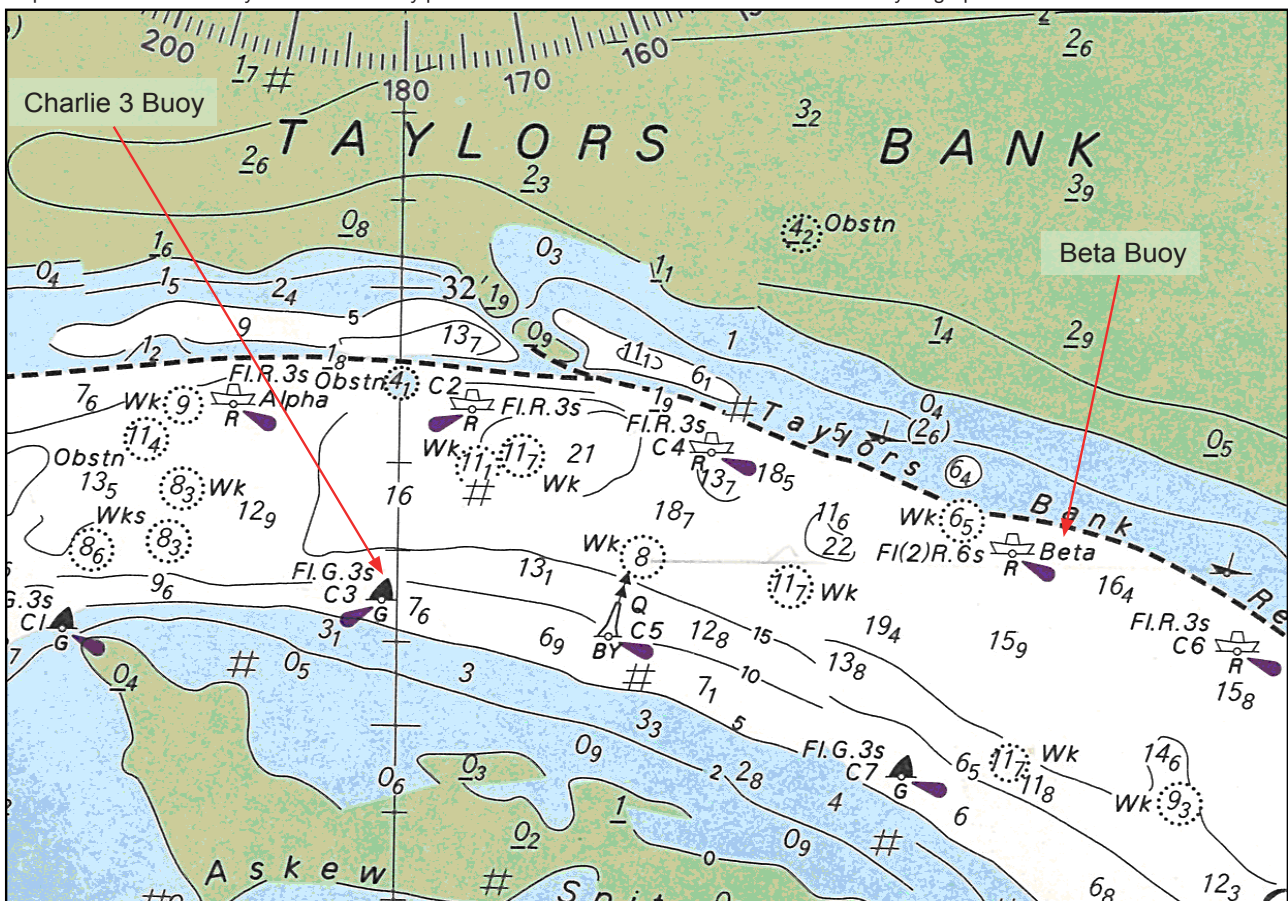
Figure 1: Crosby Channel - River Mersey

At 0800 on 21 November 2011, *Cameron* departed her berth in Liverpool. The wind was south-easterly force 3, and the sea was slight. From 0945, the vessel was anchored close to the Beta buoy in the River Mersey's Crosby Channel (**Figure 1**), to enable the buoy to be recovered and replaced. On deck were the chief officer, chief engineer, and the three able seamen. Although the chief officer

In a toolbox talk conducted before the vessel sailed on 21 November 2011, the master briefed *Cameron’s* crew that the Beta buoy was to be recovered and a replacement laid in its place, and that Charlie 3 buoy (**Figure 1**) was to be recovered, inspected and re-laid. The master also briefed the crew on the expected environmental conditions, the anchor that would be used when alongside the buoys, and the importance of the crew being safety conscious for themselves and for each other.
