Serious injury to a chief officer **CAMERON**

Crosby Channel, Liverpool

21 November 2011

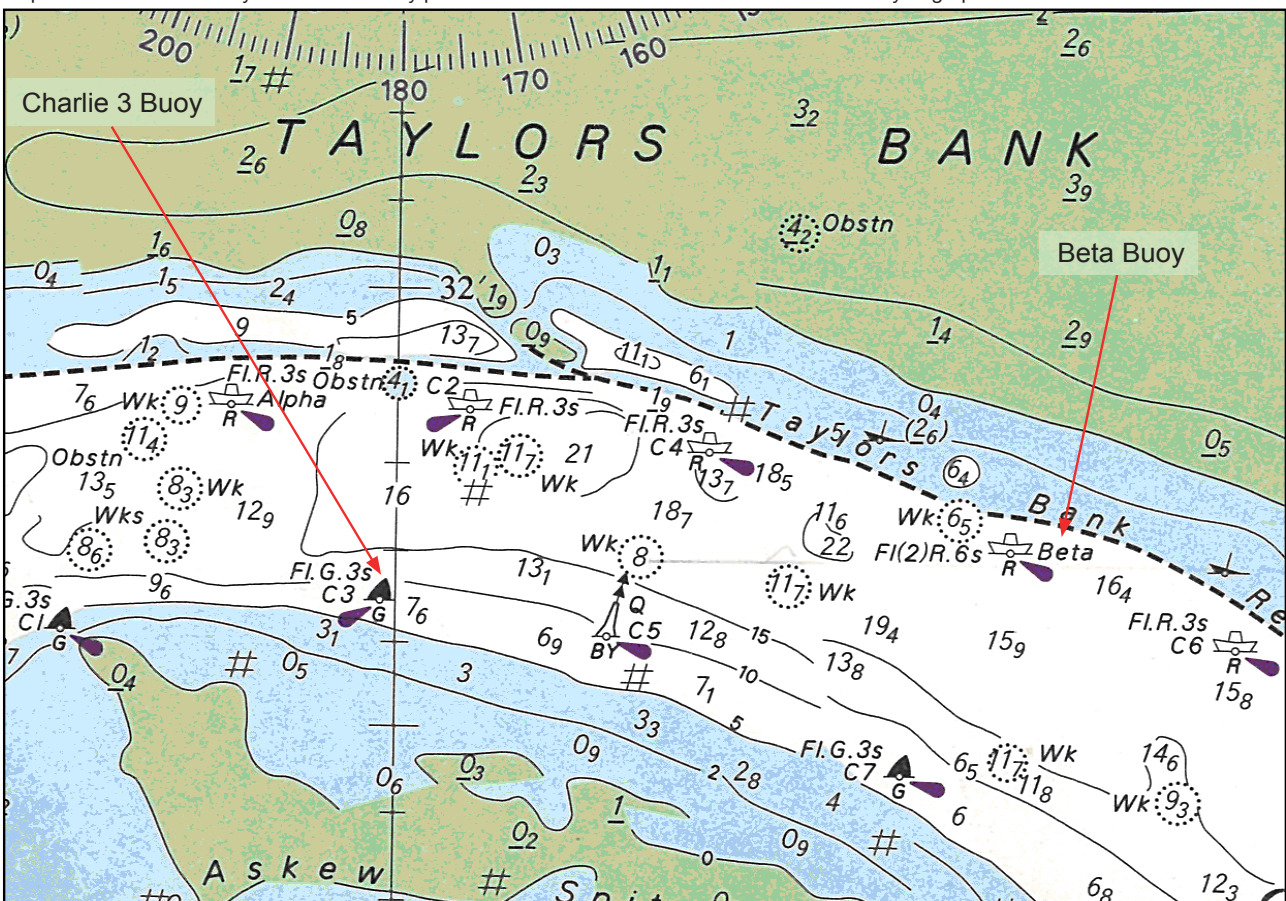
Figure 1: Crosby Channel - River Mersey

At 0800 on 21 November 2011, Cameron departed her berth in Liverpool. The wind was south-easterly force 3, and the sea was slight. From 0945, the vessel was anchored close to the Beta buoy in the River Mersey's Crosby Channel (Figure 1), to enable the buoy to be recovered and replaced. On deck were the chief officer, chief engineer, and the three able seamen. Although the chief officer
