Report on the investigation of the
failure of the controllable pitch propeller of the cargo ship

Saffier

resulting in heavy contact with a berthed tug
in Immingham harbour

25 June 2011

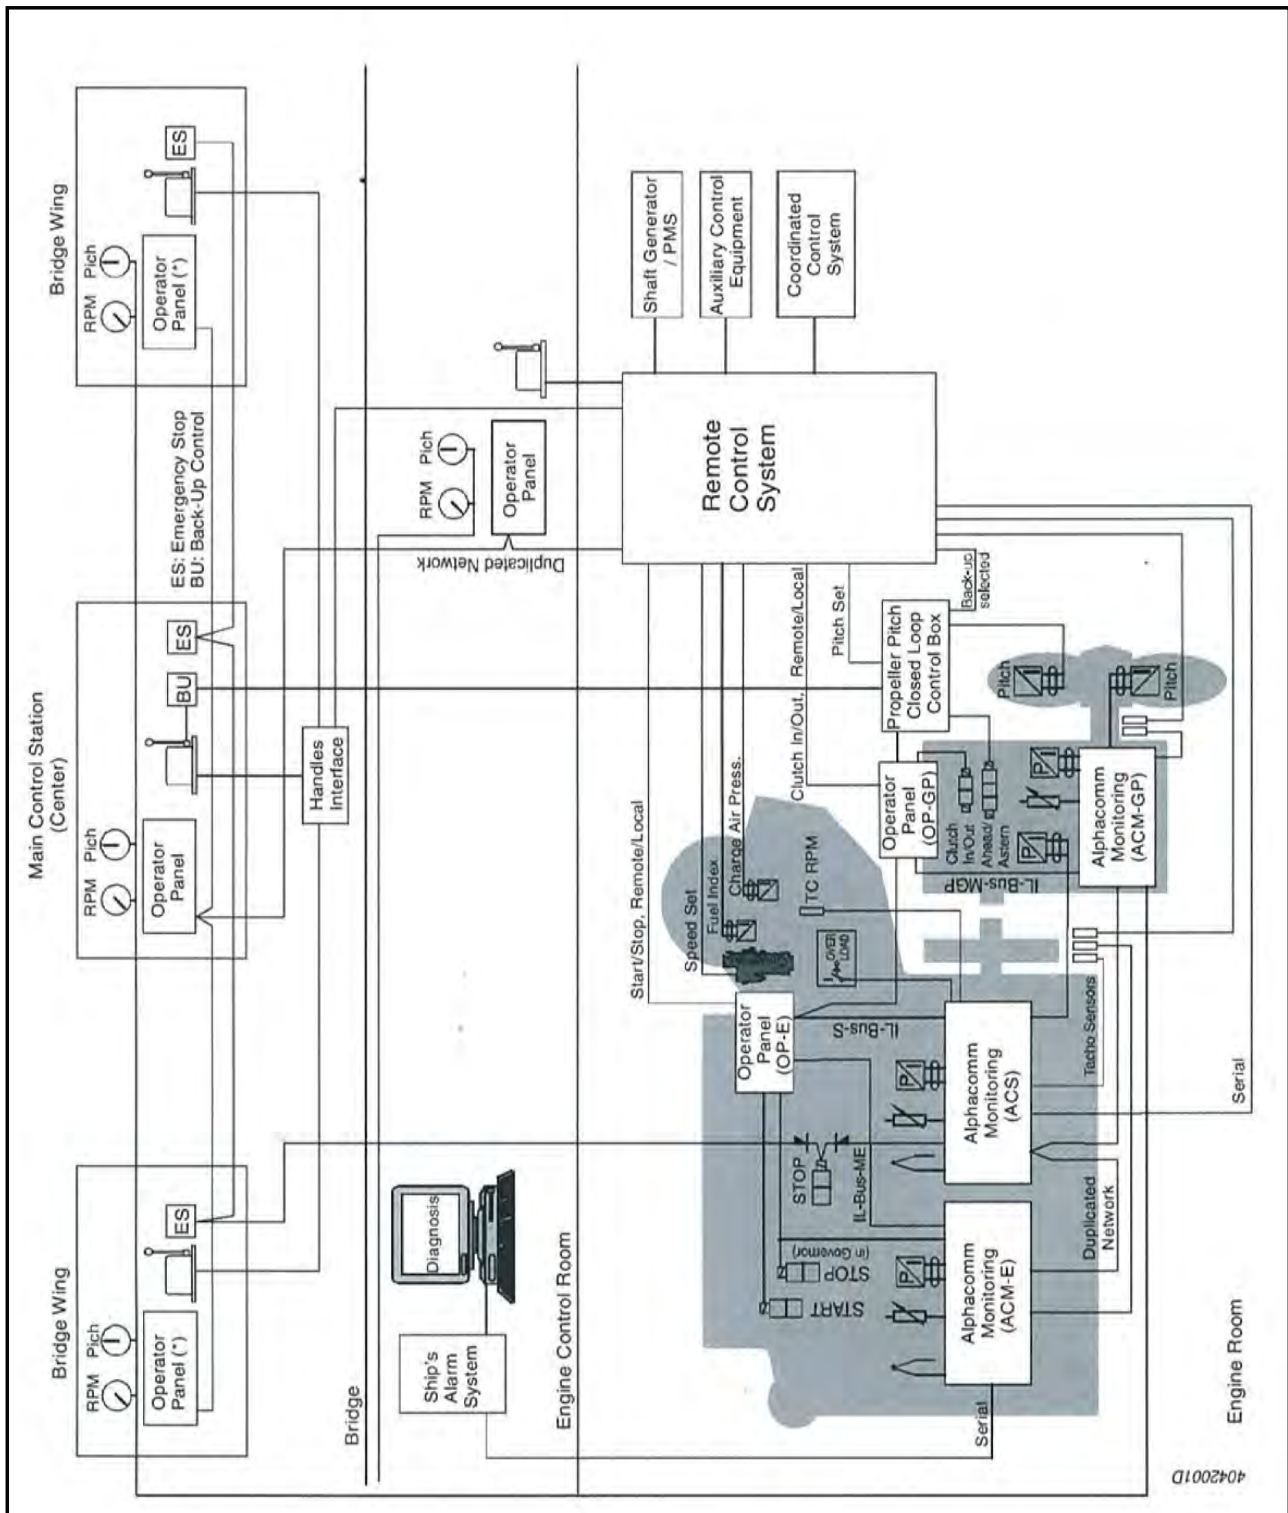
Figure 5: Propulsion control and monitoring system

The ship's propulsion equipment was controlled by MAN's Alphasonic 2000 propulsion control system (AT2000 PCS) (**Figure 5**). It was integrated through a network with systems for engine safety (ACS), engine monitoring (ACM-E), and gearbox and propeller monitoring (ACM-GP). The AT2000 PCS was capable of several functions including: starting and stopping the main engine; operating the propulsion system in three different modes (combinator², constant speed and independent control); main engine load control; transfer of control between engine

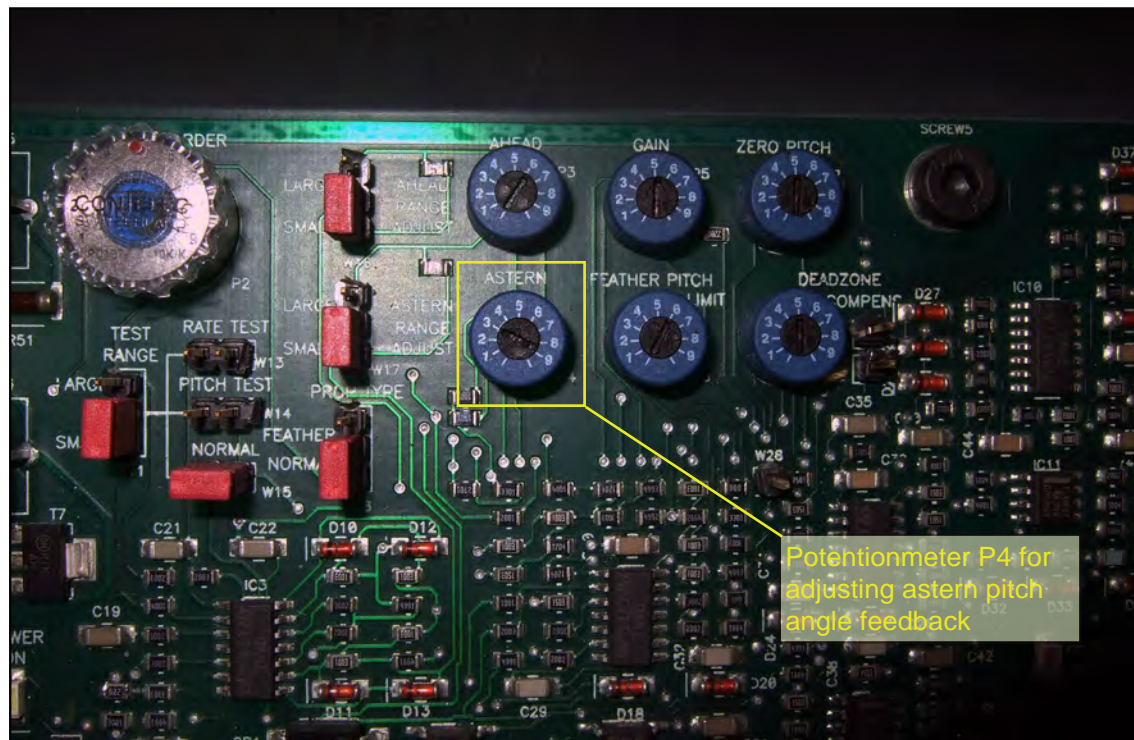
Figure 6: Closed loop control system ASP12

The pitch control levers at both the central control console and portable console were connected to potentiometers, which communicated the amount of pitch required by the operator to the AT2000 PCS. A pitch demand signal, of between 4 and 20mA, was generated and fed into the ASP12 unit (**Figure 6**), which then compared the demand and feedback position signals. The feedback signal represented the actual pitch of the propeller blades and was received from one of two position feedback transmitters.

The closed loop control system (the ASP12 unit) was located next to the engine gearcase. It compared the pitch demand signal from the AT2000 PCS with the feedback from the pitch position indicating transmitter. The ASP12 unit contained six potentiometers, P3 to P8 (**Figure 6**), which could be used to calibrate the pitch servo response to the demand and feedback signals. At the time of the accident, the potentiometers on *Saffier* were set to the following values:

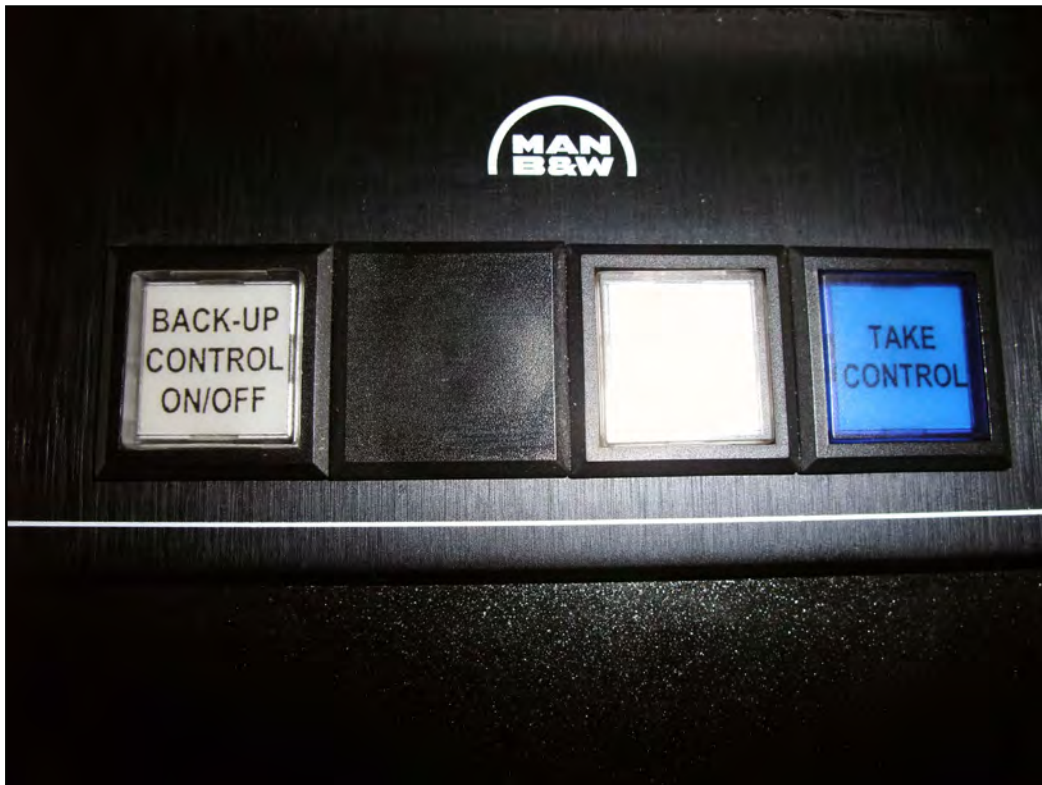
Figure 7: Backup control to bypass the AT2000 PCS

It was possible to bypass the AT2000 PCS by pressing a button labelled 'BACK UP CONTROL' (**Figure 7**) at the central control station on the bridge. When backup control was in use, a second potentiometer, also connected to the pitch control lever, was used to control the pitch. The signal was fed directly into the ASP12 unit, bypassing the AT2000 PCS, to control the pitch.

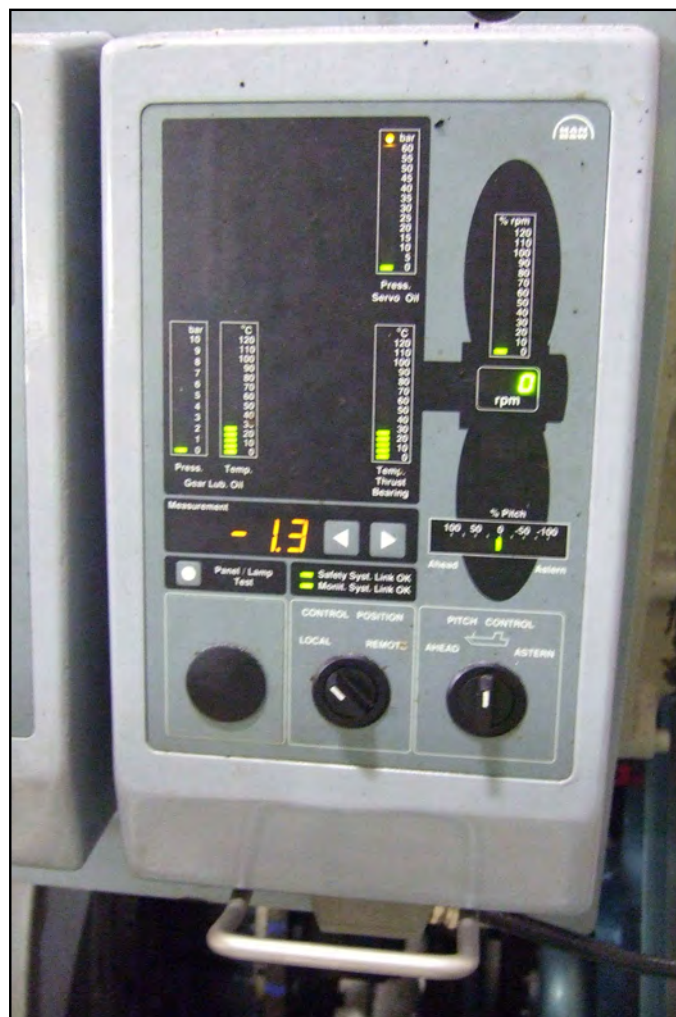
Figure 8: Local control for main propulsion system

- setting a switch to the local control position and activating an ahead or astern switch which controlled the solenoid valves directly (**Figure 8**)
- activating the solenoid valves (**Figure 9**) directly using finger pressure.
