## Fatal man overboard **FV ABOUT TIME** off Pembrokeshire 14 June 2011

### SUMMARY

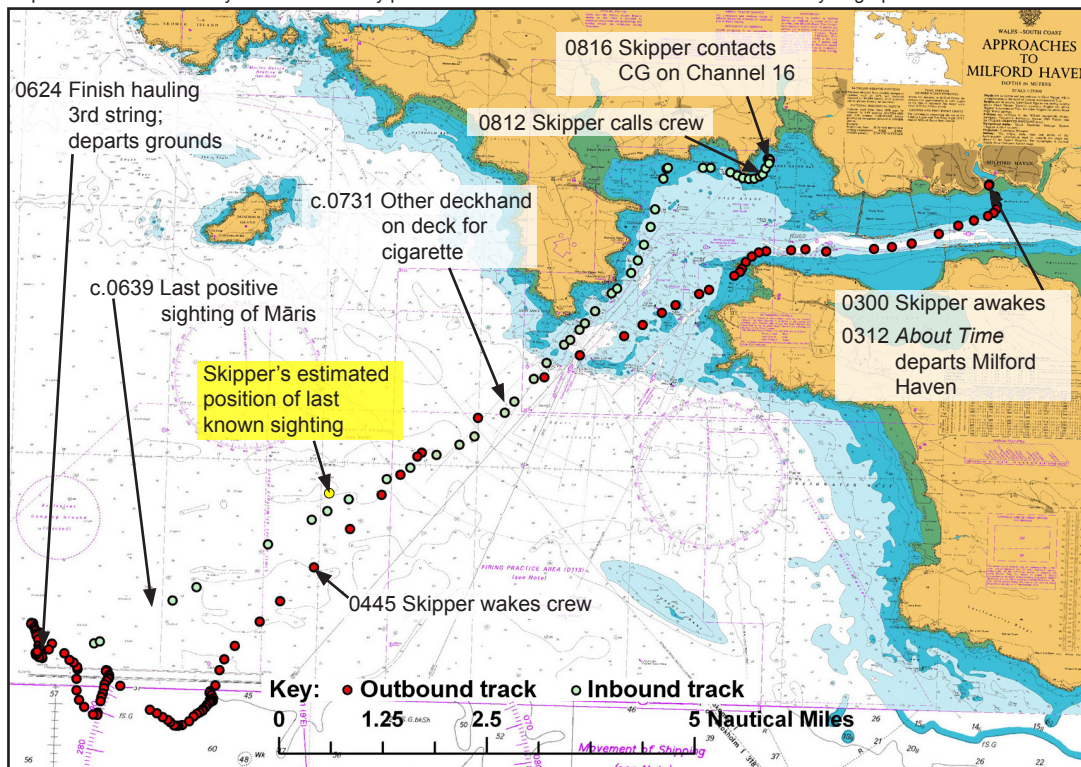
Figure 2: Chart showing track of vessel

At 0312 on 14 June 2011, *About Time* departed Milford Haven for the fishing grounds (Figure 2), about 7 miles to the south-west of St Ann's Head, to recover the remaining six strings of whelk pots.

At 0826 the skipper once more provided *About Time*'s current position as the last known sighting of Māris. This was queried by Milford Haven coastguard and, at 0830, the skipper realised his error and provided an estimated position for the last known sighting of 51° 38.5'N 005° 14.9W (**Figure 2**). This was based on an estimate that Māris had been last seen 45 to 60 minutes prior to the time it was recognised he was missing. In fact, Māris had last been seen about 90 minutes before this time.
