Report on the investigation of the  
collision between the rigid inflatable boat

***Morfil***

and the passenger vessel

***Sun Clipper***

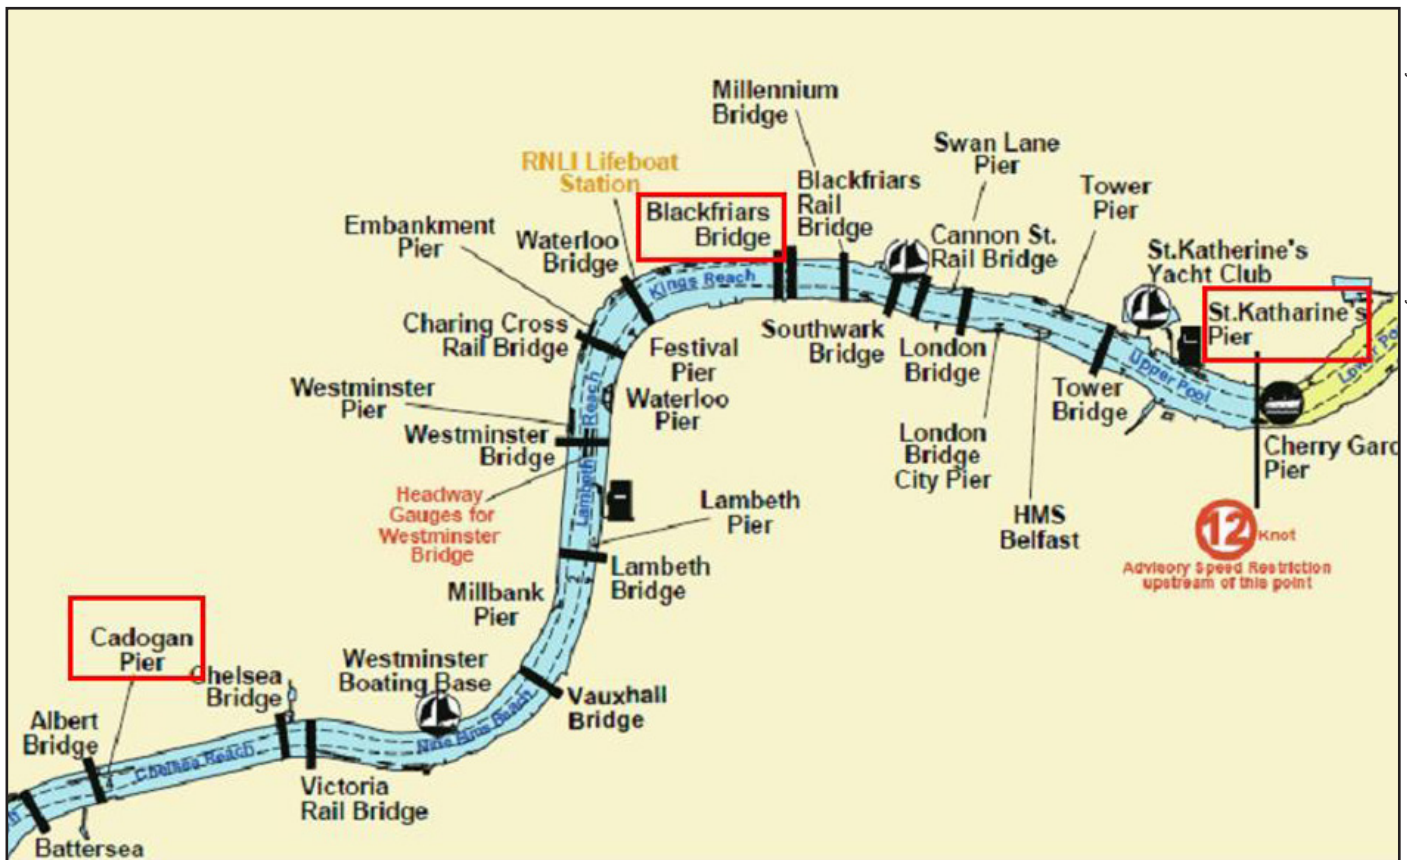
Figure 1: The River Thames

River Byelaw 48 imposes an 8 knot speed limit on the River Thames above Wandsworth Bridge, the creeks that are linked to the tidal section of the River Thames, and the area off Southend. The section of the Thames from Wandsworth Bridge to Cherry Garden Pier (**Figure 1**) has an advisory speed limit of 12 knots, which was established through the PLA's NTM No.12 of 2009 (**Annex B**). The authority's decision to recommend a speed limit of 12 knots in this area was made following careful consideration of several factors, including the navigable water available, reaction times, navigational hazards, and vessel types.

Although some vessel owners and operators might consider the recommended 12 knot speed limit between Wandsworth Bridge and Cherry Garden Pier (**Figure 1** and **Annex B**) to be unnecessarily restrictive, it was identified as a control measure through risk assessment, and was based on the careful consideration of a number of factors, including reaction times and the proximity of dangers. Indeed, by allowing vessels to close head on at speeds up to 24 knots (12.5m per second) the limit is considerably more generous than the speed limits imposed by many other harbour authorities. In this case, had *Morfil* been adhering to the speed limit, the RIB's coxswain and *Sun Clipper's* master would have had more time, albeit only seconds, for them to see each other and to take more effective avoiding action.

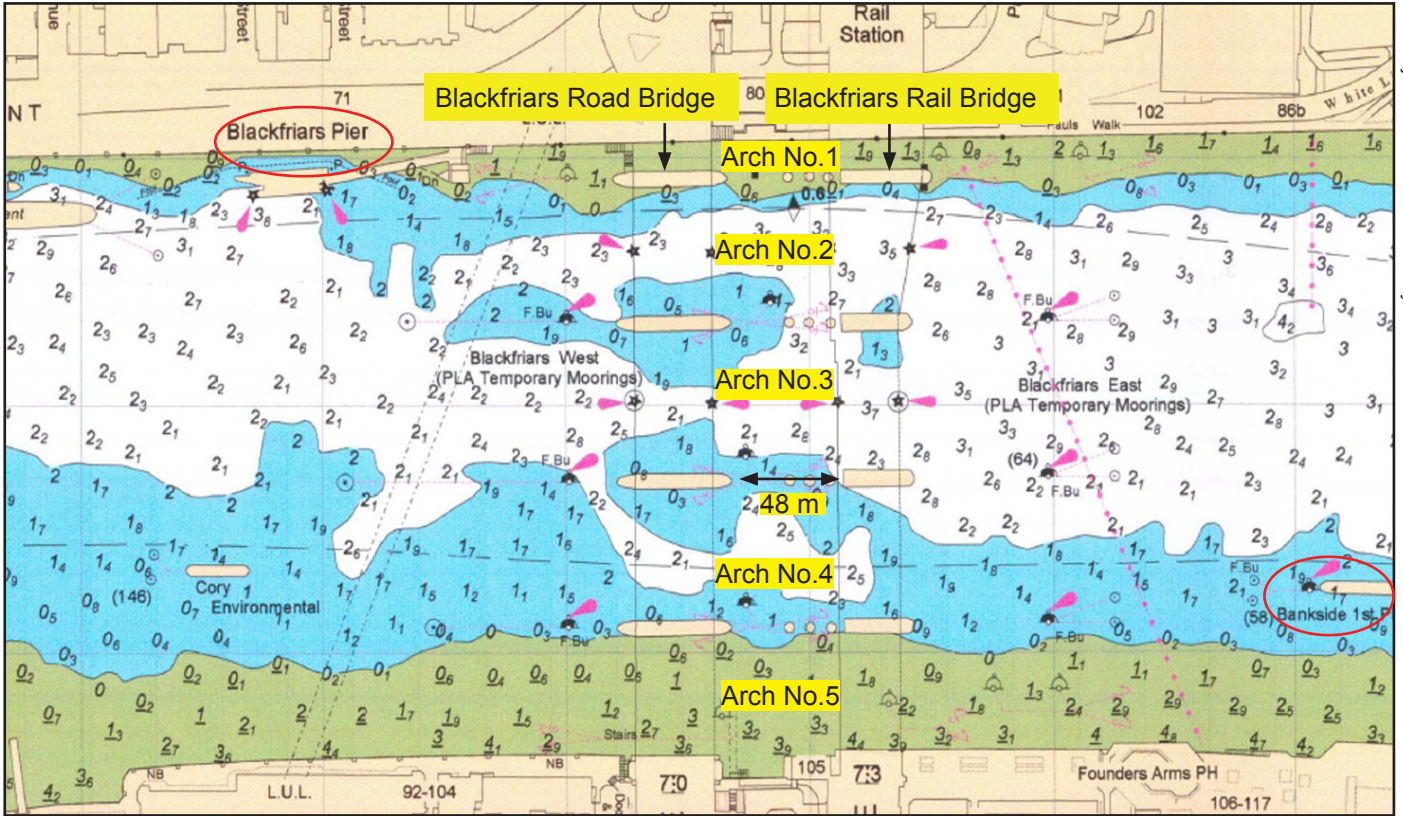
Figure 3: Extract of PLA chart 317

At 2319, the high speed craft (HSC) passenger ferry, *Sun Clipper*, departed Blackfriars Pier (**Figure 3**) as scheduled. On board were her three crew and 35 passengers. She was heading downstream towards Tower Bridge on her final service of the day. Her next scheduled stop was at Bankside Pier (**Figure 3**).

It is evident from **Figures 5 and 6a, 6b and 6c** that *Sun Clipper* and *Morfil* were potentially in sight of each other for approximately 10 seconds prior to the collision. However, the lack of reaction by *Morfil*'s coxswain indicates that he did not see the oncoming ferry until he took action to try and avoid a collision between 1 and 2 seconds before the impact. By then, the two vessels were too close and closing too quickly for his instinctive attempt to manoeuvre clear to be effective. Although *Sun Clipper*'s master immediately reduced speed when he saw *Morfil* approaching, he was prevented from taking any further avoiding action by the close proximity of the temporary mooring buoys and the No.3 arch buttresses (**Figure 3**).

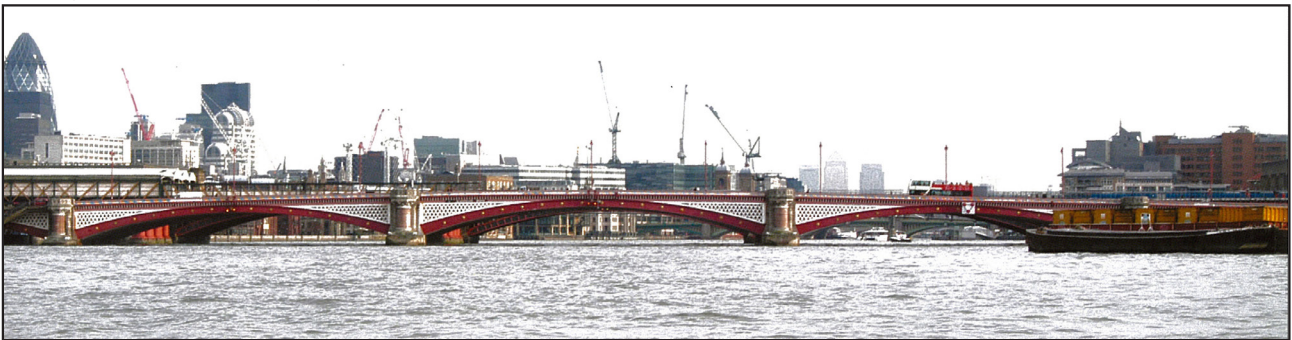
**Figure 9:** Blackfriars Road Bridge

The River Thames is the longest river in England. It is tidal from its estuary to Teddington Lock and is crossed by 29 bridges along this stretch. Blackfriars Road Bridge spans the River Thames from Blackfriars on the north bank to Southwark on the south bank (**Figure 3**). The road bridge was built in 1869 and has five steel frame arches that are supported by stone faced buttresses (**Figure 9**). Blackfriars Rail Bridge is 48m downriver from the road bridge and also has five arches. The bridges' No.3 arches are normally used by larger vessels; smaller vessels generally use No.2 and No.4 arches.

Refurbishment of Blackfriars Rail Bridge started in March 2009, which required each of the rail and road bridge arches to be closed at various times. Mariners were advised of the current works taking place via the Port of London Authority (PLA) Notice to Mariners (NTM) M3/2011 (**Annex A**), which included:

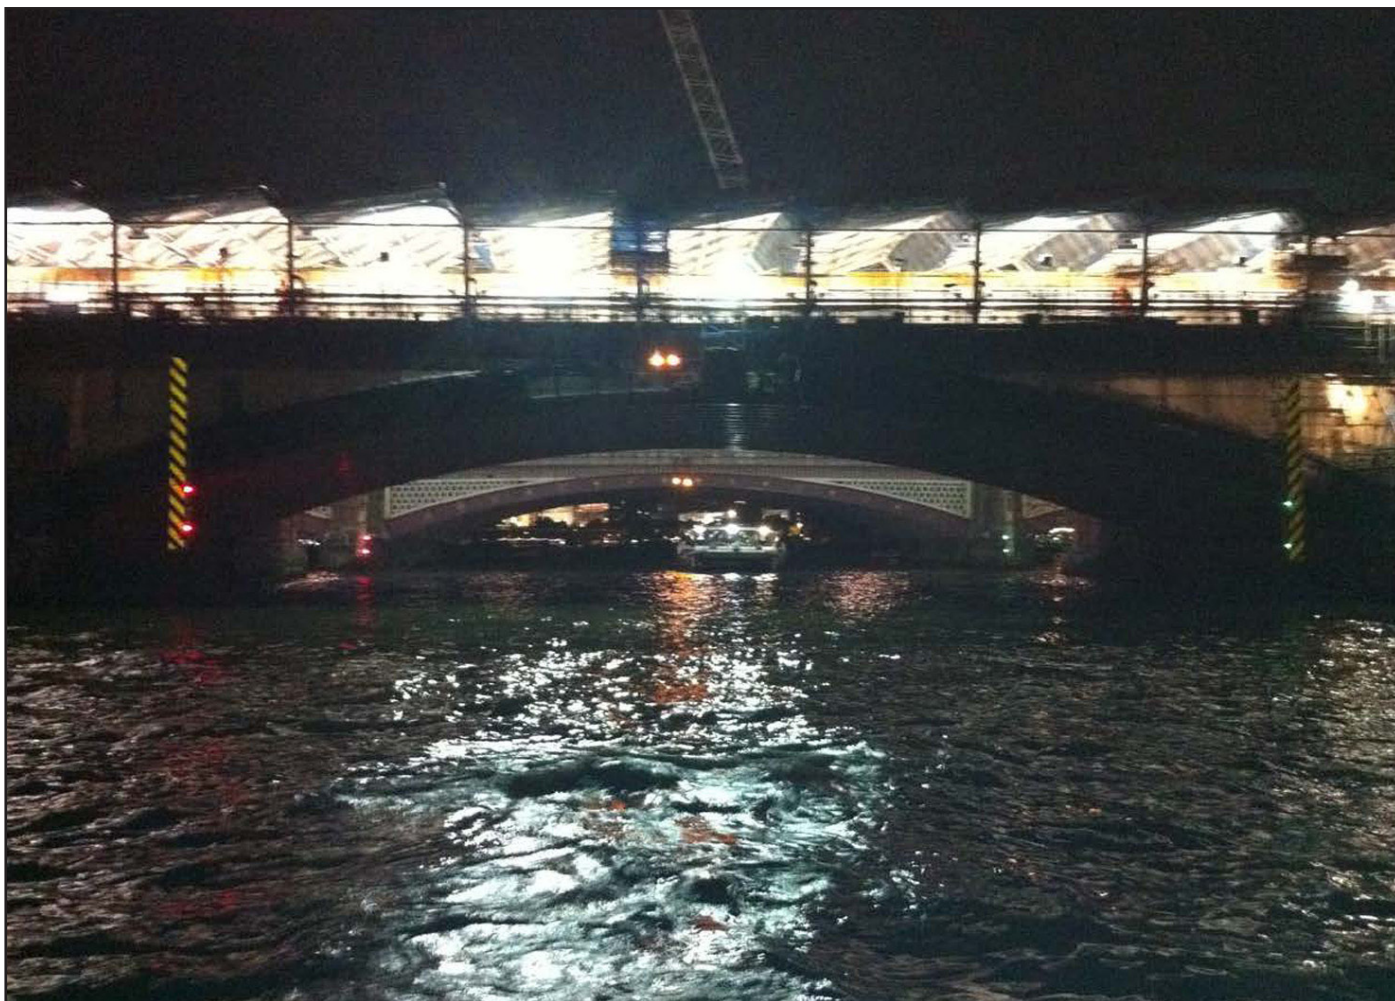
**Figure 10:** Thames Clipper at Blackfriars Bridges at night

Nevertheless, given the RIB's manoeuvrability, 10 seconds should have been sufficient time to avoid the collision if *Morfil's* coxswain had not been impaired by alcohol and had he kept a proper lookout ahead. Although there would inevitably have been some luminescence from the lights on the riverbanks, it is unlikely to have been significantly detrimental to the coxswain's night vision. Furthermore, **Figure 10** shows that the Thames Clippers' vessels are well lit and quite conspicuous at night, even under a bridge arch.
