Report on the investigation of
the electrical blackout and subsequent
grounding of the feeder container vessel

Clonlee

on the River Tyne, England

16 March 2011

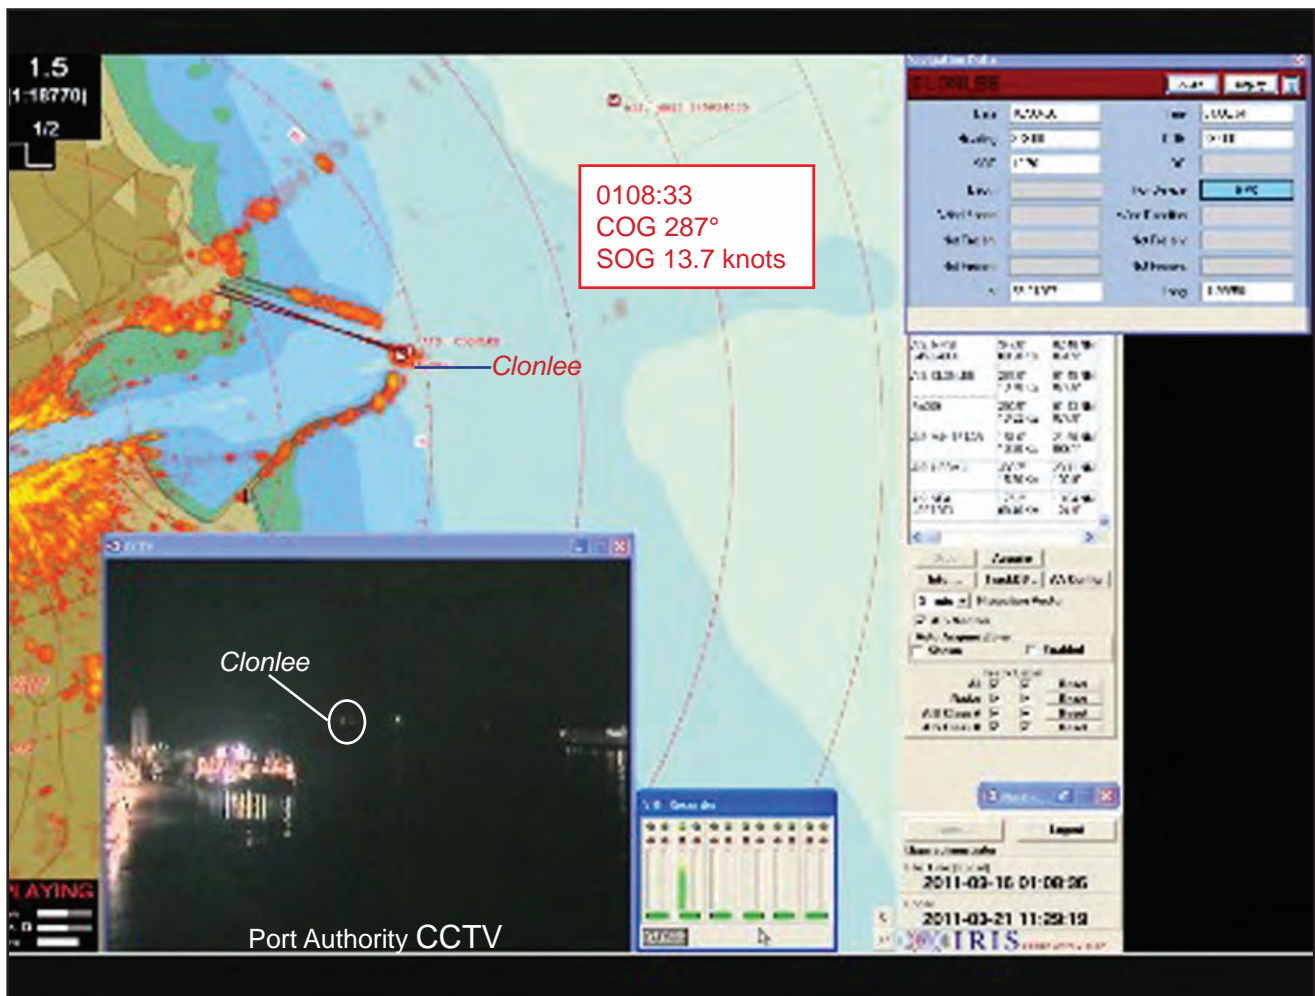
Figure 4: *Clonlee*'s position when the chief engineer was instructed to change over to manoeuvring mode

At 0106, with the breakwater's southern pier bearing approximately 275° at a distance of 0.5 mile, the master began to turn *Clonlee* to port. At 0108, the master telephoned the ECR and instructed the chief engineer to change over to the DGs (**Figure 4**). Twenty seconds later, he reported to VTS that *Clonlee* was passing between the piers. The deck party, having completed its initial preparations for entering the port, began removing the upper deck containers' lashing arrangements.

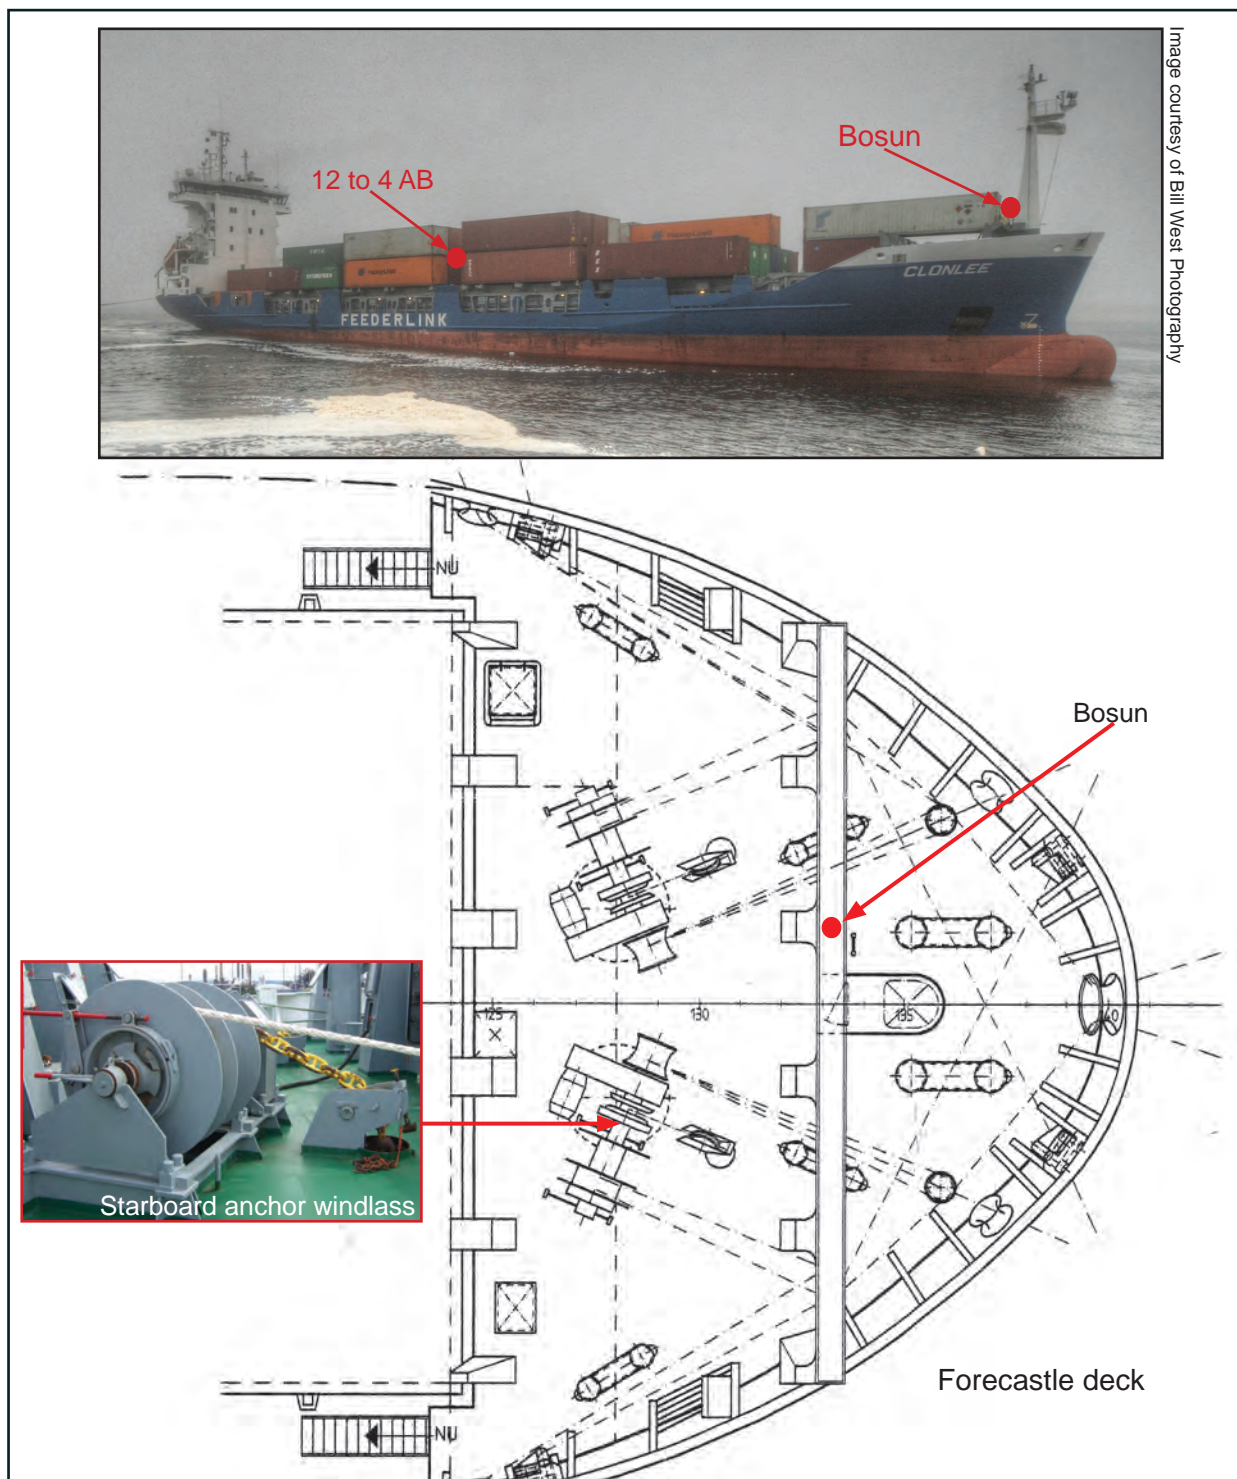
Figure 7: Location of the deck crew at the time of the blackout

The bosun was unlashng the containers at the forward end of the vessel (**Figure 7**) when he realised the ship had blacked out. He climbed down from the container support stanchion and made his way to the anchor windlasses on the forecastle deck.

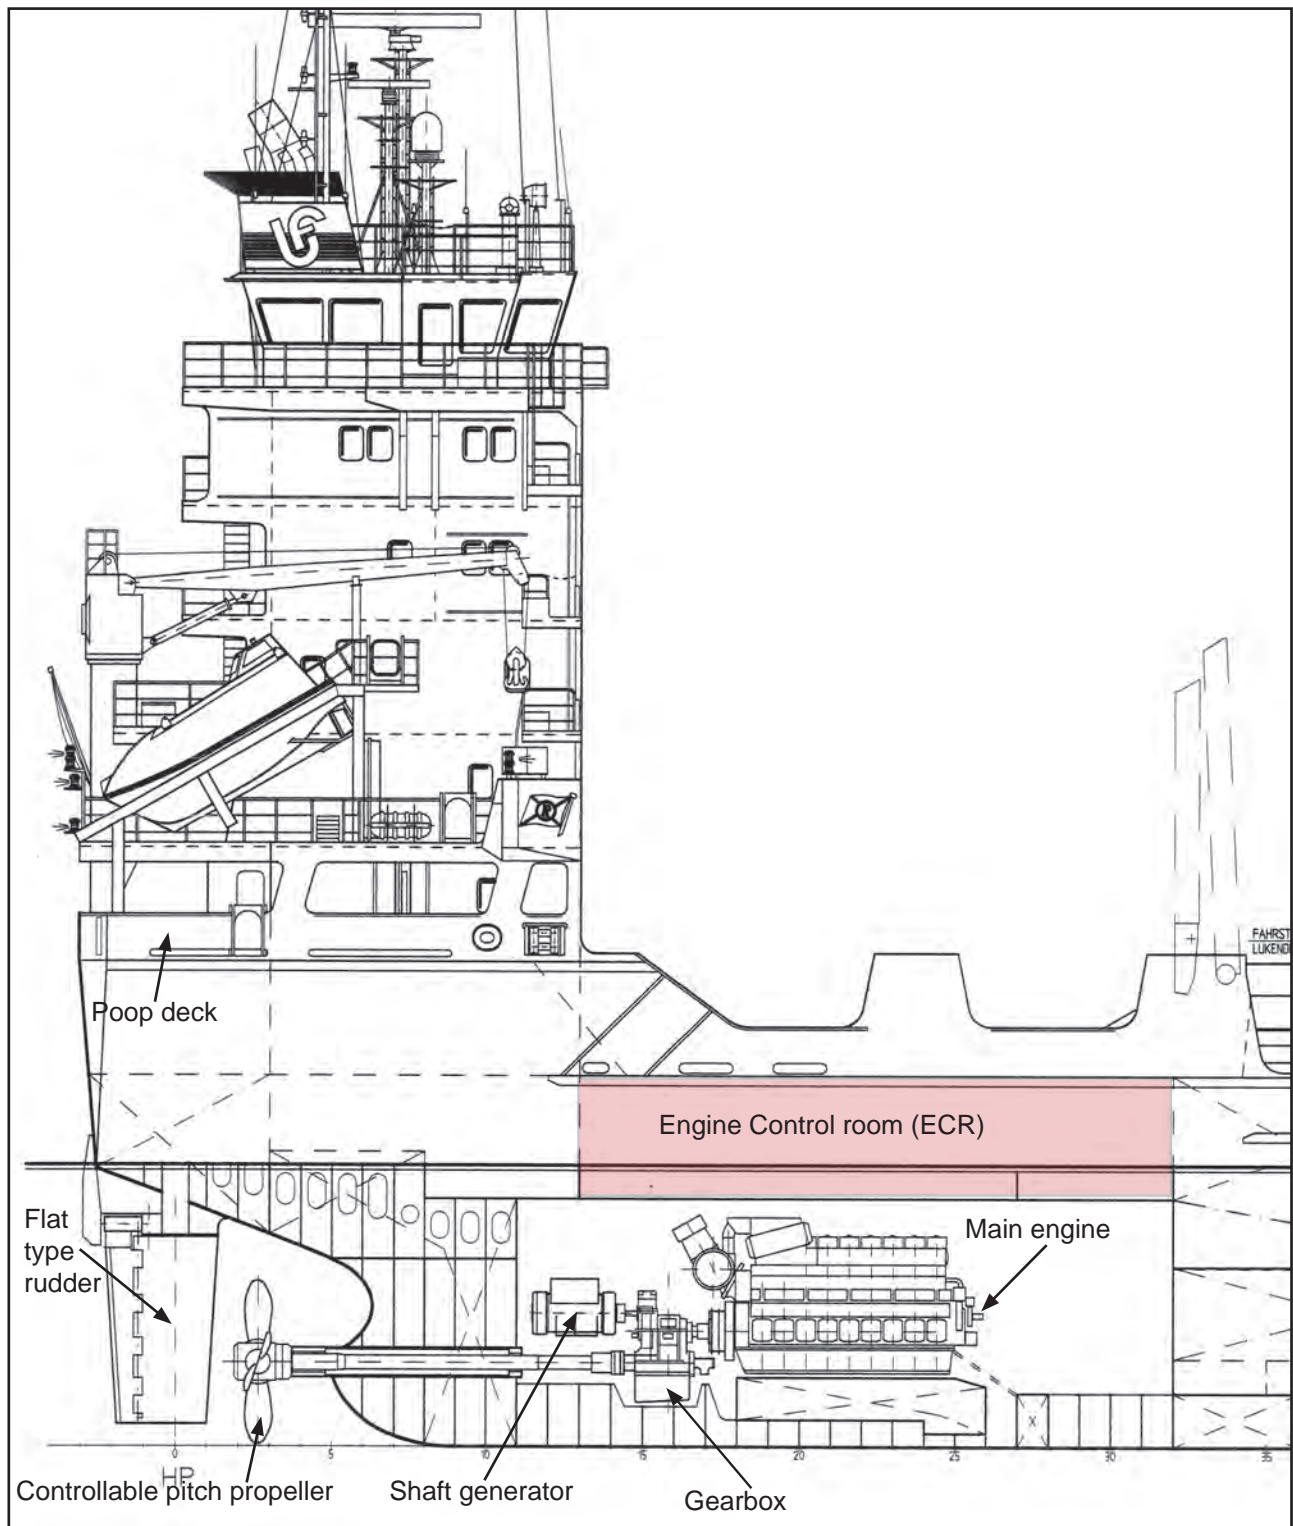
Figure 11: *Clonlee*'s propulsion drive train arrangement

Clonlee had a single 9 cylinder medium speed diesel-driven Deutz MWM type 645L9 main engine. The engine ran on low sulphur heavy fuel oil and produced up to 3,825kW of power at a speed of 600rpm. The main engine drove the ship's CPP, via a single reduction gearbox, at a constant speed of 162rpm (**Figure 11**).

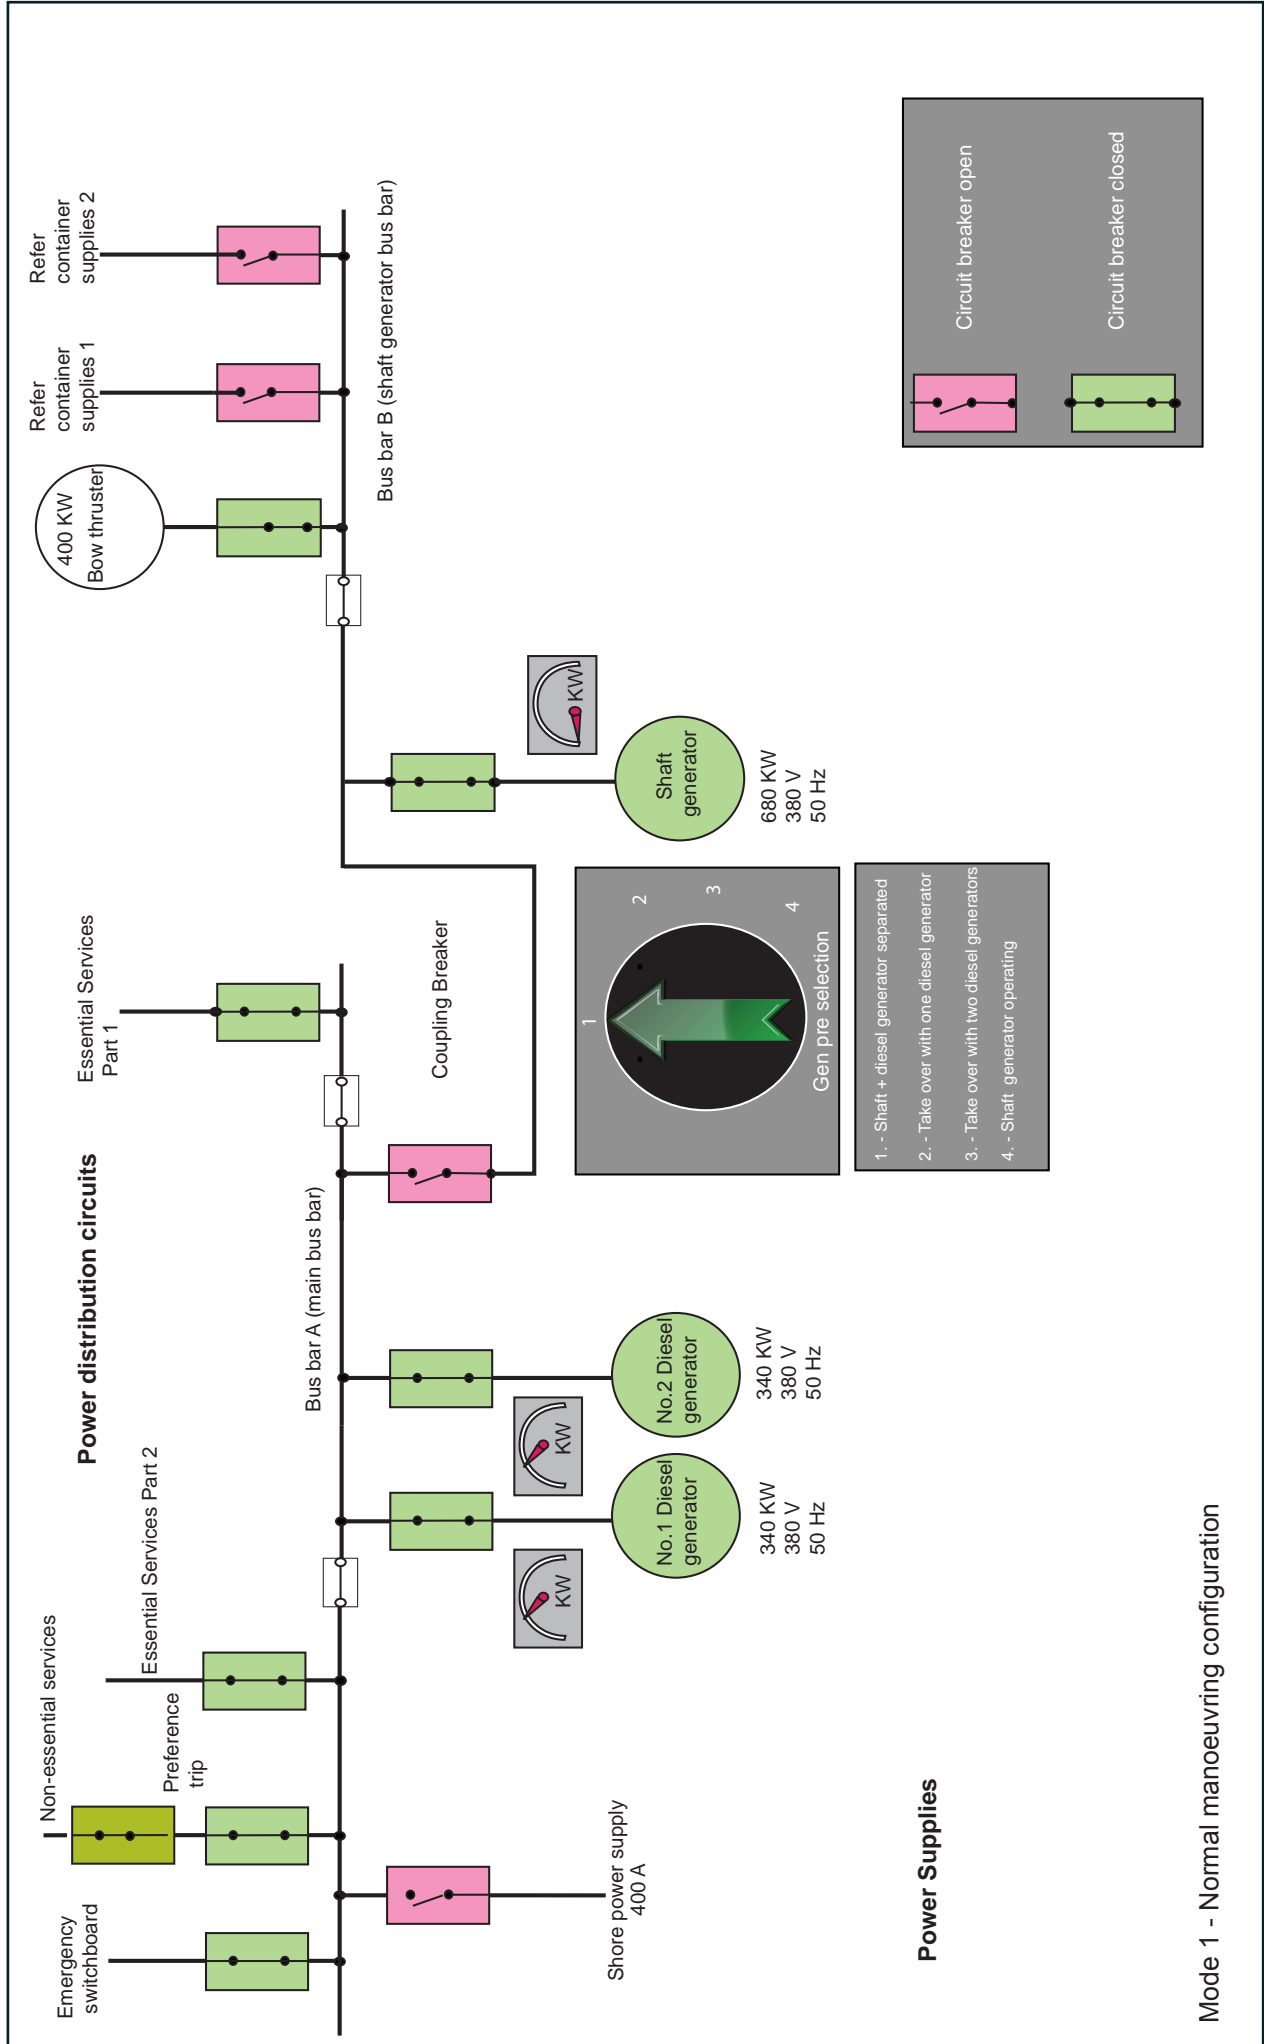
Figure 13: Switchboard power supply and distribution circuits

Clonlee had crossed the North Sea with her main switchboard operating in mode 4 (**Figure 14**), with her entire electrical load being supplied by the shaft generator. At the time of the blackout, the switchboard was reported to be in mode 1, with both DGs connected to the switchboard with power available to the bow thruster (**Figure 13**).

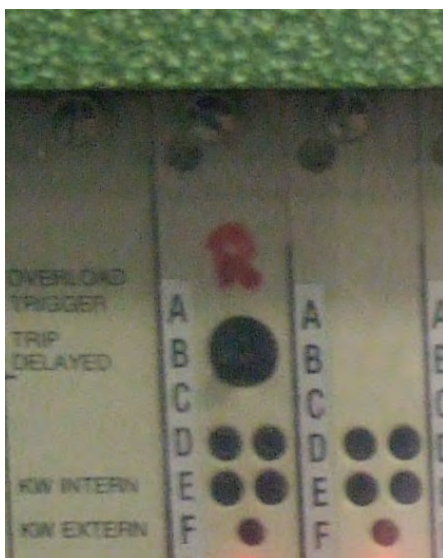
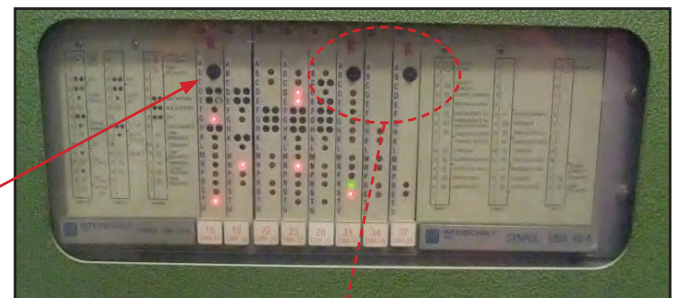
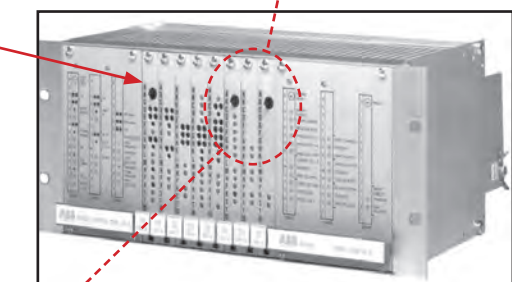
Figure 16: Synpol protection and control device reset switches

The alternators and related systems connected to the main bus bars were protected against overload, short circuits, under and over voltage, failure to synchronise, reverse power and under frequency. The trip reset switches were on the front of the Synpol units located inside the generator panels on the main switchboard (**Figure 16**). There were three switches on the panel: the two on the left reset the switchboard trips and the one on the right was a synchronisation test switch. The synchronisation test switch was used to test the synchronisation sequence without closing the main breaker. If the test switch was not in its central run position the breaker would not operate. It was noted that all three switches had been marked with the letter 'R'.

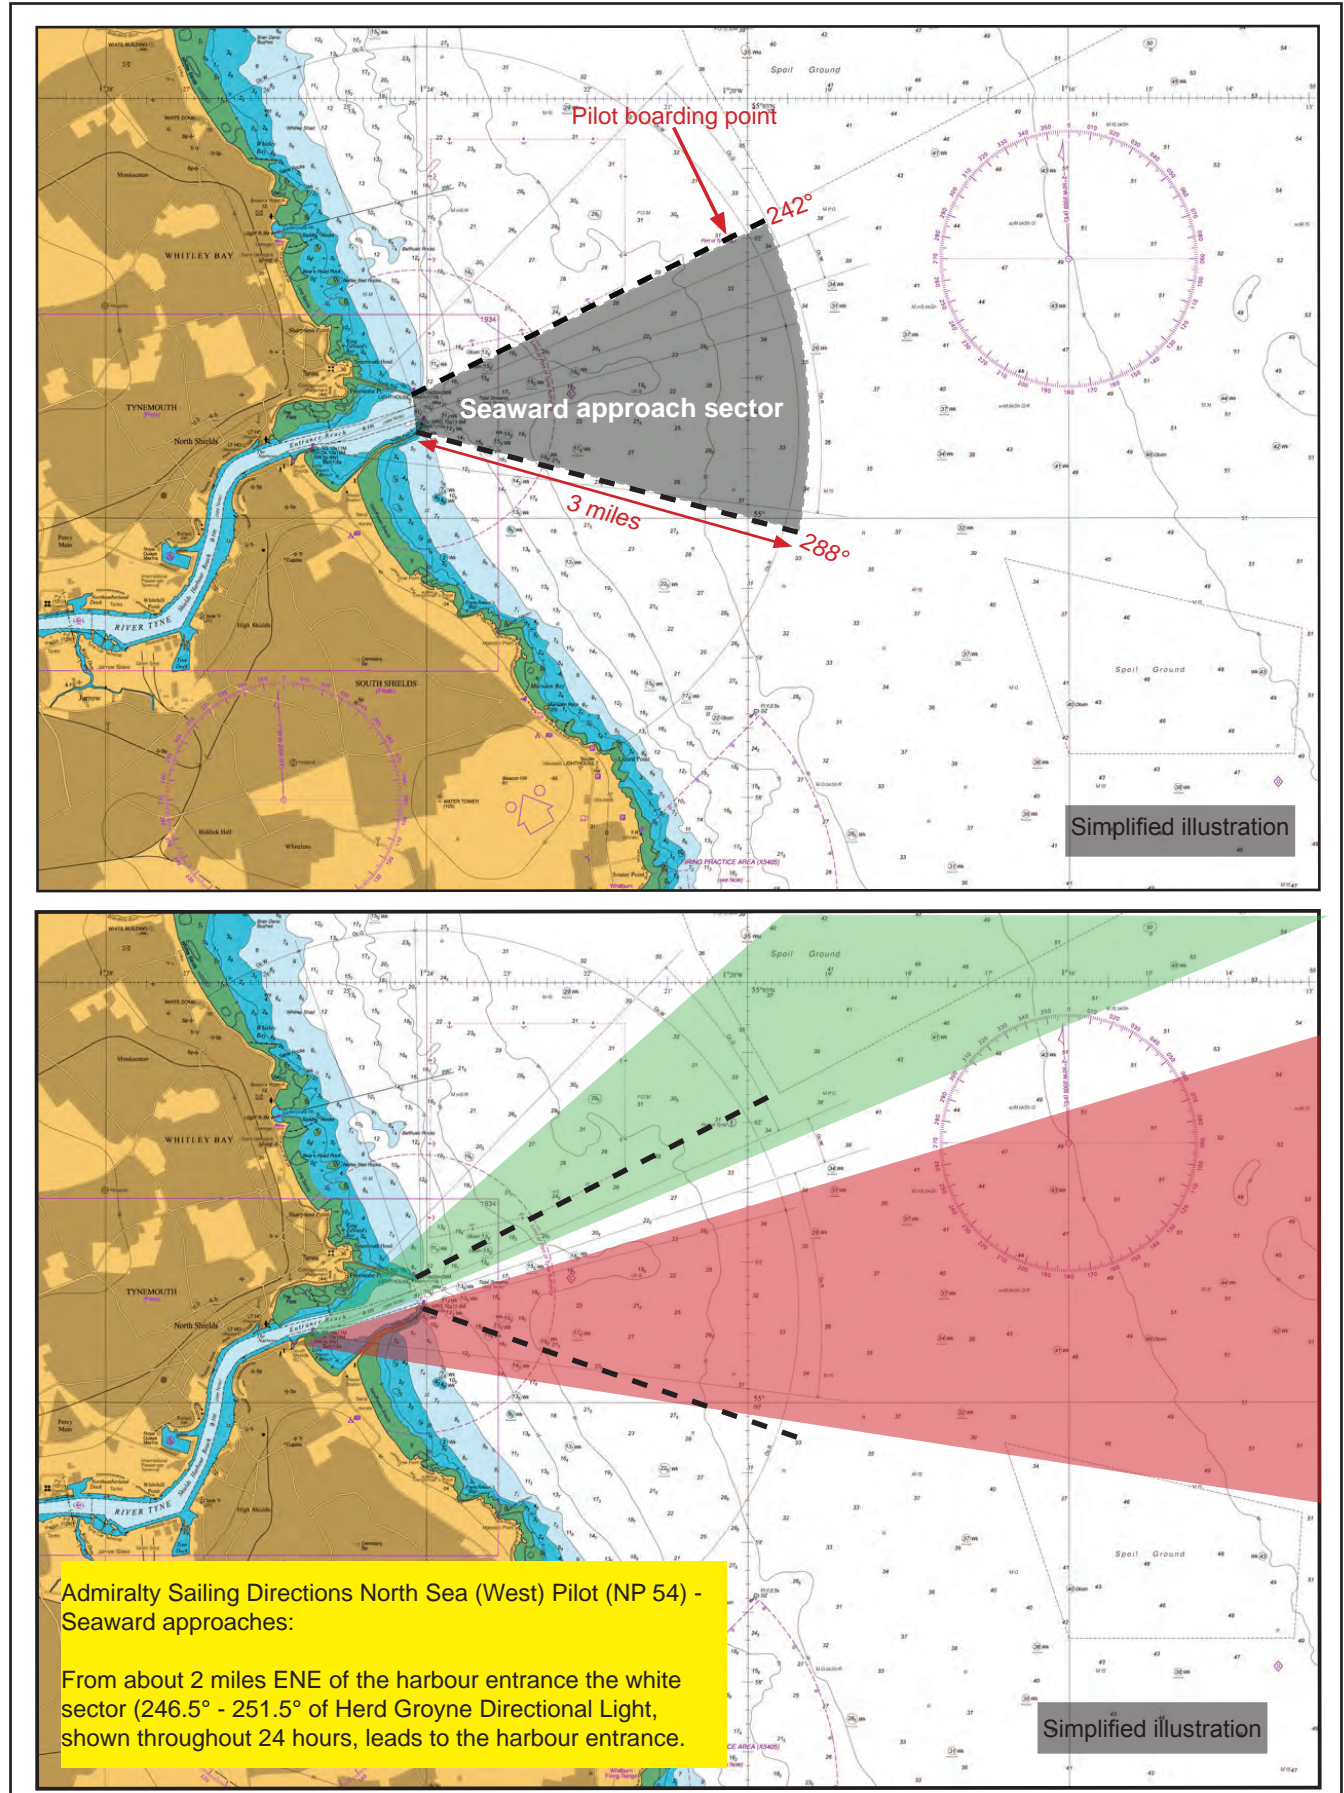
Figure 20: Port of Tyne seaward approaches

The publication, Admiralty Sailing Directions North Sea (West) Pilot (NP 54), contains general information about the Port of Tyne, local traffic regulations and directions for entering and departing the port. It defines the port's seaward approaches (**Figure 20**) as the sector with a radius of 3 miles which lies between the light on the North Pier bearing 242° and the light on the South Pier bearing 288°. It also states that:

From about 2 miles ENE of the harbour entrance the white sector (246.5° - 251.5°) of Herd Groyne directional light, shown throughout 24 hours, leads to the harbour entrance

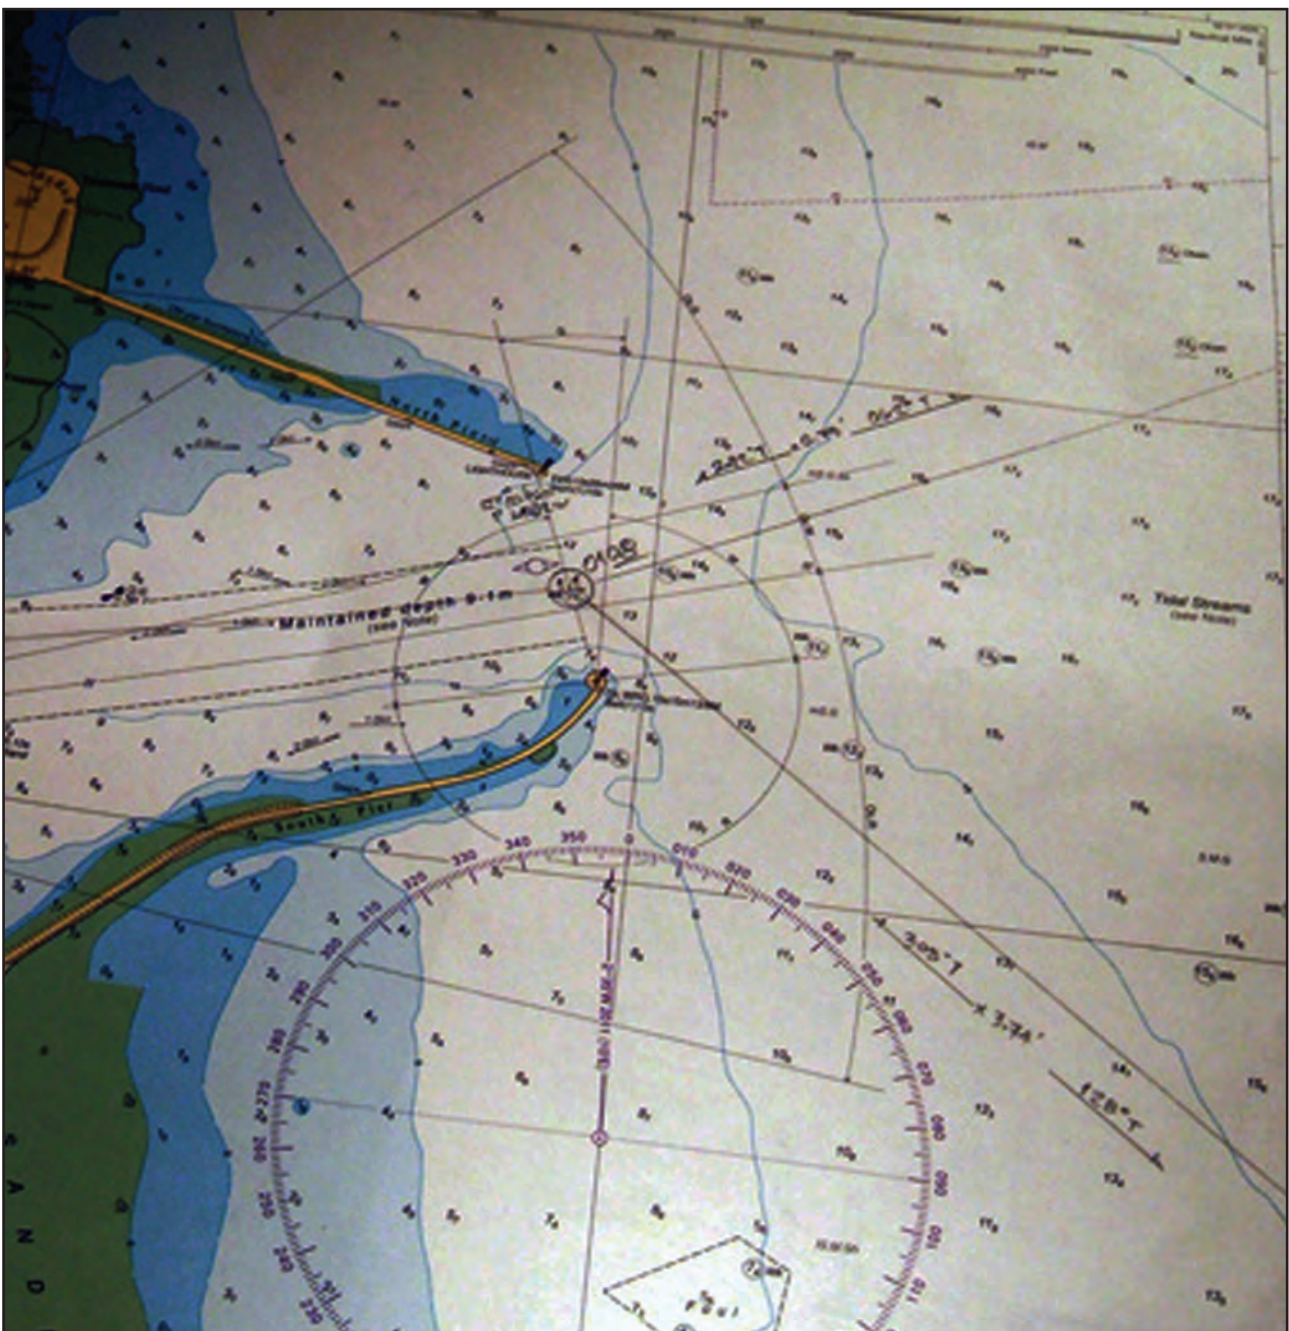
Figure 21: Passage plan marked on the paper chart

Clonlee had an electronic chart system on the bridge, but paper charts provided the vessel's primary means of navigation. The passage plan for entering the River Tyne was marked on chart number 1934 (**Figure 21**).

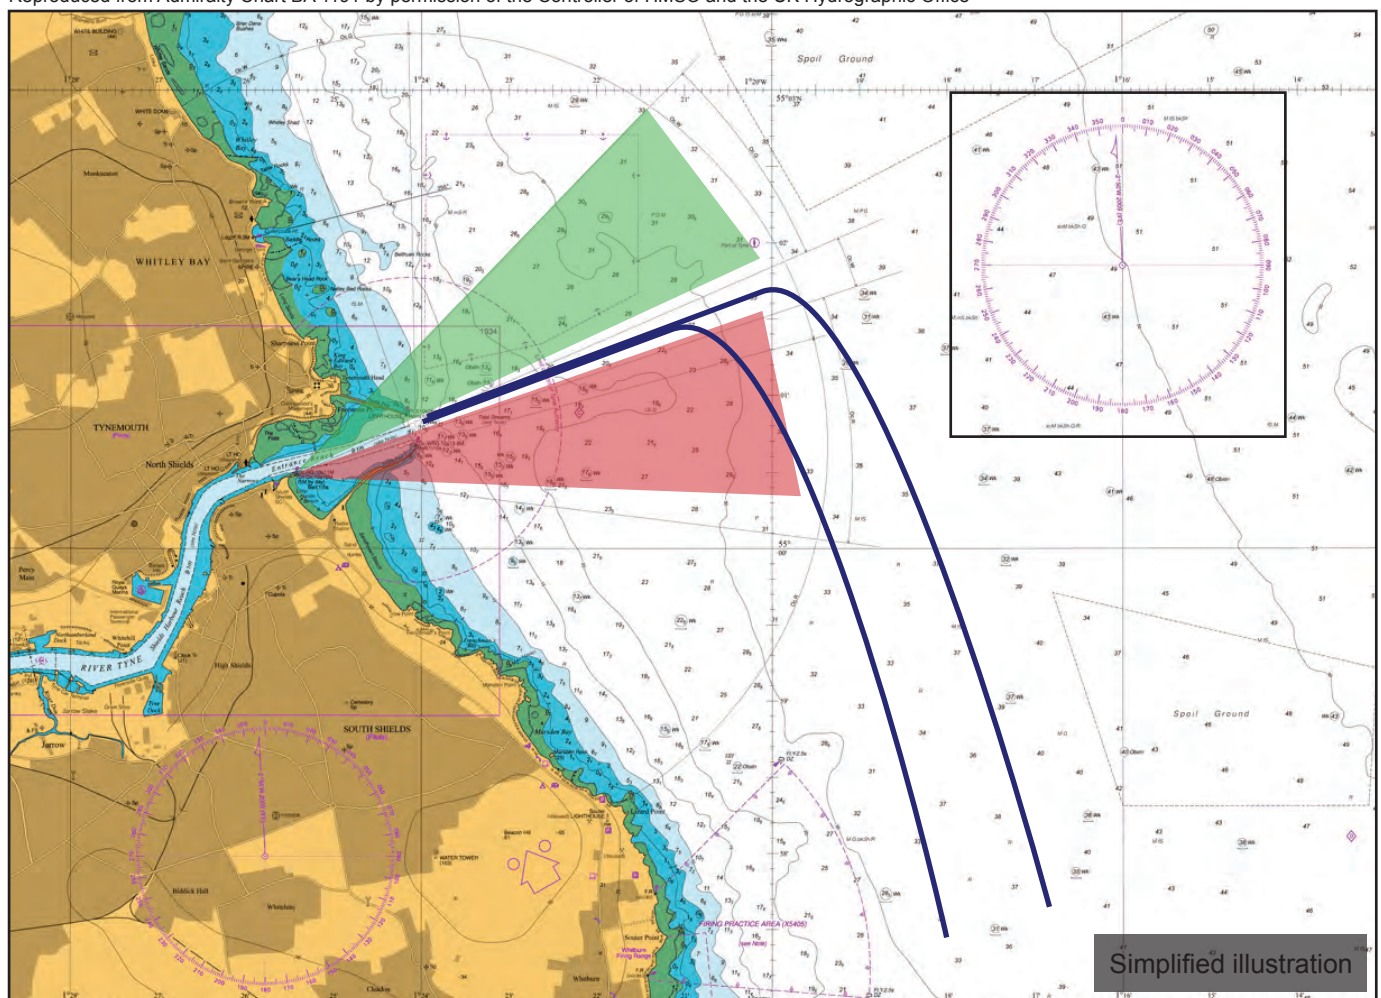
Figure 24: Typical examples of approaches made by other vessels to the River Tyne

The AIS tracks of a random selection of other vessels entering the Port of Tyne from the south were analysed in order to establish if any other vessels were ignoring the guidance provided in NP 54. The tracks analysed included those of passenger ships, car carriers and a variety of cargo vessels entering the port with and without pilots on board. All the vessels observed entered the seaward approaches 3 miles from the breakwater, and the vast majority had entered the white sector of the Herd Groyne directional light from a position at least 2 miles out (**Figure 24**).

In some situations, it would be inappropriate for VTS officers to redirect vessels, as their intervention might compound an already hazardous situation. However, if this is the case, any unsafe acts identified should be reported to the HM. Had *Clonlee*'s earlier approaches been identified as being unsafe, the HM could have taken corrective action to address the situation.
