Report on the investigation of
the collision between the container ship

Cosco Hong Kong

Zhe Ling Yu Yun 135

resulting in the loss of 11 lives

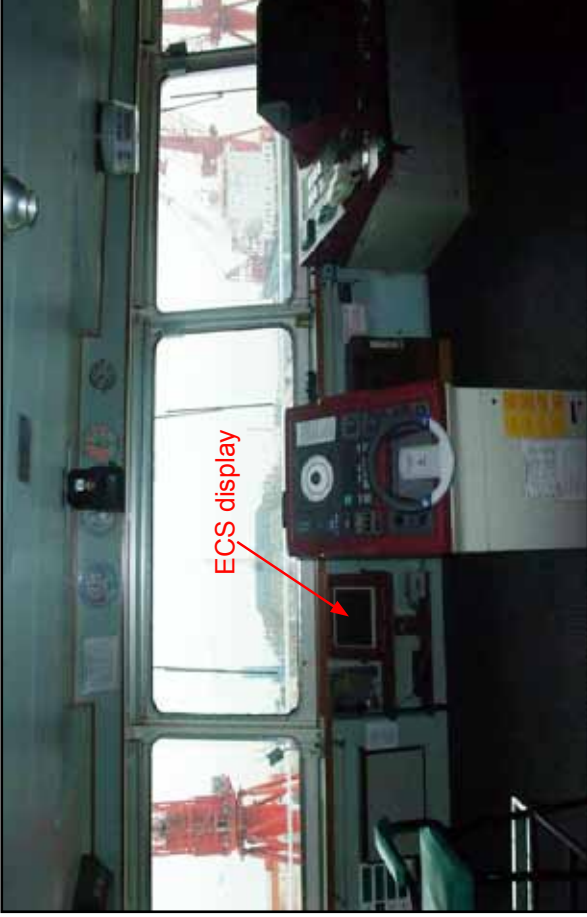
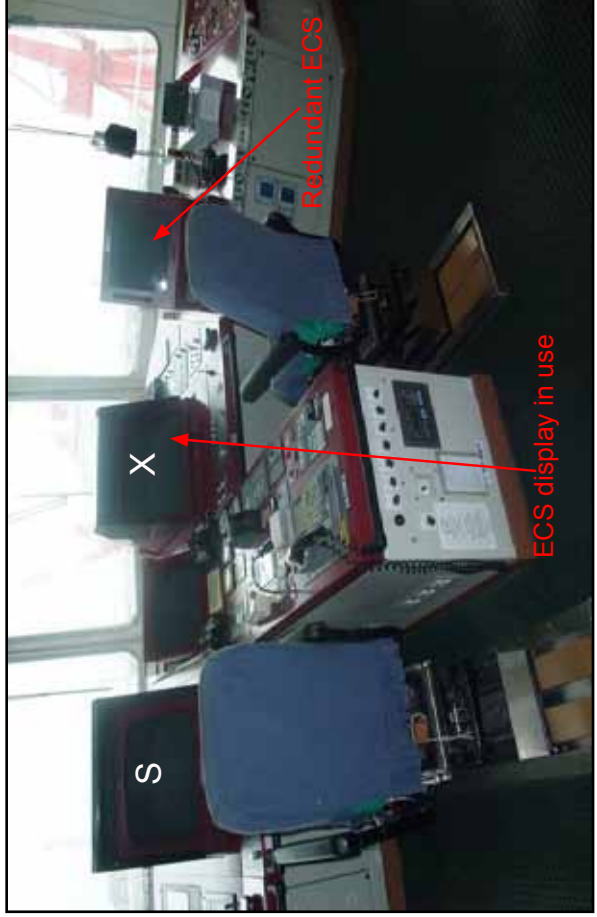
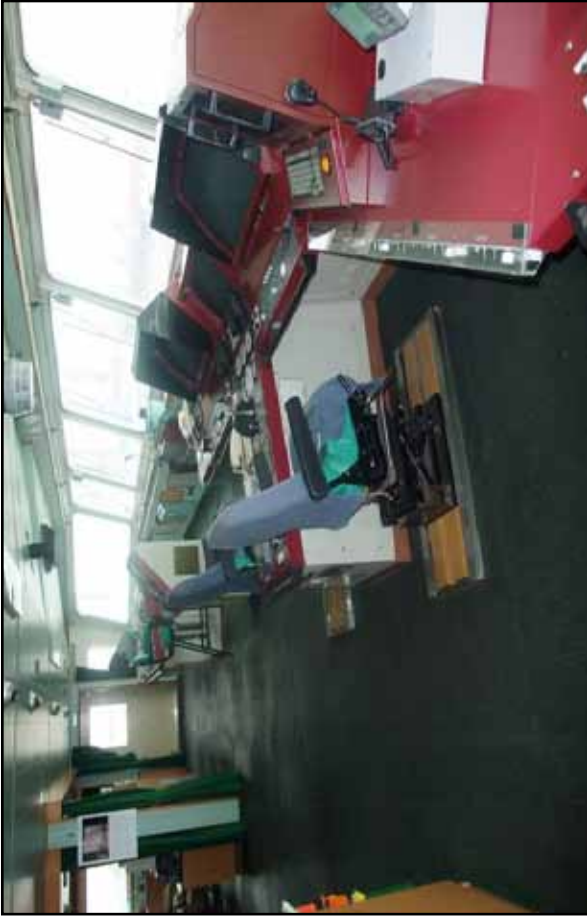
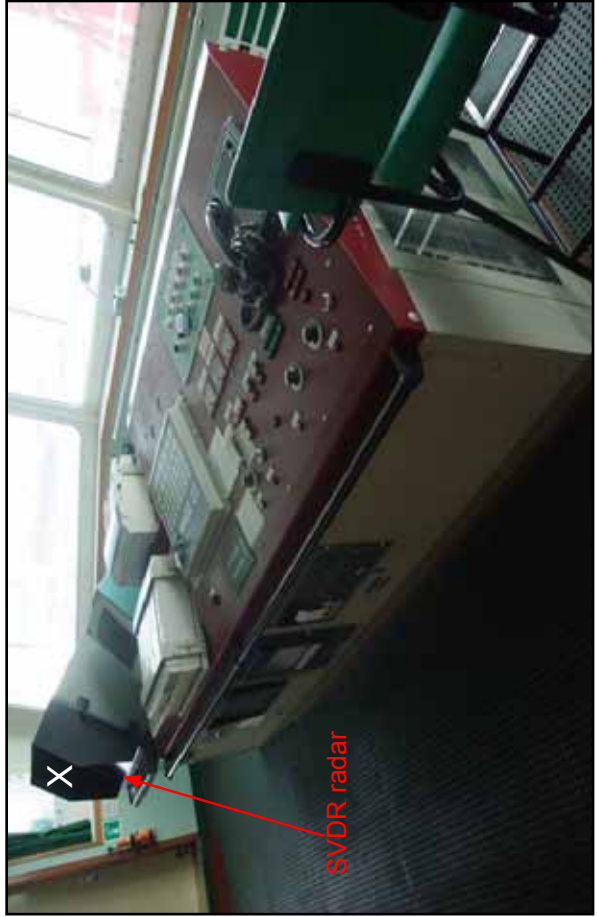
Figure 6

Cosco Hong Kong - bridge layout

The main control console on *Cosco Hong Kong's* bridge was sited to starboard of the centreline (**Figure 6**) and contained displays for STN Atlas 'X' and 'S' band radars with automatic radar plotting aids (ARPA), an electronic chart system (ECS), and AIS. The engine telegraph and an Atlas Trackpilot were also mounted on the console. The Trackpilot joystick was used to change the vessel's heading to port or starboard.

A Furuno 'X' band ARPA radar was sited on the port side of the bridge (**Figure 6**). In addition to radar data, this display also showed AIS targets, but it was not used by the second officer. No CPA or TCPA alarms were set on any of the ARPA radars as the master considered the use of these alarms in coastal waters could potentially lead to the watchkeepers relying on them too much, instead of monitoring the radars effectively.
