Report on the investigation of the fatality
of a rescue boat crewman on board

Tombarra

at Berth 3, Royal Portbury Docks,

Part B - The weight of the rescue boat

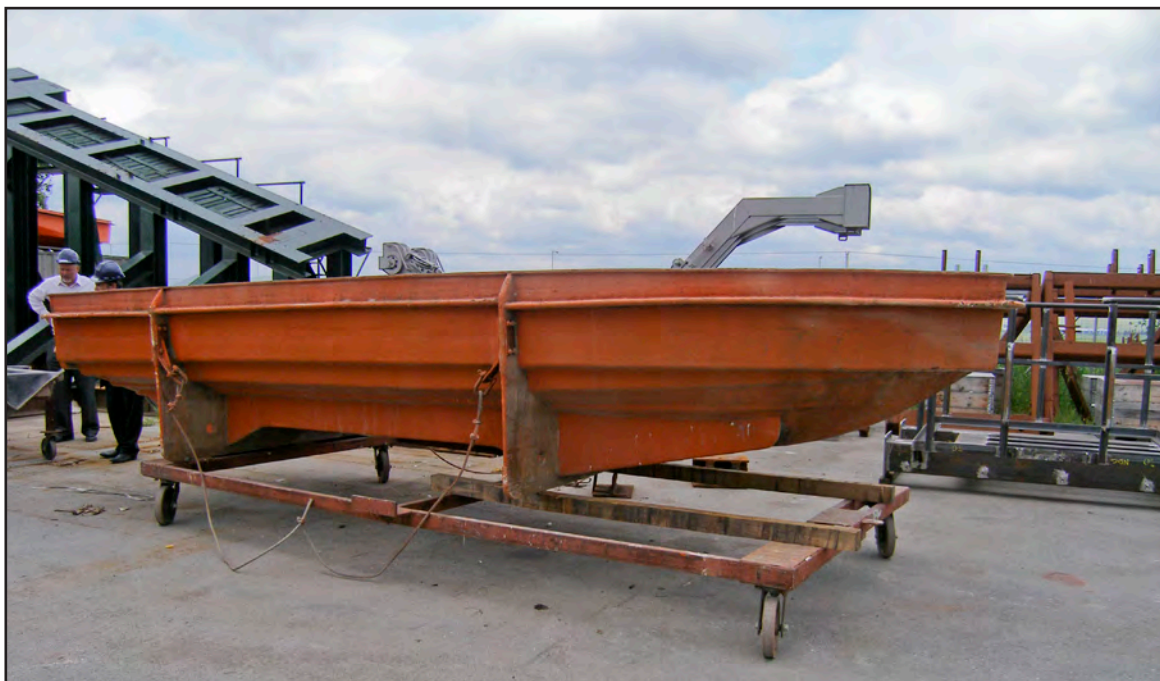
Figure 5: Boat hull mould

Tombarra's WHFRB 6.50 was manufactured by Watercraft Hellas S.A. Greece and was 6.35m in length (without engine) with a 2.2m beam. The boat was constructed from three separate GRP mouldings for the inner and outer hulls, and the stiffeners (**Figures 5, 6 and 7**). The inner hull deck, located at the upper chine, enclosed the buoyancy spaces below, and the gunwale provided an additional enclosed buoyancy space.

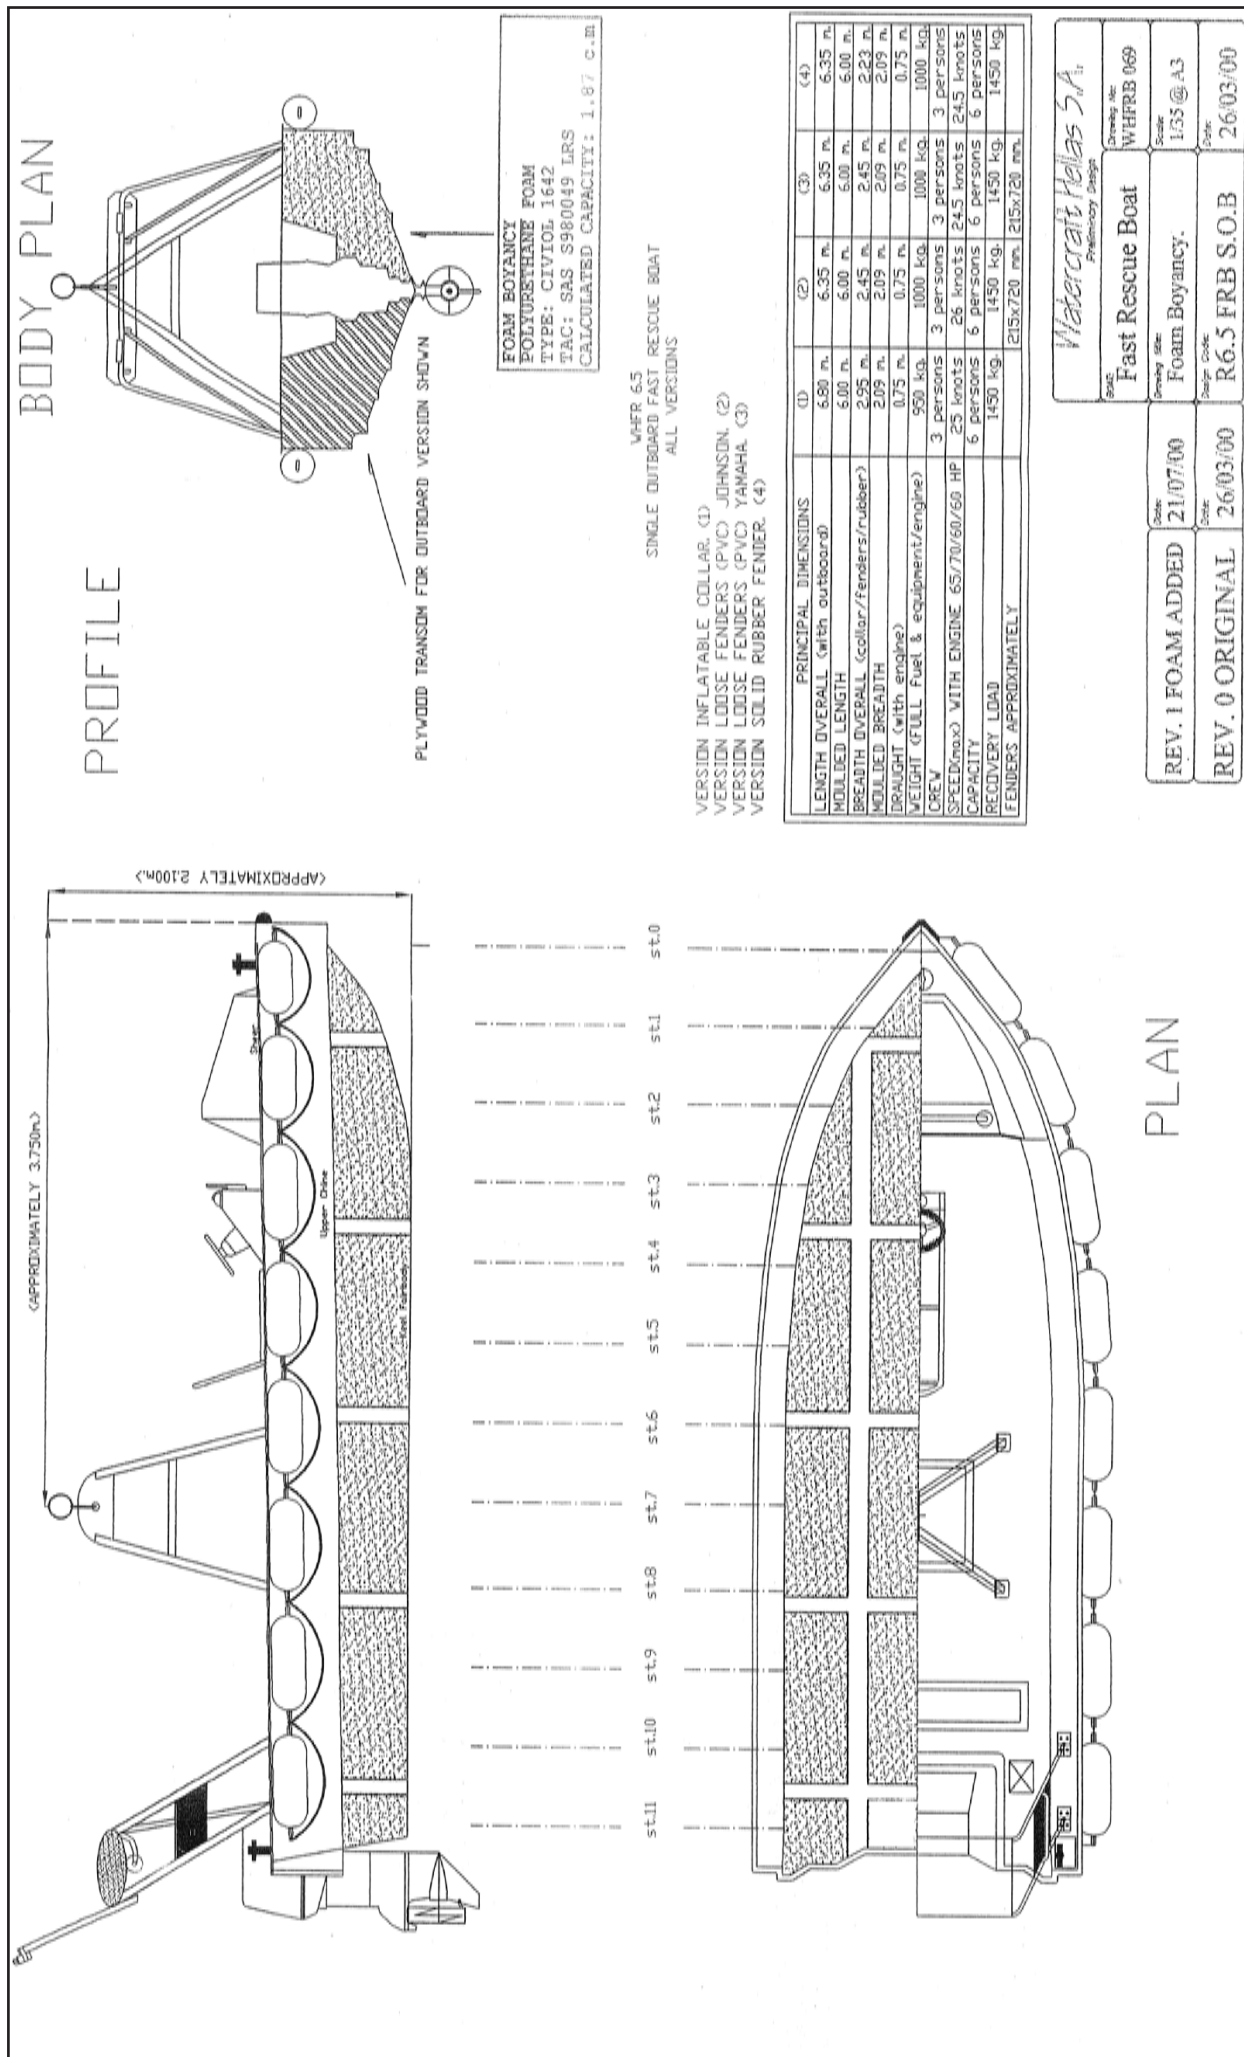
Figure 8: Body plan

The deck was constructed of balsa wood covered with GRP. The hollow GRP stiffeners comprised two longitudinal and five transverse sections, which divided the lower hull into 16 spaces or pockets (**Figure 8**). There was a gap of approximately 60mm between the upper surfaces of the stiffeners and the inner hull deck.

The WHFRB 6.50's internal structure was subdivided into 16 spaces by hollow stiffeners (**Figure 8**), but 15 of the spaces were filled with PU foam and had no means of drainage. Consequently, once water penetrated the hollow stiffeners and into voids within the foam, not only would its presence not have been readily apparent, the water could also only be removed by drilling into the hull (**Figure 12**) or by removing the deck (**Annex E**). The boats' 'elephant's trunks' only drained water from the deck, and the transom drain plug only drained water from the aft space that provided access to the bolts on the engine mounting (**Figure 9**). Without a detailed knowledge of the rescue boat's construction, ships' crews would not have known the limited value of the transom drain plug, which in many smaller GRP craft, such as dinghies, is used to drain the entire hull.

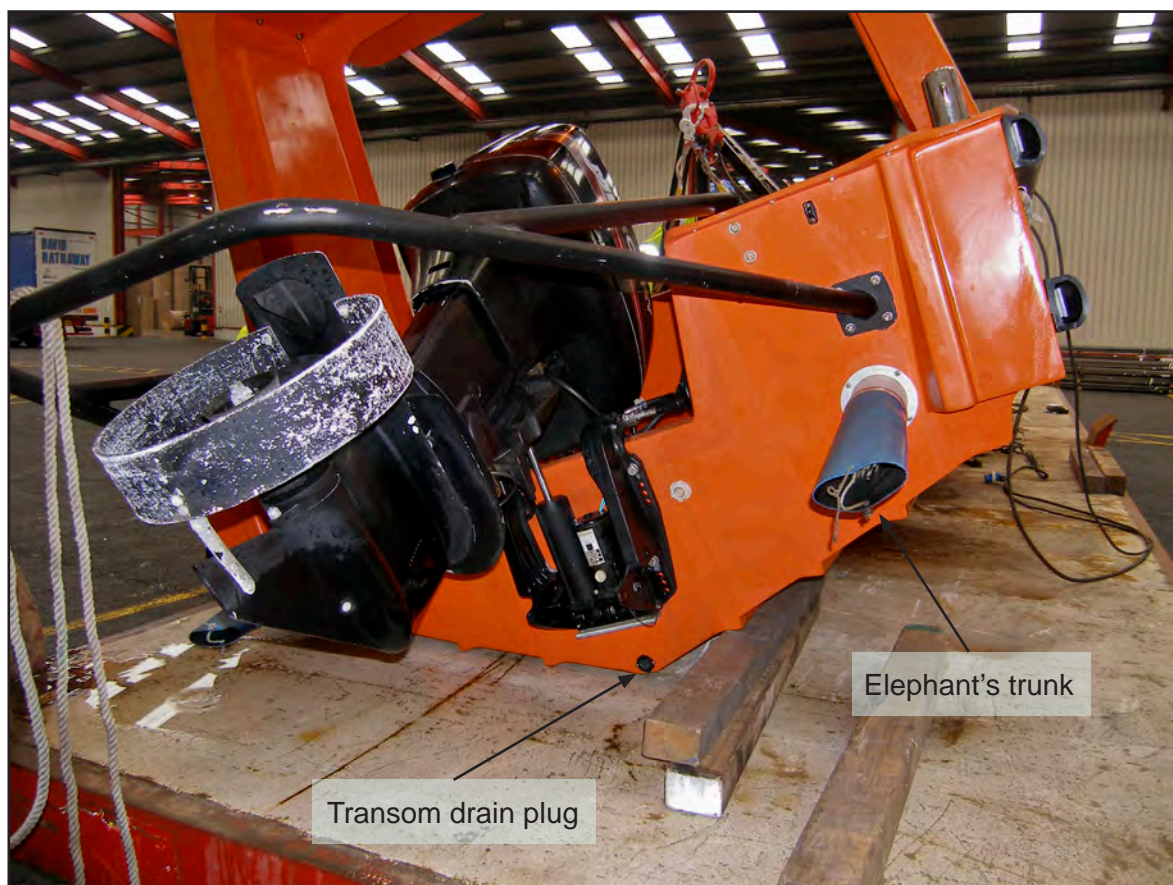
Figure 9: Deck and transom drains

Fifteen of the hull spaces were filled with low density rigid polyurethane (PU) closed cell foam which extended above the stiffeners to the underside of the deck. The remaining hull space was sited on the centreline aft and was left empty to allow access to the engine's mounting bolts. This space could be drained through a screwed plug in the transom (**Figure 9**). The 15 foam-filled spaces were not inter-connected at the lower level, for example by limber holes in the stiffeners, for drainage. Two 'elephant trunks' were fitted on the transom to drain water from the deck (**Figure 9**).

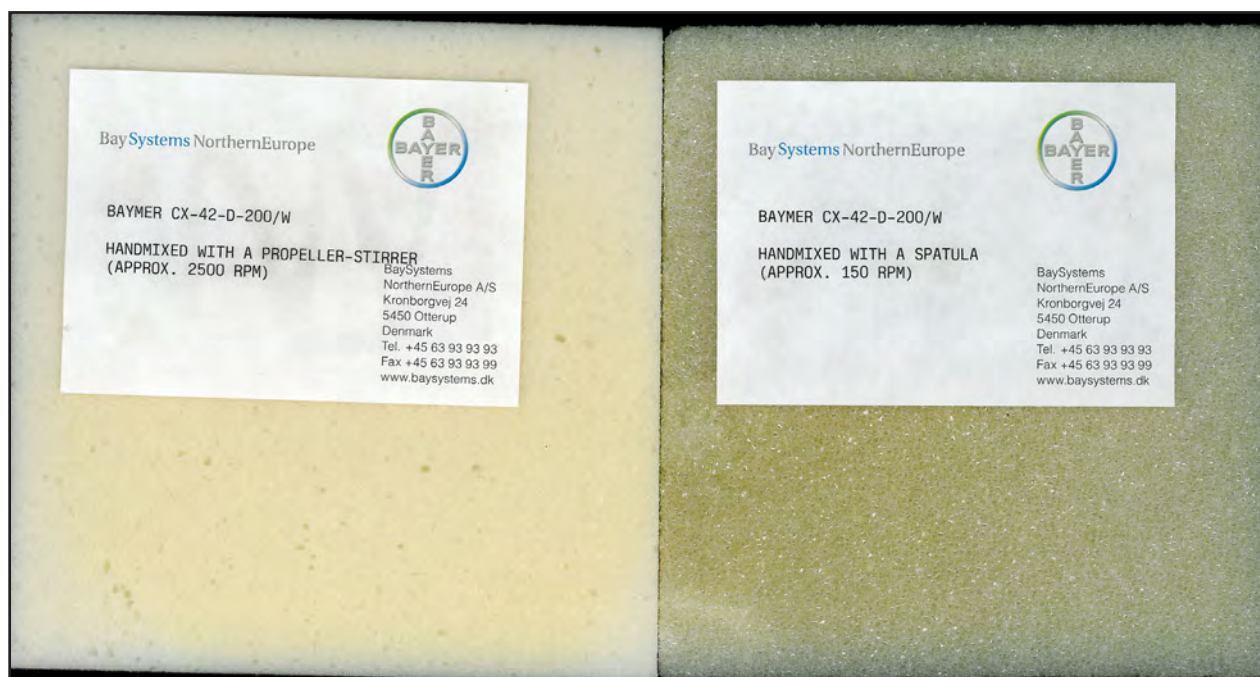
Figure 16: Bayer foam reference samples

Bayer's analysis of the foam from *Tombarra's* rescue boat indicated that the lower layer of the foam, which was darker and more brittle than the upper layer, had been poorly mixed and also possibly contained a higher proportion of Polymeric Methylene Diphenylene Isocyanate (PMDI) than recommended⁴. As a result, the darker foam had a high proportion of open cells, that had allowed water to penetrate the foam. However, the characteristics of the darker foam were considered to result from processing errors rather than from the foam coming into contact with water. In support of its conclusion, Bayer produced two foam samples for reference (**Figures 16 and 17**). Both samples were made using the correct ratio of constituents, but were mixed at different speeds. One sample, which was considered by the manufacturer to be representative of the quality expected, was mixed at a speed of 2500rpm, and the other at 150rpm. The appearance and feel of the sample mixed at the lower speed was similar to the samples removed from the lower hull of the rescue boat, while the samples mixed at the higher speed were similar to the foam found in the upper section of the boat.

- The water from the boat's hull was primarily sea water.
- The darker foam sample from the lower section of *Tombarra's* boat, and the Bayer reference sample mixed at 150rpm, with a spatula, were able to support the least weight.
- The darker foam sample from the boat had a density of 90kg/m³, whereas the reference sample mixed at 2500rpm had a density of 47kg/m³.

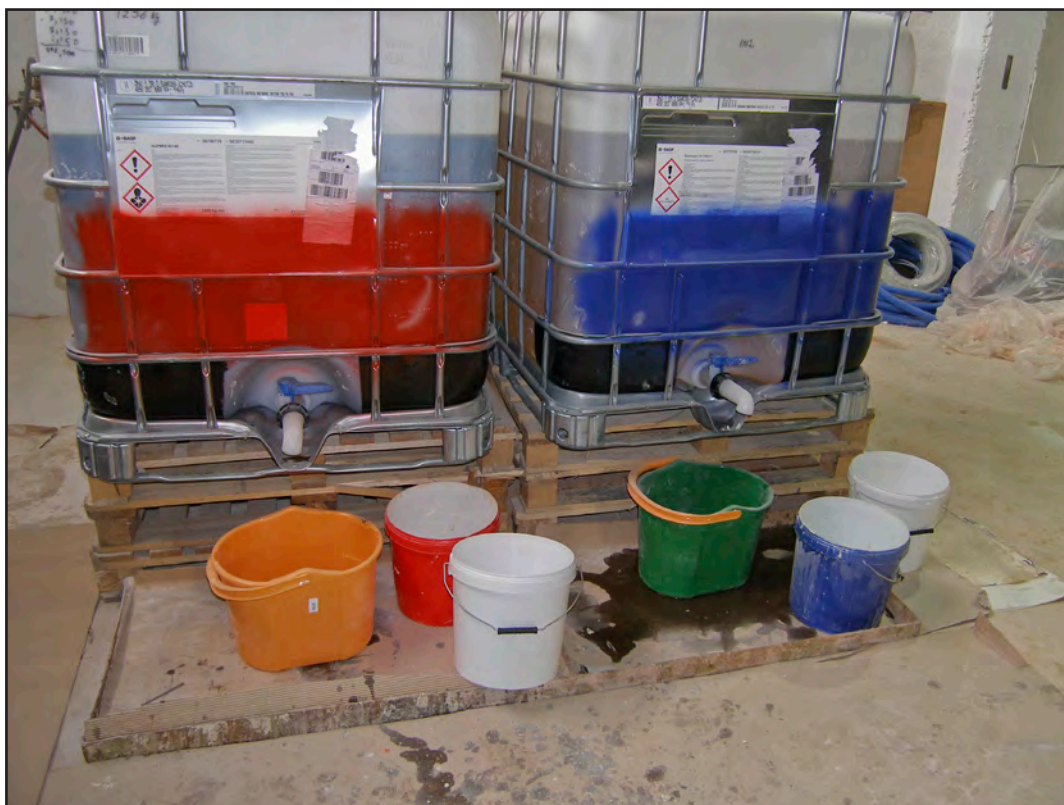
Figure 19: Foam hand-mixing plant

In the WHFRB 6.50 hulls in which Civiol 1642 was used, the boats' 15 buoyancy spaces were filled in two stages. First, the isocyanate and polyol were measured in separate buckets with overflow orifices to ensure the correct quantities of liquid were used (**Figures 19 and 20**). The liquids in the two buckets was poured into a third bucket and hand-mixed for a short period using an electric drill and paint mixing tool (**Figures 21 and 22**). The mixture was then poured into the boat hull buoyancy spaces in two layers, each of between 10cm and 20cm in depth. The foam expanded rapidly to nearly fill the spaces (**Figures 23 and 24**). Once the deck was
