COMMENTARY AND OPINION IN RESPECT OF INSPECTIONS AND TESTS COMPLETED ON A BROKEN FAST RECOVERY CRAFT HOIST ROPE FROM THE CAR CARRIER VESSEL MV TOMBARRA

KPR report

MV Tombarra

Following an incident on the MV Tombarra on Monday 7th Feb 2011 where a winch system continued to operate when it should have activated a limit switch and been electrically disabled, ERA RFA department have been asked to assess the limit switch which appears to have failed to operate correctly.

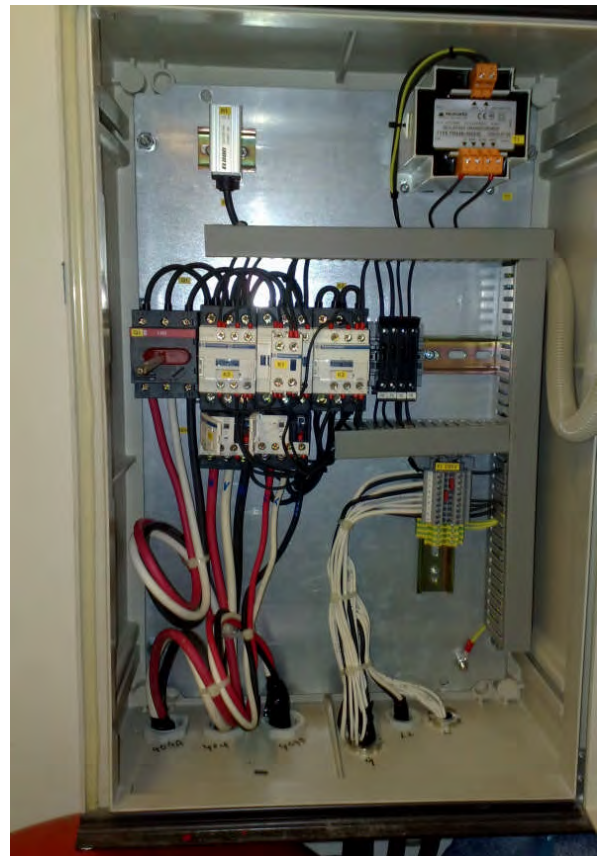
A visual inspection of the control panel was carried out. The cables were followed from point to point, which showed that the control panel was wired to the schematic drawing inside.

The supply to the panel is 440V 3 Phase AC.

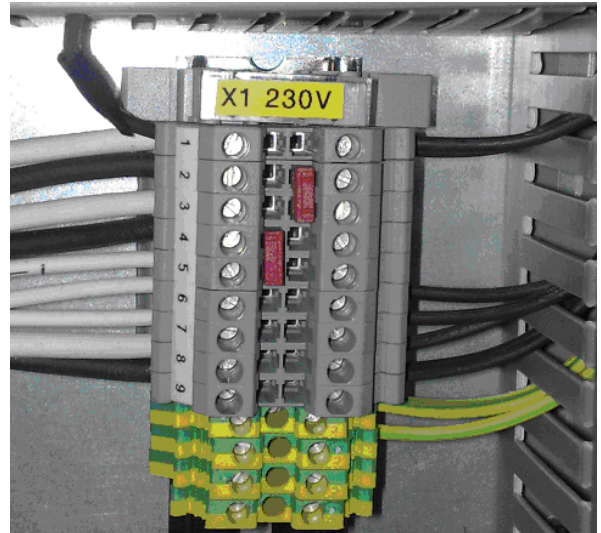
3.3 Outgoing Terminals

The two external proximity sensors are connected between terminals 1 & 2 and 3 & 4.

Jumpers are fitted between the common terminals 2 & 3 and 4 & 5.

The cable seen on the outgoing side of terminal 1 is to do with the heater circuit.

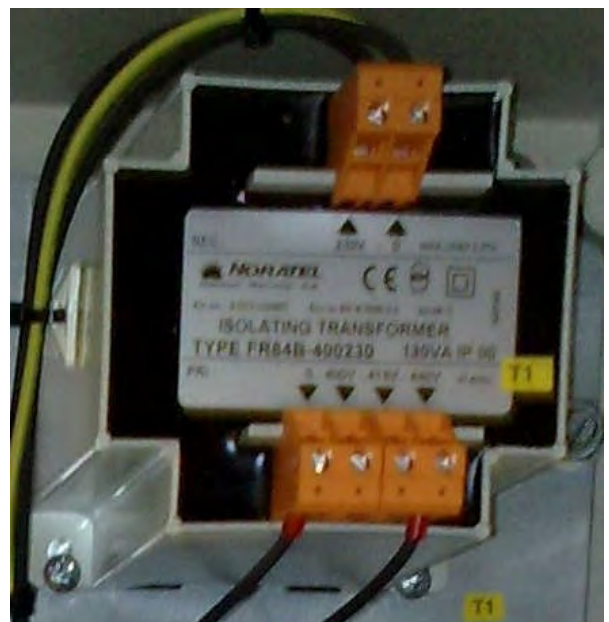
3.4 Control Transformer

The transformer (rated 135VA) is used to provide a control voltage of 230V. The fuses on the primary and secondary side of the transformer were checked and are as follows:

There were no ratings shown for the fuses on the drawing in the panel. The drawing later provided showed the ratings and matched the fuses fitted.

The 0V leg of the transformer was earthed to the back plate of the control panel. The back plate of the control panel was not earthed to the ship.

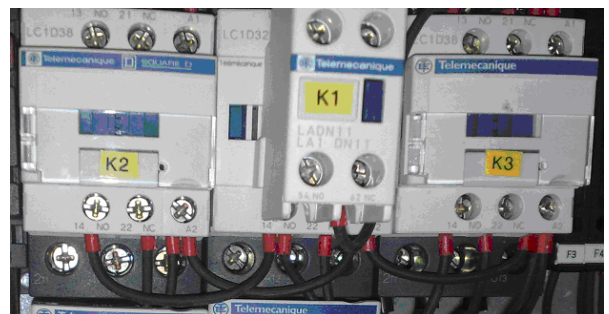
3.5 Motor Contactors

The winch motor is a two-speed motor requiring three contactors for correct operation. I don't have details of the winch motor but it appears to be a pole amplitude type arrangement where the low speed arrangement is star or delta connected and the high-speed arrangement is double star connected.

Contactors K1 is used for low speed; contactors K2 and K3 are used for the high speed. Interlocks are used to prevent simultaneous operation of K1 and K3.

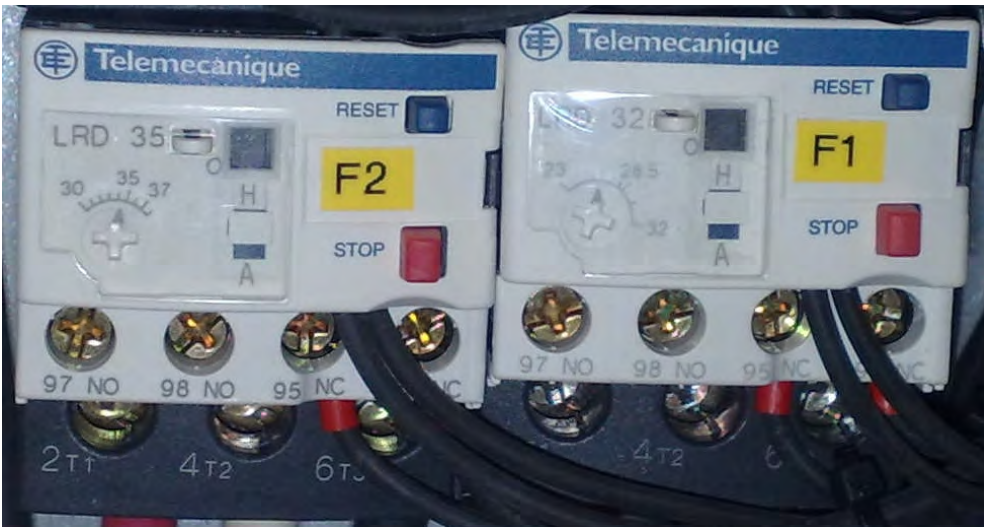
3.6 Overloads

The overloads are set to manual reset mode. When an overload occurs the blue reset button needs to be pressed to clear the overload. To set these overloads to auto reset the plastic tab (between the letters H and A on the photo) needs to be broken off and the switch below moved to the A position.

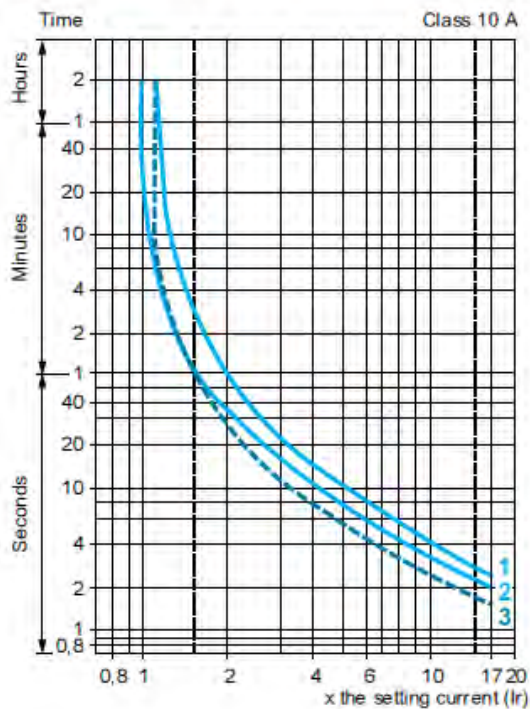
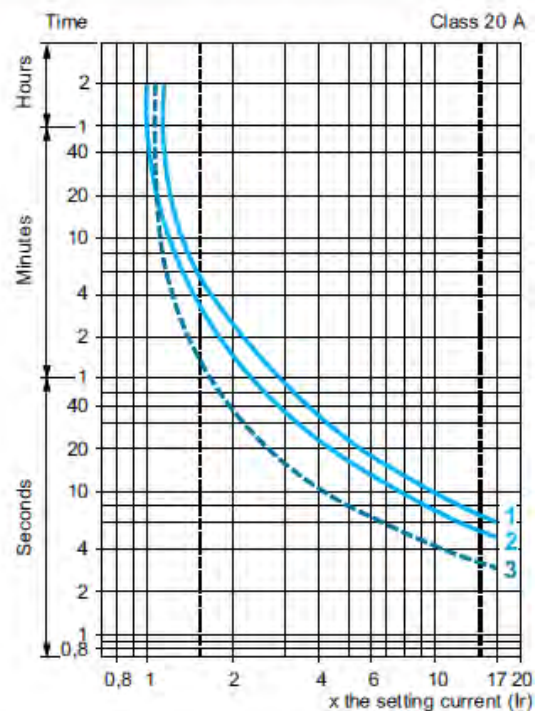
Tripping curves

Without details of the load that would have been put on the motor from the winch I cannot say if or when the overload would of tripped. However as can be seen from the tripping curves above, the following load currents are required to trip the overloads in the specified times.

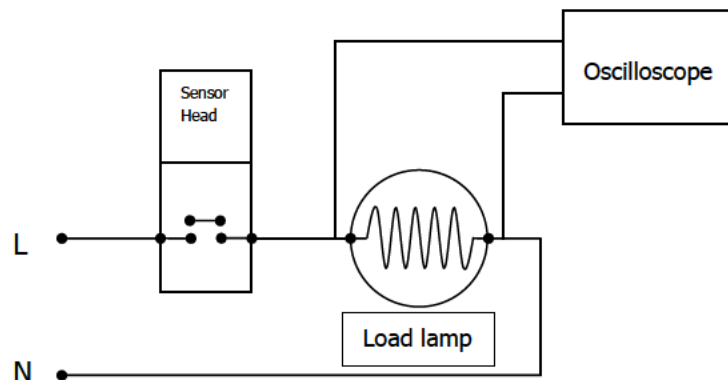
The scope trace showed that the failure was indeed a half wave failure: i.e. the negative part of the mains failed to switch off. See Figure 1. This test took place with the failed switch unit mounted into the 'socket' of the new unit. The 'socket' of the failed unit was thereby positively eliminated from suspicion.

**Figure 1: Failed Limit switch with load lamp connected along with monitor oscilloscope:
above: metal mass away from switch – power full on
below: metal mass close to switch – negative voltage fails to switch off.**

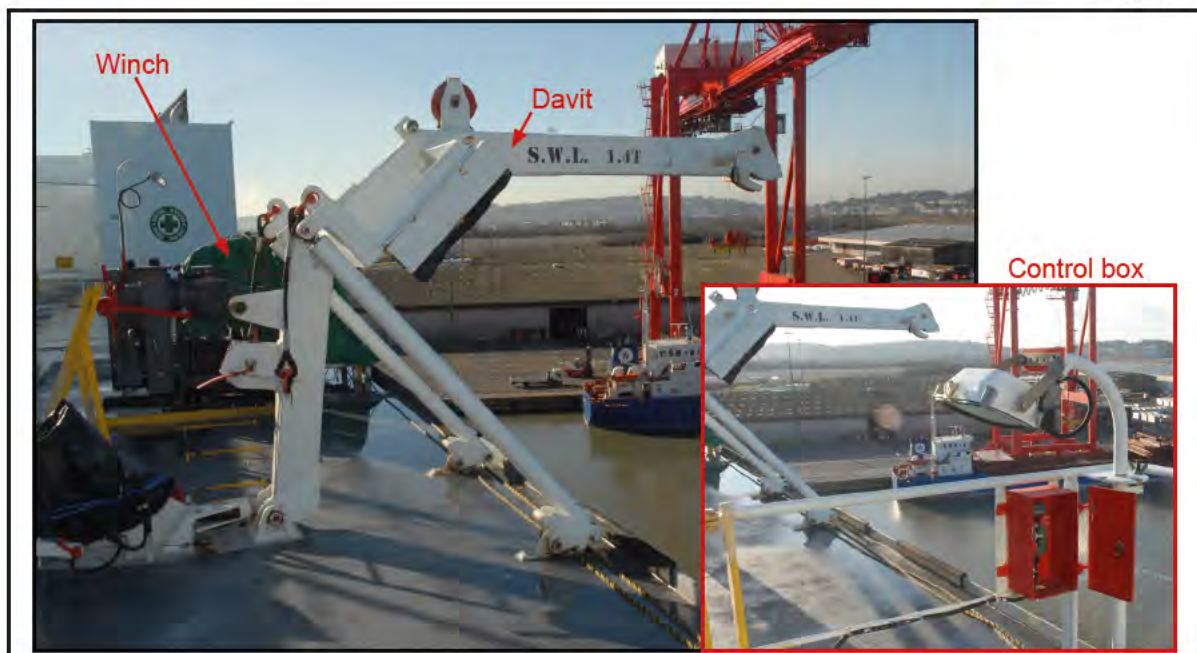
Figure 2

The 12mm diameter fall wire had a certified minimum breaking load of 141kN. Its safe working load (SWL) was 23.5kN based on a factor of safety of six. The wire was fitted to a single-arm davit (SA 1.5) (**Figure 2**), manufactured by Umoe Schat-Harding Equipment AS (Schat-Harding). The davit system was powered by a Schat-Harding W50 two-speed electric winch with a nominal pull of 50kN.

Davit system
