Report on the investigation of
the collision between

Two Cardiff Bay Yacht Club RIBs

resulting in injuries to three students

27 October 2010

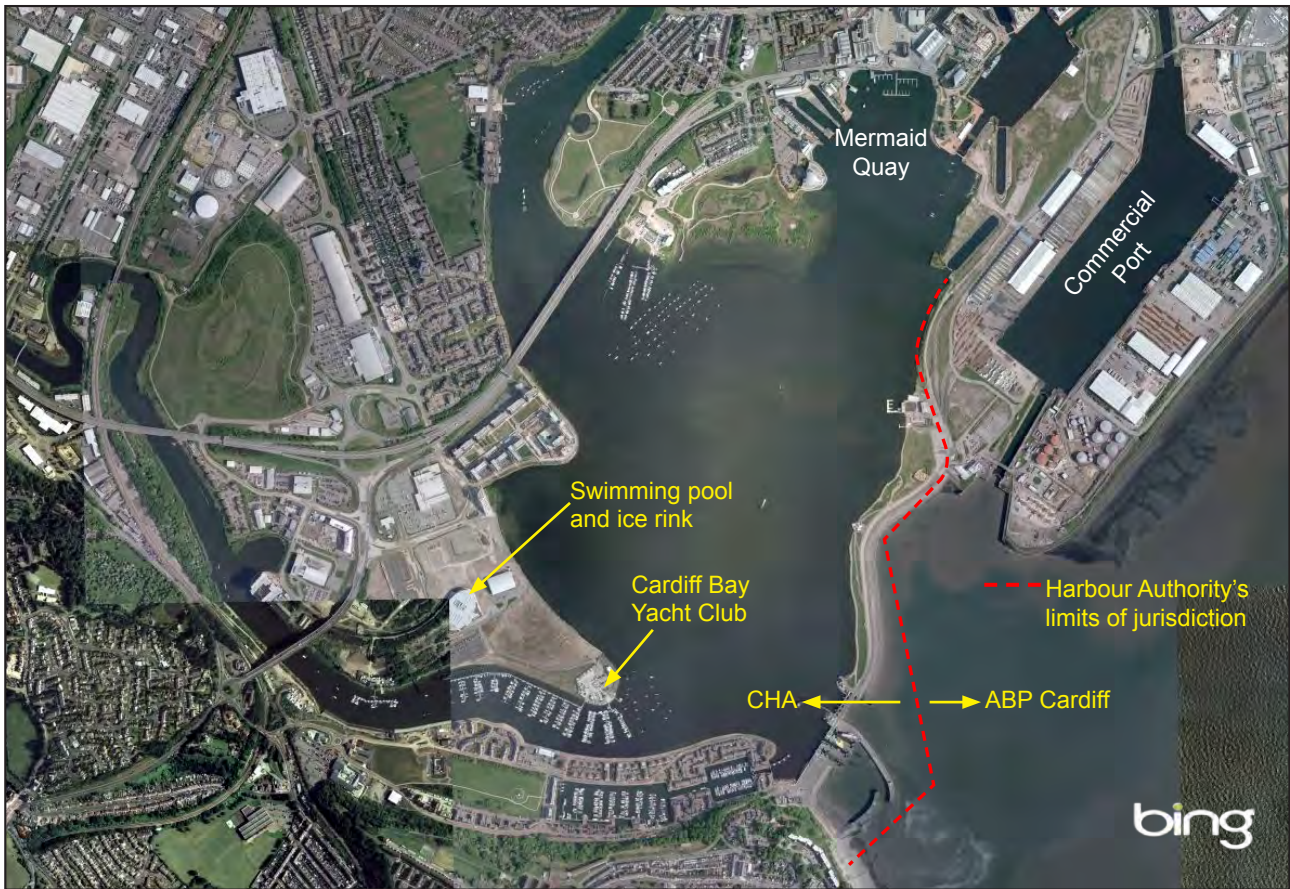
Figure 7

The Cardiff Harbour Authority was formed in 2000 under powers conferred by the Cardiff Bay Barrage Act 1993. CHA is the statutory harbour authority for the waters of Cardiff Bay inside a line drawn close to seaward of the barrage (**Figure 7**).

Cardiff Bay showing the Cardiff Harbour Authority's area of jurisdiction
