MV ANTONIS

Contact with Langton-Alexandra swing bridge In the Port of Liverpool 11 December 2010

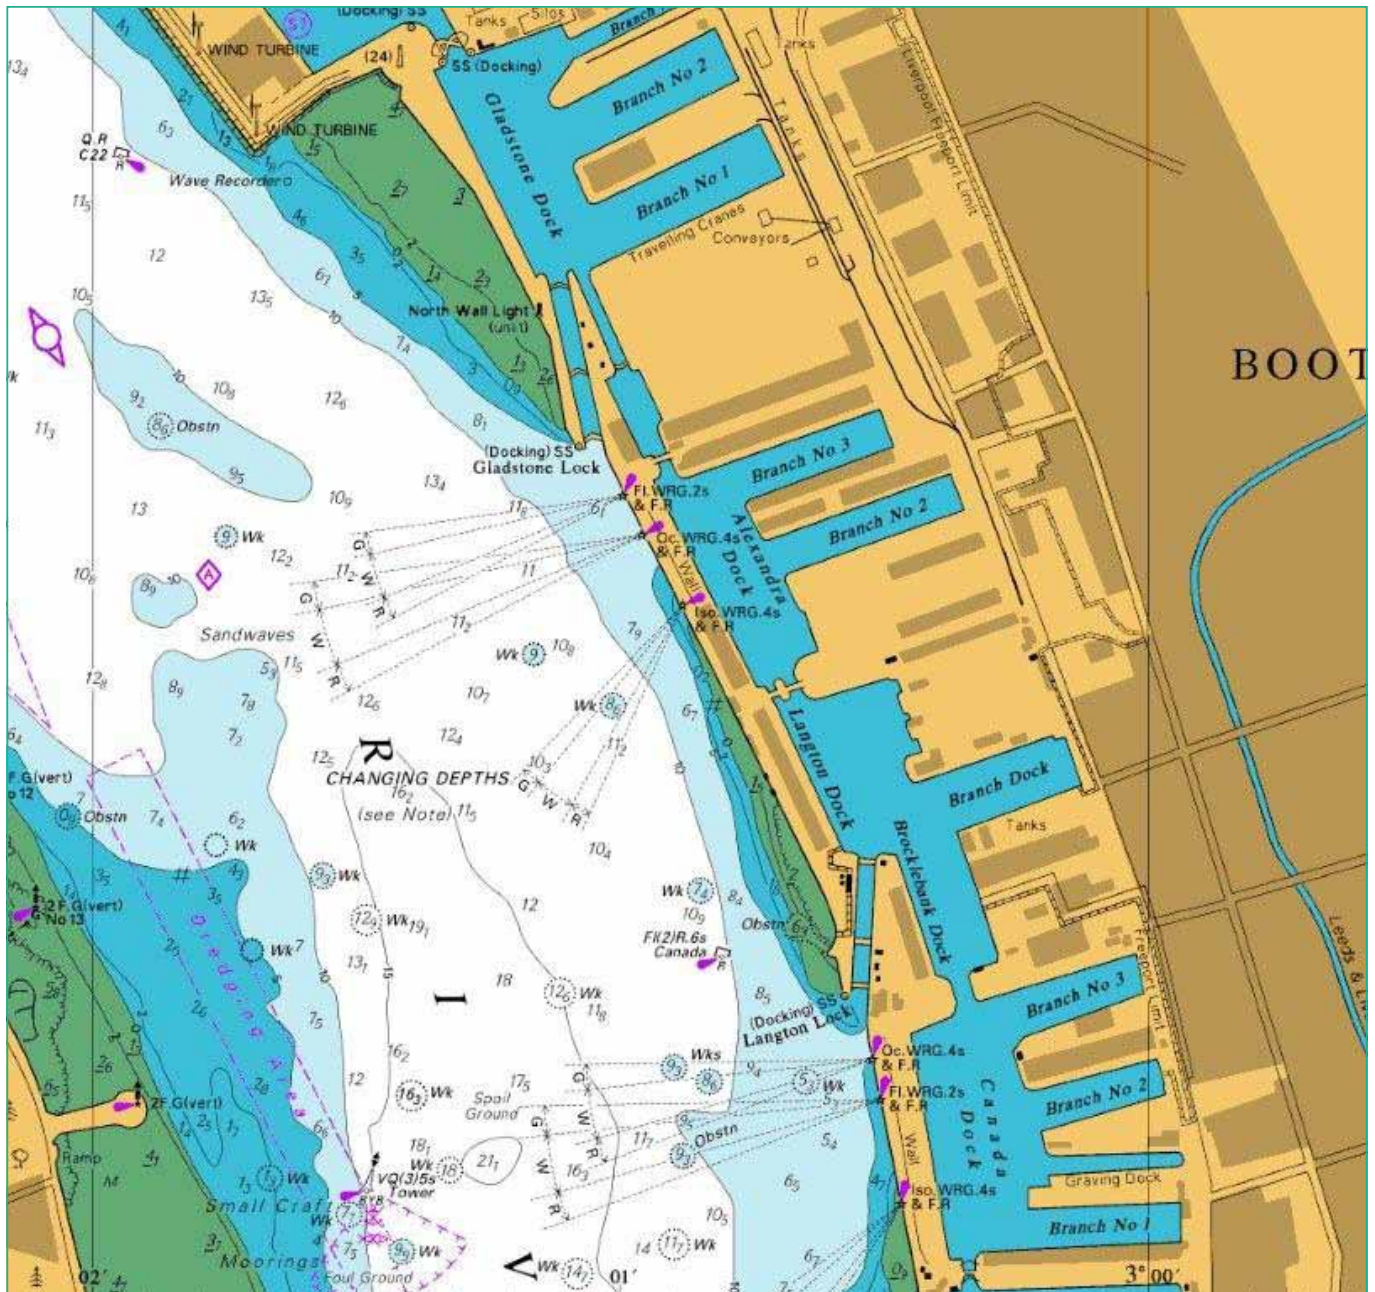
Figure 1

Antonis embarked a pilot at the Liverpool Bar at 0120 (UTC) on 11 December 2010. She was in ballast and bound for Alexandra Dock (**Figure 1**), where she was to load a cargo of iron scrap destined for Thailand. The bridge was manned by the master, second officer, helmsman and a pilot, who had conduct of the vessel.

At about 0230, the deck crew were tasked to go to their mooring stations. By 0256, two tugs, one forward and one aft, were made fast just before the vessel arrived off Langton Lock (**Figure 1**). A third tug was also available.
