Report on the investigation of
the catastrophic failure of a capacitor
in the aft harmonic filter room on board
RMS Queen Mary 2
while approaching Barcelona
23 September 2010

At 0425 on 23 September 2010, as *RMS Queen Mary 2 (QM2)* was approaching Barcelona, an explosion occurred in the vessel's aft main switchboard room. Within a few seconds, all four propulsion motors shut down, and the vessel blacked out shortly afterwards. Fortunately, the vessel was clear of navigational hazards and drifted in open sea.

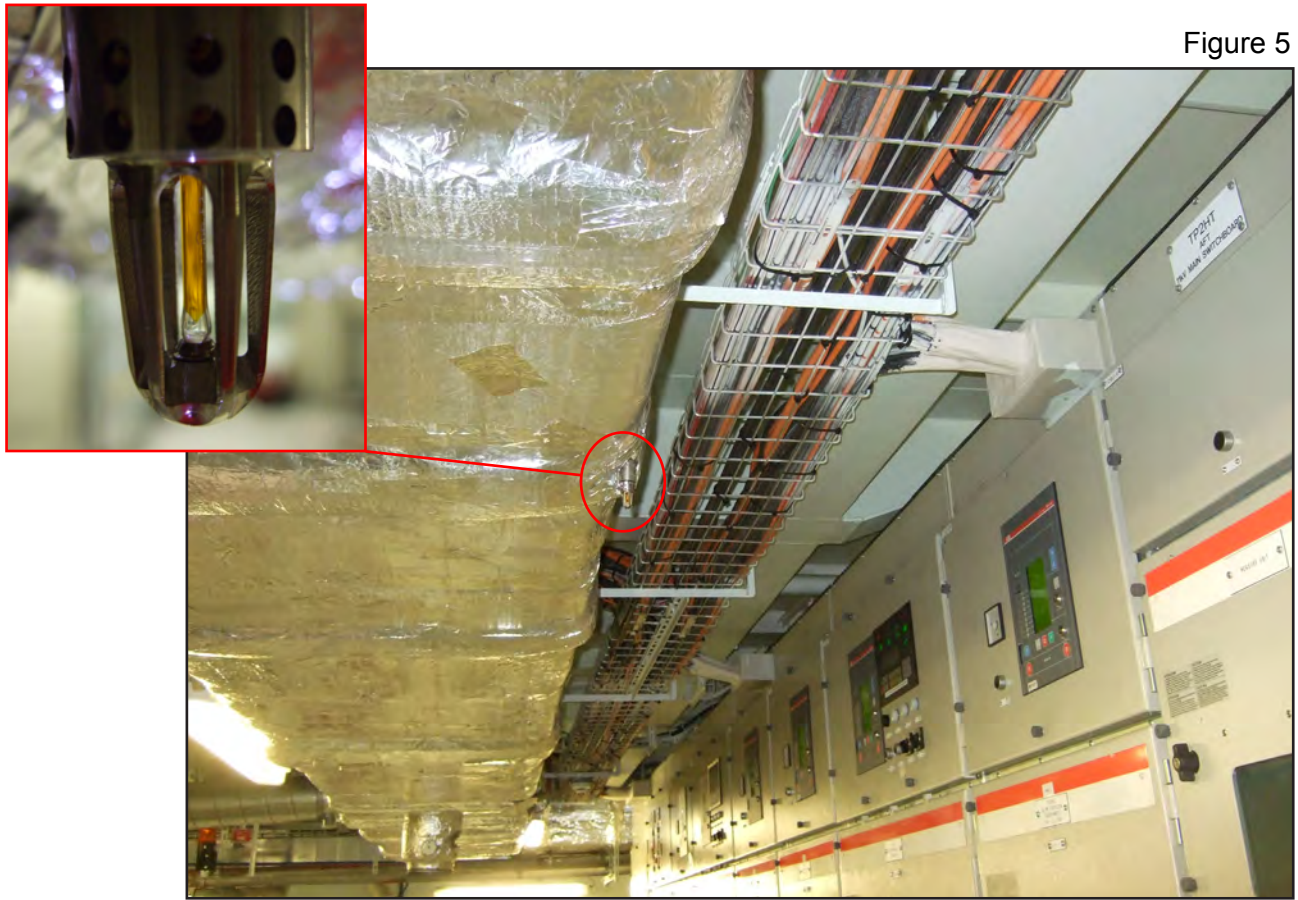
Figure 5

By 0439, the second electro-technical officer and a third engineer, both wearing breathing apparatus and carrying carbon dioxide portable fire extinguishers and a thermal imaging camera, were ready to carry out an inspection of the scene. They entered the aft MSB room and made their way into the HF room, stopping just after entering the doorway (**Figure 4**). They confirmed that the space was filled with thick black smoke; but there was no fire and, using their thermal imaging cameras, they did not detect any hot spots. Two *Hi-Fog* glass bulbs (**Figure 5**), one in the aft HF room and another in the aft MSB room had ruptured and there was approximately 10mm of water on the decks of both compartments (**Figure 6**).

Hi-fog glass bulb in the aft main switchboard room

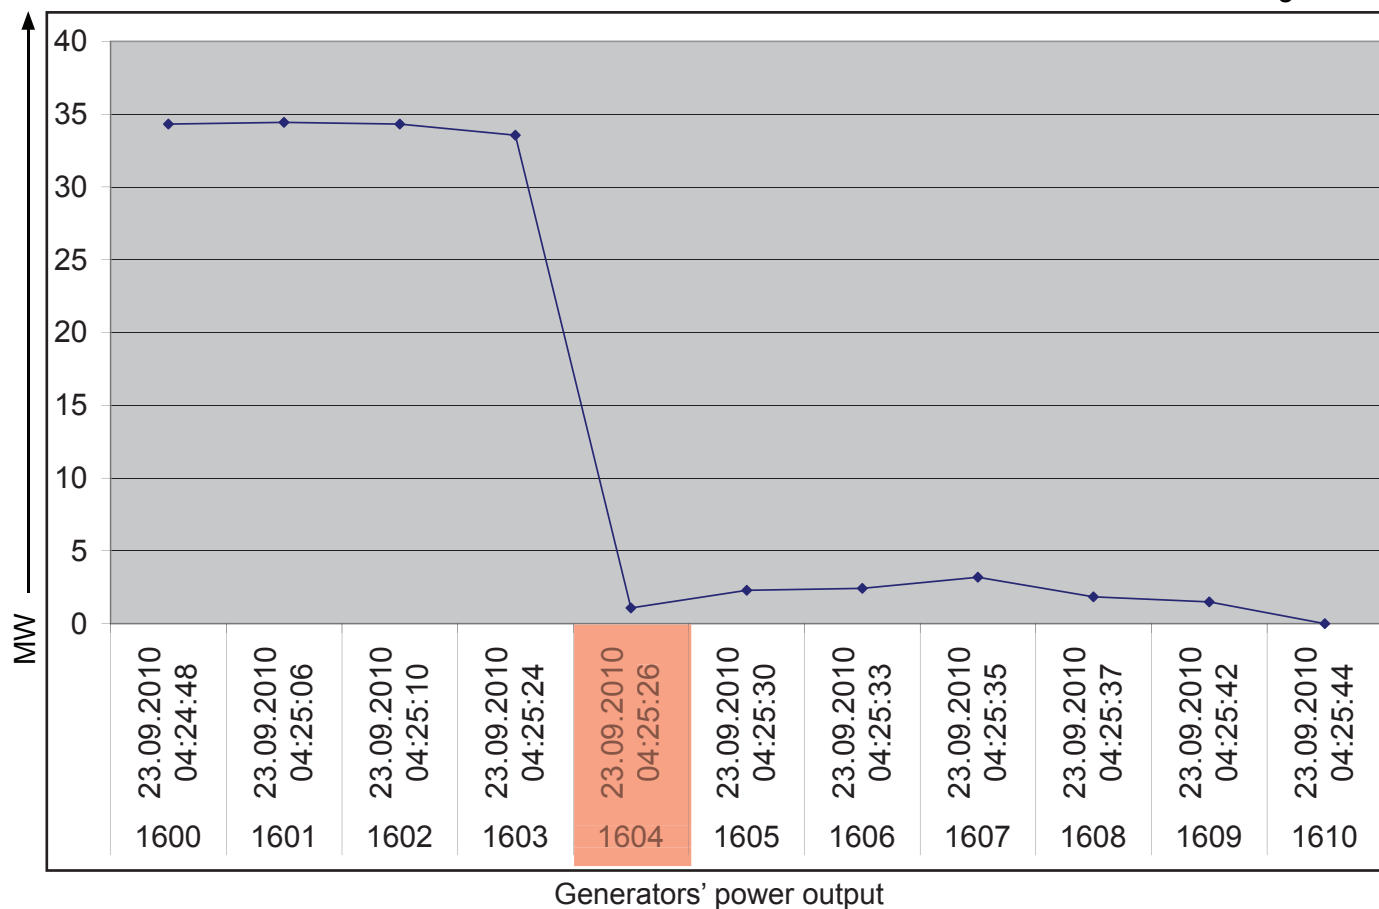
Figure 11a

Immediately after the HF circuit breaker tripped at around 0425, alarms activated indicating problems with all of the propulsion motor converters and excitation systems. The propulsion system P1200 alarm log indicated that all the four propulsion motors registered undervoltage alarms immediately after the HF breaker tripped. However, these were very short term and the actual voltage levels were not recorded by the P1200 system or transferred to the IAS. The motors themselves continued to run under reduced power for approximately 16 seconds after the undervoltage alarms until the generators themselves shut down (**Figures 11a and 11b**). An annotated record of alarms from the IAS and from the P1200 system for propulsion is available at **Annex A**.

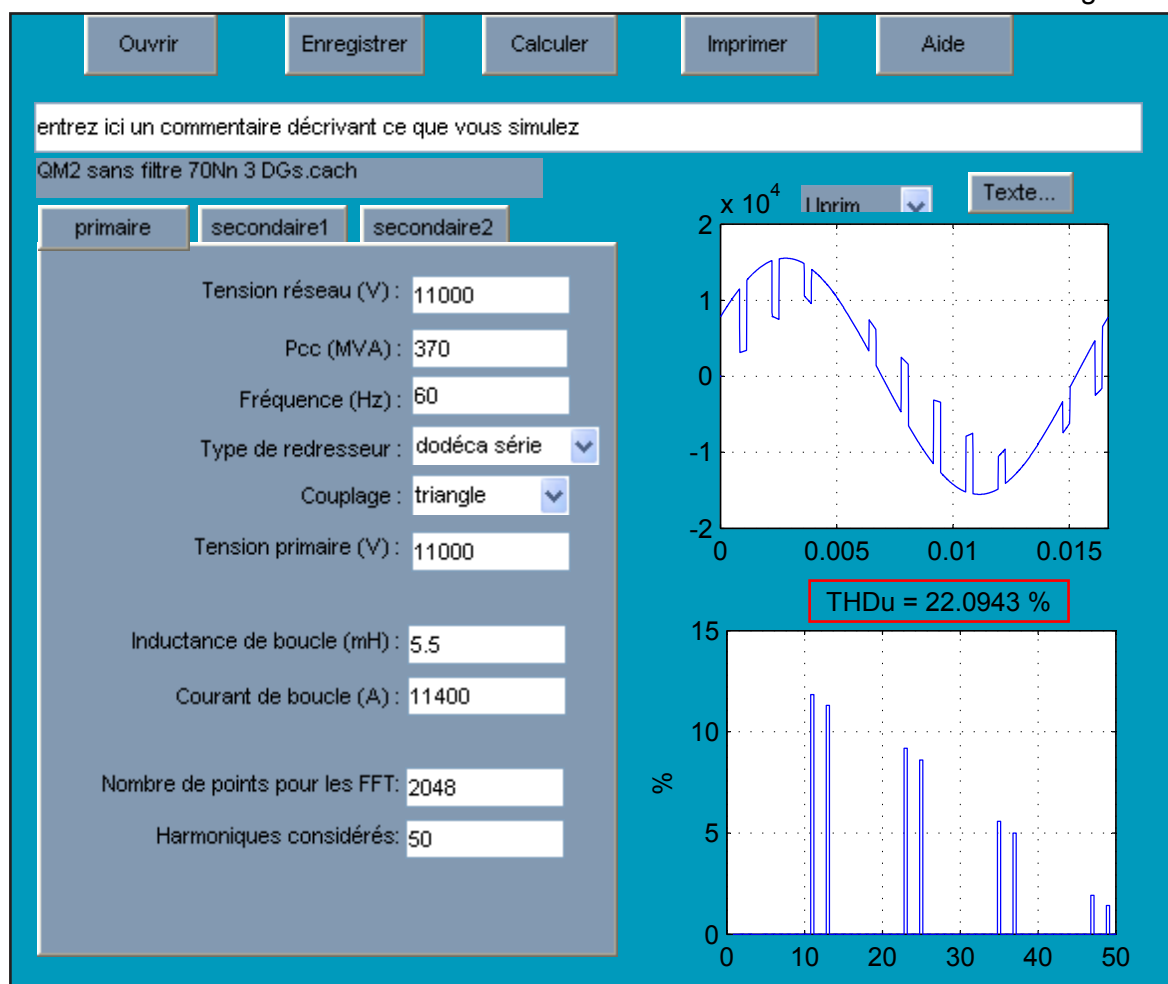
Figure 13

A month after the accident, Converteam carried out a simulated study on harmonic distortion levels expected without any HF in use. By extrapolating the graph for the case with no filters in use, the THDv was predicted to exceed 22% at 70% speed. This estimation was subsequently confirmed by Converteam when they calculated the amount of THDv in this configuration (**Figures 12a, 12b** and **Figure 13**). In its conclusion, the Converteam study stated:

Simulation of expected total harmonic distortion of voltage with three diesel generators and at 70% propulsion power output

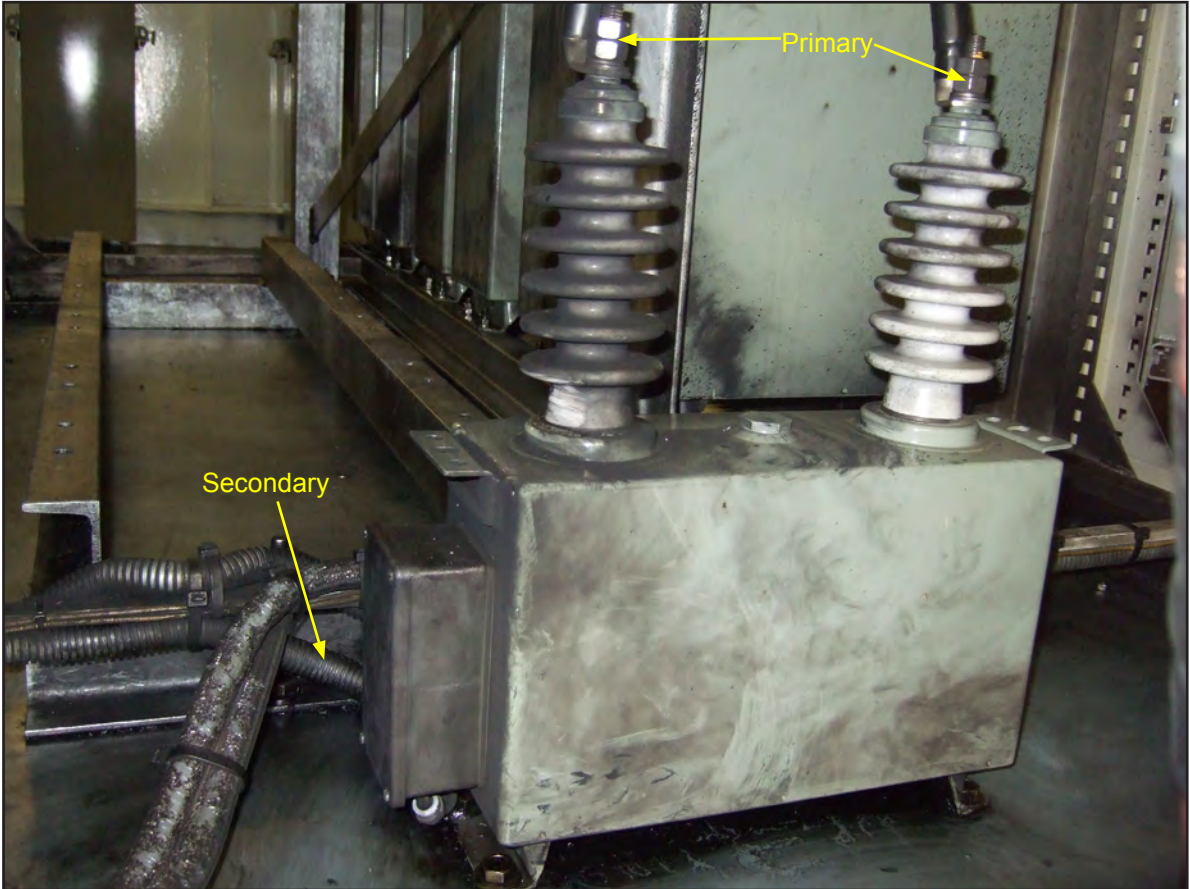
Figure 20

The two neutral points at the double star termination of the capacitor circuit were connected to the primary coil of a current transformer (**Figure 20**) which had a current ratio 10:1 (50A at the primary winding and 5A at the secondary winding) and was part of the monitoring and protection system '*EstaSym 3C*' supplied by Vishay Electronics GmbH, Germany. There were no records available to verify the transformer's service history.

Current transformer for the imbalance detection system

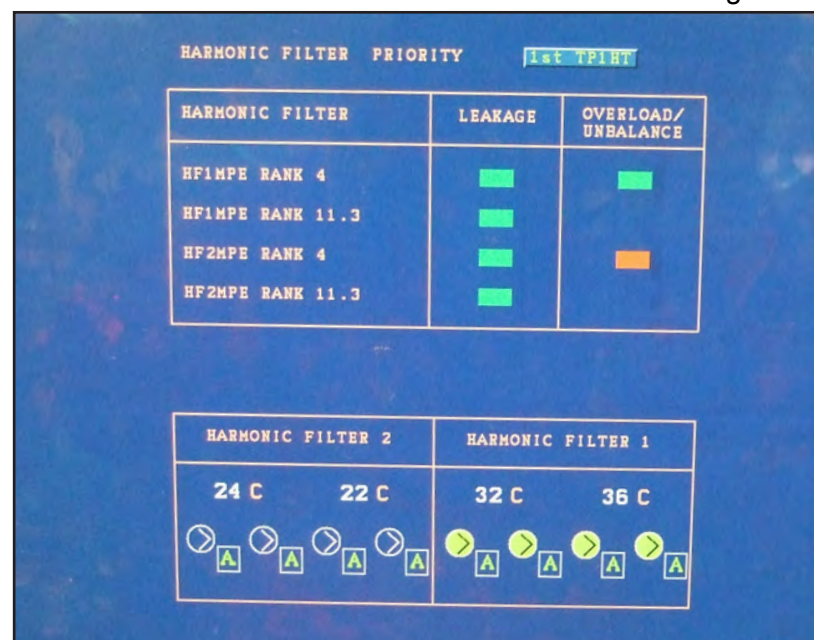
Figure 23

When the IAS received an imbalance or overload alarm from an HF, the duty engineer could interrogate the graphical user interface (GUI) in the ECR, which indicated the rank of the HF which was in alarm (**Figure 23**). The GUI display for both the overload and the imbalance alarm was combined, and read 'OVERLOAD/ UNBALANCE'. If the circuit breaker to the HF was tripped, it would be indicated as an additional alarm in the IAS, as an electrical fault on the breaker. There were no records of the imbalance alarms or trips being tested either at commissioning, or at any other point in the life of the vessel.

Engine control room display of harmonic filter operating parameters
