Extracts from Hawkins & Associates Ltd's report on Ignition of Hydraulic Oils by Hot Surfaces –  
C69/45210 dated 10 November 2010

MAIB Safety Flyer

### **YEOMAN BONTRUP: RADIATION HAZARD IDENTIFIED FOLLOWING A FIRE**

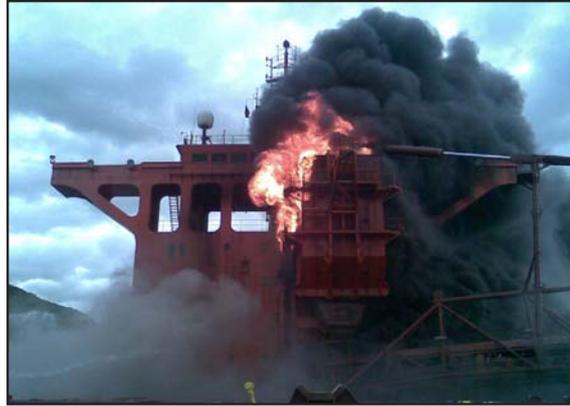
On 2 July 2010, a fire was discovered on the vertical cargo conveyor belt of the self-unloading bulk carrier *Yeoman Bontrup* while the cargo hopper was being repaired. The crew tackled the fire from the conveyor tunnels under the holds, but it quickly spread throughout the cargo handling area and into the accommodation. The fire also spread into the engine room by heat transfer through the bulkheads and via an open connecting door, and then to the steering gear compartment which contained a number of hydraulic systems as well as stocks of oils, greases, and ship's-use chemicals. There, the fire caused a large explosion that blasted the entire poop deck into the air and onto the funnel deck (**Figures 1 & 2**). Fortunately, there were only minor smoke inhalation and bruising injuries.

The fire was most likely caused by hotwork repair debris falling from the cargo hopper at the top of the tower into the flammable side curtain of the vertical conveyor belt.
