Extracts from Hawkins & Associates Ltd's report on Ignition of Hydraulic Oils by Hot Surfaces –
C69/45210 dated 10 November 2010

YEOMAN BONTRUP: RADIATION HAZARD IDENTIFIED FOLLOWING A FIRE

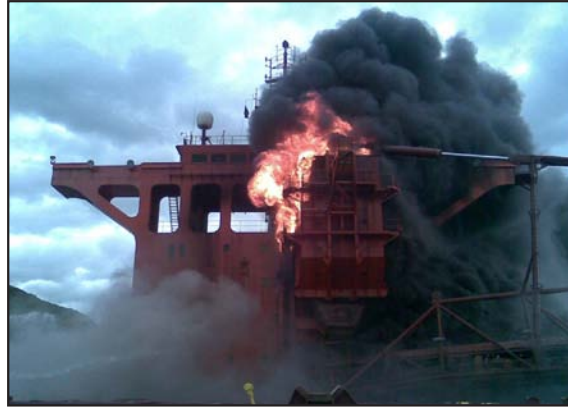
On 2 July 2010, a fire was discovered on the vertical cargo conveyor belt of the self-unloading bulk carrier *Yeoman Bontrup* while the cargo hopper was being repaired. The crew tackled the fire from the conveyor tunnels under the holds, but it quickly spread throughout the cargo handling area and into the accommodation. The fire also spread into the engine room by heat transfer through the bulkheads and via an open connecting door, and then to the steering gear compartment which contained a number of hydraulic systems as well as stocks of oils, greases, and ship's-use chemicals. There, the fire caused a large explosion that blasted the entire poop deck into the air and onto the funnel deck (**Figures 1 & 2**). Fortunately, there were only minor smoke inhalation and bruising injuries.

The fire was most likely caused by hotwork repair debris falling from the cargo hopper at the top of the tower into the flammable side curtain of the vertical conveyor belt.
