Report on the investigation of
the fire and explosion on board

Yeoman Bontrup

Glensanda Quarry, Loch Linnhe, Western Scotland

Report No 5/2011
May 2011

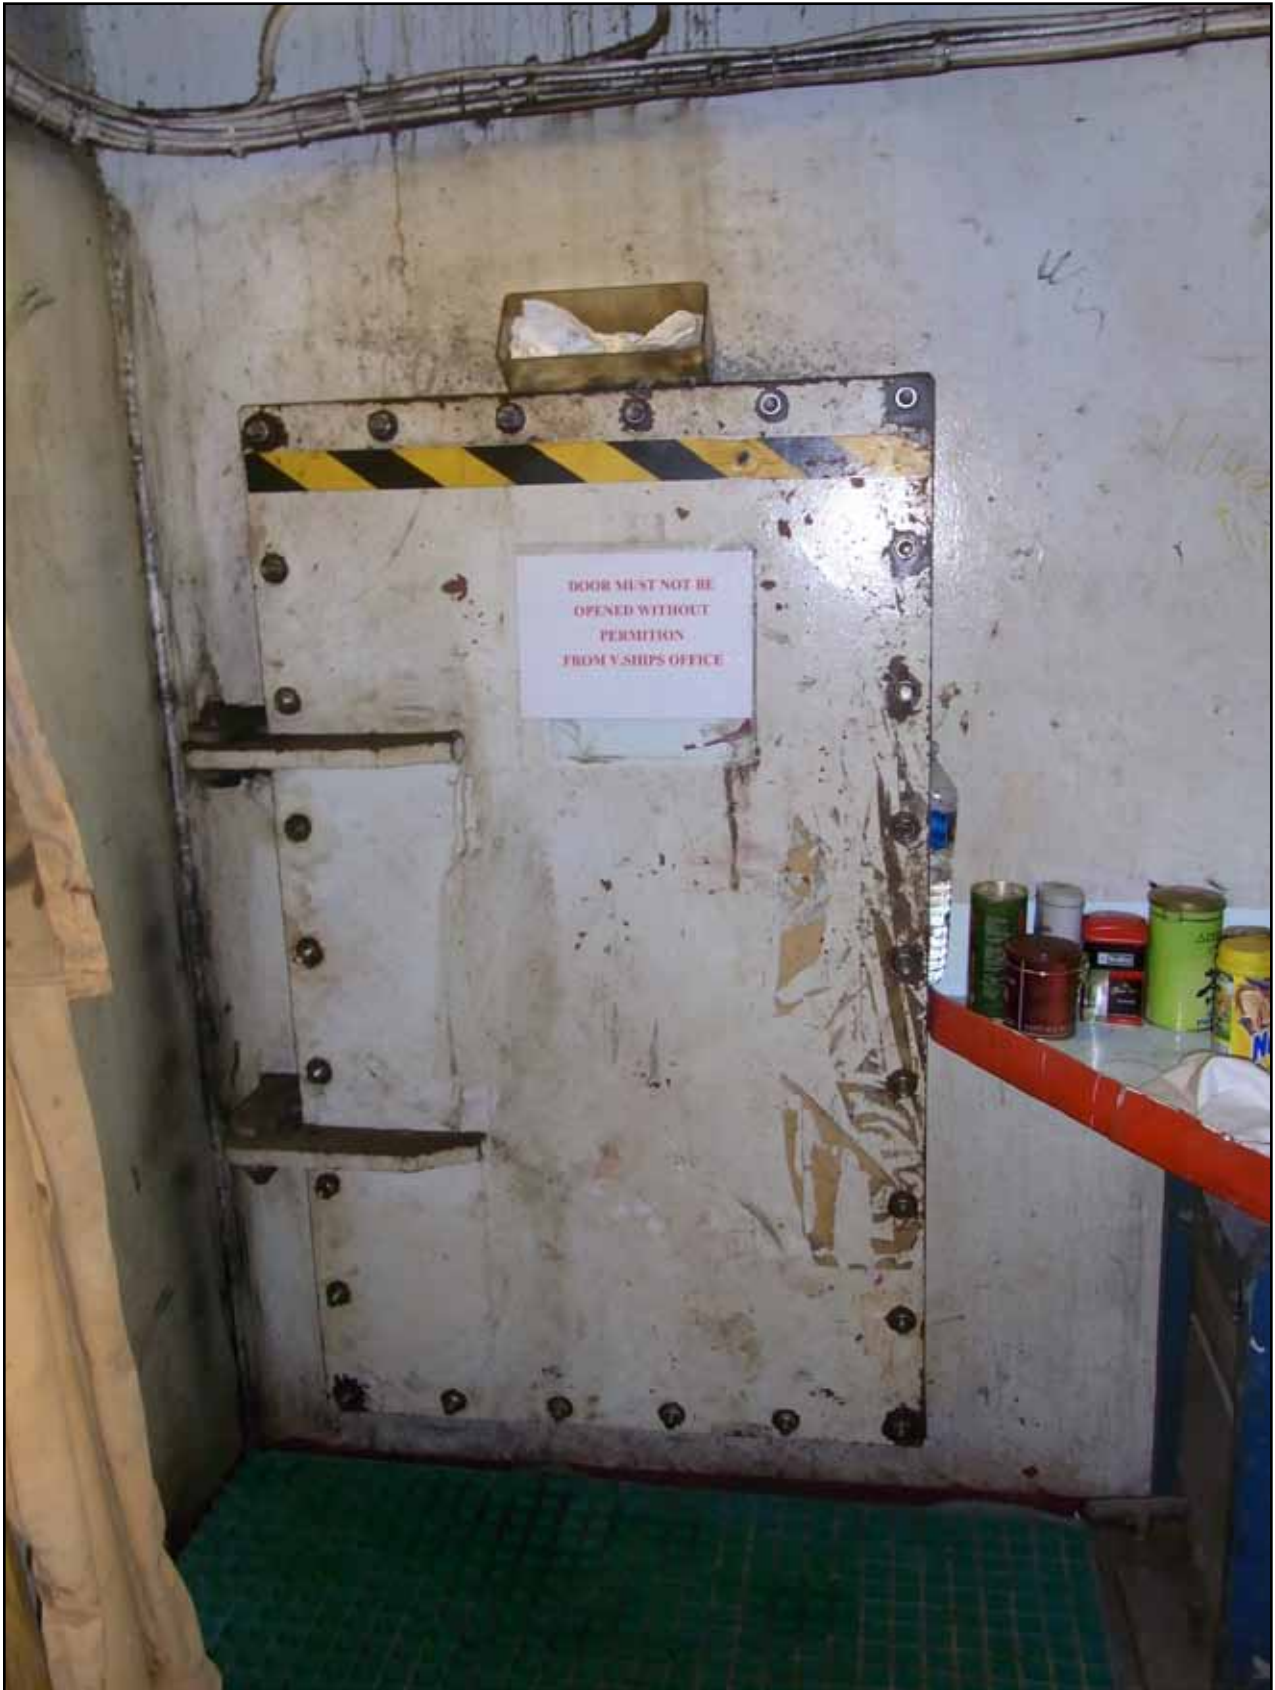
Figure 4

Yeoman Bontrup arrived at Glensanda Quarry at 2135 on 1 July. Soon afterwards the bolted, hinged door¹ in the engine room workshop's forward bulkhead was opened into the SUS hydraulic pump space (**Figure 4**). This was normal practice in harbour and provided easy access between the tower and hold tunnels, and the workshop.

Door between the engine room workshop and the SUS hydraulic pump space

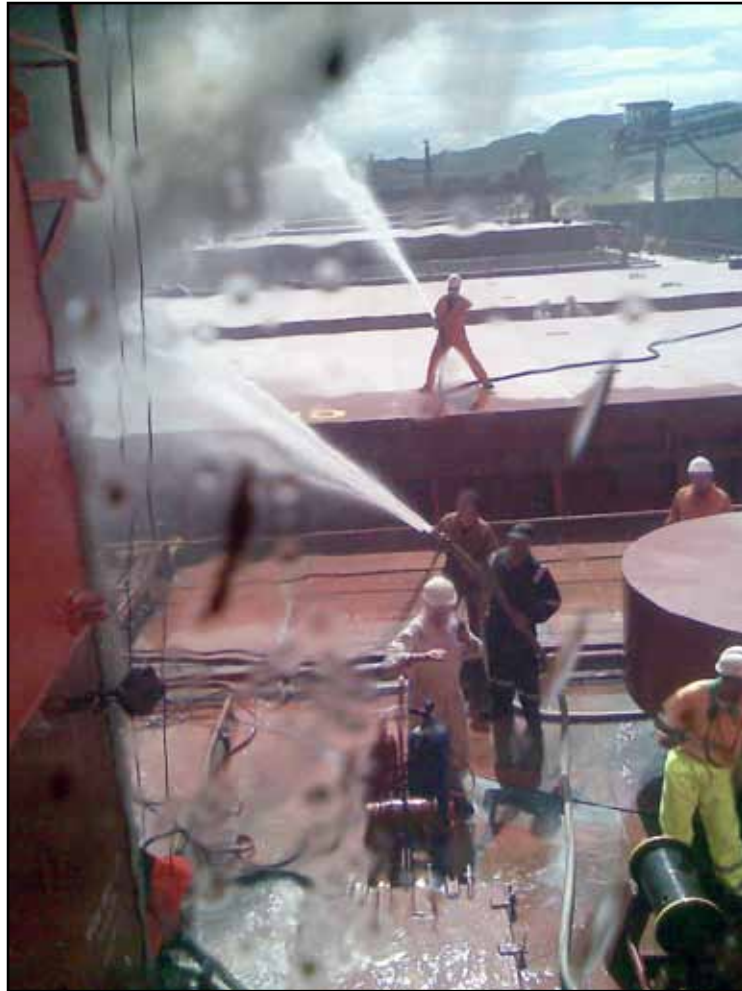
Figure 7

On the upper deck, the cargo engineer was relieved by a crew member who continued to direct the fire hose into the tower. Immediately afterwards, at 1524, a number of additional hoses were directed at the tower (**Figure 7**). The cargo engineer activated the tower wash-down sprays from inside the SUS hydraulic pump space in an attempt to help douse the fire. He then went to the base of the tower, where he rigged a fire-fighting hose and directed it at the fire.

Fire-fighting on the tower

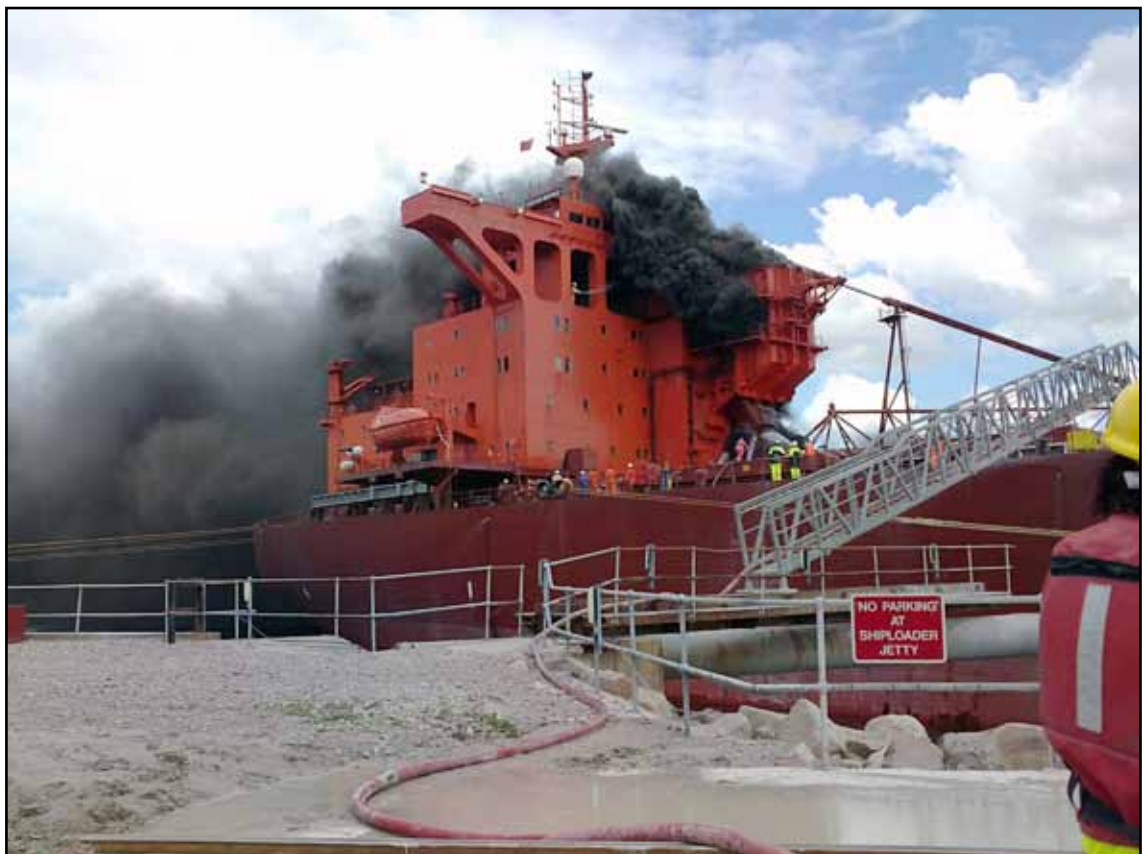
Figure 8

At 1533, the Glensanda Quarry fire team arrived with its tender under the direction of the Primary Production Operations (PPO) manager, who was also the senior site manager. The team connected its fire hoses to the shore-side hydrants and supported the boundary cooling effort around the tower (**Figure 8**).

Additional fire support from Glensanda Quarry's fire team

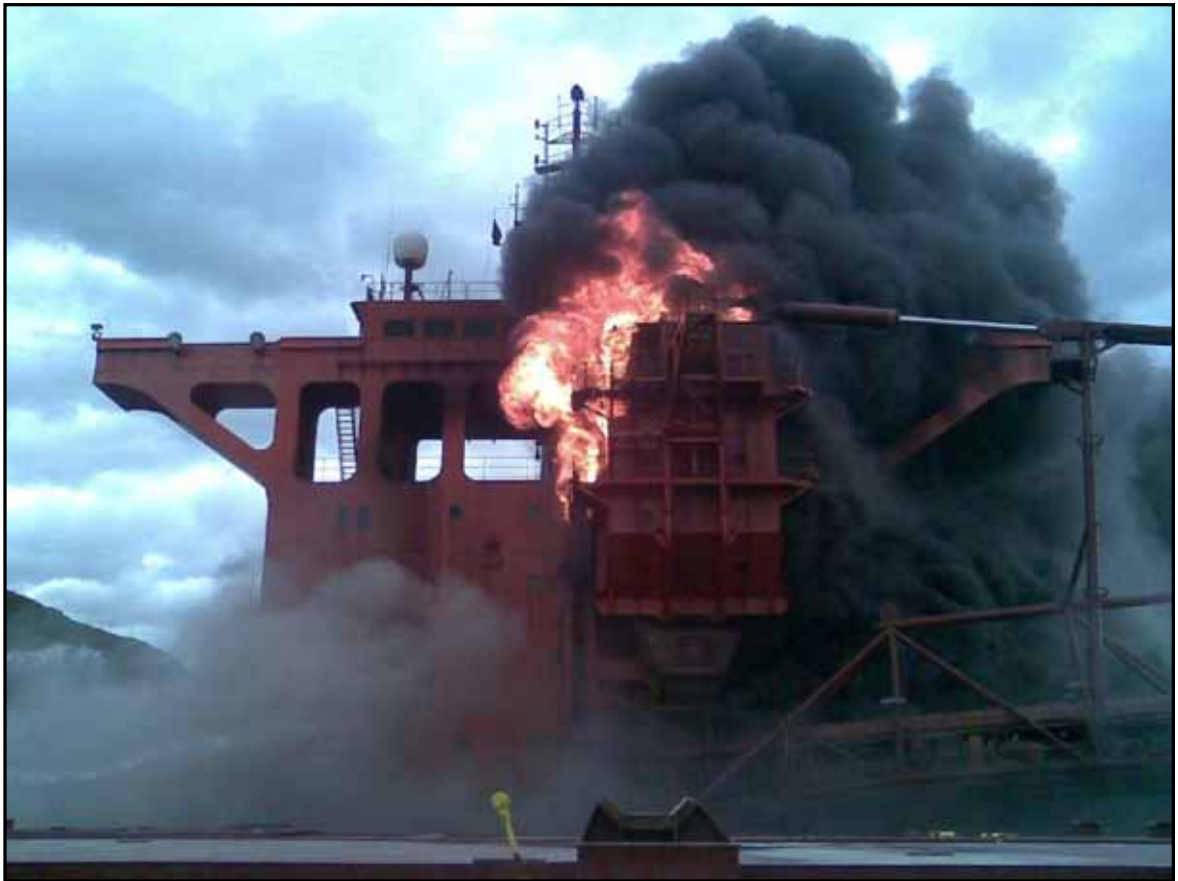
Figure 9

At 1700, a doctor arrived by the personnel boat with the first of the HIFRS firefighters. The fire team immediately set up its ground monitor fire hoses to continue the boundary cooling effort. At approximately 1715, a large fireball erupted from the top of the tower (**Figure 9**) and, about 10 minutes later, the gangway fell from the ship as the after mooring lines parted. The fire continued to develop and, by 1800, it had spread to the boom conveyor (**Figure 10**).

Fireball erupting from the SUS tower

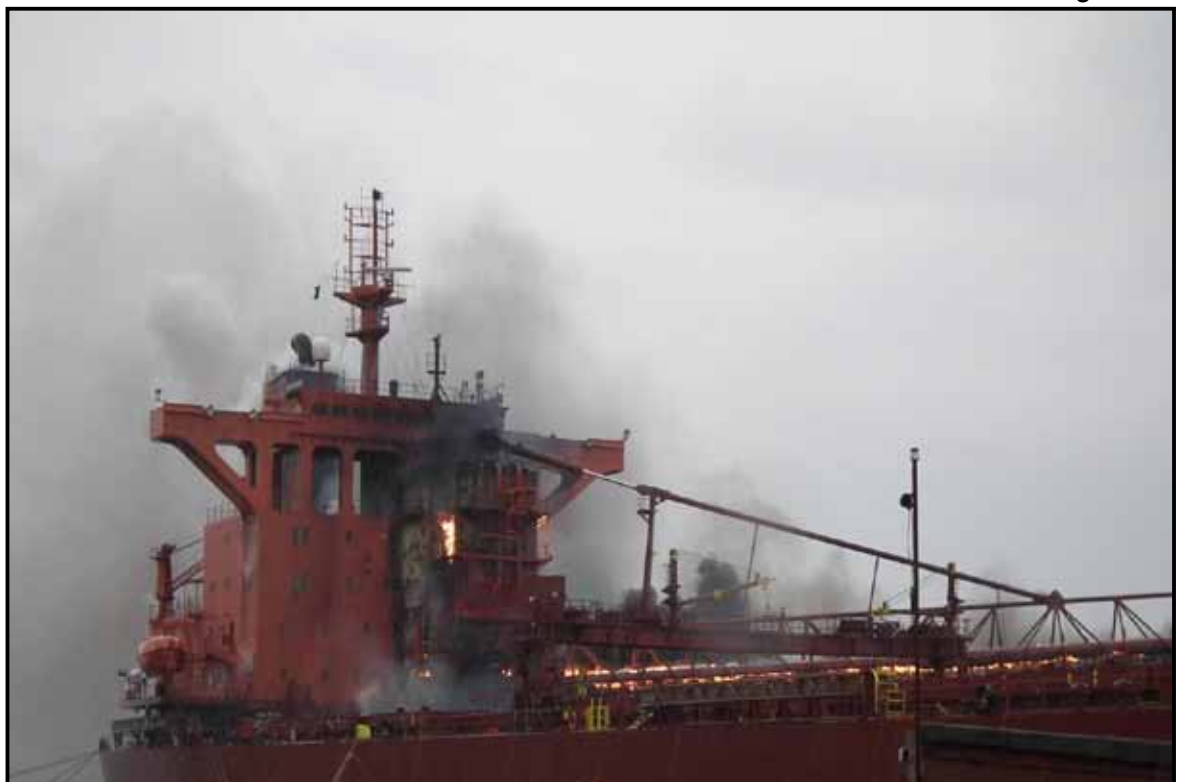
Figure 10

Fire spread onto the conveyor boom

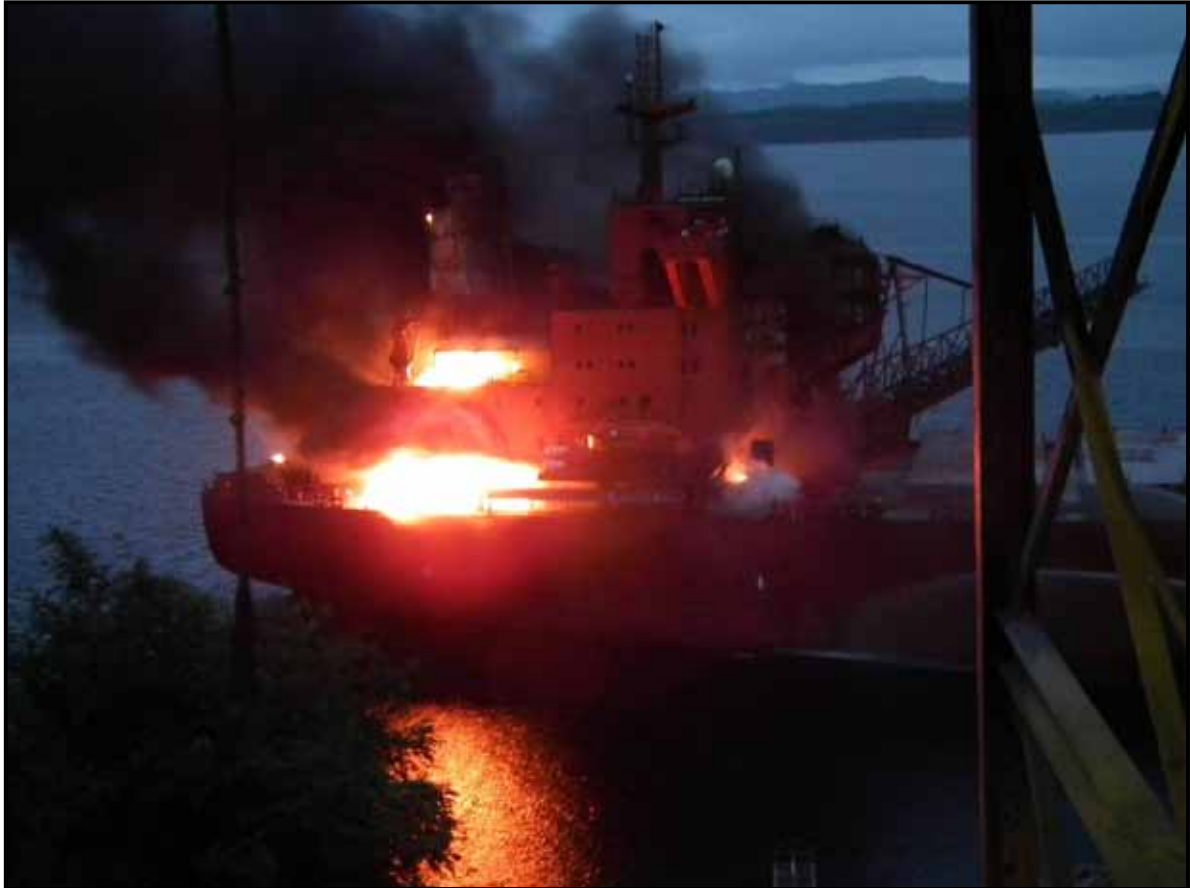
Figure 12

Fuel tanks “flaring” off

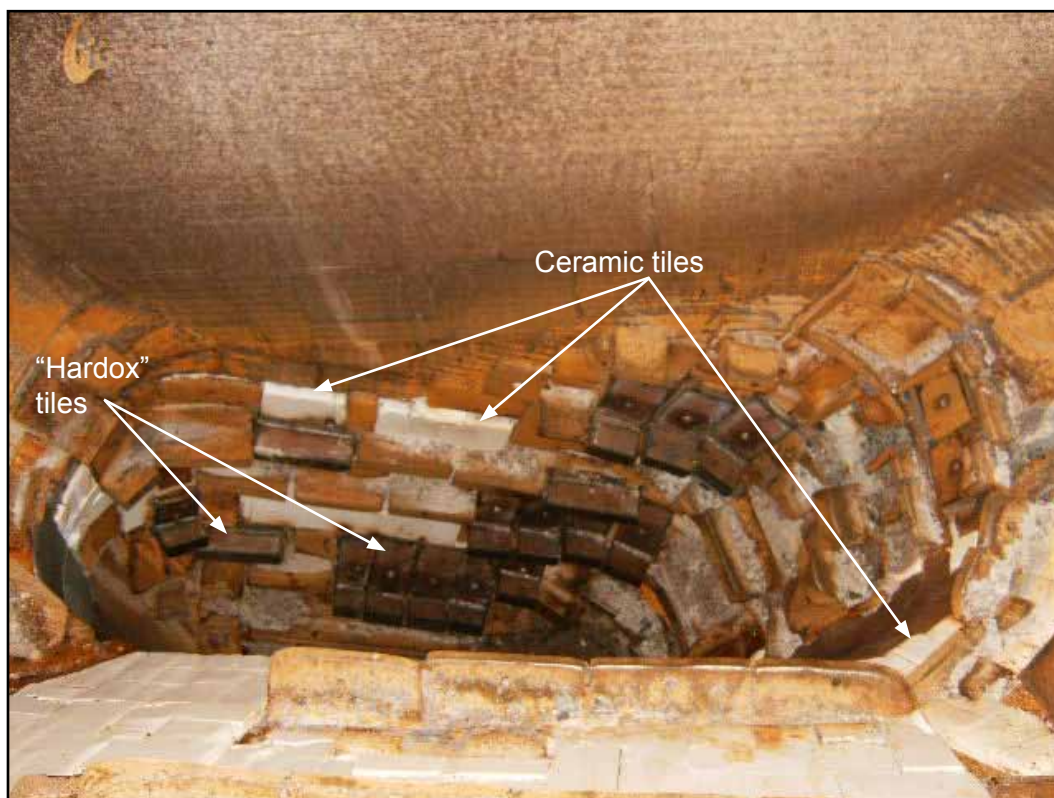
Figure 20

The internal surfaces of the hopper were protected by a combination of sacrificial “Hardox” and ceramic tiles. The ceramic tiles were secured to the hopper carcass using a special adhesive while the “Hardox” tiles were secured using a nut and bolt arrangement. Both tile types (**Figure 20**) required frequent replacement. In the case of the “Hardox” tiles, this involved flame-cutting hotwork to trim the tiles and tack welding to secure the new tiles to adjacent tiles. The internal apex created by the legs was protected by right-angled “Hardox” tiles. The angle formed filled with cargo and provided a flush face to assist the cargo discharge. The system was designed for discharge rates of up to 6000 tonnes/hour. Each cargo type had an optimum discharge rate, greater or lesser rates of discharge resulted in stones impacting on the more vulnerable side of the hopper, which then required more maintenance.

Internal view of the hopper “trouser leg” showing sacrificial “Hardox” and ceramic tiles

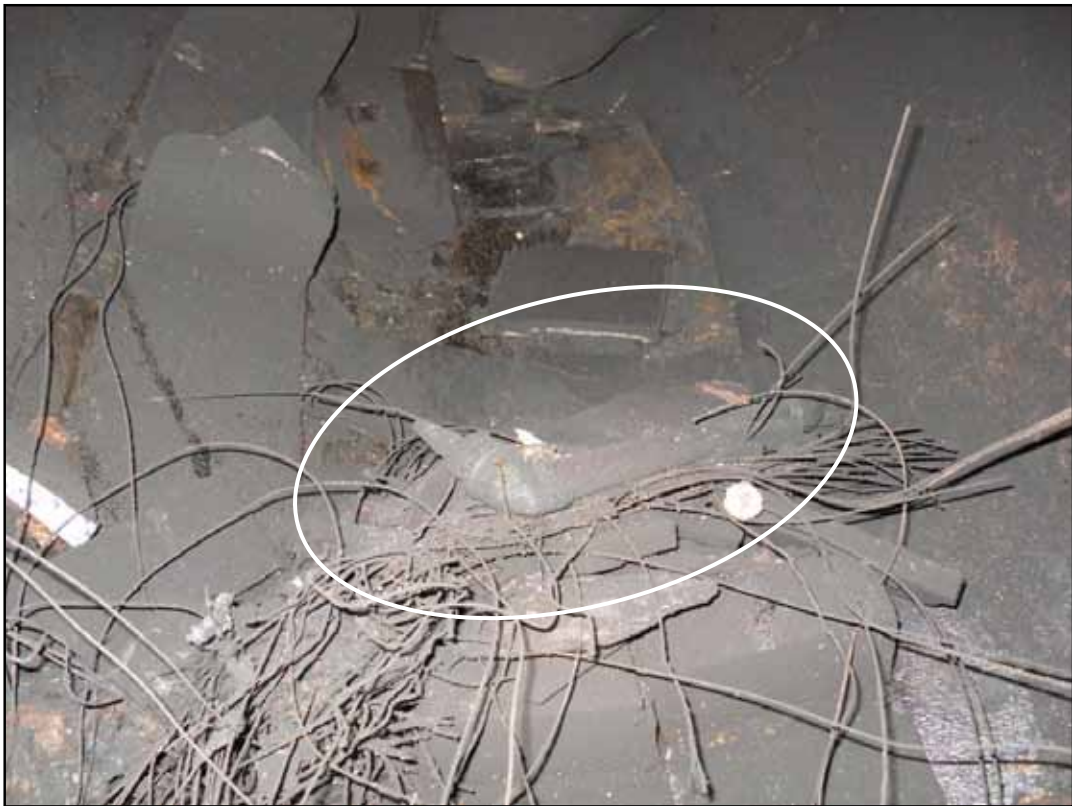
Figure 26

The cutting attachment of an oxy-acetylene torch was found resting on the “Hardox” tiles inside the hopper at about 2.5m from the chute opening, and the shank was found with hose connections still attached⁵ at the tail end of the boom conveyor (**Figures 26 and 27**).

Oxy-acetylene torch cutting attachment

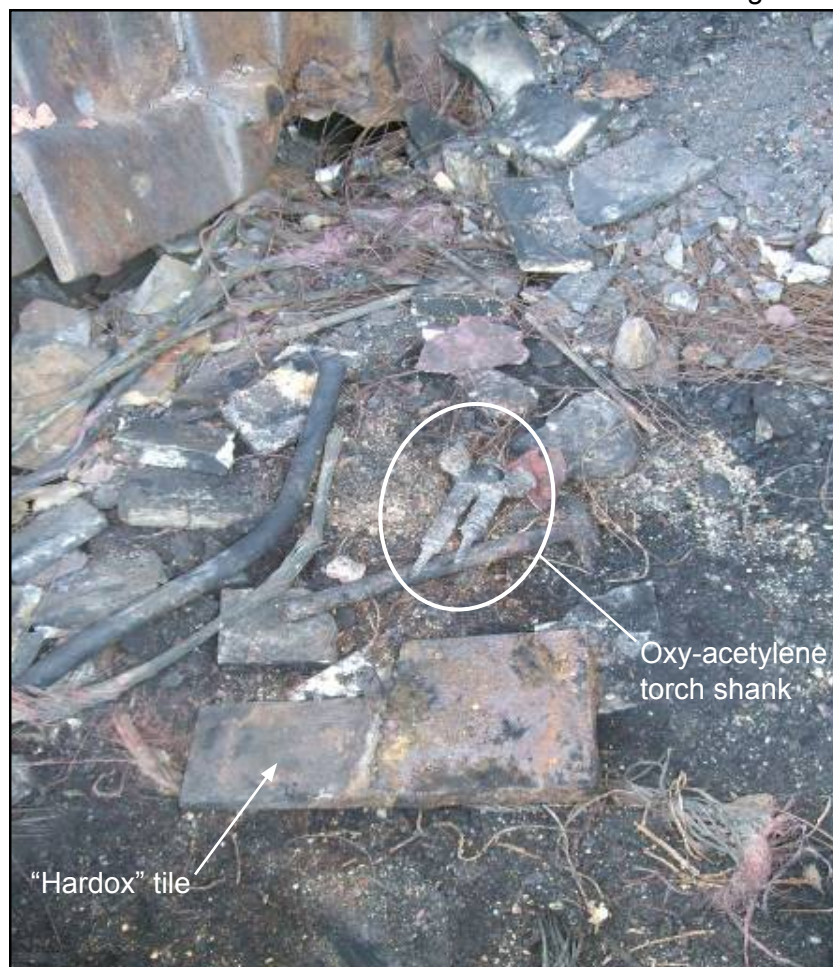
Figure 27

Oxy-acetylene torch shank

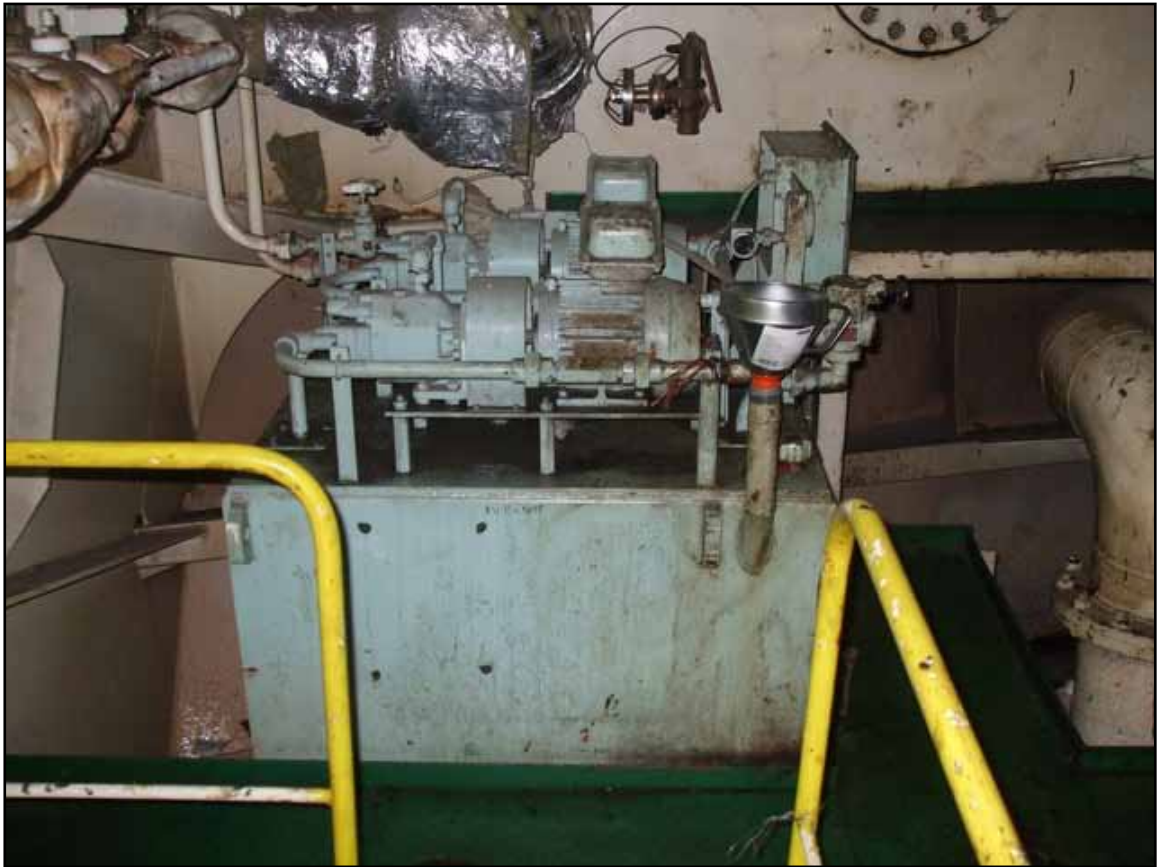
Figure 28

A number of water ballast butterfly valves were hydraulically-operated and remotely-controlled from the CCR. The associated self-contained hydraulic system power pack was located on the starboard side, adjacent to the forward bulkhead of the engine room (**Figure 28**).

Water ballast tank valves - hydraulic power pack

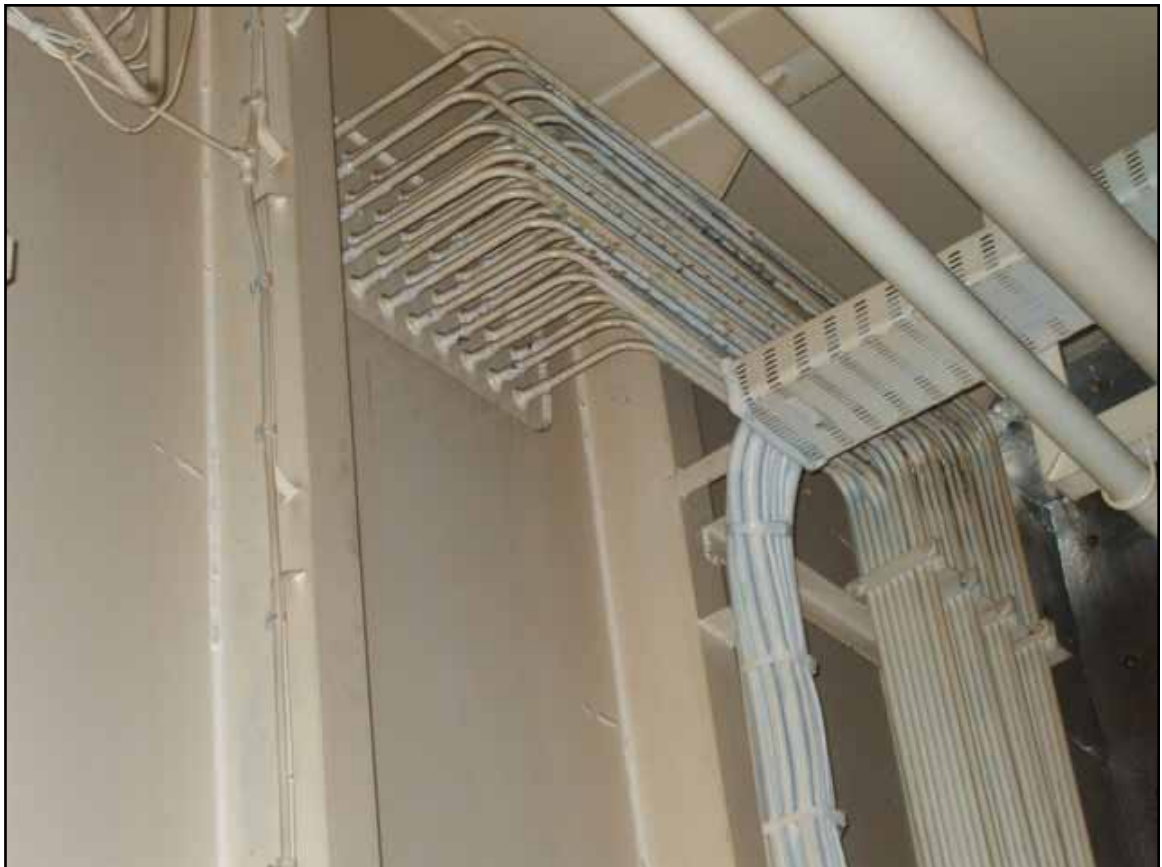
Figure 29

The hydraulic oil was delivered to the ballast valves through 20mm diameter copper pipes which were located in the general vicinity of the fire. The sections of pipes were connected by brazed cup and cone couplings (**Figure 29**). The system was pressurised at the time of the fire.

Water ballast tank valves - hydraulic distribution lines

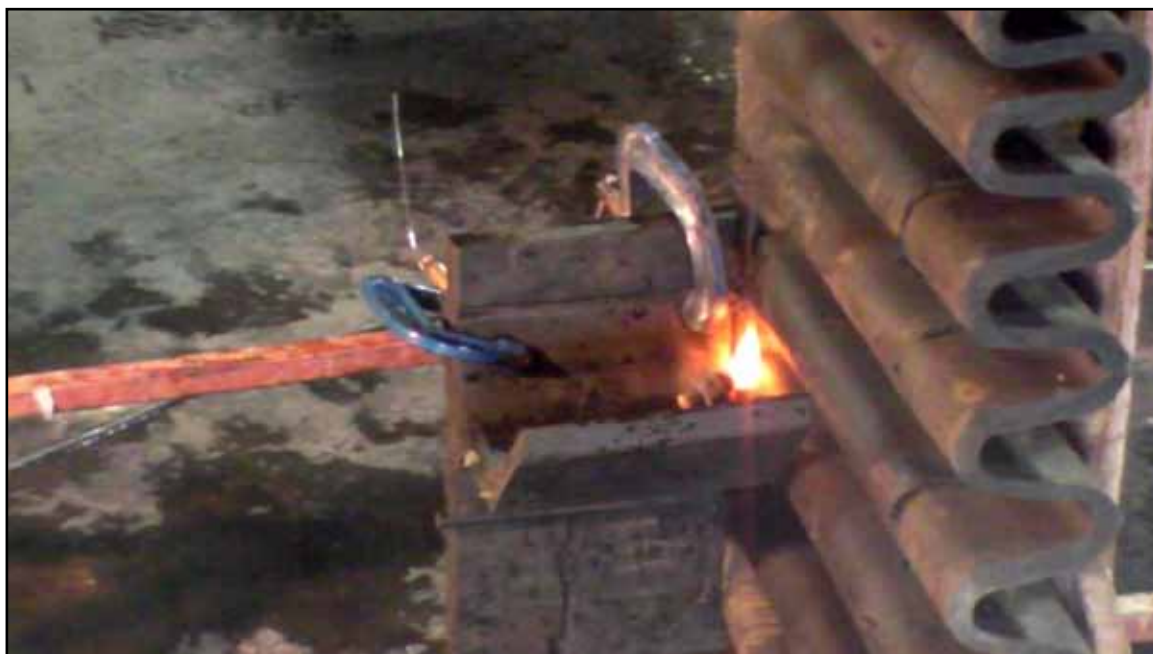
Figure 32

During the second series of tests, the stud and nut were heated to just below their melting point of 1370°C, about the temperature that would have been reached had oxy-acetylene equipment been used. Following a 3-second delay to take into account cooling during a 21m fall¹¹, the hot stud and nut were placed centrally in the cleat, in the cleat and against the side curtain, and in the side curtain corrugation. The three separate tests were carried out in 0 m/s and 0.4 m/s wind speeds to simulate airflows in the SUS tower. On each occasion, the cleat ignited, smouldered and then self-extinguished. However, when the stud and nut were in contact with the side curtain, the latter readily ignited (**Figures 32 and 33**).

Fire Tests - stud and nut placed in cleat adjacent to the side curtain
