Report on the investigation of
the fire on the main vehicle deck of
Commodore Clipper
while on passage to Portsmouth
16 June 2010

SYNOPSIS

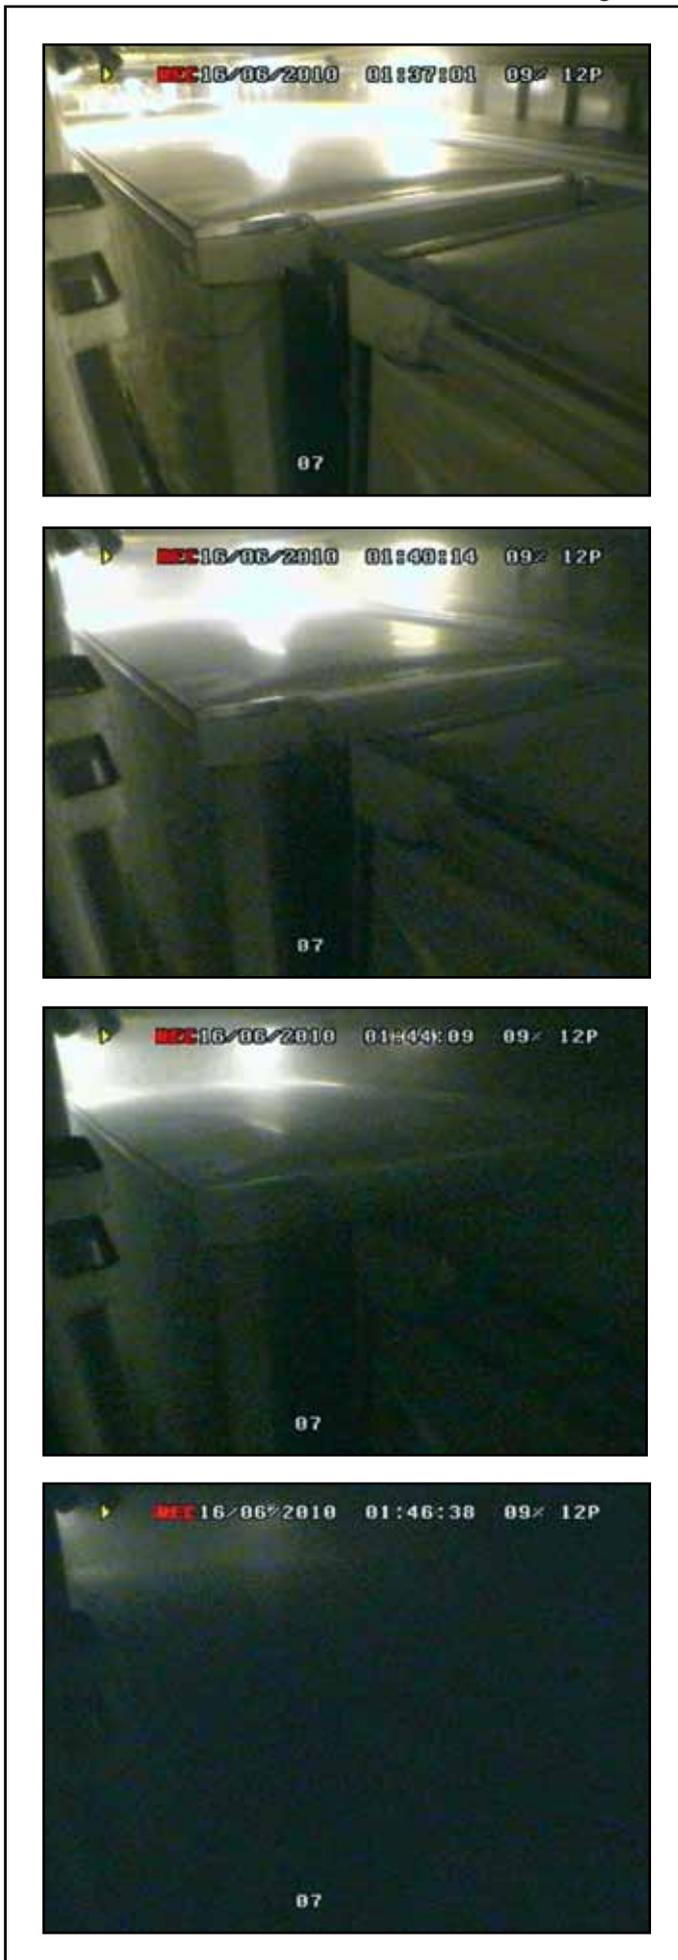
Figure 1

At 0237, the picture recorded by CCTV camera 7 on the port side of the main vehicle deck started to get hazy (**Figure 1**). The vehicle deck lighting began to appear more diffused and the picture gradually faded grey. Shortly afterwards a machinery control alarm showed an earth fault at the bus-tie breaker linking the two parts of the main 400V electrical distribution system. The third engineer, on duty in the engine control room, also heard the noise of the breaker opening. Two minutes later, at 0241, the image recorded on CCTV camera 6, at the centreline of the main vehicle deck (**Figure 2**), began to darken.

Sequence of images recorded by CCTV camera no.7 from 0237 BST (CCTV timings are in UTC)

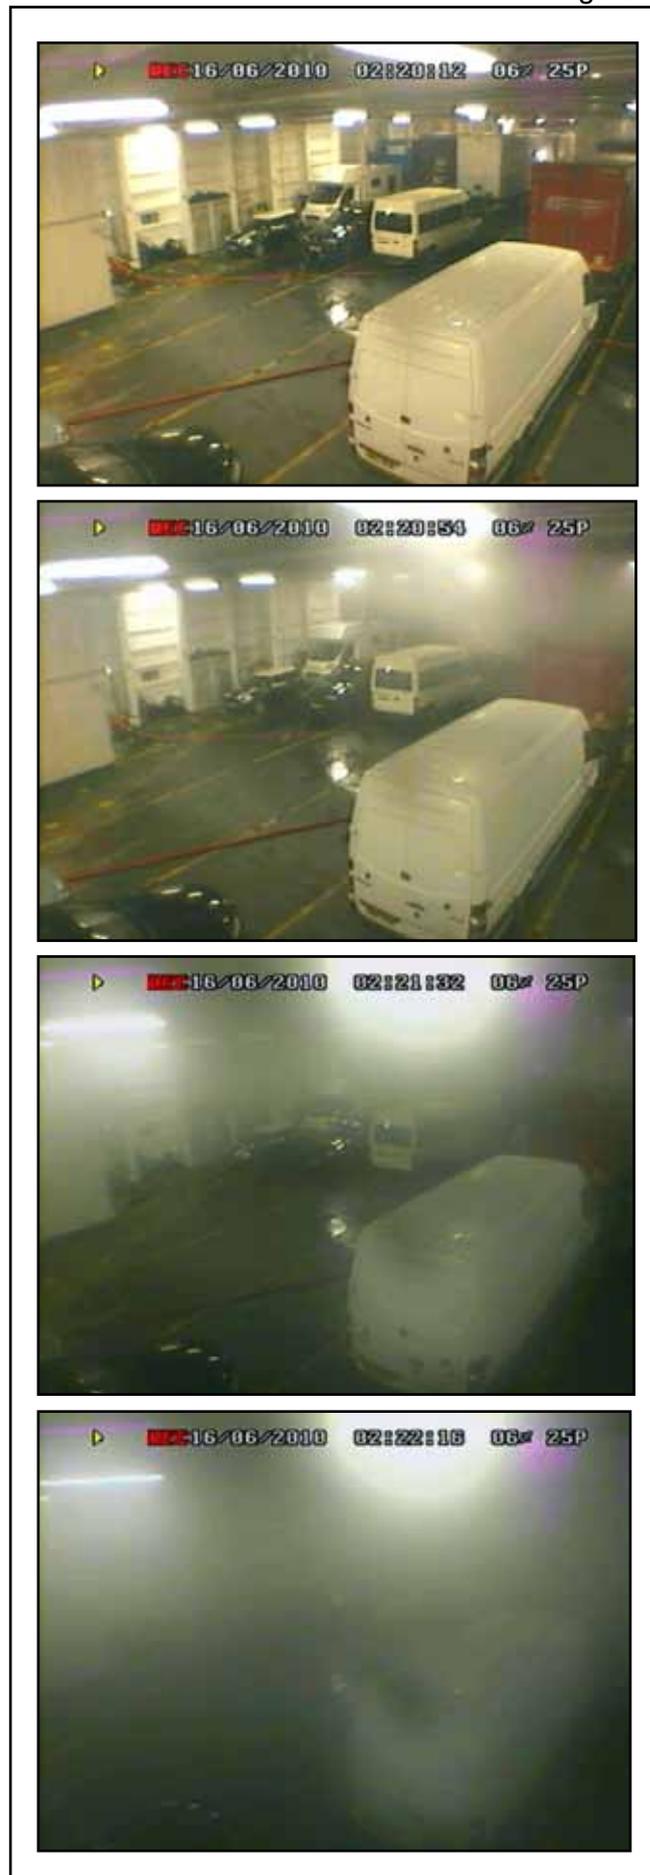
Figure 5

The chief officer led crew from emergency teams 1 and 2 to the forward part of the upper vehicle deck to provide boundary cooling above the fire. They started to rig two fire hoses at 0319, and could see that the deck was very hot and starting to buckle. The initial flow of water from the hoses was described as being "steaming hot" and made the metal nozzles uncomfortably hot to hold. CCTV cameras on deck 5 recorded a very large cloud of steam being generated at 0324 as water was sprayed onto the deck area immediately above the fire (**Figure 5**).

Cloud of steam from the upper vehicle deck as boundary cooling was started (CCTV timings are in UTC)

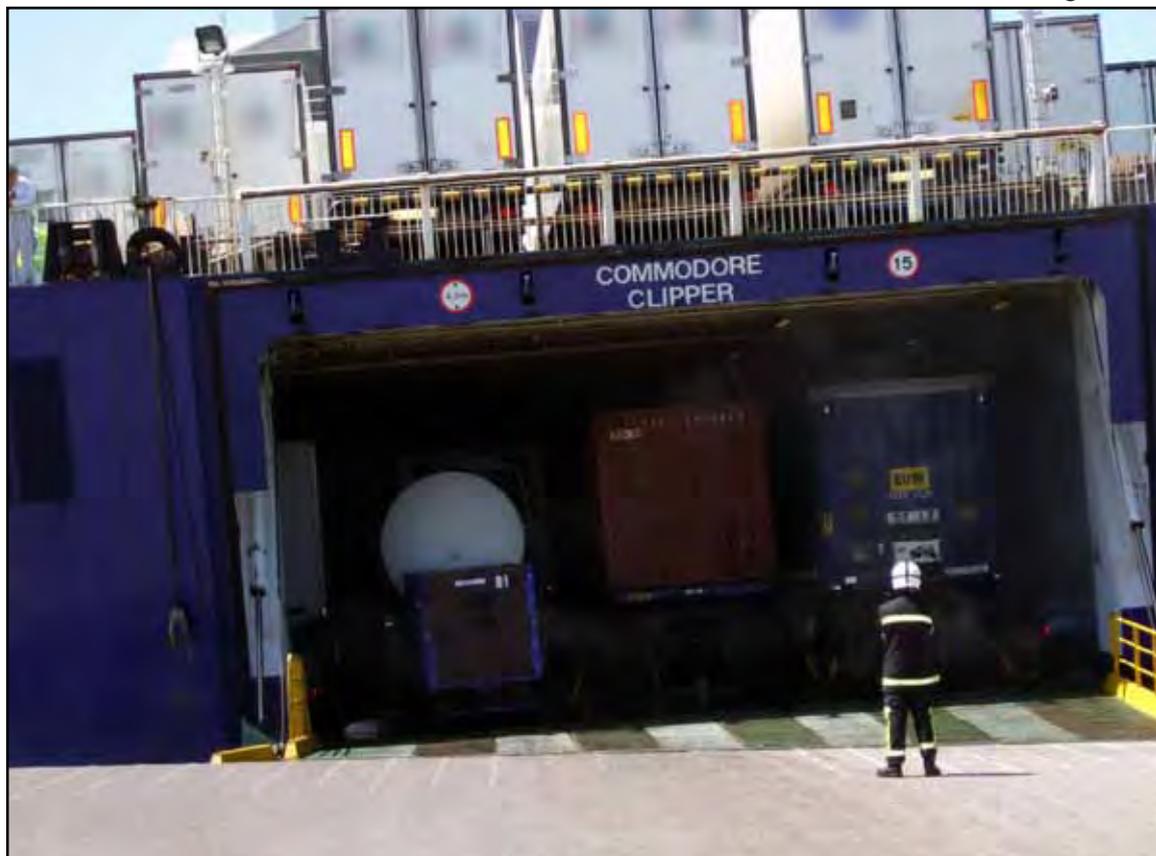
Figure 11

Commodore Clipper's stern ramp was opened, using controls on the upper vehicle deck, by about 1m shortly after 1230 and then slowly opened to its full extent over the next few minutes (**Figure 11**). There did not appear to be significant amounts of smoke in the main vehicle deck and no flames could be seen from the linkspan. It was agreed that as much cargo as possible should be removed from the main vehicle deck to improve access to where the fire had started.

View of the main vehicle deck after the stern ramp was opened

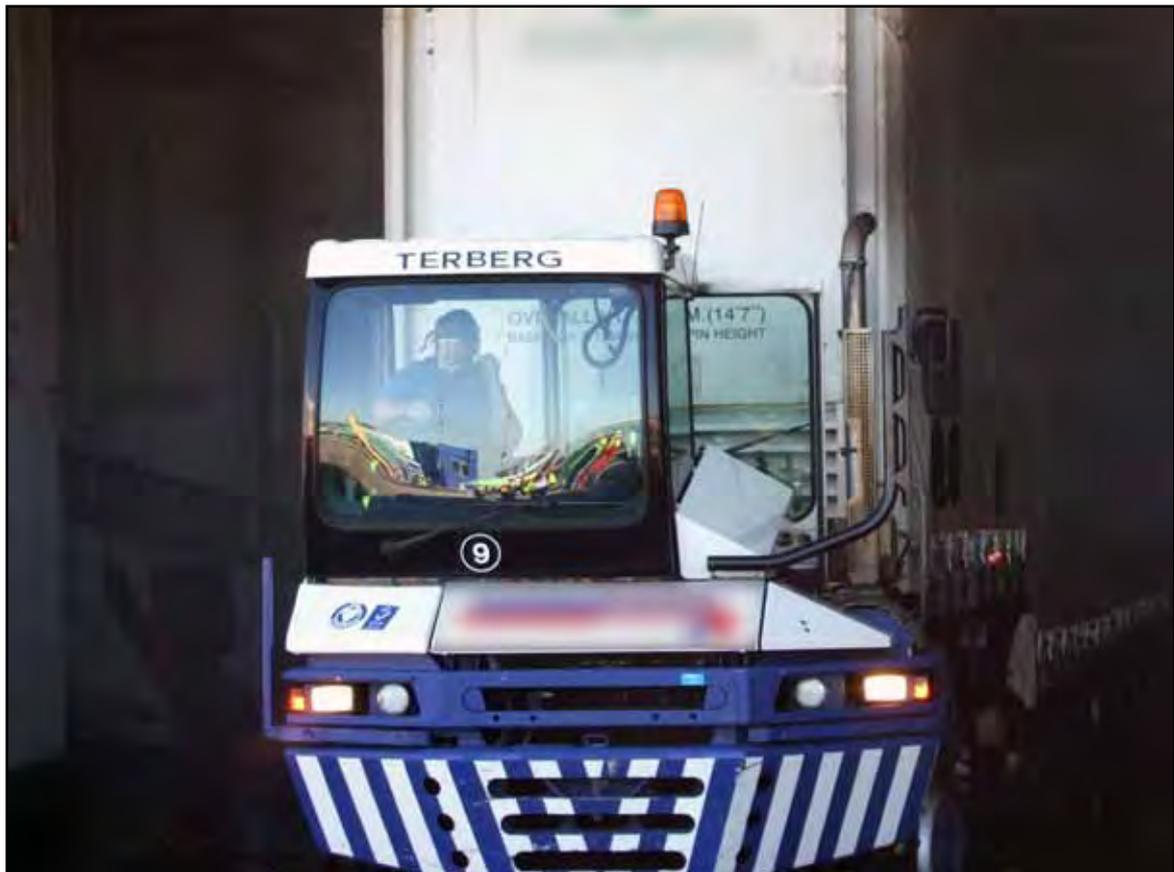
Visibility from the cab of the tugmaster was poor, and reduced to zero in the thickest smoke. Due to the limited space in the cab, the BA set had to be put to one side rather than worn conventionally, and the length of the hose between the cylinder and the facemask further limited the stevedore's movement. The stevedore used his knowledge of the vessel and the motion of the tugmaster as the tyres bumped over the lashing securing points in the deck to manoeuvre into the correct position and attach to each trailer.

Stevedore wearing breathing apparatus in order to remove trailers from the smoke-filled vehicle deck

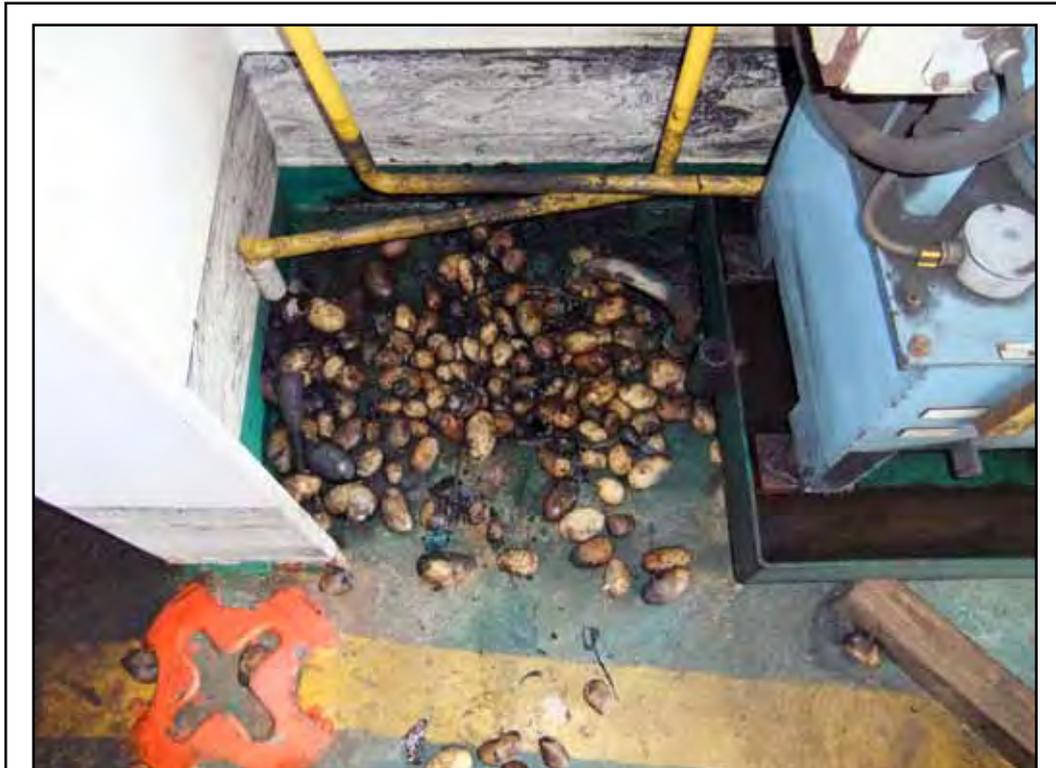
Deck drain blocked by potatoes

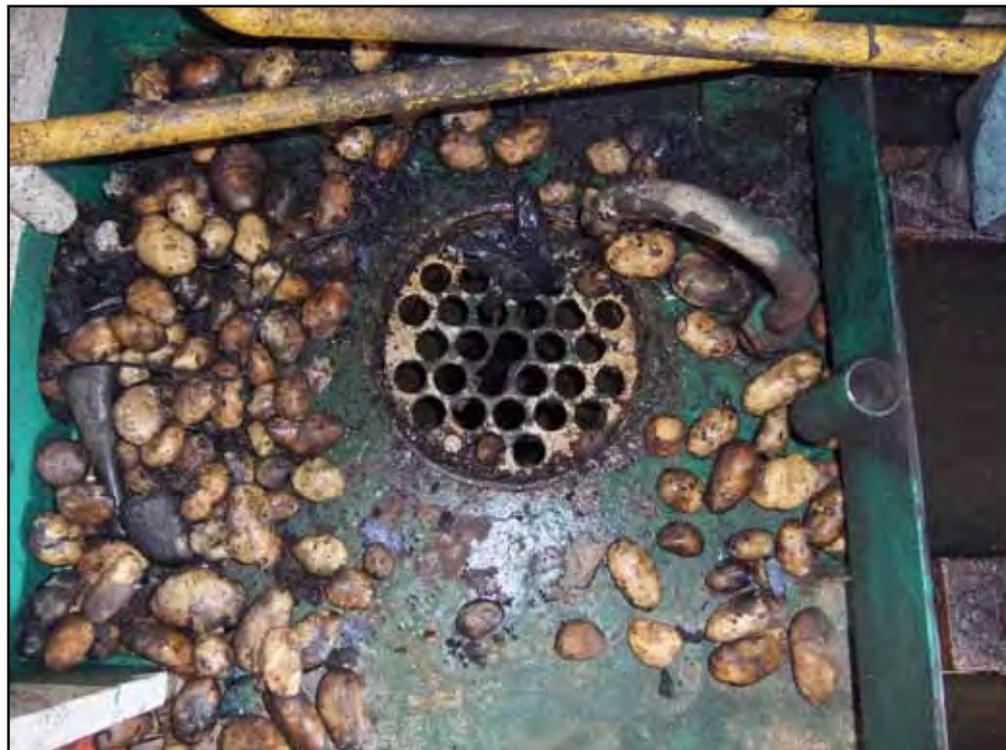
Deck drain cover with potatoes removed

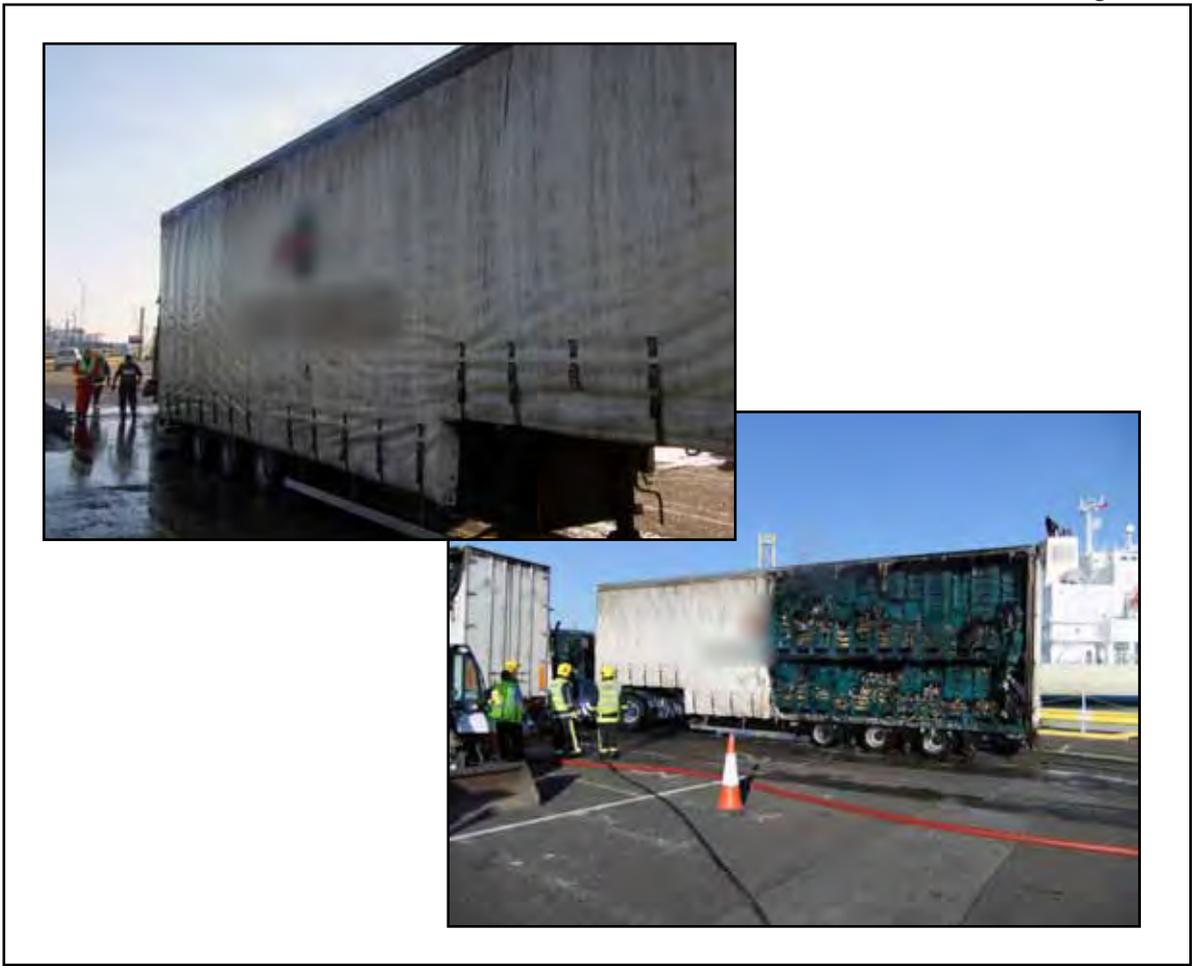
Figure 17

Trailer CR439 had curtain-sides, but the only fire damage was to the cargo area at the rear on the left-hand side. The curtain had been burnt away over the last half of the trailer, and the outer edges of the exposed cargo of pre-packaged potatoes had been involved in the fire (**Figure 17**).

Trailer CRF439

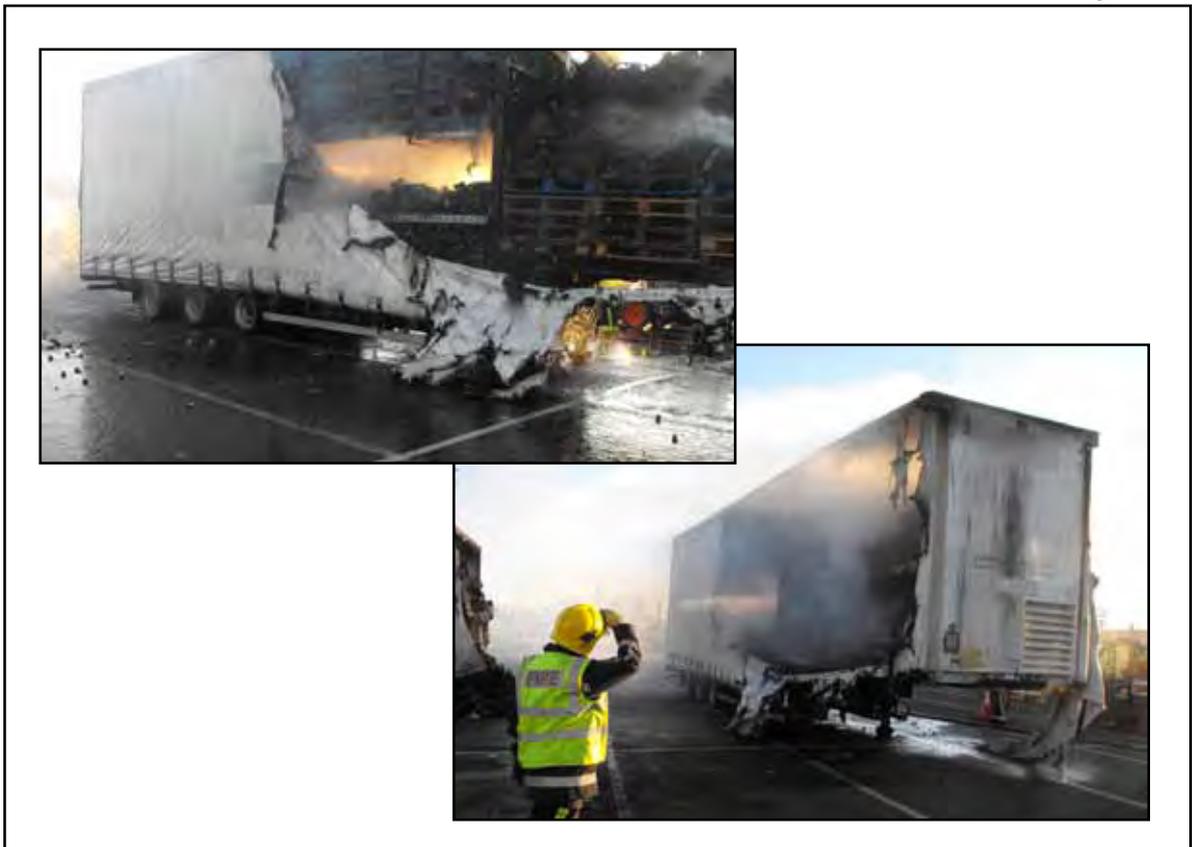
Figure 18

Trailer CRF461

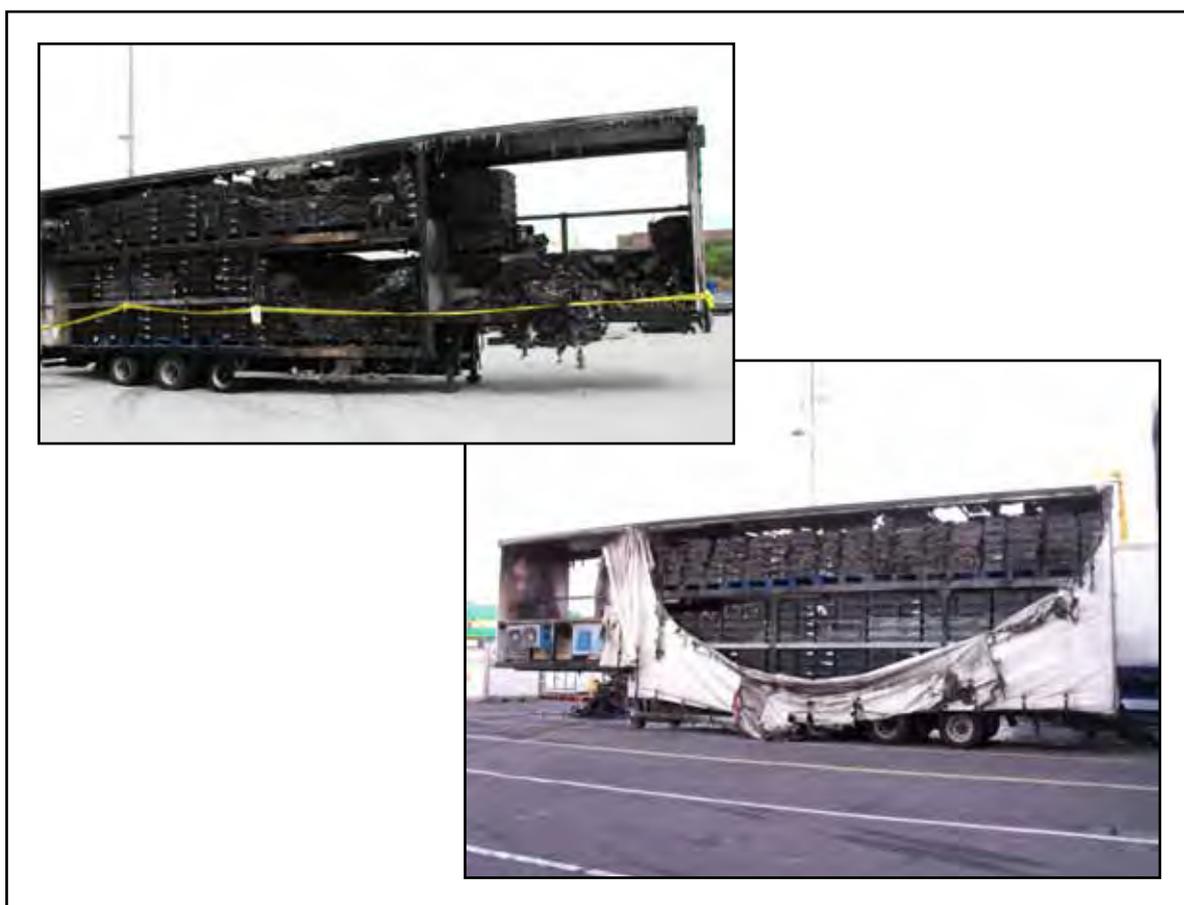
Trailer CRF459 had the most extensive damage, with the entire curtain on the right-hand side having been burnt away (**Figure 19**). There was extensive damage to the cargo in the central section on the right-hand side, immediately above the electrical power distribution circuits. The composite aluminium/glass reinforced plastic roof had also been destroyed in this area, with remnants of molten and solidified aluminium at the periphery. The left-hand side was less damaged, but the curtain had detached at the top over the rear three-quarters of the trailer. Some cargo on the upper levels had also been involved in the fire, but the amount of damage reduced considerably lower down.

Trailer CRF459

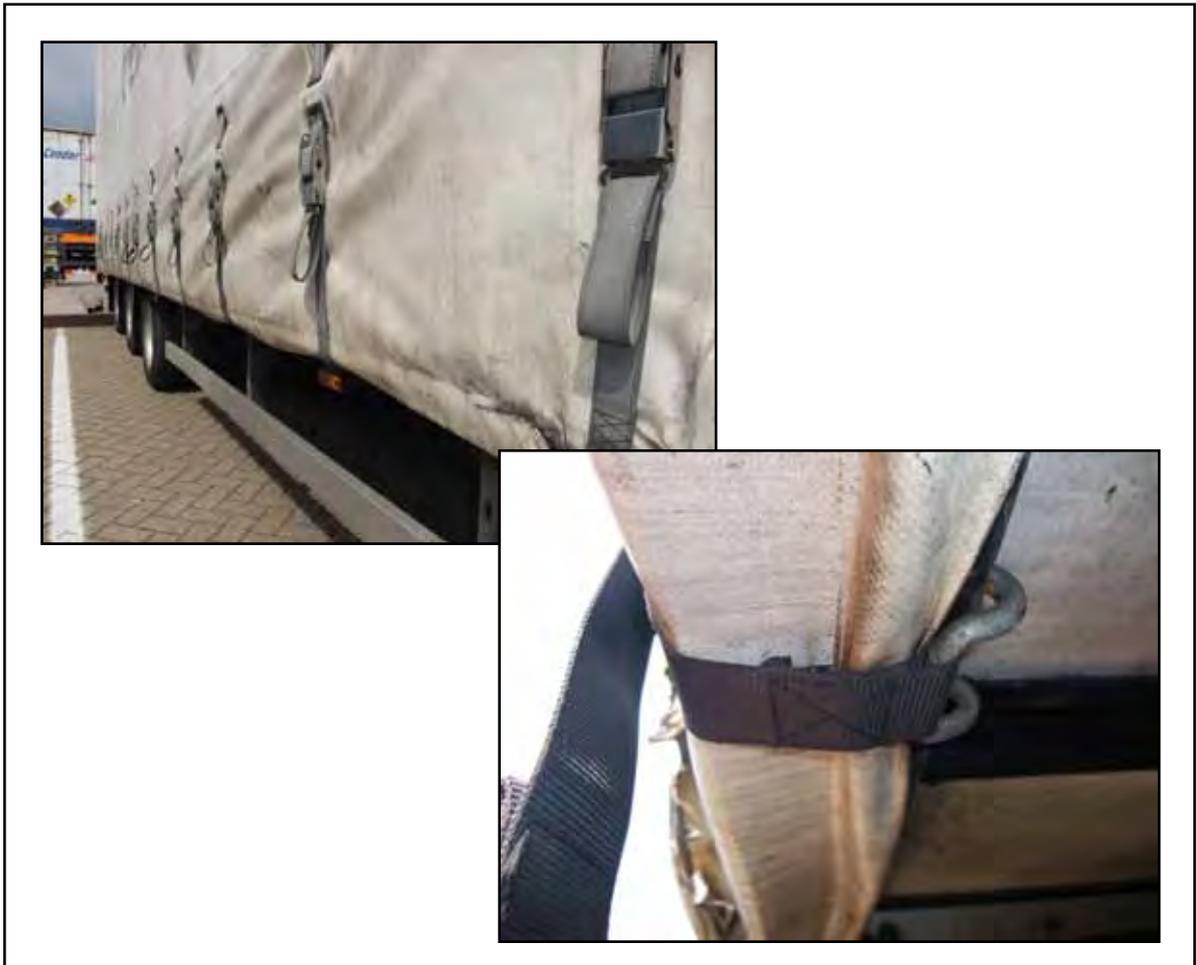
Figure 20

Trailers CRF459 and CRF461 were similar triple-decked units, designed to carry fresh produce, chilled to between 5° and 8°C. When full, each trailer was capable of carrying about 18-20 tonnes of packaged potatoes. The curtain-sides were made from two outer layers of tough plastic which enclosed a central layer of flexible insulating material. The curtain-sides hung just below the sides of the load-bed and were secured in place with webbing straps (**Figure 20**).

Insulated curtain-side material

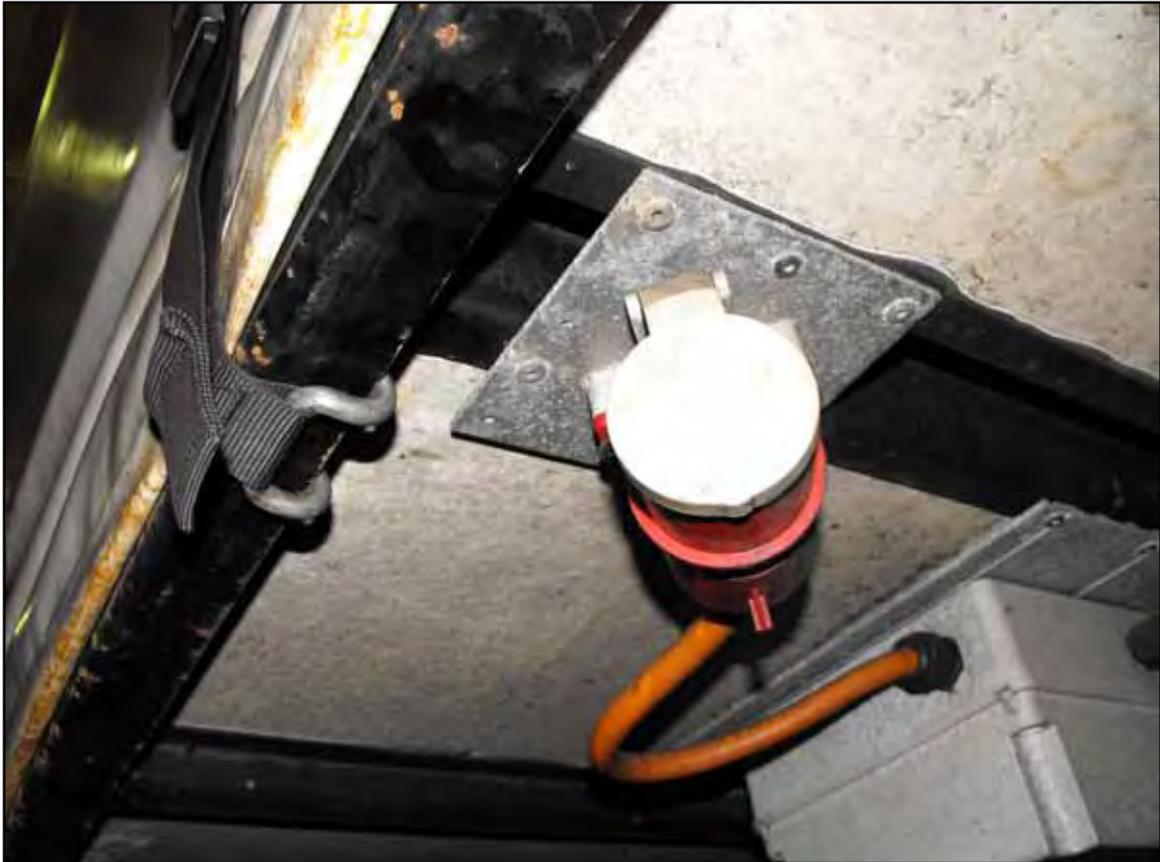
Figure 24

The external power supply socket on trailer CRF459 was found to have detached from the underside of the load-bed, and had indications of internal overheating, rather than external charring from fire (**Figure 24**). Insulation materials which were fitted into the load-bed, and the lower flange of the steel beam forming the outer edge of the load-bed in the area where the socket was fitted, were also damaged by heat. It was possible to determine that part of the plug fitting from *Commodore Clipper's* power supply was still attached. The remainder of the plug had been consumed by fire, and the parts of the cable terminals that were left were heavily charred. The cable was no longer attached.

Damaged external power supply connection on trailer CRF459

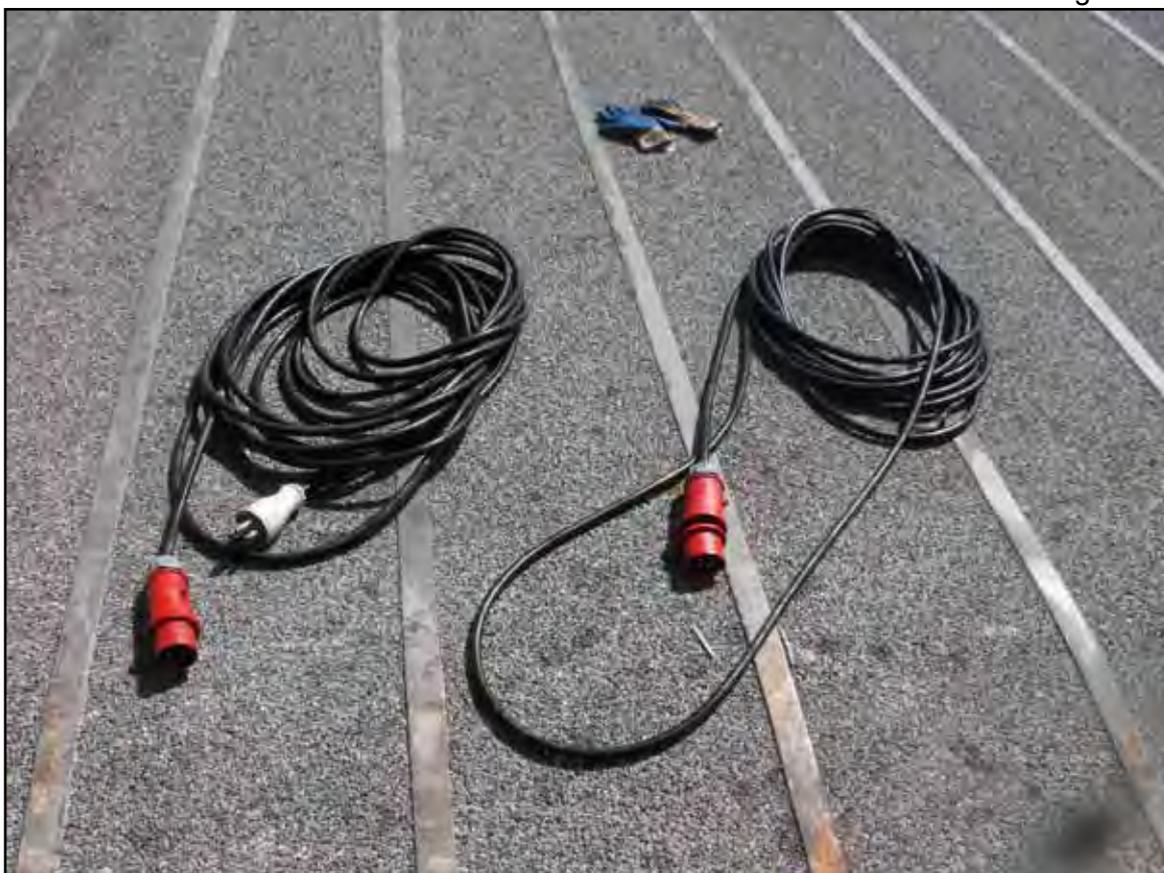
Figure 25

One power cable, which had consisted of two standard 20m lengths plugged together, was found lying in a straight line leading from socket No.9 on a bank of power supply sockets close to frame 101, to a position in lane 2 at frame 201 (**Figure 25**). The connecting ends of the two standard cables were found pulled apart at frame 86. The plug and sockets shared a common pattern of damage that was likely to have been sustained during the fire-fighting and cargo removal operation, indicating that they had been connected during the accident. The end of the cable that would have been connected to the trailer was the only one without a plug, and the bare wires were exposed. Another set of power supply sockets was closer to the trailers involved in the fire, and these could have been used to avoid the need to use an extension lead.

Reefer power supply cable

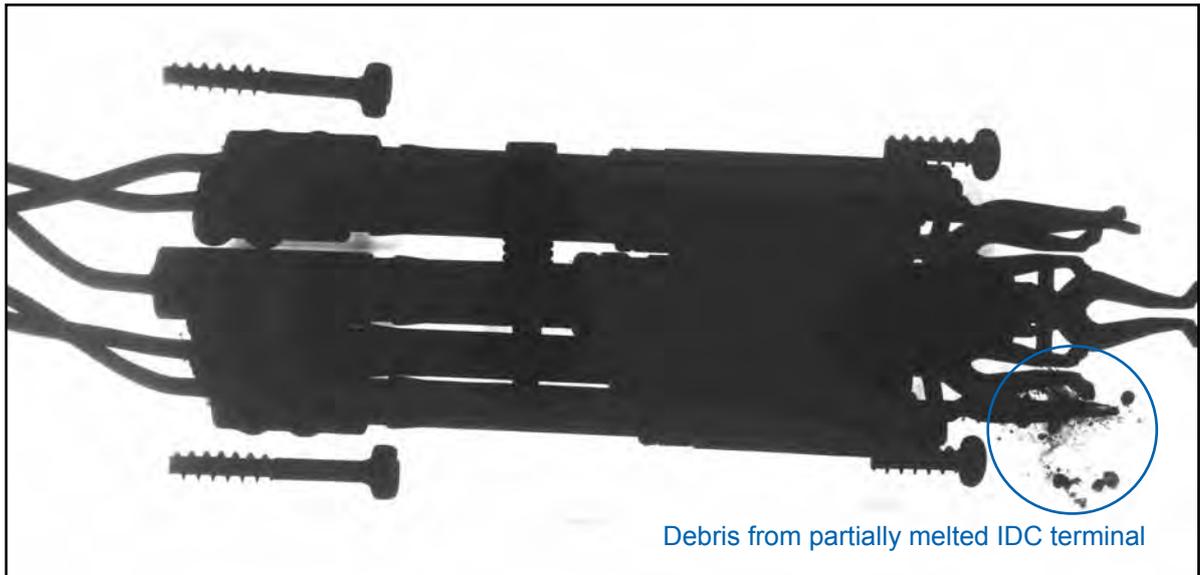
Figure 26

The power supply cable plug and socket were removed from CRF459 and x-rayed to determine the condition of the terminals. The x-ray showed several globules of metal around the area of one of the plug terminals where the ship's power supply cable was connected (**Figure 26**). The plug was identified as a 'StarTop' type, manufactured by Mennekes.

X-ray of the external power supply connection on trailer CRF459

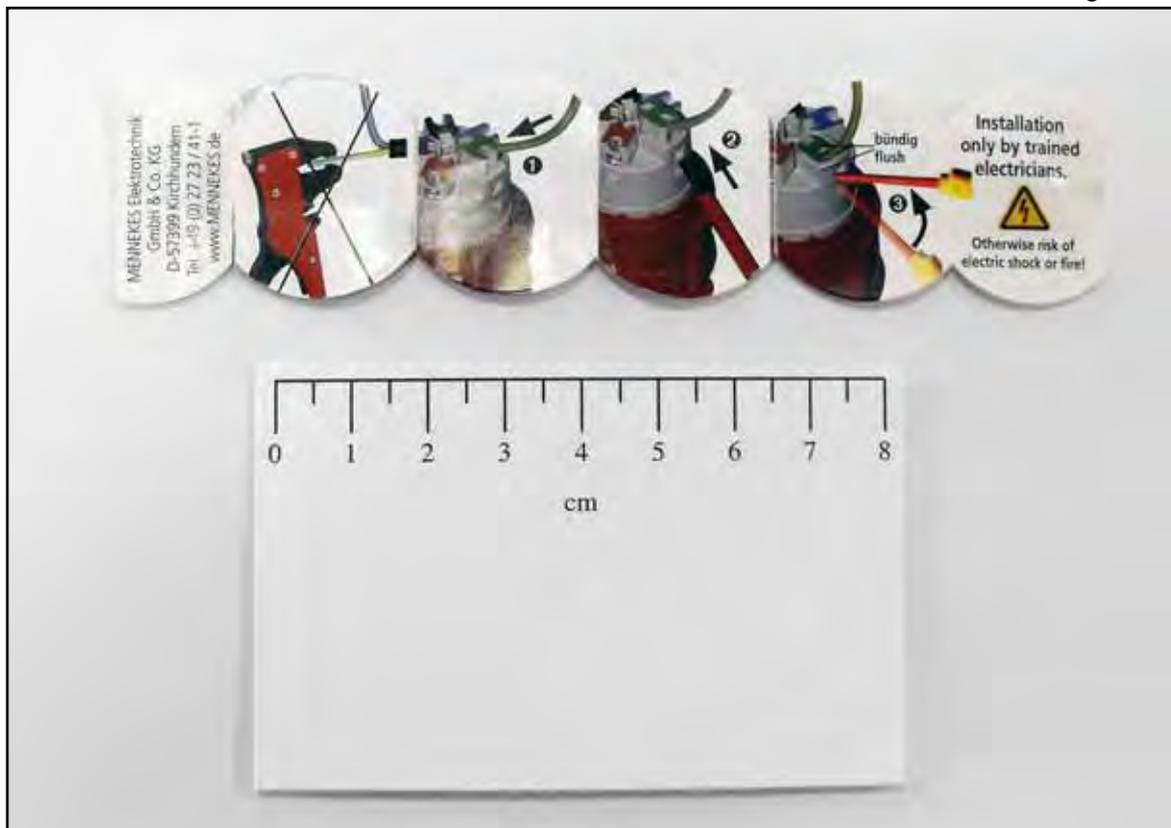
Figure 28

The StarTop plugs were suitable for up to 440V and 32A and were IP44 rated. The cable cores used on *Commodore Clipper* were the maximum size that the StarTop IDC terminals could accommodate. Each plug was supplied with a small instruction leaflet (**Figure 28**) that was secured to the terminals inside each plug assembly and indicated that insulation should not be removed from the conductors. Instead, each core of the cable should be inserted into the plug and the cap pushed down by hand or levered into place using a screwdriver. This forced the cable core into the IDC and cut the insulation, securing the conductor to the terminal. In practice, a considerable amount of force was required to achieve this successfully when using the maximum cable size.

StarTop plug instruction leaflet

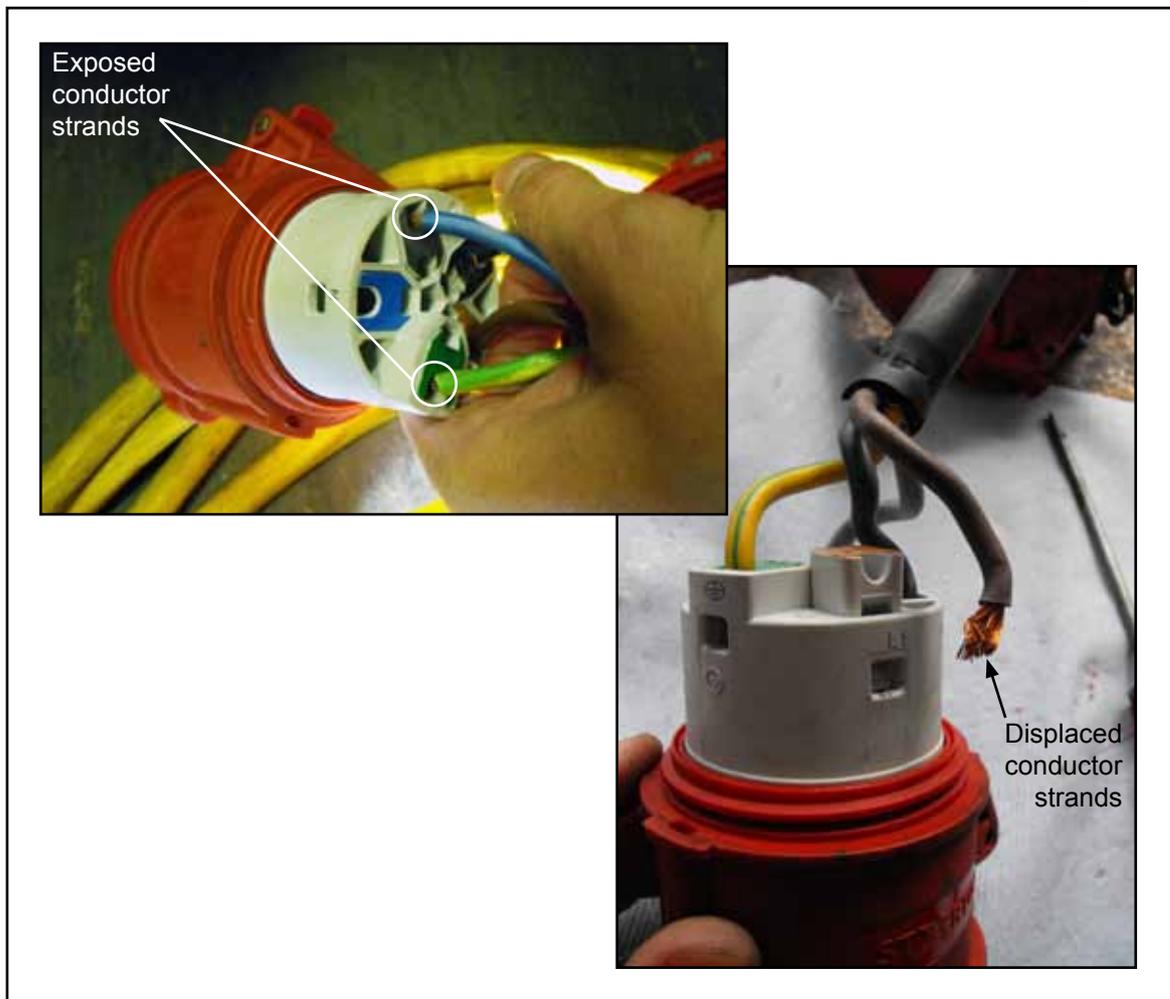
Figure 29

The three other examples of reefer cables found on board *Commodore Clipper*, that were fitted with StarTop plugs, were examined (**Figure 29**). In each case, the insulation had been removed from the ends of the cable cores before they had been inserted into the IDC. It is normal practice to remove insulation for a traditional screw terminal, but when using an IDC, the insulation is required to support the strands of the conductor and secure them in position. In the undamaged examples, the strands of the conductors were found to be displaced and at risk of not making adequate contact with the terminal. This would have been exacerbated if the cable gland became loose and the handling loads were transferred to the terminals.

Other StarTop plug connections assembled on board *Commodore Clipper*

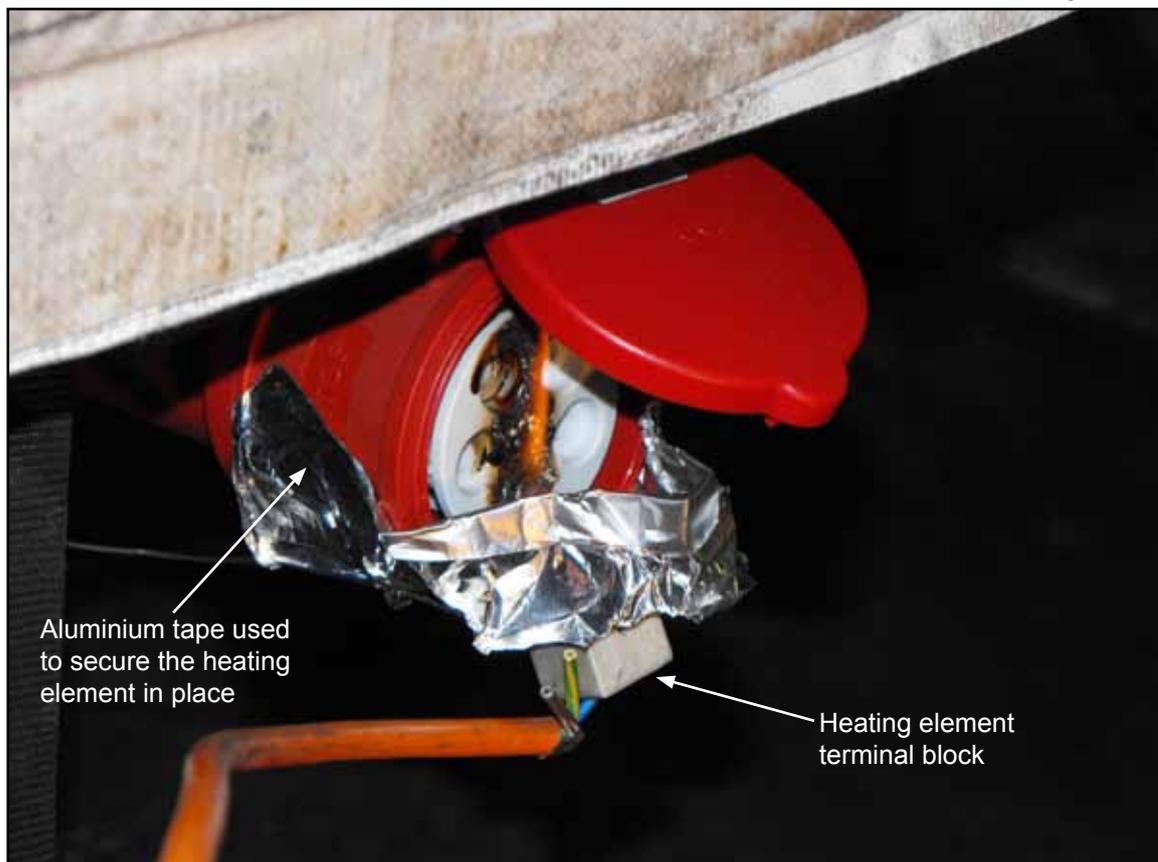
Figure 30

After approximately 10 minutes of sustained heating, the white plastic material around the terminals ignited. One and a half minutes later, flames had spread upwards and started to affect the red plastic cap (**Figure 30**).

Ignition of the StarTop plug after sustained internal heating

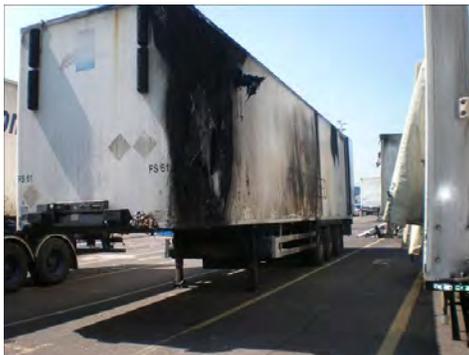
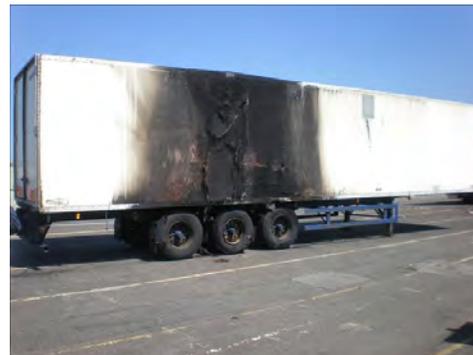
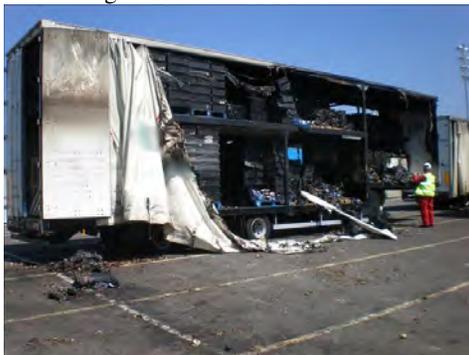
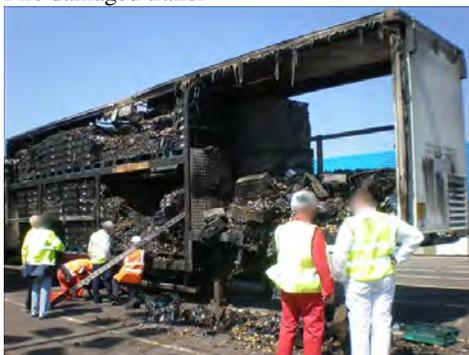
Fire damaged trailer

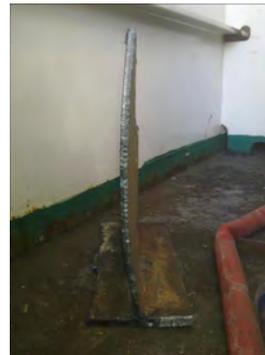
Section of cropped deep frame

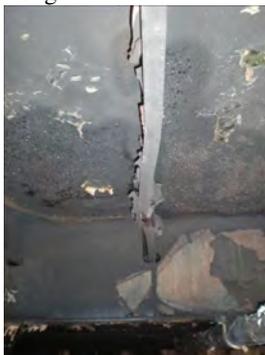
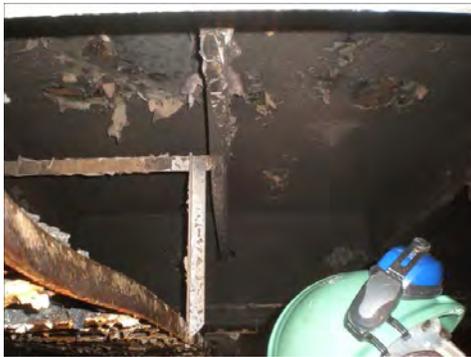
Longitudinal buckled

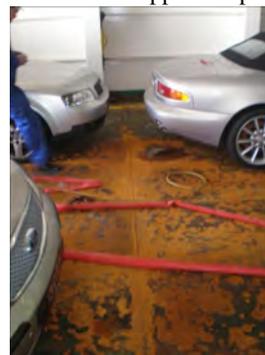
Upper Vehicle Deck buckled

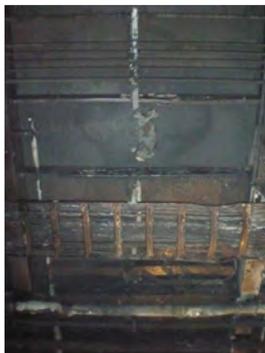
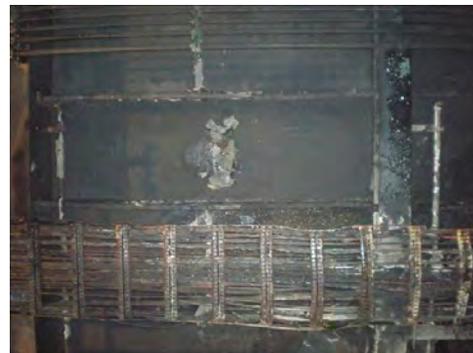
- Main Vehicle Deck (deck3), port side main cable tray buckled and cable insulation destroyed, between frames 74 and 77.
- Forward switchboard, both power supplies fire damaged.
- Reefer socket, fuse boxes and breaker cabinets water damaged.

Fire damaged cable tray

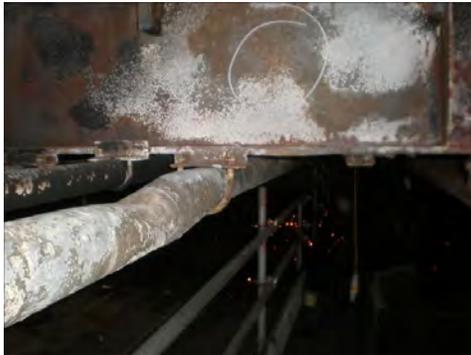
Main Vehicle Deck (deck3), port side drencher main (zone 4) buckled, between frames 74 and 77.

Buckled drencher main aft of frame 77

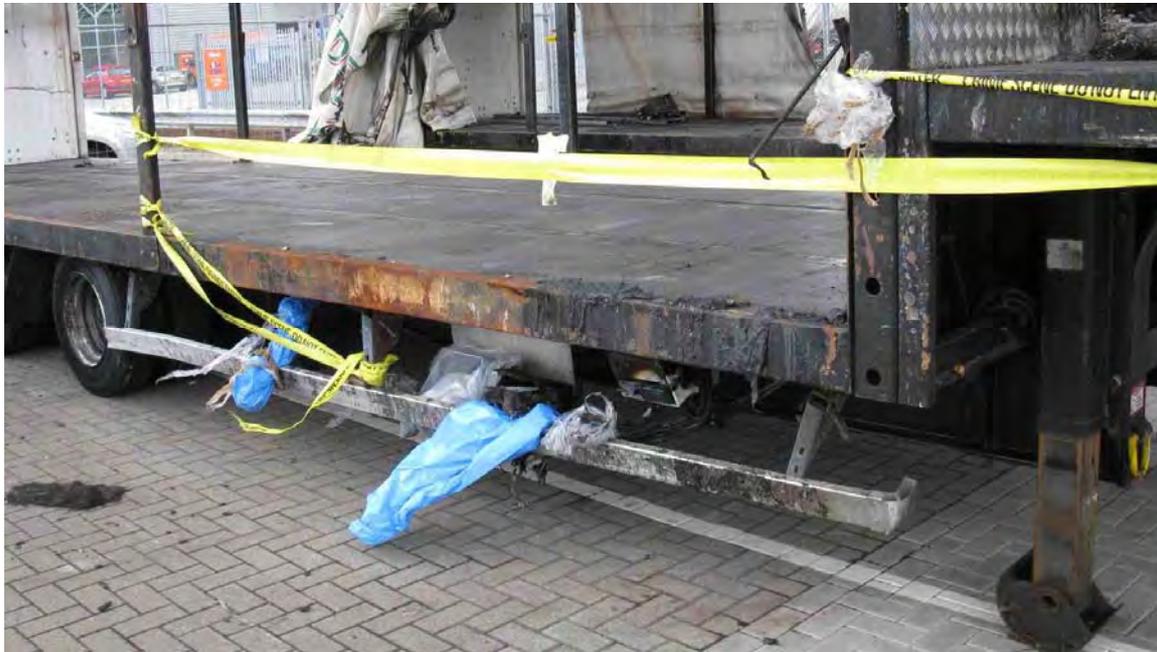
A general view of the location of the fire damage to the components under the bed of the trailer is shown in Fig. 1.

Figure 1 Location of electrical units

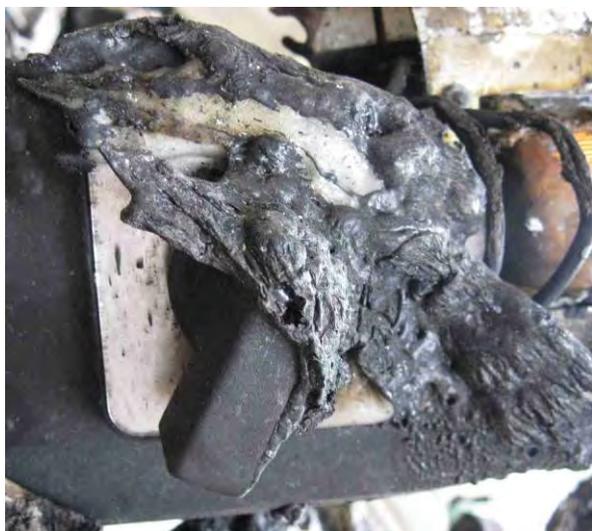
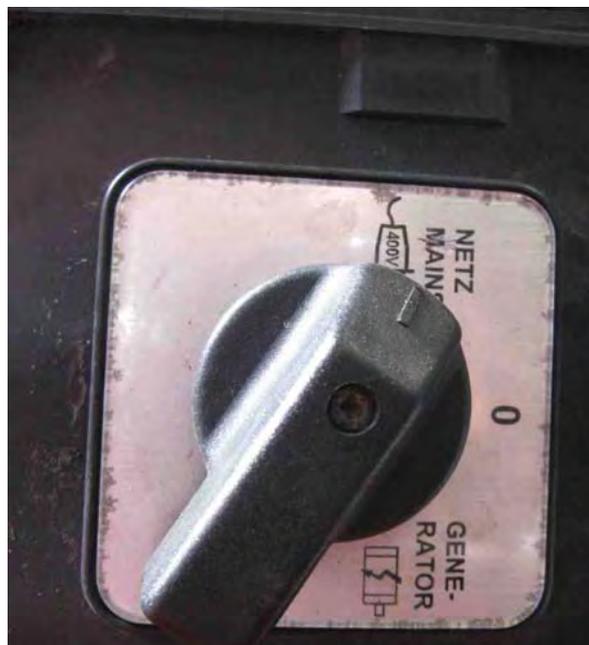
The changeover switch on the side of the control unit was found to be in the correct position for taking a mains supply from the ship, Fig. 9

Figure 9 Changeover switches

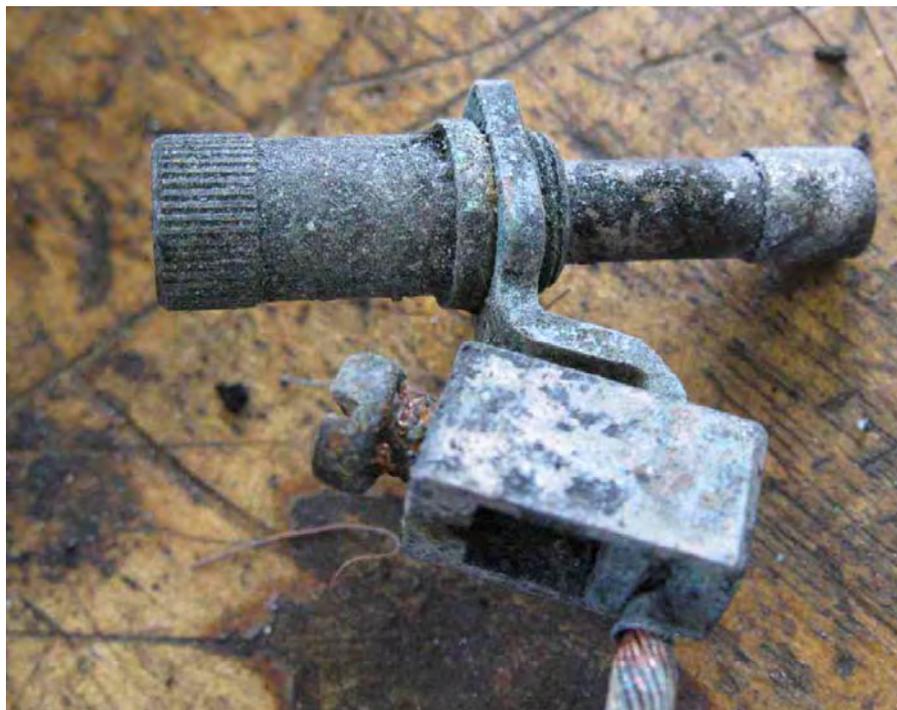
The wiring and the remains of the contactors in the three linked control units was examined in detail for evidence of arcing between cables, at contacts or at terminations, Figs 11 to 13. The middle unit was the most severely damaged with the main compressor contactor housing having been completely destroyed. The insulation had been burned away from most of the interconnecting wiring and the cases of the remaining relays and contactors were charred.

Figure 12 Terminal and spring contact
