Report on the investigation of
the fire on the main vehicle deck of
Commodore Clipper
while on passage to Portsmouth
16 June 2010

SYNOPSIS

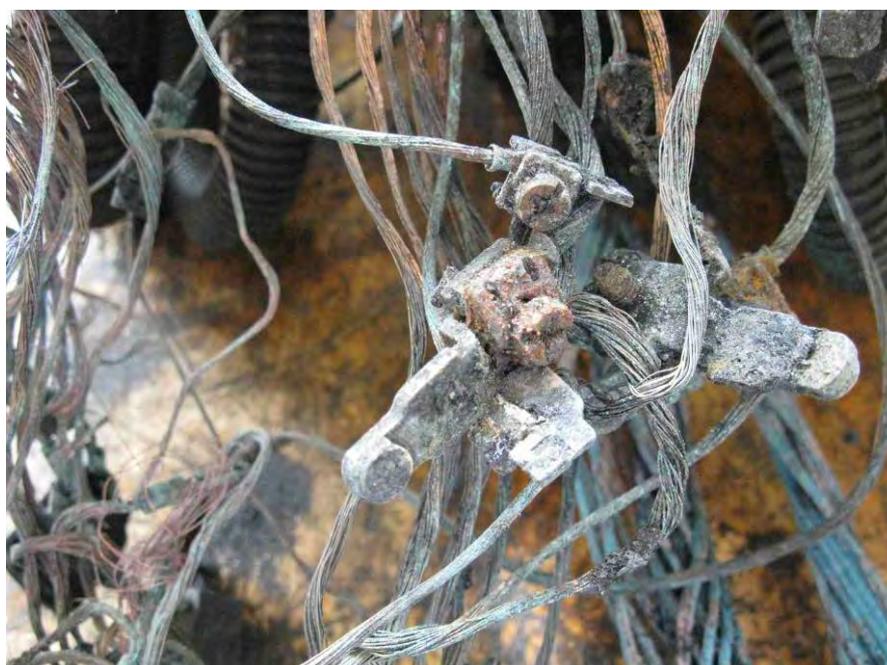
The wiring and the remains of the contactors in the three linked control units was examined in detail for evidence of arcing between cables, at contacts or at terminations, Figs 11 to 13. The middle unit was the most severely damaged with the main compressor contactor housing having been completely destroyed. The insulation had been burned away from most of the interconnecting wiring and the cases of the remaining relays and contactors were charred.

Figure 13 Contacts

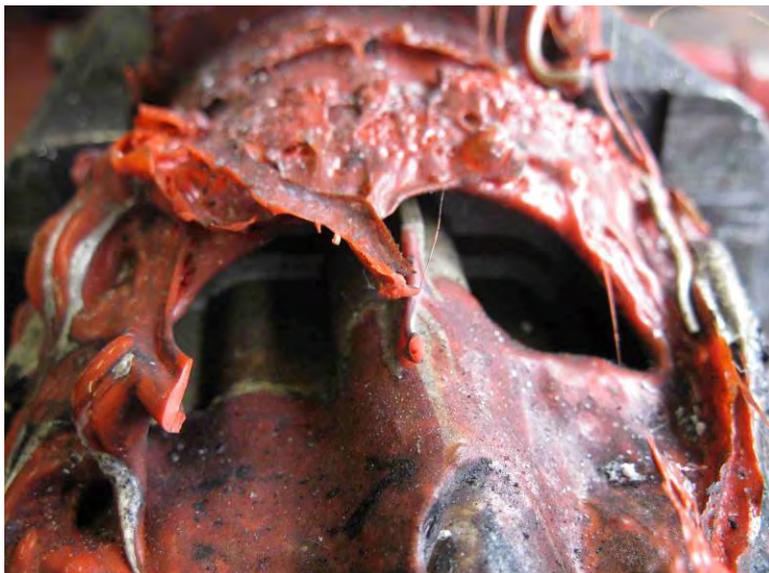
The free socket at the trailer end of the cable from the ship's supply was a five-pin, 32 A, Mennekes 'Startop' socket. The trailer mounted plug and the socket were fused together by molten plastic. At the plug end the terminals were visible and did not show any evidence of arcing or severe overheating, Fig. 14. A large portion of the free socket had burned away, Fig. 15. The ends of one of the IDC connectors could be seen emerging from the charred plastic, Fig. 16.

Figure 14 Terminals in fixed plug

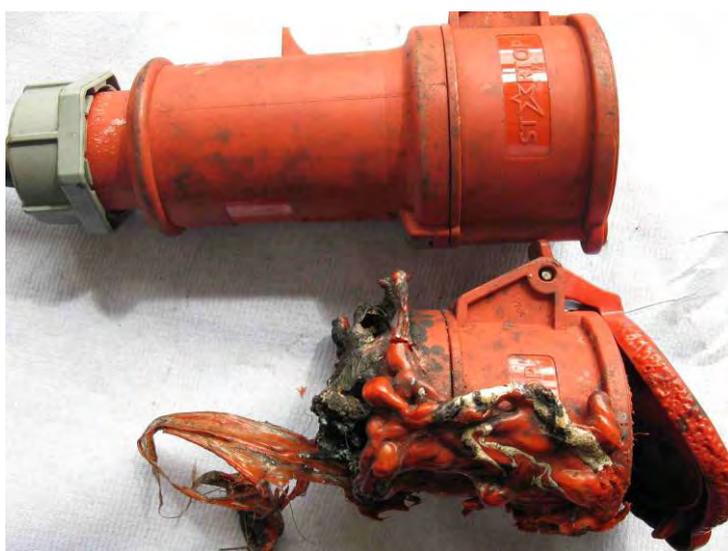
Figure 15 Damaged and undamaged free socket

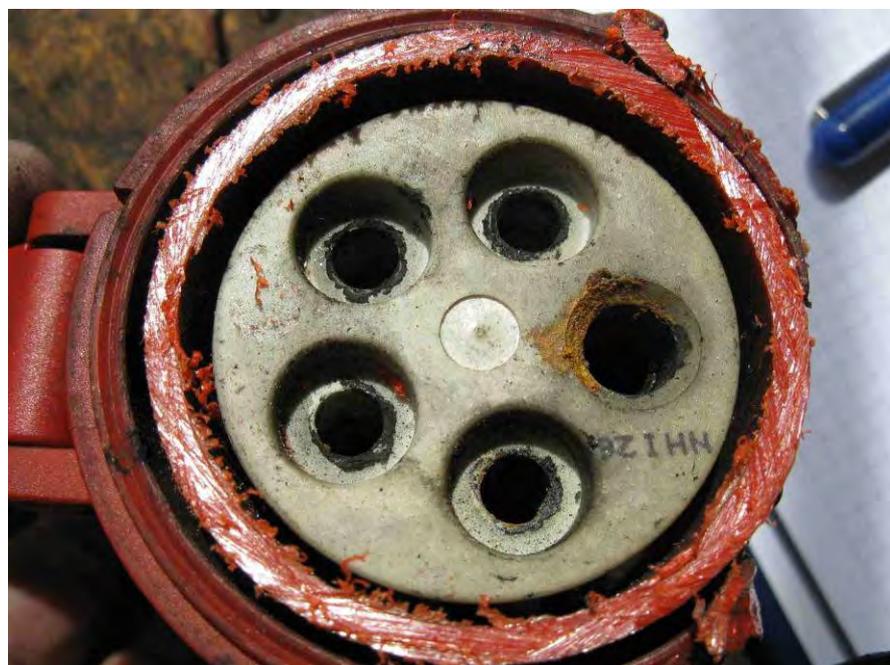
The plug and socket were separated and the contact faces of the pins were examined. The corrosion and debris seen on the pins was light and probably partially due to the fire fighting activities, Fig. 17. There was no evidence of poor contacts between the plug and the socket and no arc damage at the ends of the pins to indicate that it may have been connected or disconnected 'on-load'. From the condition of the socket it appeared that a grease may have been applied to the pins at some stage, Fig. 18.

Figure 18 Free socket

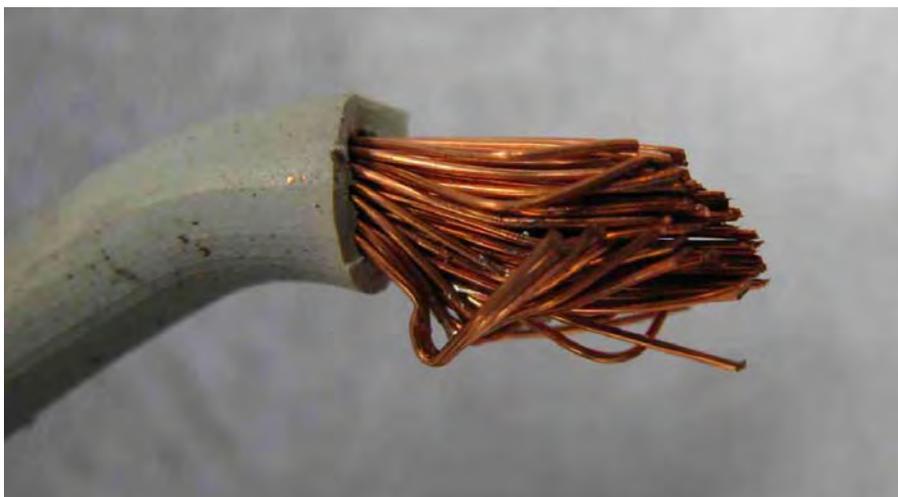
The other plugs and sockets recovered from the *Commodore Clipper* were examined. Most of these had screw terminals all of which were found to be tight with no evidence of overheating. One of the free sockets, recovered from the *Commodore Clipper*, was a 'Startop' socket with IDC terminals. On examination of this unit it was noted that the ends of some strands could be seen in the connector, Fig. 24. On dismantling the connector it was noted that the insulation appeared to have been stripped from the ends of the cable cores before the cable was inserted into the IDC, Fig. 25. Cobham remade one connection into the IDC without stripping the insulation, Fig. 26.

Figure 25 Insulation removed before fitting

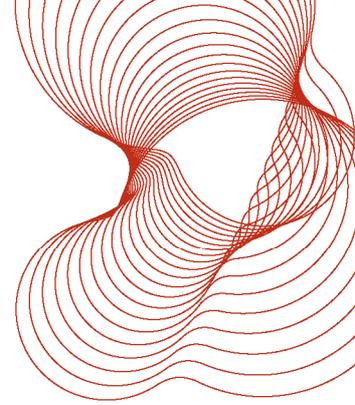
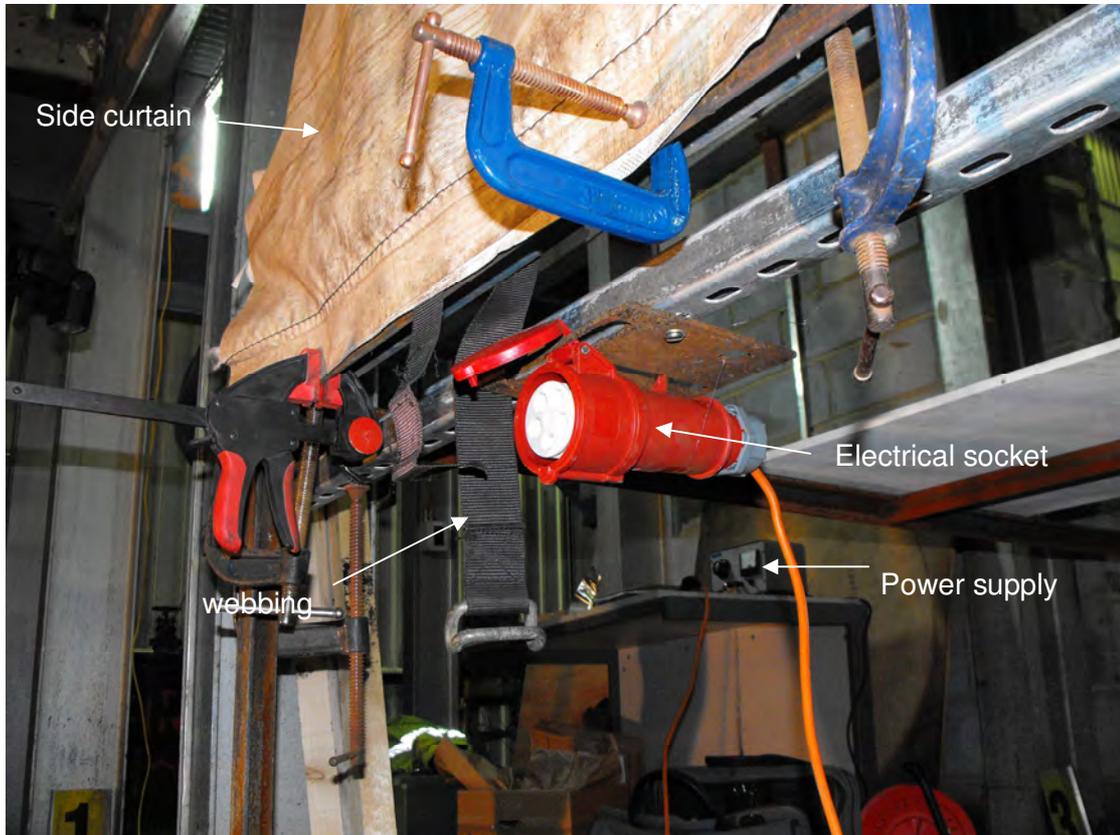
Figure 2 Experimental set up

The test set up consisted of a hollow section representing the side rail of the trailer, a profile representing the frame to which the electrical socket was attached and a section of the curtain side material incorporating samples of the webbing straps used on the trailer. Figure 1 shows the location of the socket on an identical trailer to the one involved in the incident while Figure 2 shows the experimental set up.

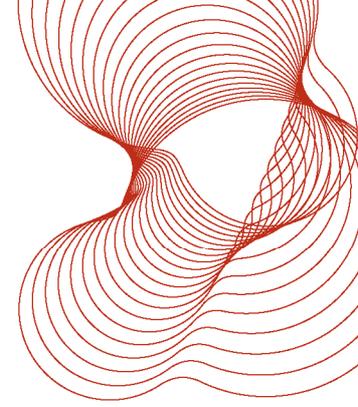
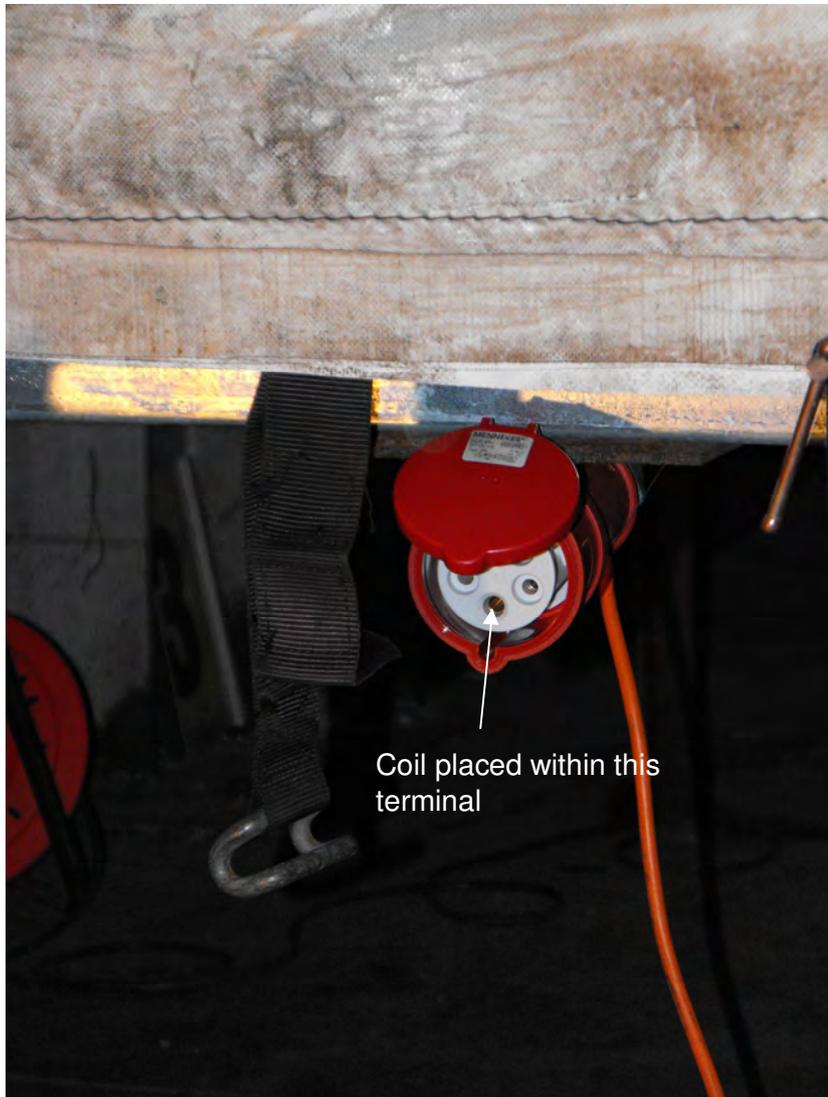
Figure 3 location of heated platinum coil

A high temperature platinum alloy coil was placed inside one of the terminals in the 32 amp socket provided to BRE by the MAIB. The coil was heated using a variable voltage power supply with a maximum output of 100 Volts at a current of 10amps. The coil was placed in to the lowest (earth) terminal within the socket as shown in Figure 3.

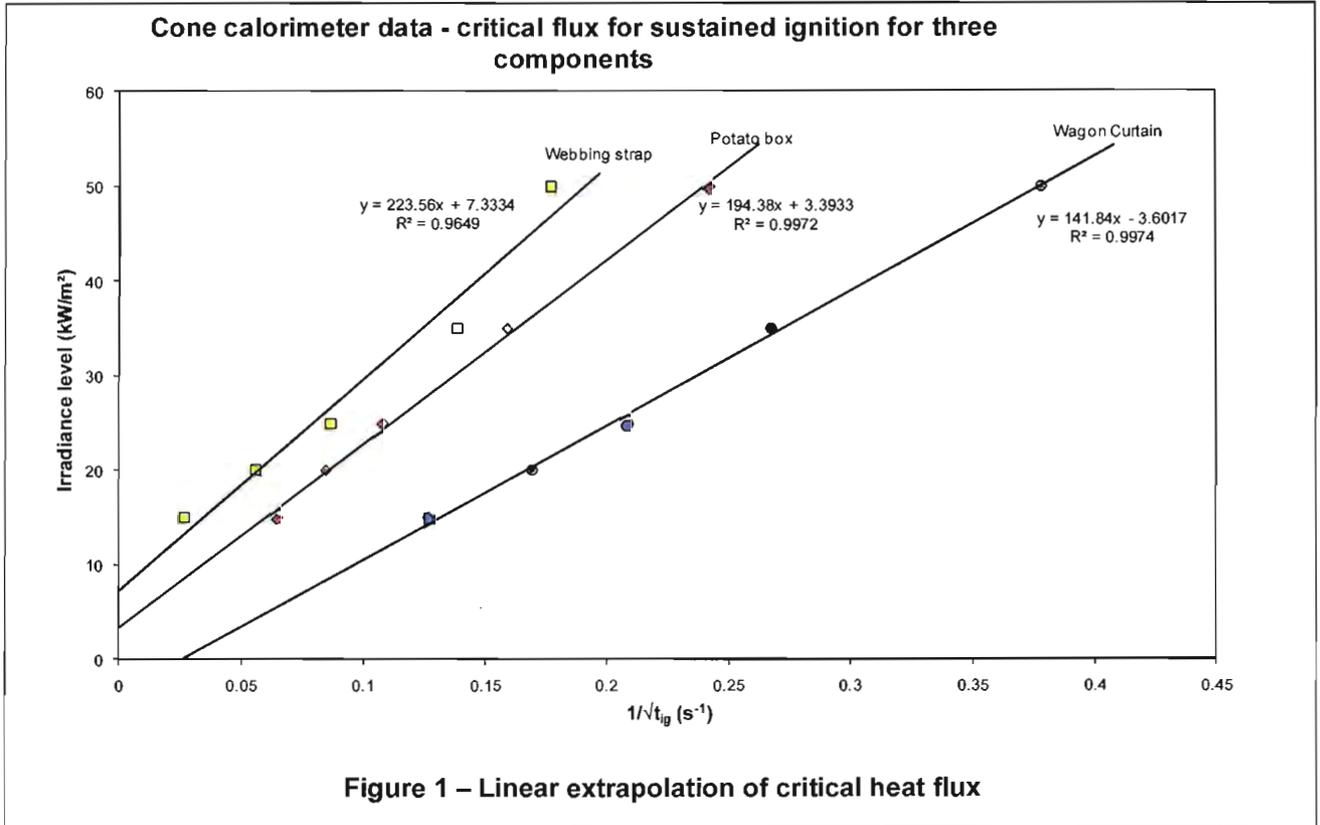
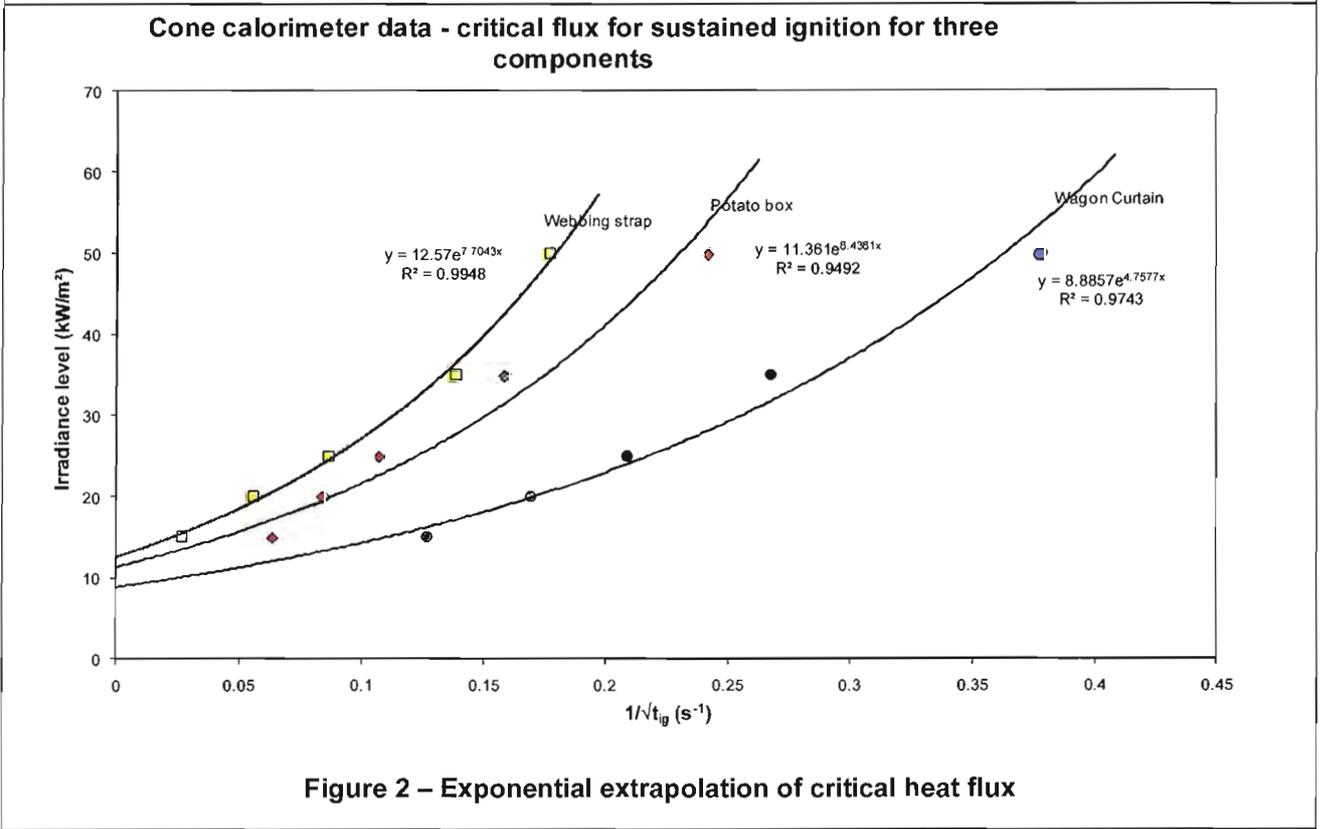
The time to sustained flaming was recorded at five irradiance levels; the reciprocal of the square root of this time was then plotted against the irradiance level incident on the surface of the specimen, to estimate the minimum flux required to affect sustained ignition. According to ISO 5660, sustained flaming is deemed to have occurred if flaming is visible on or over the surface of the specimen for more than ten seconds. The results of this critical flux determination are shown below.

The values achieved from the extrapolation of the plots above are given in Table 1 below.

Component	Estimated critical heat flux, kW/m ²	
	Linear extrapolation	Exp. extrapolation
Cream wagon curtain	-3.6 (R=0.997)	8.9 (R= 0.974)
Black webbing strap	7.3 (R = 0.965)	12.6 (R = 0.995)
Black potato box	3.4 (R=0.997)	11.4 (R = 0.949)

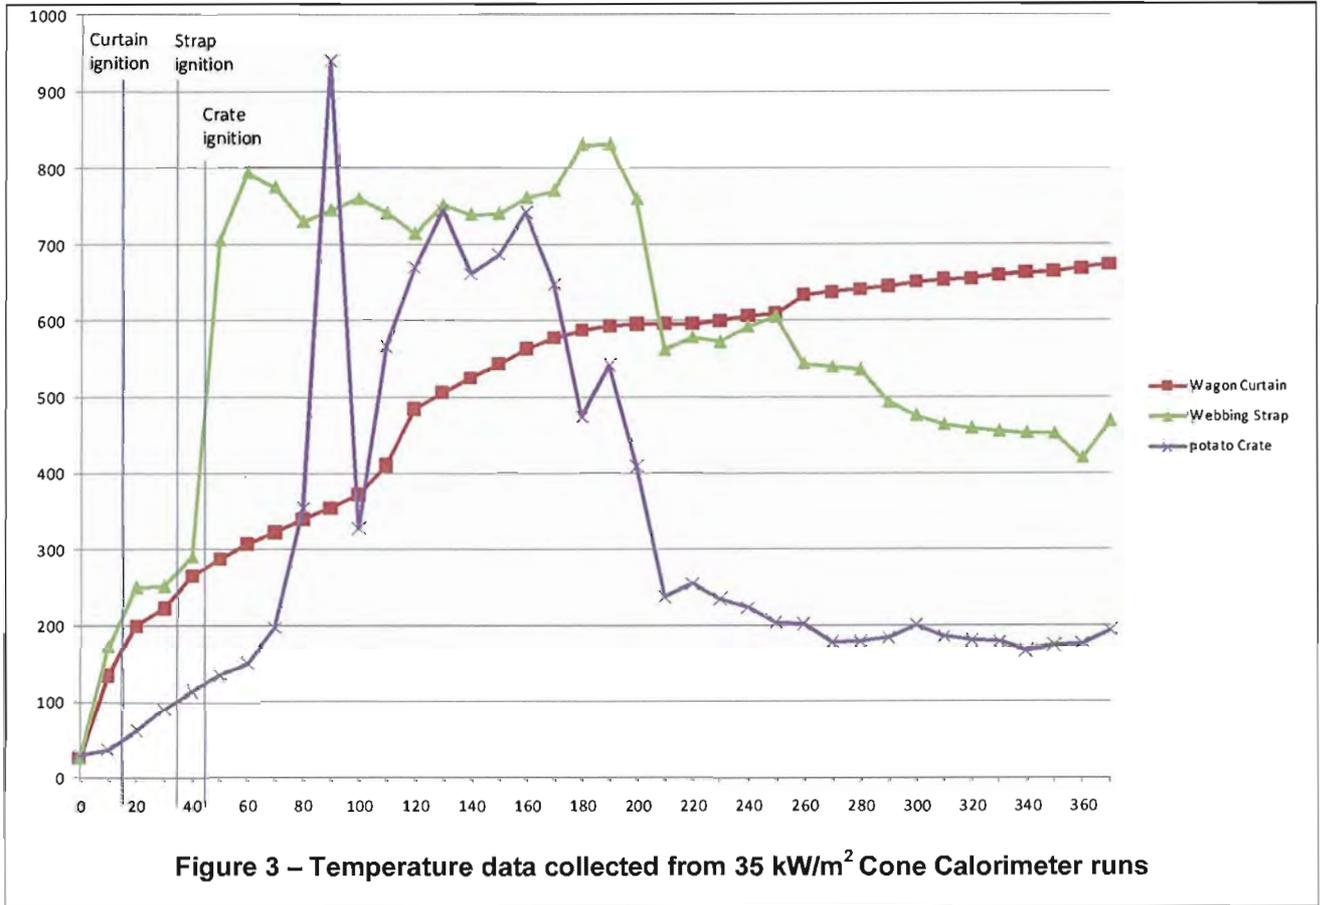
The temperature data and ignition times for each of these runs are plotted below in Figure 3.

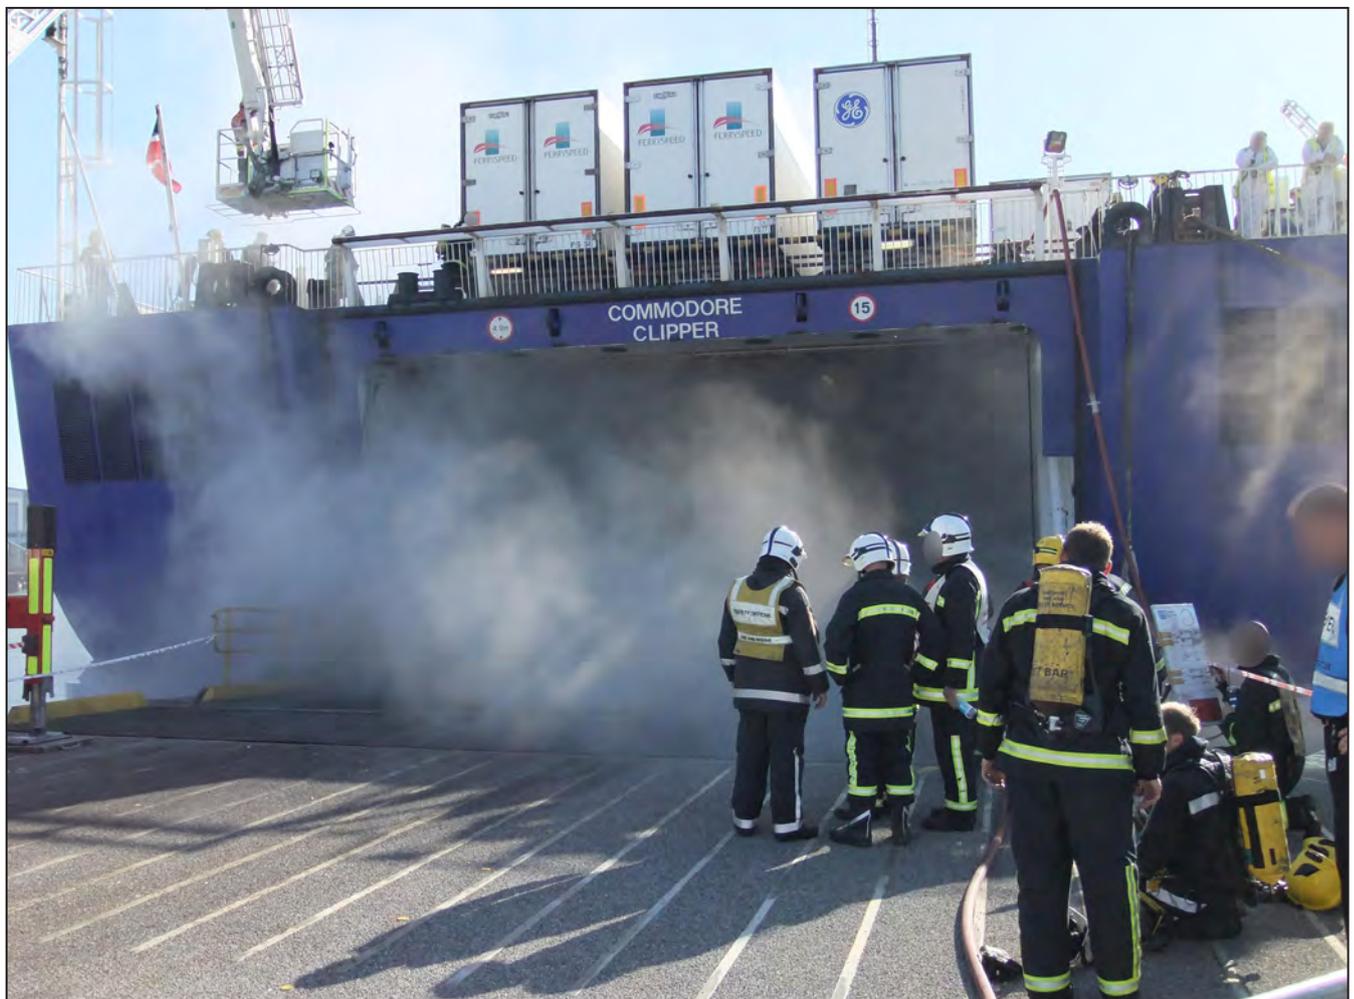
Firefighters preparing to attack the fire from the stern door

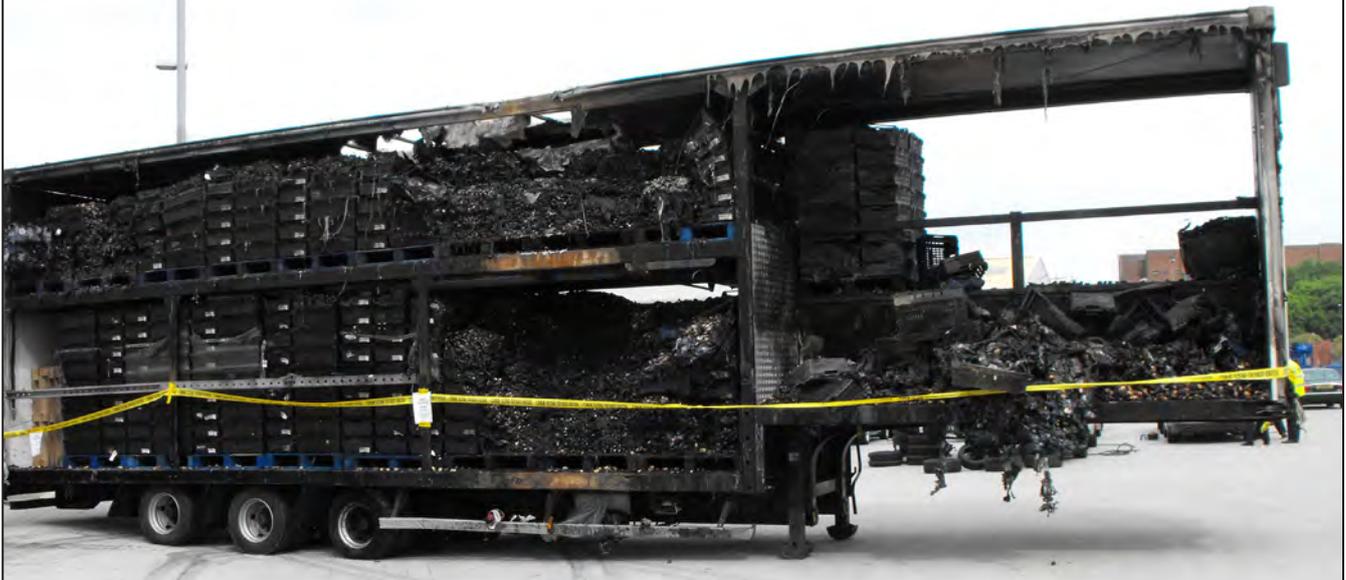
Preliminary findings of the subsequent accident investigation indicate that the fire was caused by an electrical fault involving the power supply from the ship and the trailer's refrigeration control system. The resultant sustained overheating led to the curtain-side of the trailer igniting. Although the ship's electrical breakers were found to be working correctly, they did not trip before the fire started.

Damage to one of the refrigerated trailers and its cargo of potatoes

- Take immediate action to ensure that all power supply cables and fittings provided for refrigerated trailer units are in good condition and that electrical protection devices will activate at an appropriate level.
- Until such time as the exact causes of this fire have been established, make additional checks of refrigerated trailers powered by ships' electrical systems to provide early warning of any overheating.

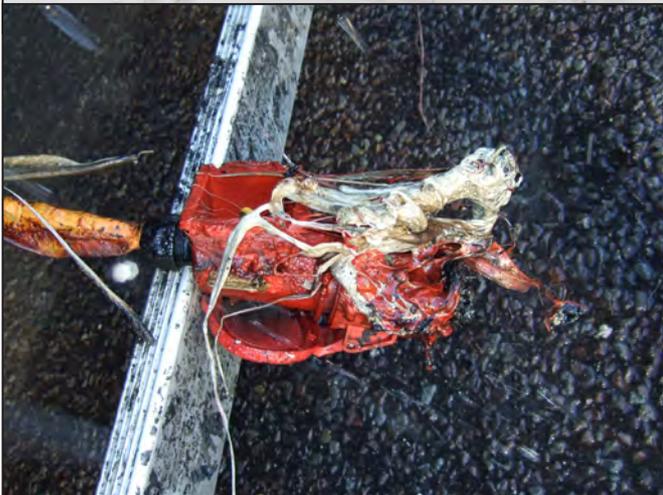
MAIB has also received other reports of power supply cables to refrigerated trailers becoming very hot while in use.

Electrical power connection
