Report on the investigation of
injury to a passenger on board a

Delta 8.5m RIB

River Thames, London

Report No 1/2011
January 2011

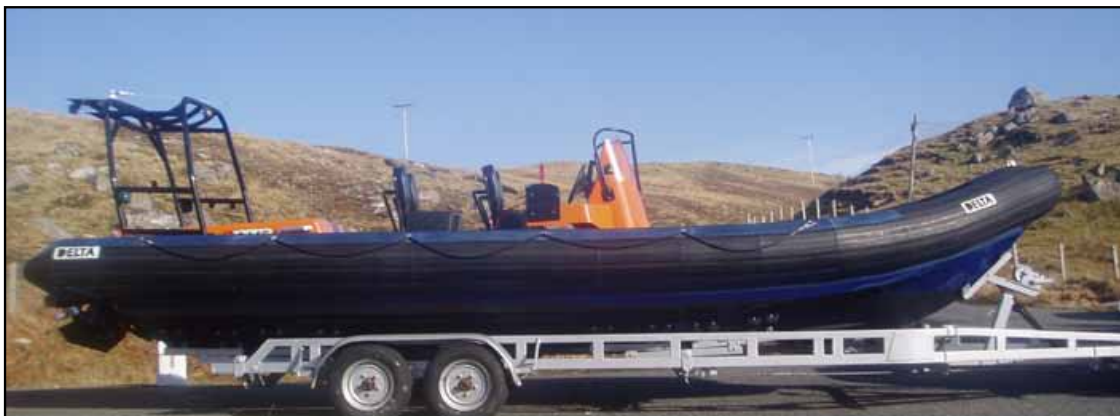
Figure 1

The Delta 8.5m RIB on its launching trailer

As part of the investigation the boat was inspected by MAIB inspectors on the day of the accident. It was observed that several of the remedial items identified by the PLA at the "*Fitness for Purpose Inspection*" in October 2009 had not been addressed. It was also noted that the emergency shut down cord (kill cord) for the engine was broken and inoperable. The rail around the console, in front of the helmsman's position, was observed to be broken, with an unprotected jagged edge. The seat coverings were worn and some of the foot straps were broken or missing.

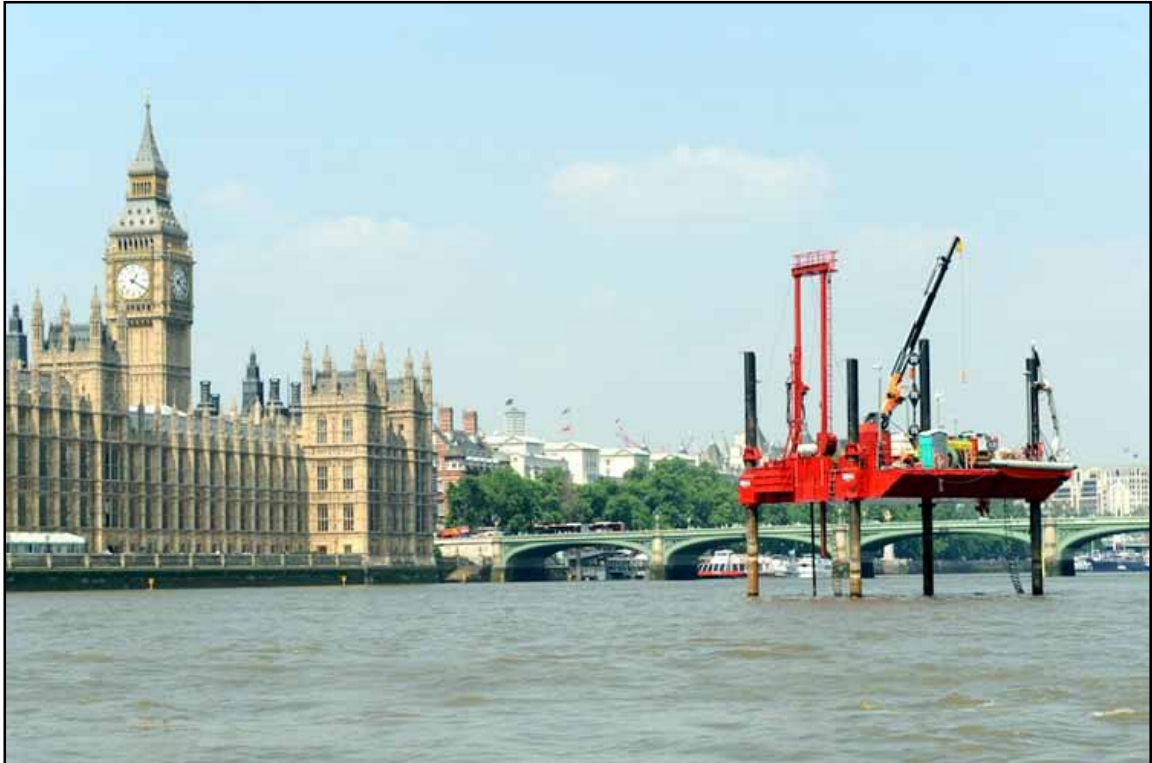
Figure 2

Fugro Seacore jack-up rig operating on River Thames

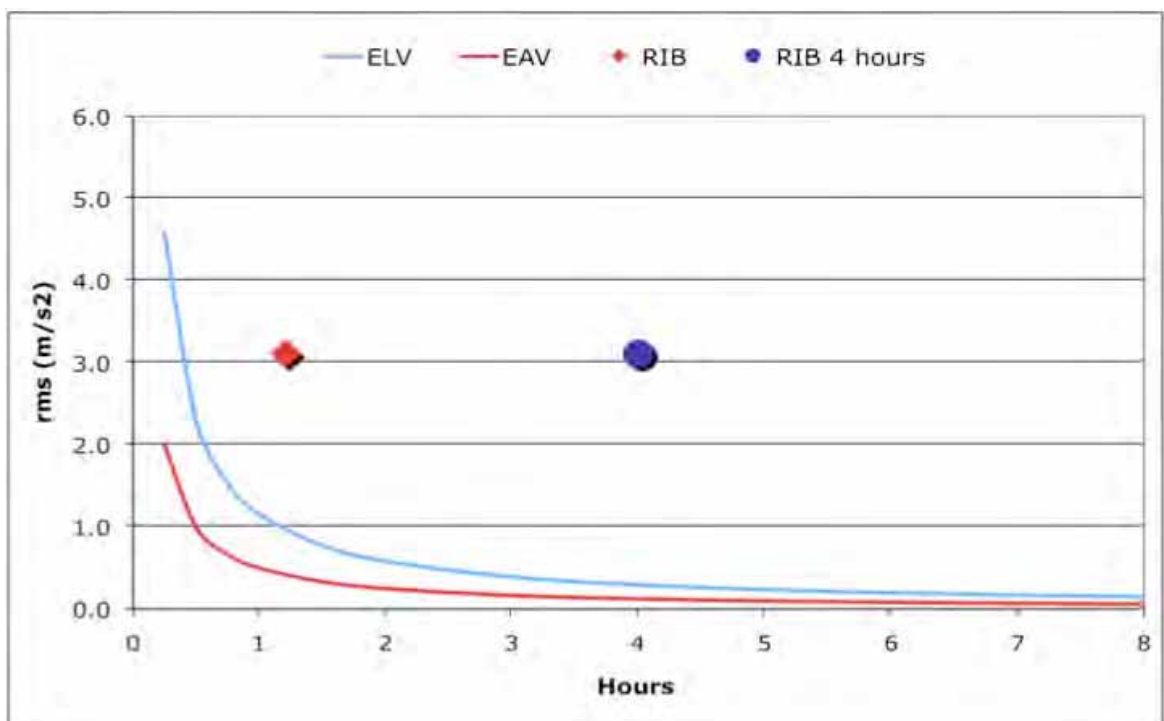
Figure 9

An example of how a 28' RIB travelling at ~40kts in a sea state 2 will exceed the EU WBV Exposure Action and Limit Values.
