Report on the investigation into the fatal
accident to the chief engineer in the lift shaft on board

Ever Excel

in Kaohsiung, Taiwan

Report No 6/2010
May 2010

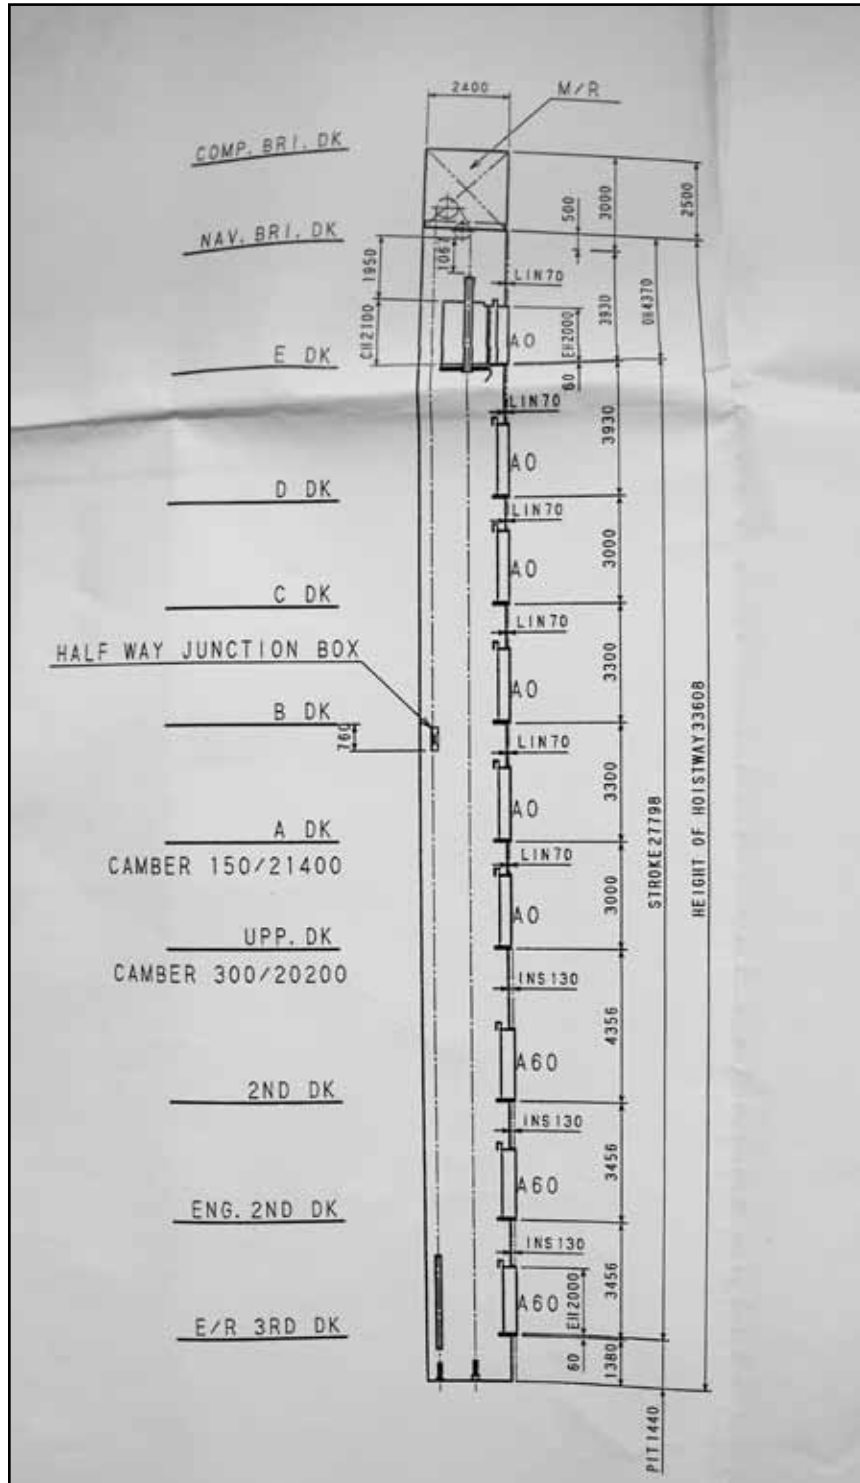
Figure 5

The lift was manufactured by Schindler, and had a capacity of 7 persons or 550kg. It was powered by an 11kW motor producing a lift speed of 55m per minute. The lift served 9 decks and the shaft was 28m in height (**Figure 5**).

Lift shaft plan

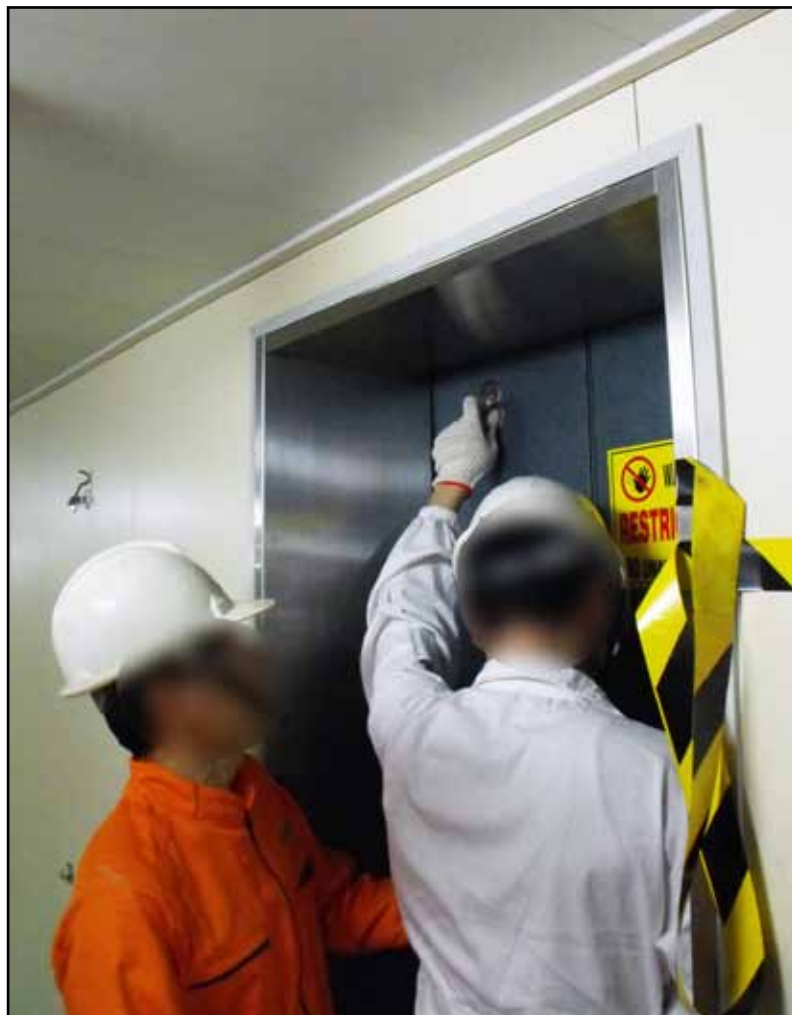
Figure 6a

Weekly checks of effluent in the lift pit, and the rescue of personnel trapped in the lift, required crew to be able to open the lift shaft doors manually. A metal probe, referred to as a 'key' (**Figure 2a**), was kept in the engine control room, and this fitted into an access hole in the top left corner of each of the lift shaft doors. Moving the key from side to side (**Figure 6a**) allowed it to engage with a lever (**Figure 6b**) which, in turn, released the door locking mechanism. The mechanical drive was also disconnected, allowing the doors to be pushed open against the resistance of a counter-weight.

Lift shaft door manual opening

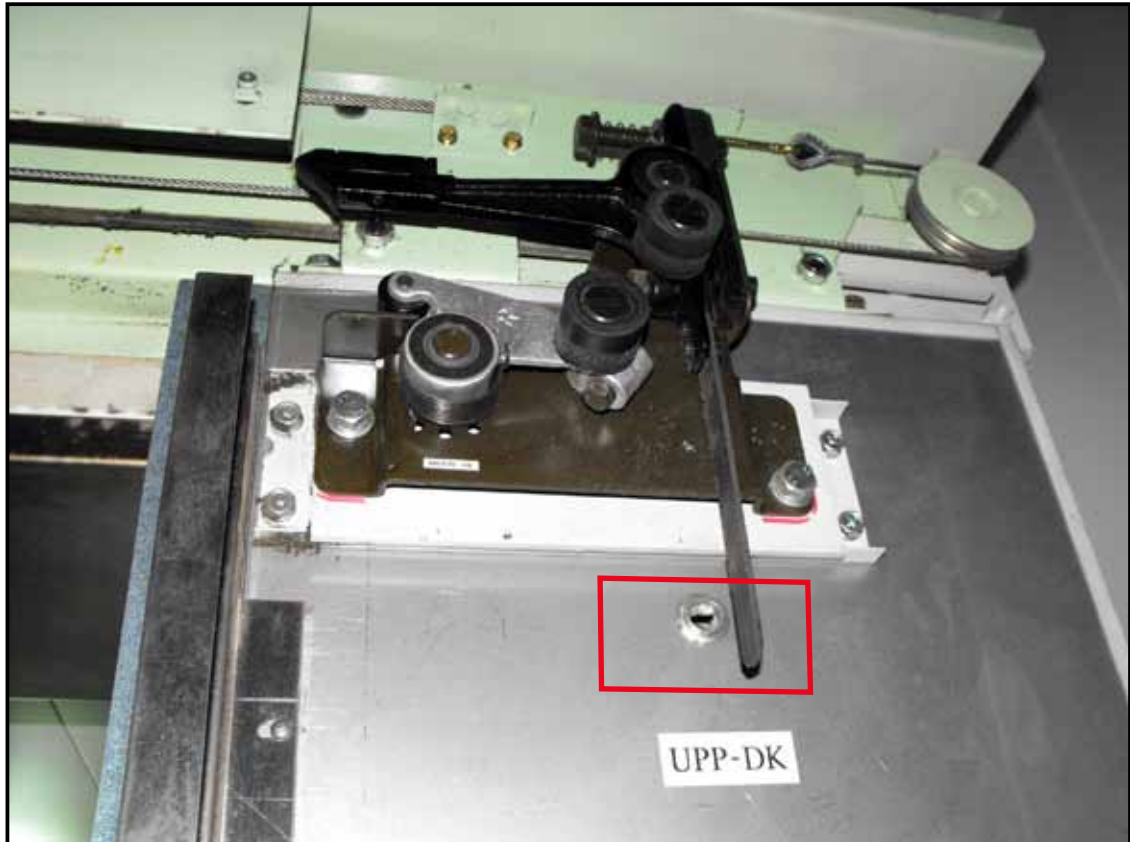
Lift shaft door locking mechanism
