Report on the investigation into the
unintended movement of the ro-ro passenger vessel

Ben-My-Chree

during loading operations at Heysham

Report No 17/2010
December 2010

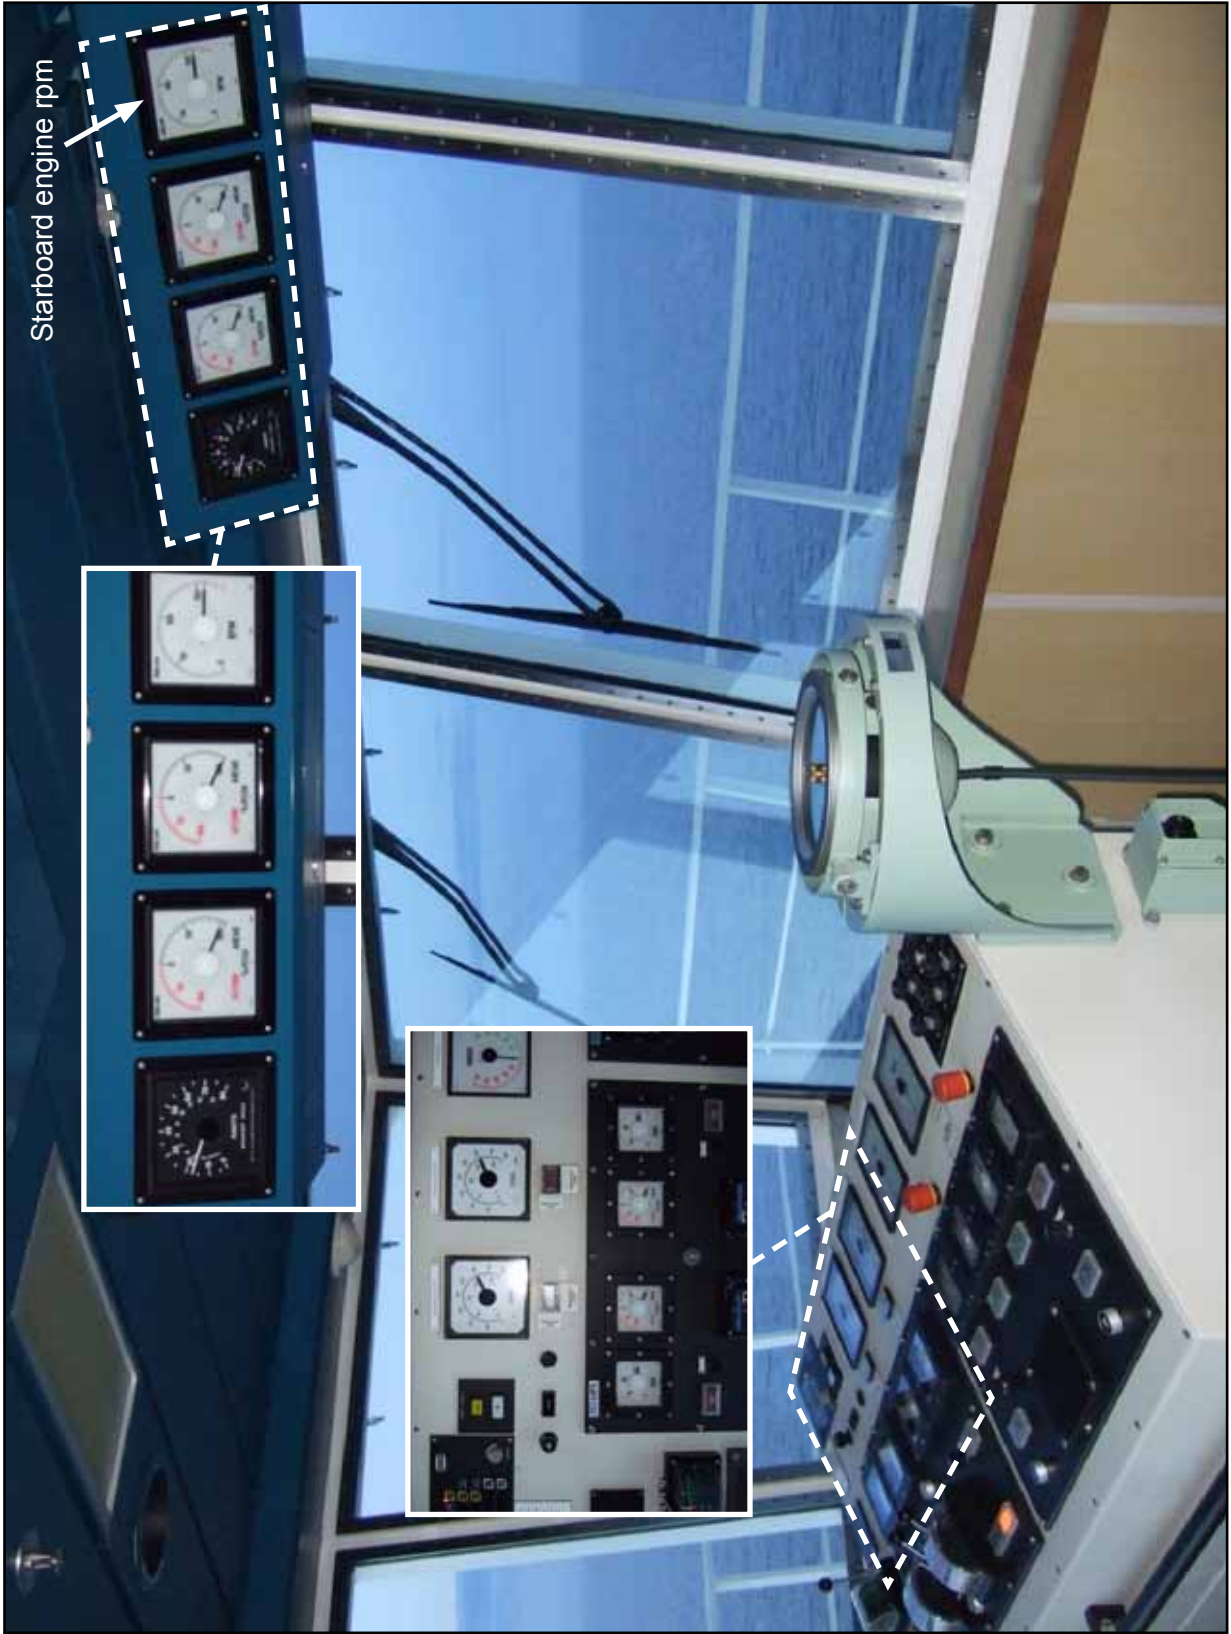
Figure 13

The main control panel (**Figure 12**) and two wing control stations (**Figure 13**) had rpm indicators for both engines and pitch indicators for both CPPs. In addition, there were rpm indicators just below the deckhead in front of each control panel. There was also a separate panel between the port wing and the main control station duplicating most of the important displays and alarms in the ECR. Both this panel and the wing stations contained two additional rpm indicators for each engine: one before the reduction gear and another of the shaft after the gearbox. The port wing deckhead display contained an rpm indicator for the starboard engine only; the port engine rpm indicator at this location having been replaced by an anemometer. On the starboard side deckhead display the starboard engine rpm indicator had also been replaced by an anemometer.

Port wing station (inserts show rpm and pitch gauges)
Note: Black faced gauge is an anemometer that has replaced the port engine rpm gauge

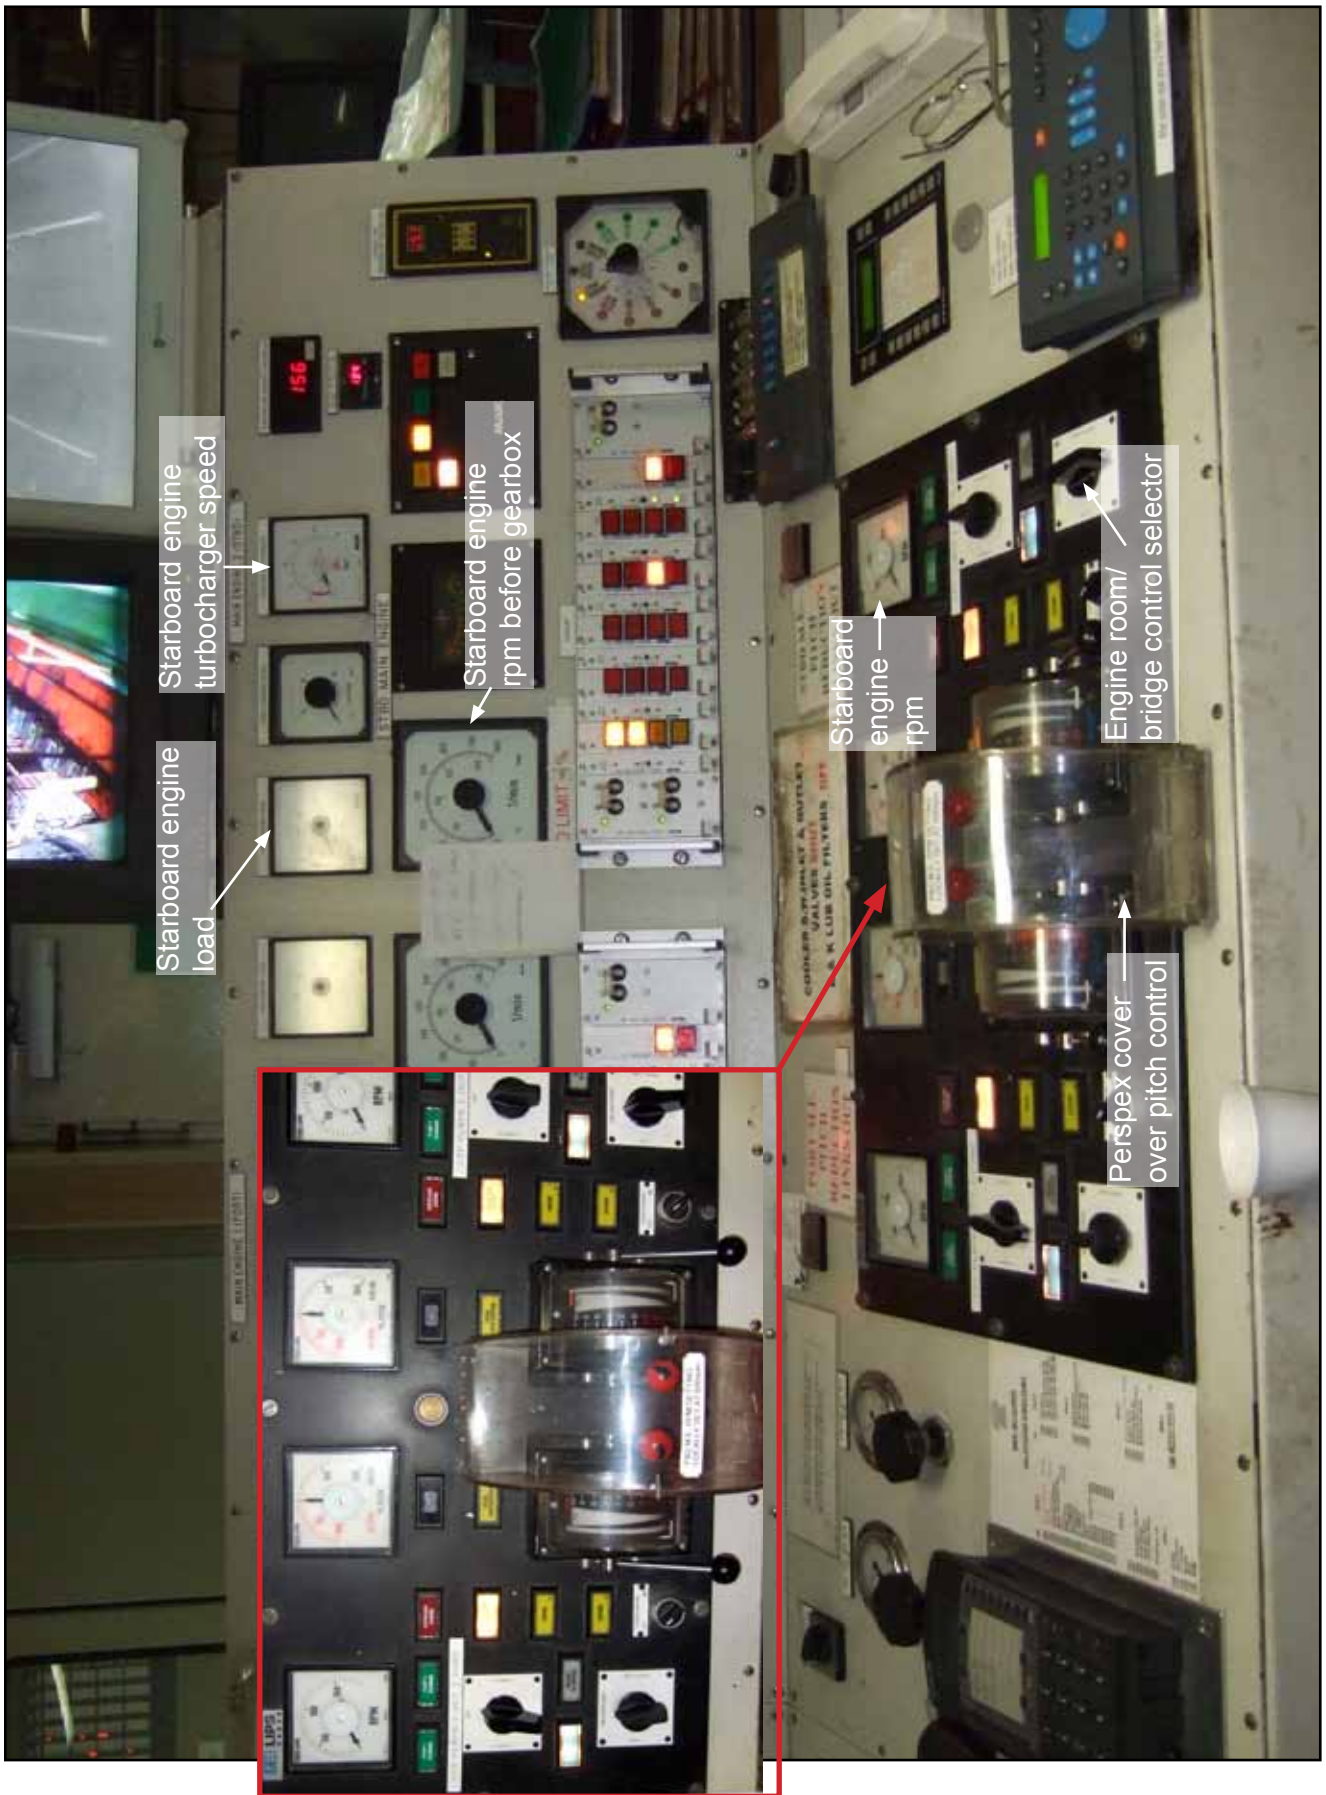
Figure 14

In the ECR, the pitch control levers had a Perspex cover to prevent accidental movement of the levers. There were several indications to show that an engine was running, including: engine and shaft rpm, turbocharger rpm, engine load, scavenge air pressure and several other technical parameters representing the operational state of the engines (**Figure 14**).

ECR control panel

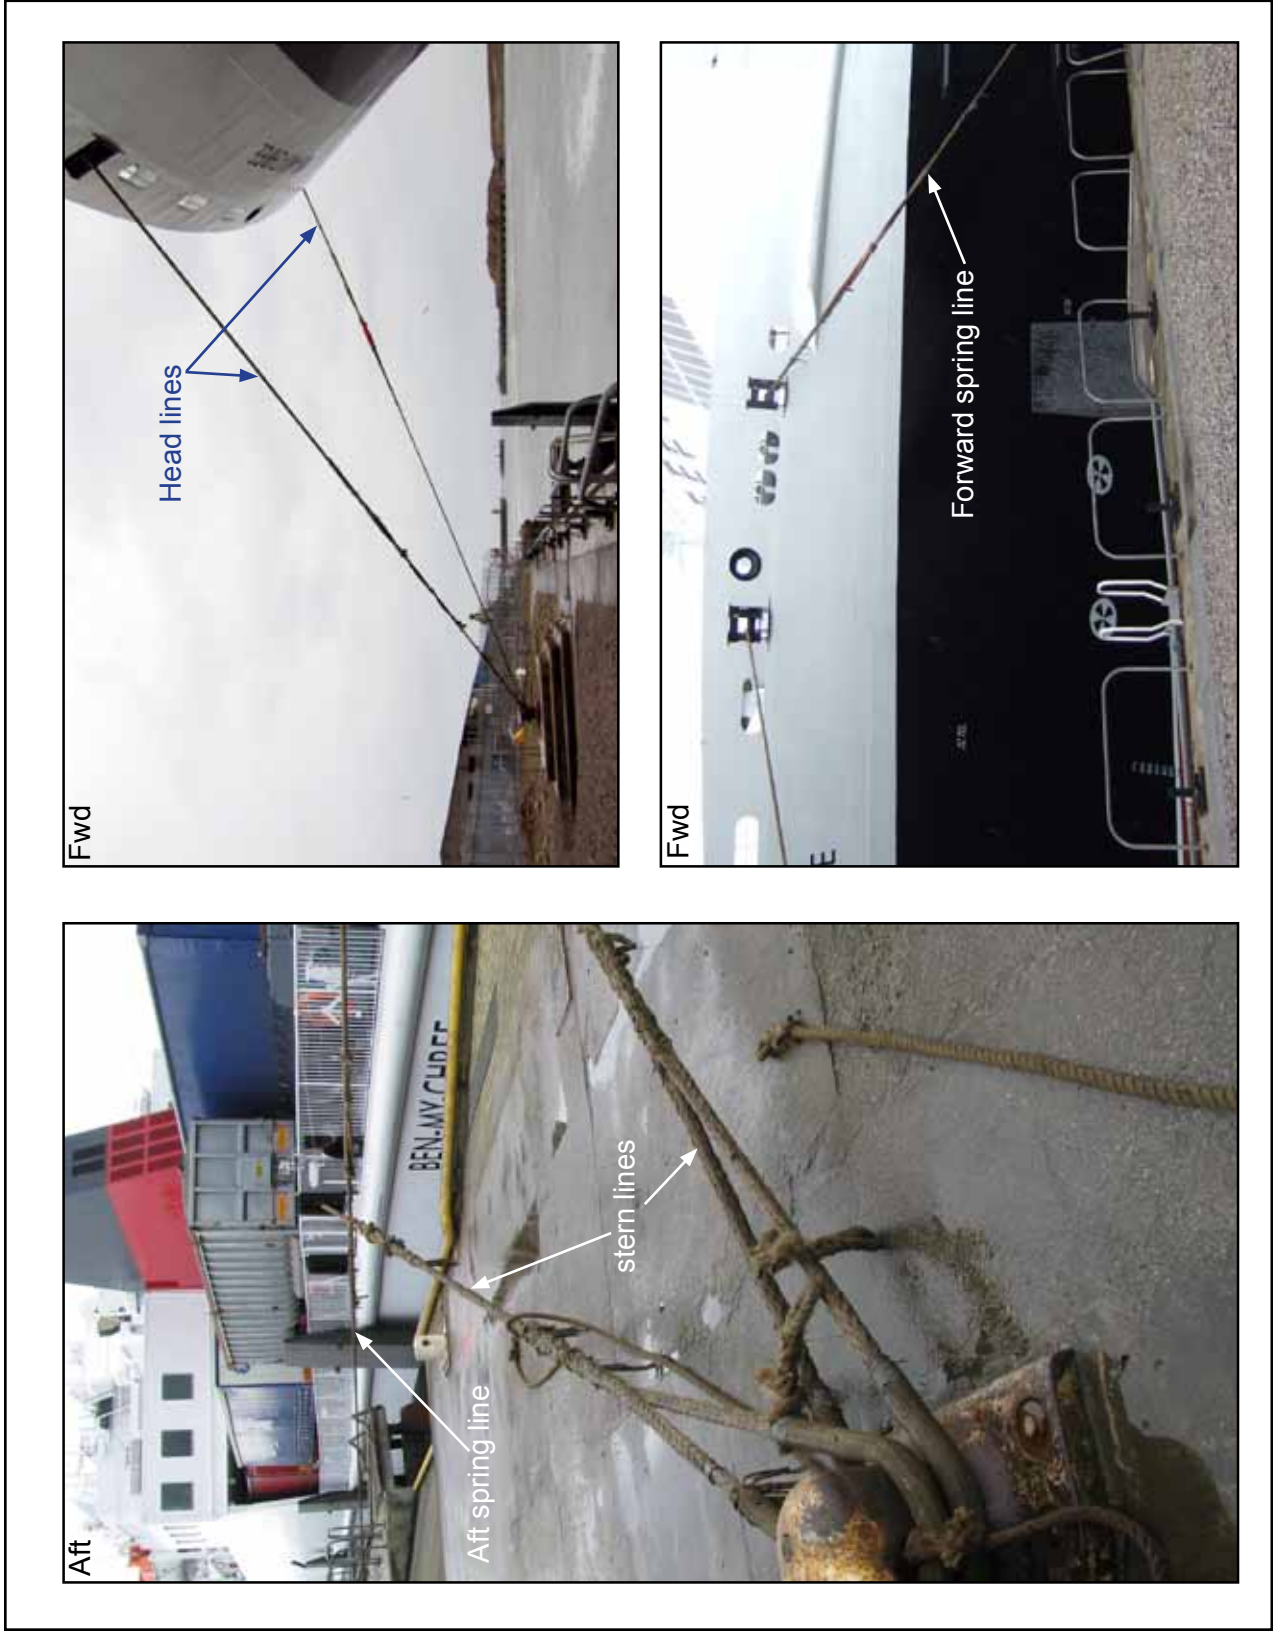
Figure 15

In Heysham, *Ben-My-Chree* moored using two head lines and a fore spring and two stern lines and a back spring (**Figure 15**). All the lines except the back spring were held by winches in the autotension mode (**Figure 16**) at 25% of 150kN (the rated tension or pull exerted by the winch). The back spring was secured on the brake on the port aft mooring winch.

Mooring arrangements
