Report on the investigation into the

unintended movement of the ro-ro passenger vessel

Ben-My-Chree

Marine Accident Investigation Branch Mountbatten House Grosvenor Square Southampton United Kingdom SO15 2JU Report No 17/2010 December 2010

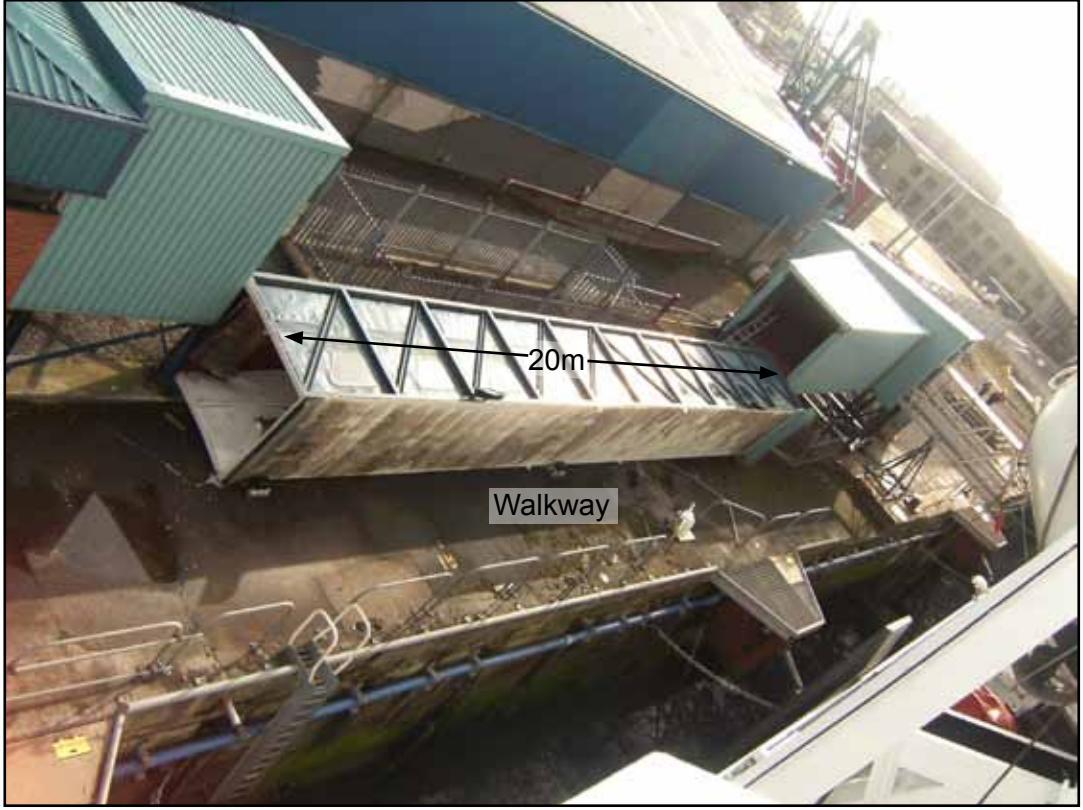
Meanwhile, the walkway connecting the passenger terminal to the gangway compartment detached at both ends and fell about 2m, first landing on a metal fence, then falling to the quay having turned 90 degrees to lie on its side (Figures **5a & 5b**). In the passenger terminal, a party of 26 school children who had been about to enter the walkway had been held back by their group leader to allow one of their members to catch up. At the other end of the walkway, a mother and child

Passenger access structure

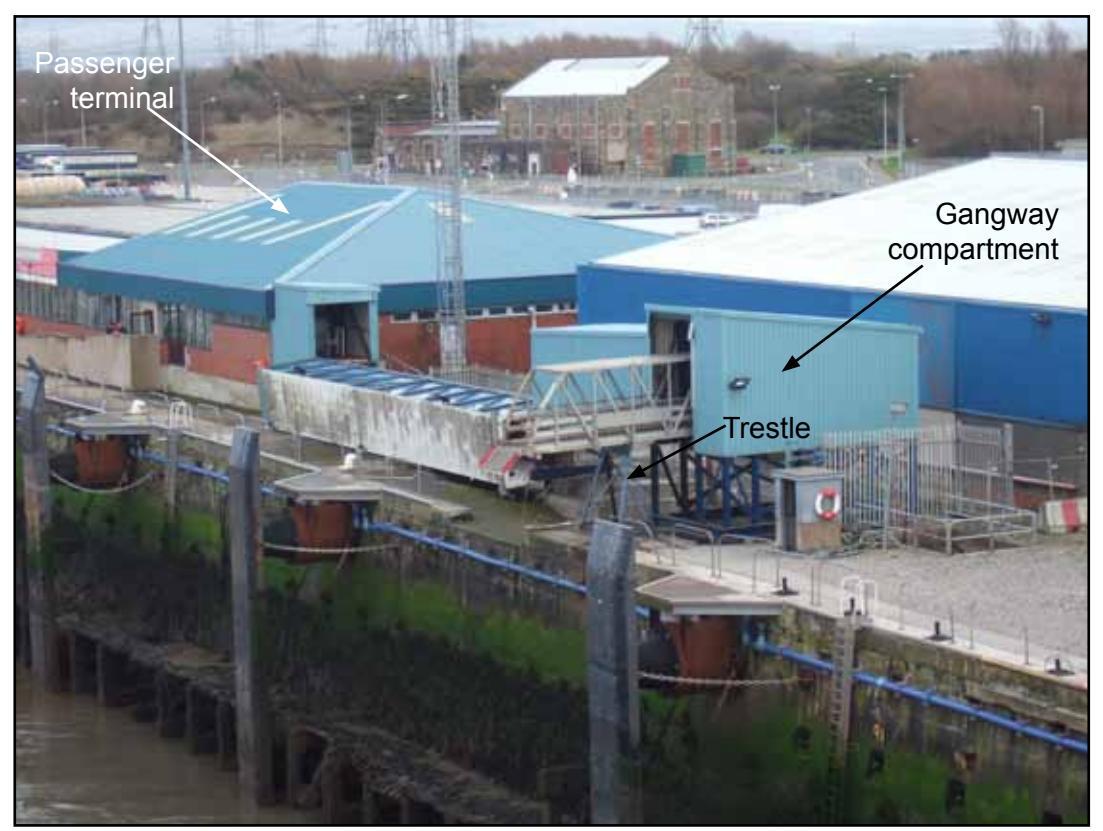
Figure 5b

Passenger terminal and access structure

After checking in their luggage and clearing security in the terminal building, foot passengers entered the walkway and followed it along to the gangway compartment. Once there, they turned a 90 degree corner and crossed the gangway onto the ship (**Figure 5b**). The gangway was lifted into place with a crane, hooked on and lashed to the ship. The opposite end of the gangway was mounted on rollers, allowing it to move freely in and out of the gangway

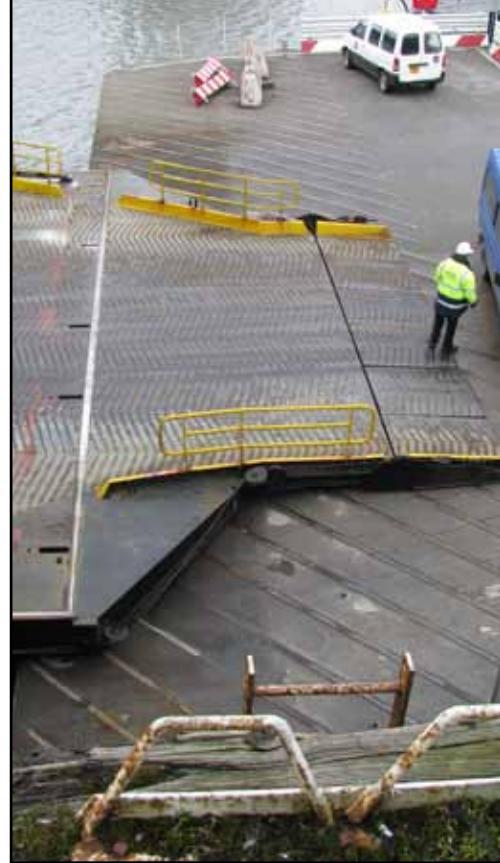
At the stern of the vessel, a charge hand (harbour employee) was supervising vehicle loading at the linkspan while the ship's second officer was talking to the trainee second officer. They all noticed the ship's movement when they heard the stern ramp scrape along the linkspan (**Figure 6**). The second officer ran into the ship and raised the stern ramp, closing it completely, thereby preventing vehicles from embarking.

Stern ramp on linkspan

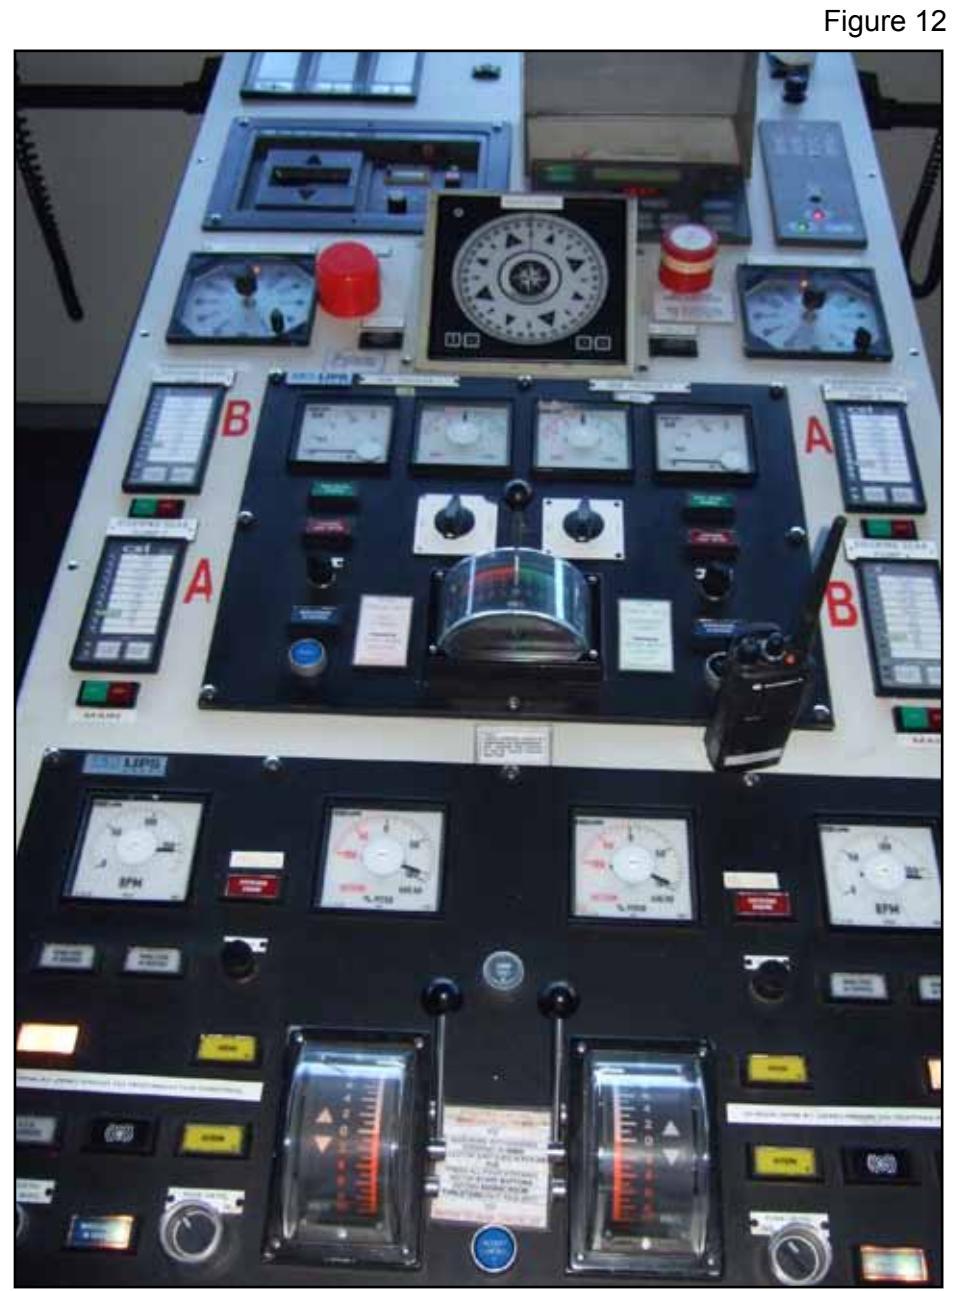
The main control panel (Figure 12) and two wing control stations (Figure 13) had rpm indicators for both engines and pitch indicators for both CPPs. In addition, there were rpm indicators just below the deckhead in front of each control panel. There was also a separate panel between the port wing and the main control station duplicating most of the important displays and alarms in the ECR. Both this panel and the wing stations contained two additional rpm indicators for each engine: one before the reduction gear and another of the shaft after the gearbox. The port wing deckhead display contained an rpm indicator for the starboard engine only; the port engine rpm indicator at this location having been replaced by an anemometer. On the starboard side deckhead display the starboard engine rpm indicator had also been replaced by an anemometer.

Centre control panel (bridge), looking down

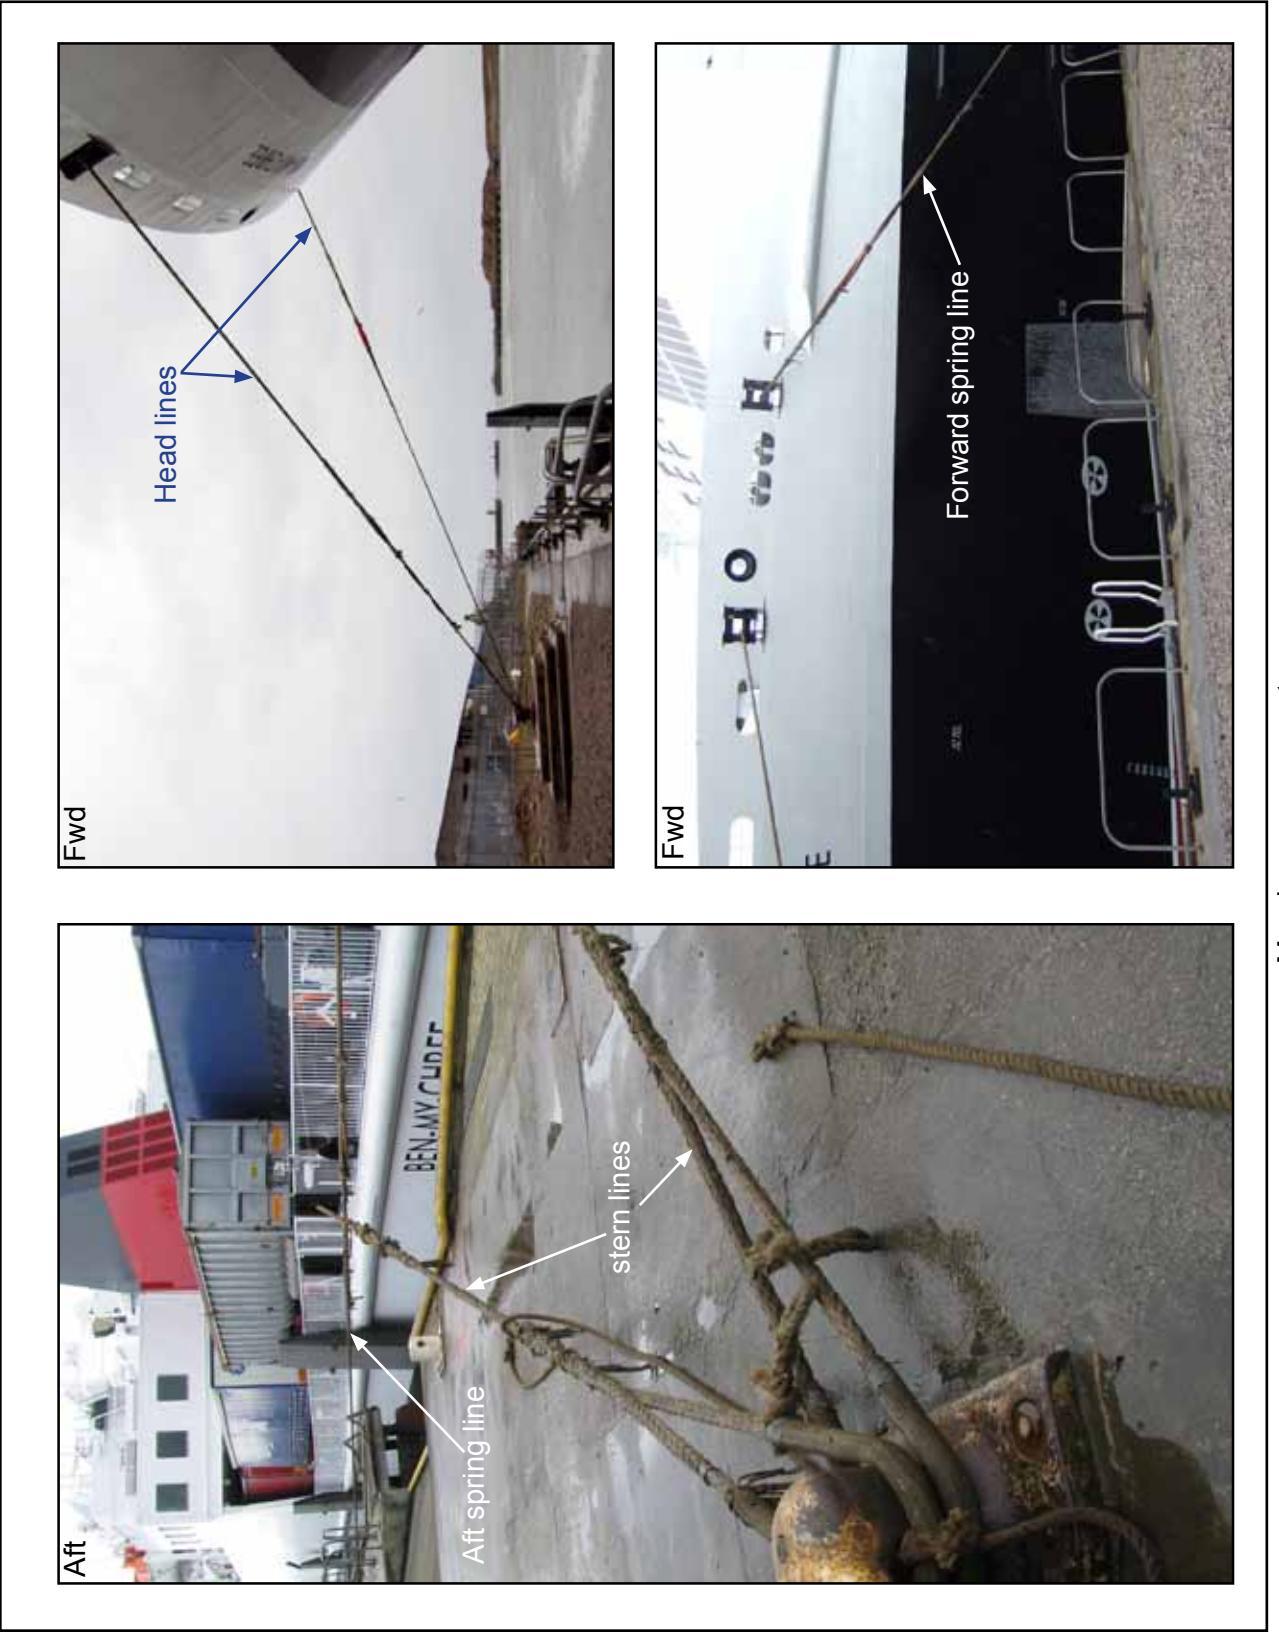
Figure 15

In Heysham, *Ben-My-Chree* moored using two head lines and a fore spring and two stern lines and a back spring (**Figure 15**). All the lines except the back spring were held by winches in the autotension mode (**Figure 16**) at 25% of 150kN (the rated tension or pull exerted by the winch). The back spring was secured on the brake on the port aft mooring winch.

Mooring arrangements

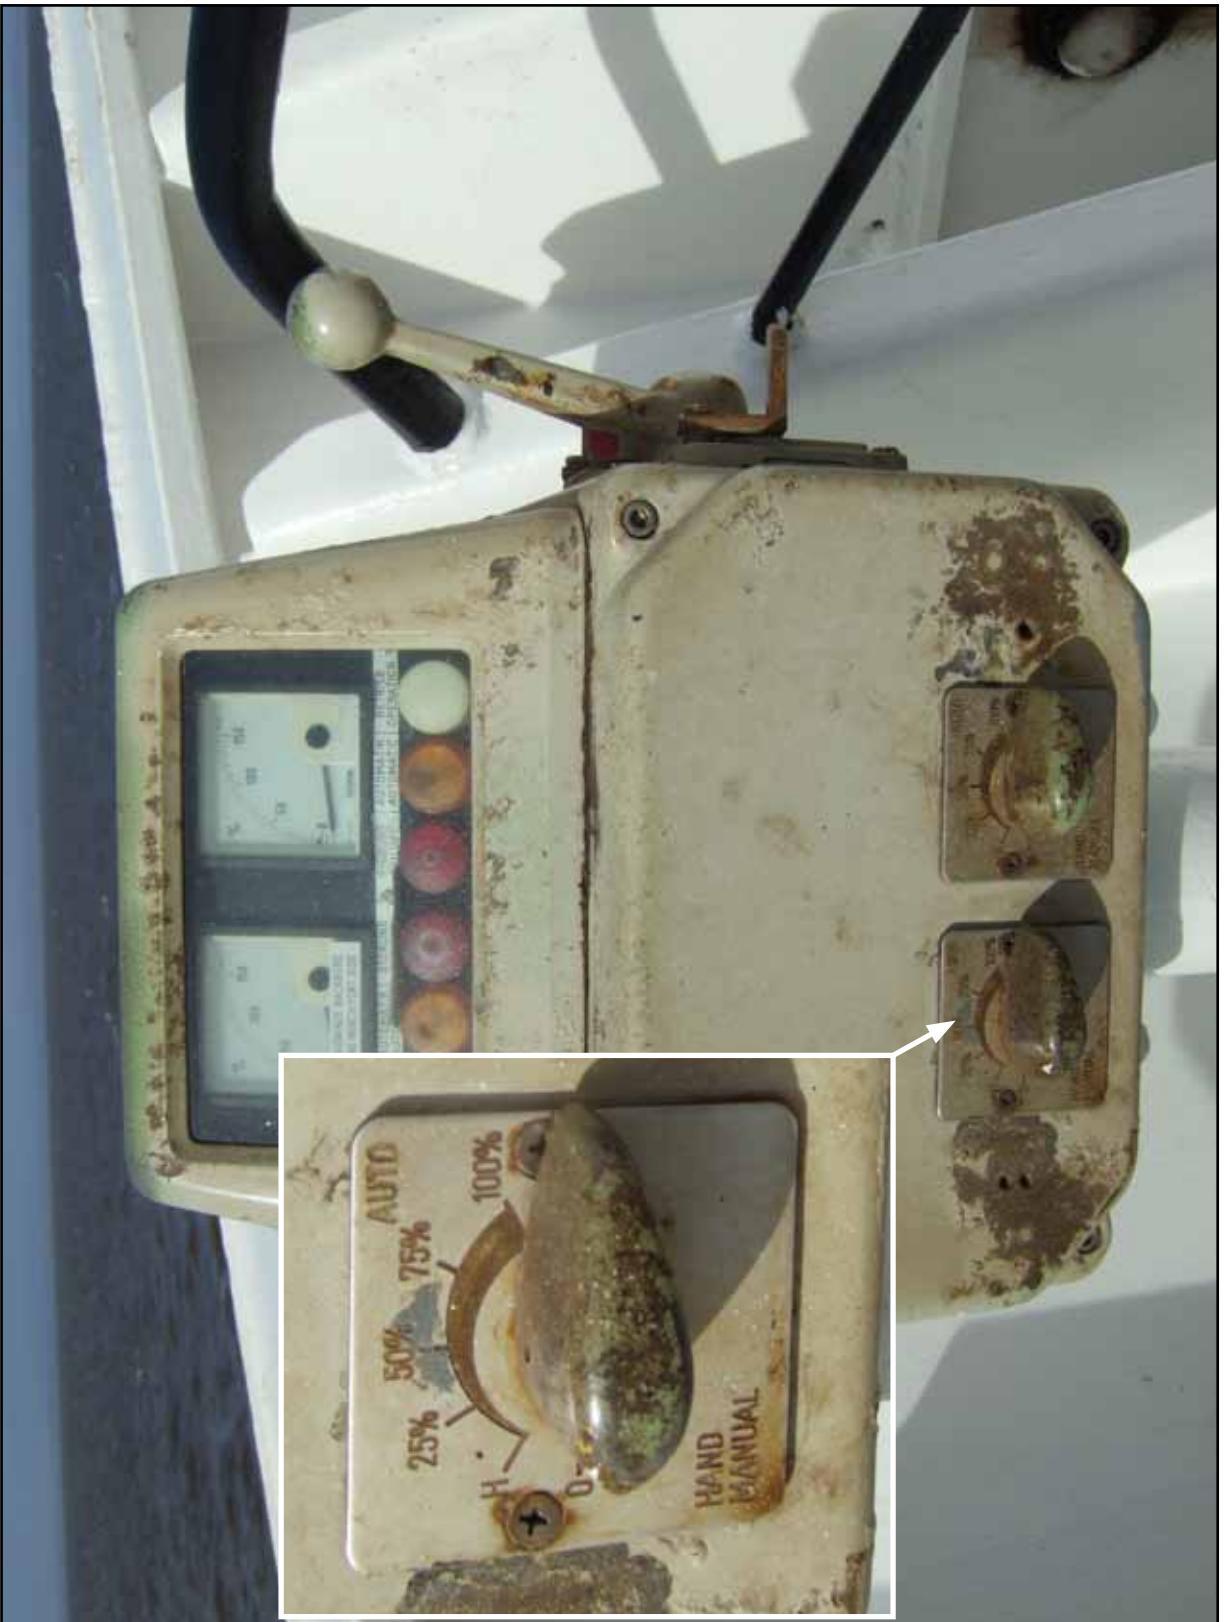
Figure 16

Autotension winch setting
