Report on the investigation into the
unintended movement of the ro-ro passenger vessel

Ben-My-Chree

during loading operations at Heysham

Report No 17/2010
December 2010

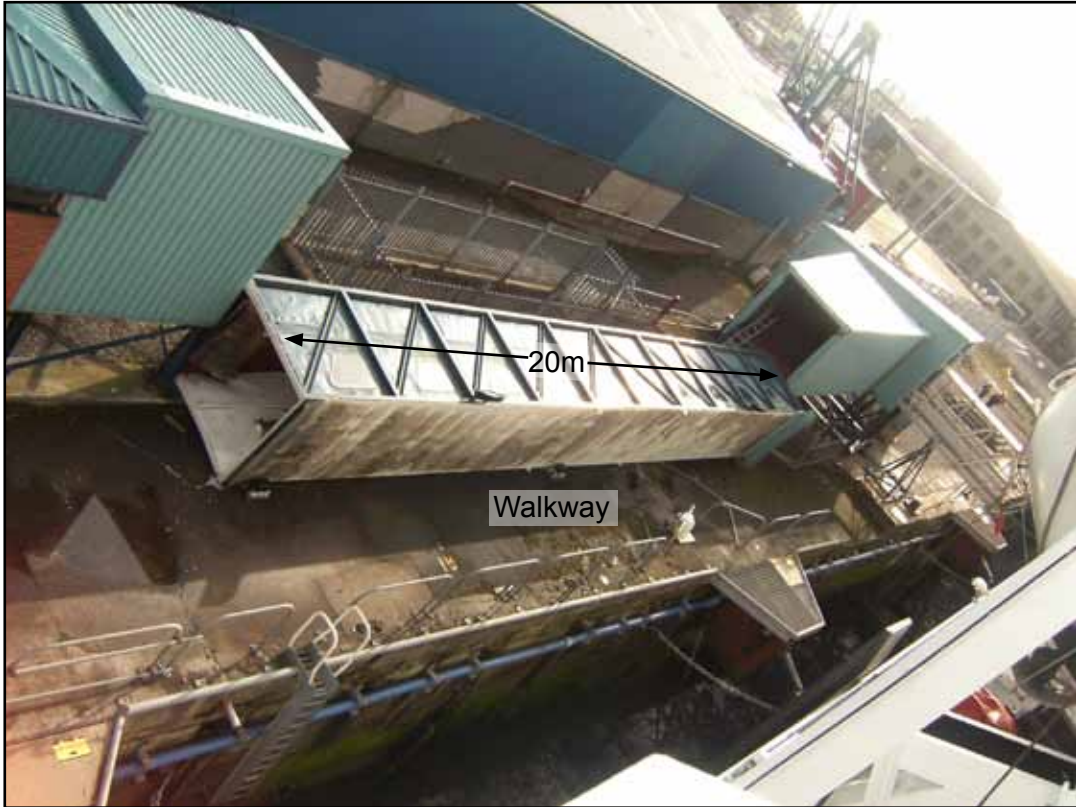
Figure 5a

Meanwhile, the walkway connecting the passenger terminal to the gangway compartment detached at both ends and fell about 2m, first landing on a metal fence, then falling to the quay having turned 90 degrees to lie on its side (**Figures 5a & 5b**). In the passenger terminal, a party of 26 school children who had been about to enter the walkway had been held back by their group leader to allow one of their members to catch up. At the other end of the walkway, a mother and child

Passenger access structure

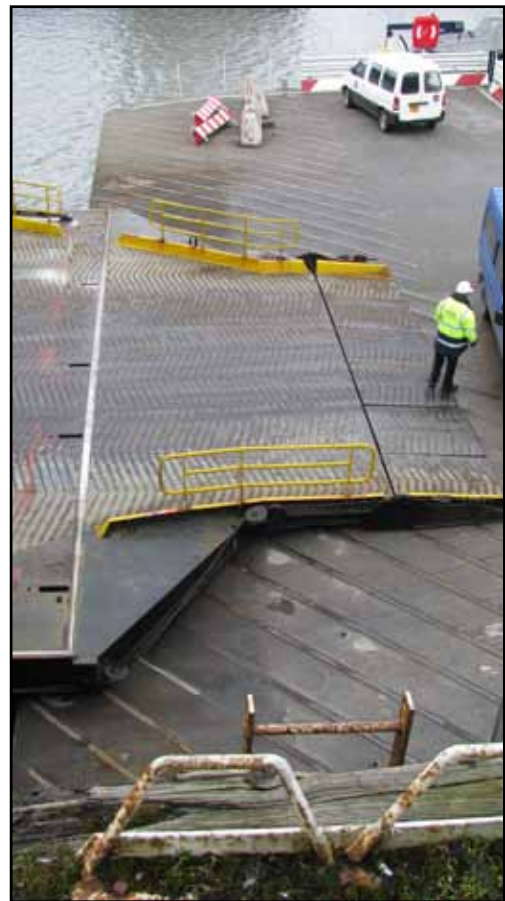
At the stern of the vessel, a charge hand (harbour employee) was supervising vehicle loading at the linkspan while the ship's second officer was talking to the trainee second officer. They all noticed the ship's movement when they heard the stern ramp scrape along the linkspan (**Figure 6**). The second officer ran into the ship and raised the stern ramp, closing it completely, thereby preventing vehicles from embarking.

Stern ramp on linkspan

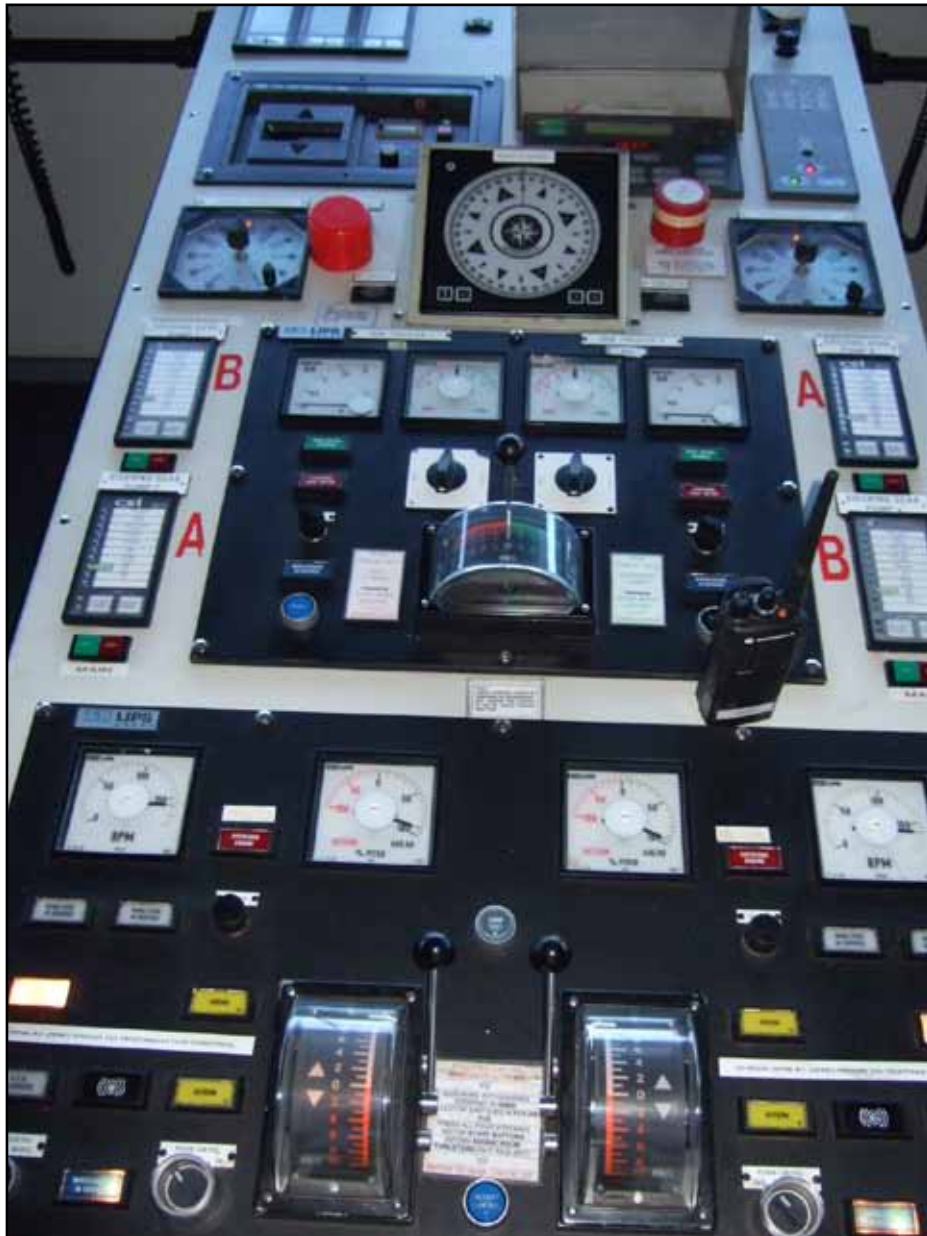
Figure 12

The main control panel (**Figure 12**) and two wing control stations (**Figure 13**) had rpm indicators for both engines and pitch indicators for both CPPs. In addition, there were rpm indicators just below the deckhead in front of each control panel. There was also a separate panel between the port wing and the main control station duplicating most of the important displays and alarms in the ECR. Both this panel and the wing stations contained two additional rpm indicators for each engine: one before the reduction gear and another of the shaft after the gearbox. The port wing deckhead display contained an rpm indicator for the starboard engine only; the port engine rpm indicator at this location having been replaced by an anemometer. On the starboard side deckhead display the starboard engine rpm indicator had also been replaced by an anemometer.

Centre control panel (bridge), looking down

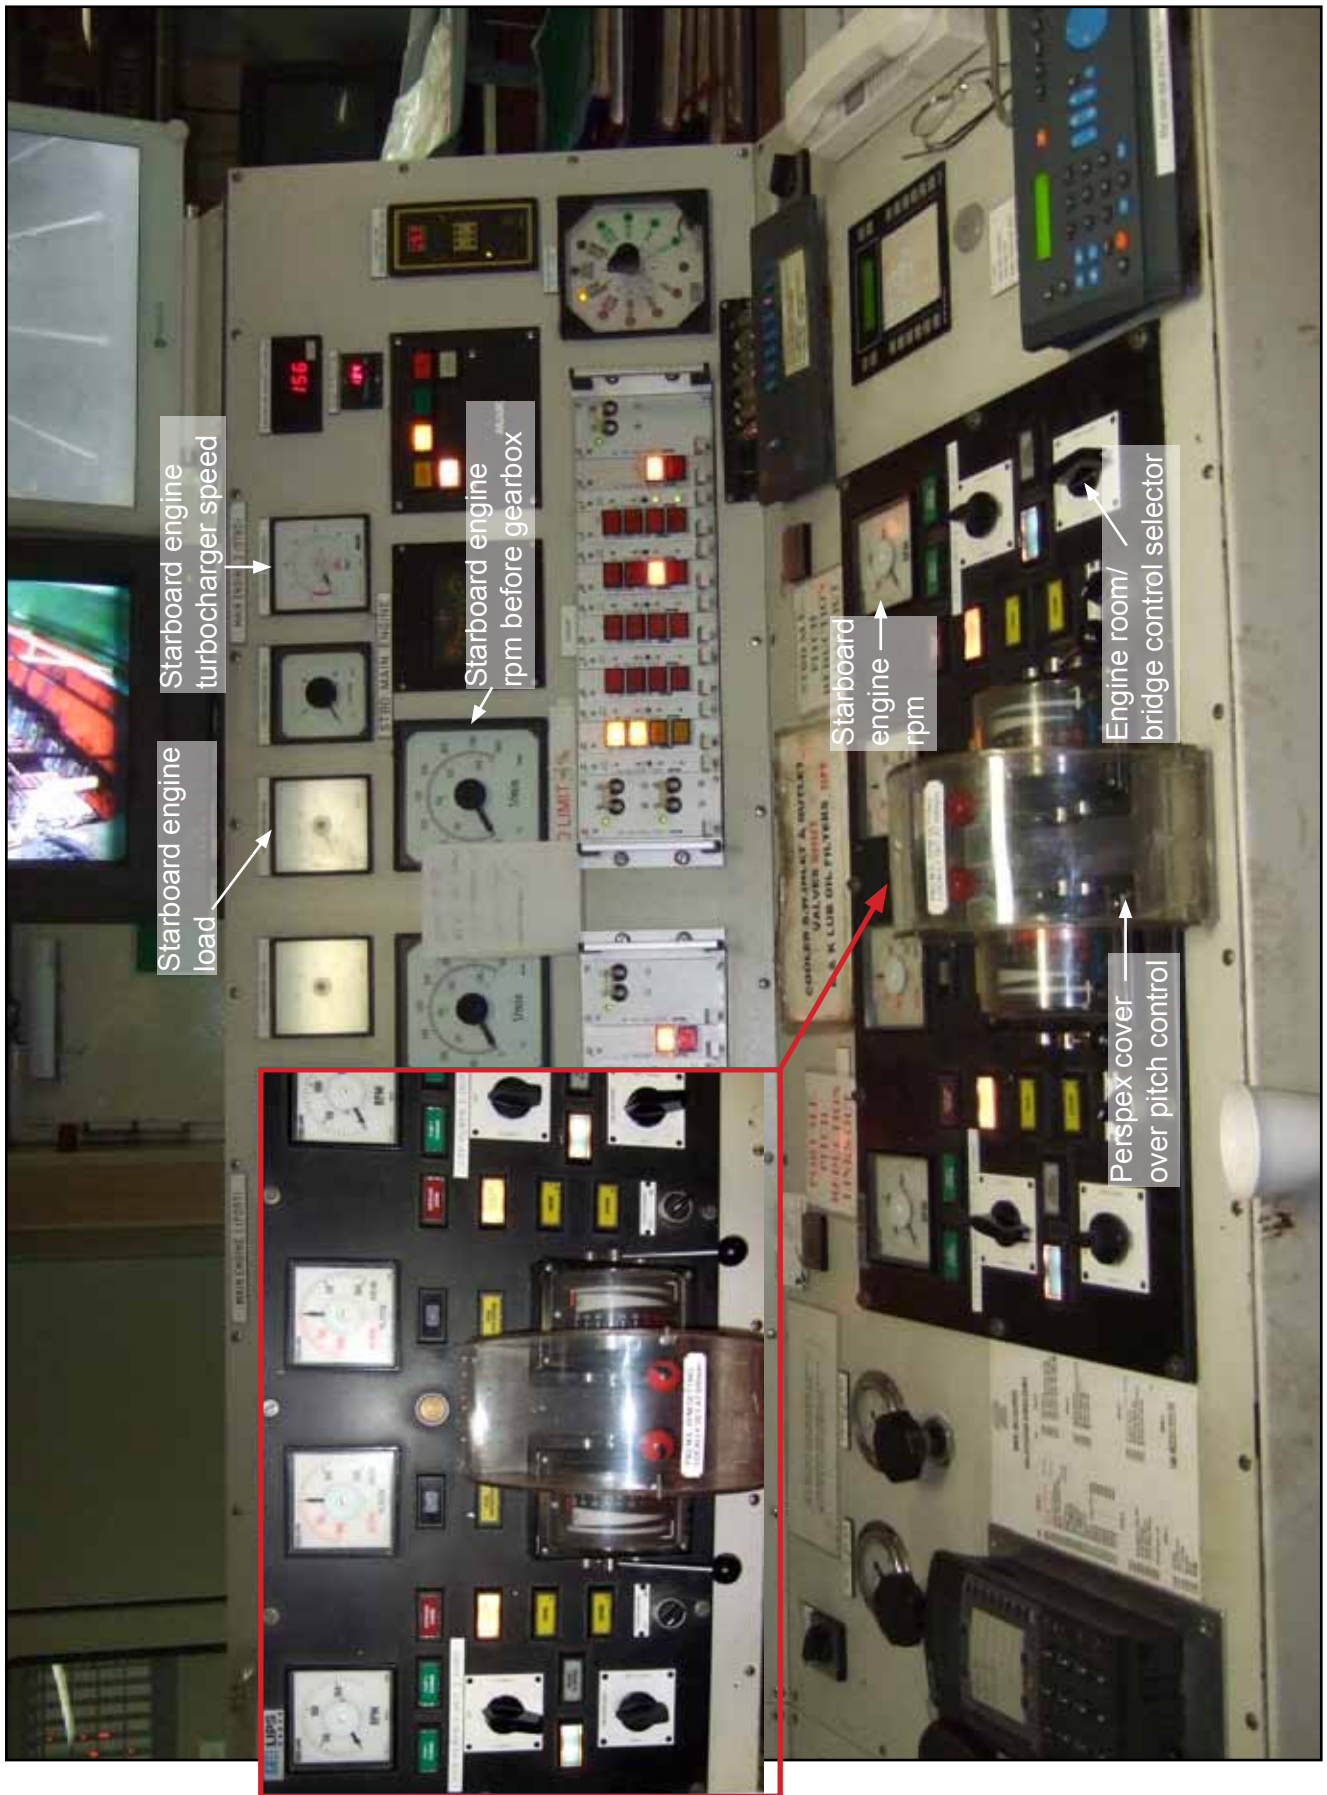
Figure 14

In the ECR, the pitch control levers had a Perspex cover to prevent accidental movement of the levers. There were several indications to show that an engine was running, including: engine and shaft rpm, turbocharger rpm, engine load, scavenge air pressure and several other technical parameters representing the operational state of the engines (**Figure 14**).

ECR control panel

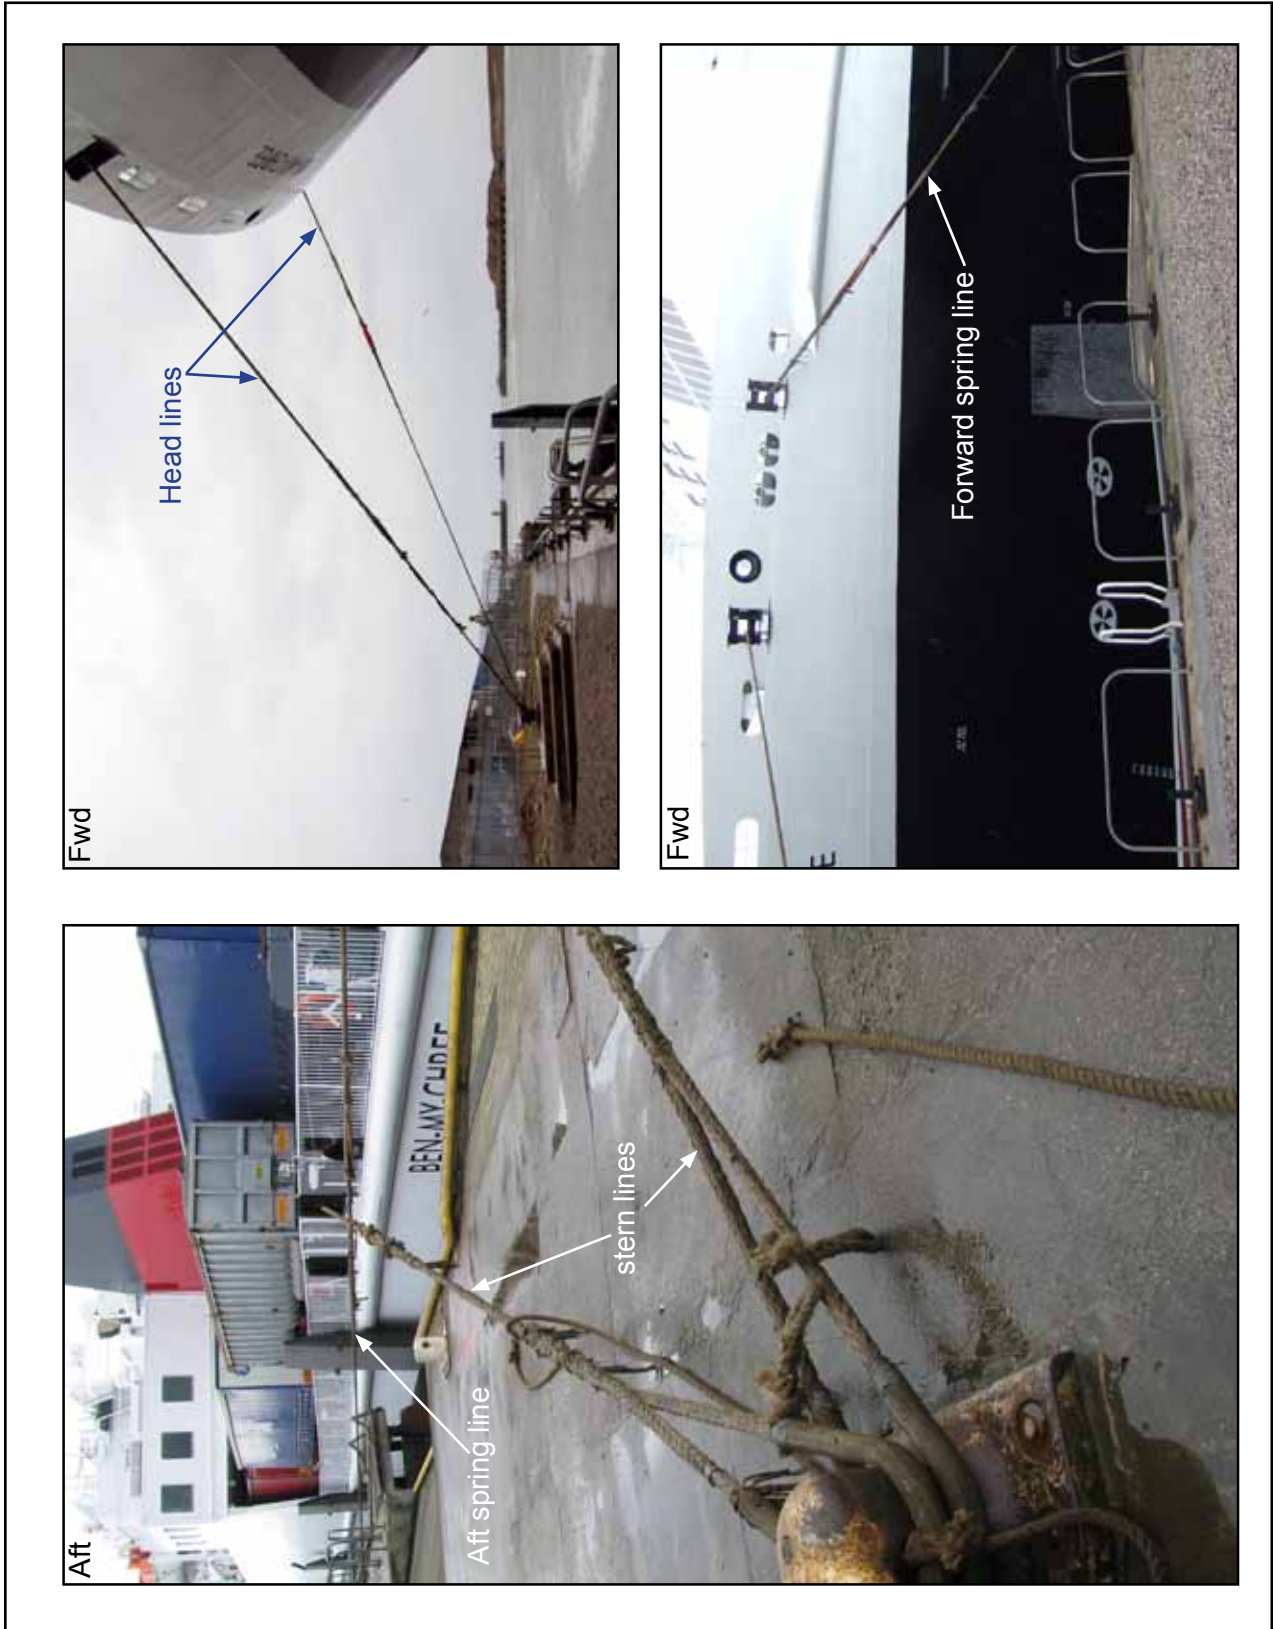
Figure 15

In Heysham, *Ben-My-Chree* moored using two head lines and a fore spring and two stern lines and a back spring (**Figure 15**). All the lines except the back spring were held by winches in the autotension mode (**Figure 16**) at 25% of 150kN (the rated tension or pull exerted by the winch). The back spring was secured on the brake on the port aft mooring winch.

Mooring arrangements
