Report on the investigation into the
unintended movement of the ro-ro passenger vessel

Ben-My-Chree

during loading operations at Heysham

Report No 17/2010
December 2010

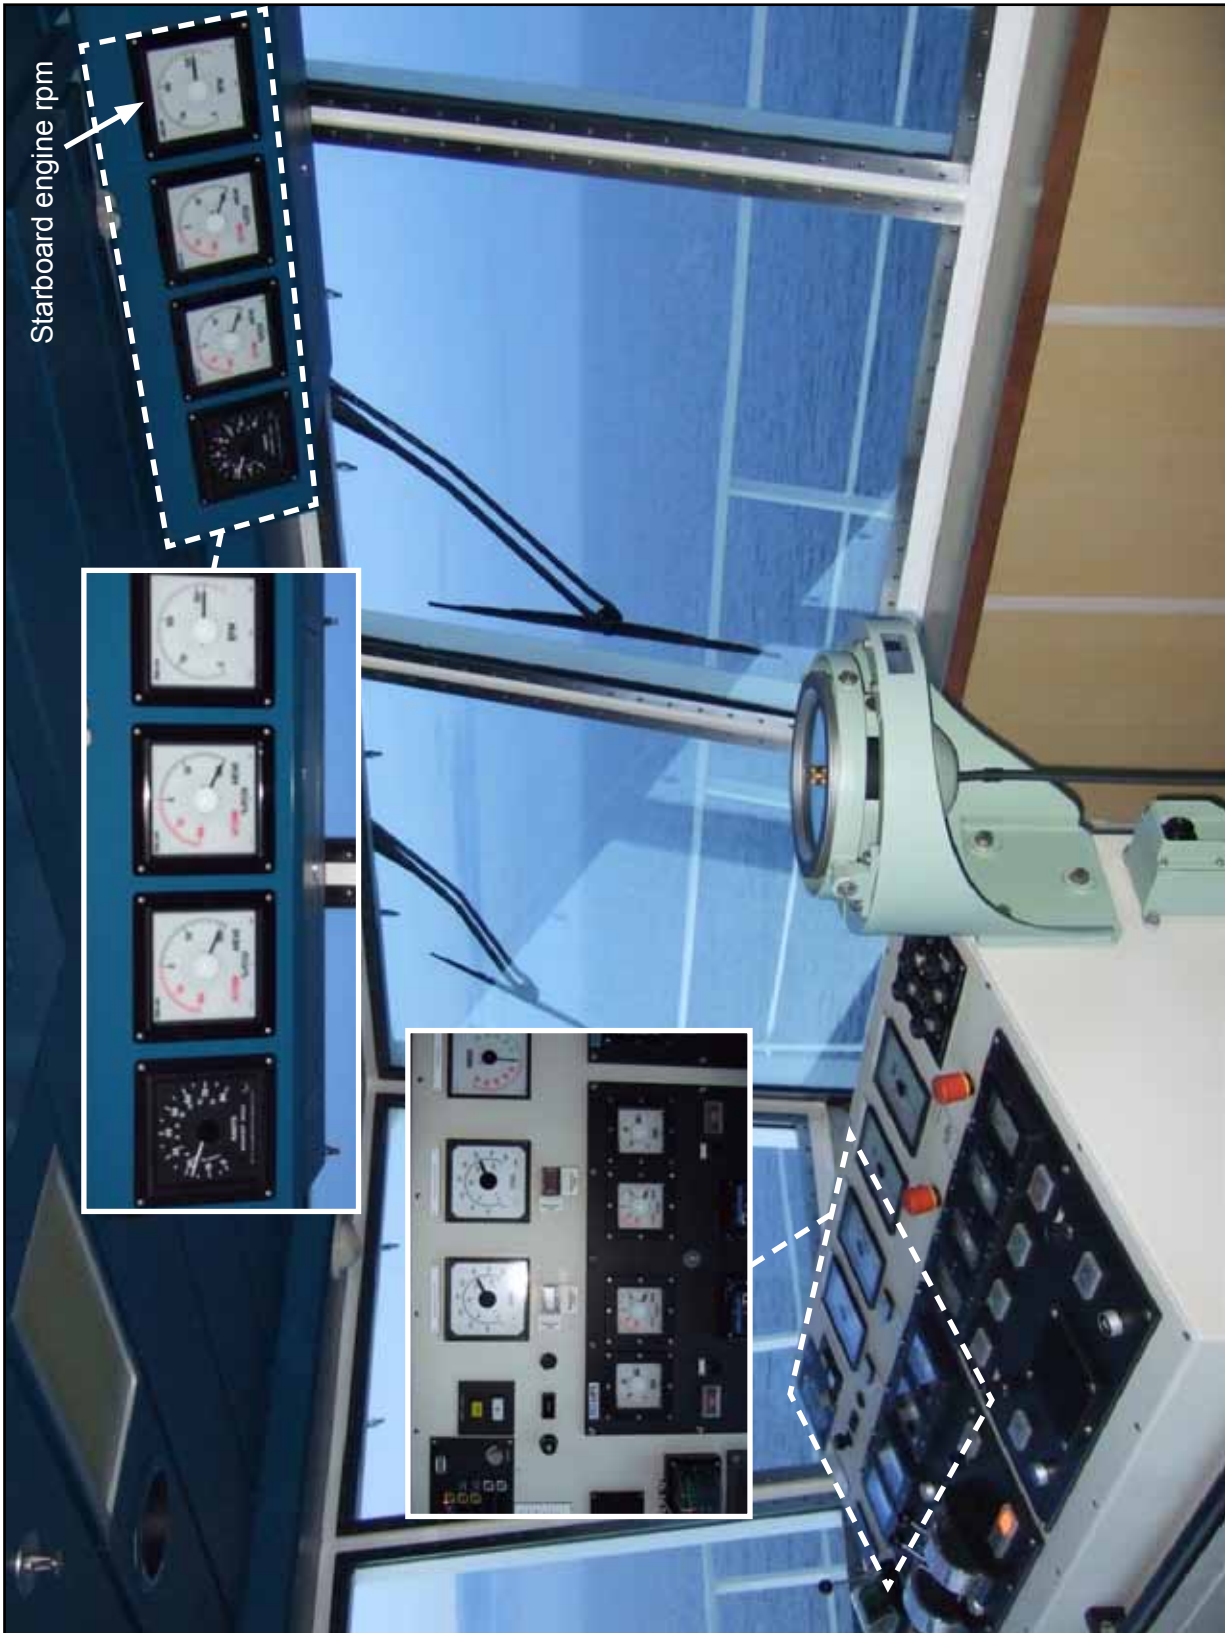
Figure 13

The main control panel (**Figure 12**) and two wing control stations (**Figure 13**) had rpm indicators for both engines and pitch indicators for both CPPs. In addition, there were rpm indicators just below the deckhead in front of each control panel. There was also a separate panel between the port wing and the main control station duplicating most of the important displays and alarms in the ECR. Both this panel and the wing stations contained two additional rpm indicators for each engine: one before the reduction gear and another of the shaft after the gearbox. The port wing deckhead display contained an rpm indicator for the starboard engine only; the port engine rpm indicator at this location having been replaced by an anemometer. On the starboard side deckhead display the starboard engine rpm indicator had also been replaced by an anemometer.

Port wing station (inserts show rpm and pitch gauges)
Note: Black faced gauge is an anemometer that has replaced the port engine rpm gauge
