Report on the investigation into the
unintended movement of the ro-ro passenger vessel

Ben-My-Chree

during loading operations at Heysham

Report No 17/2010
December 2010

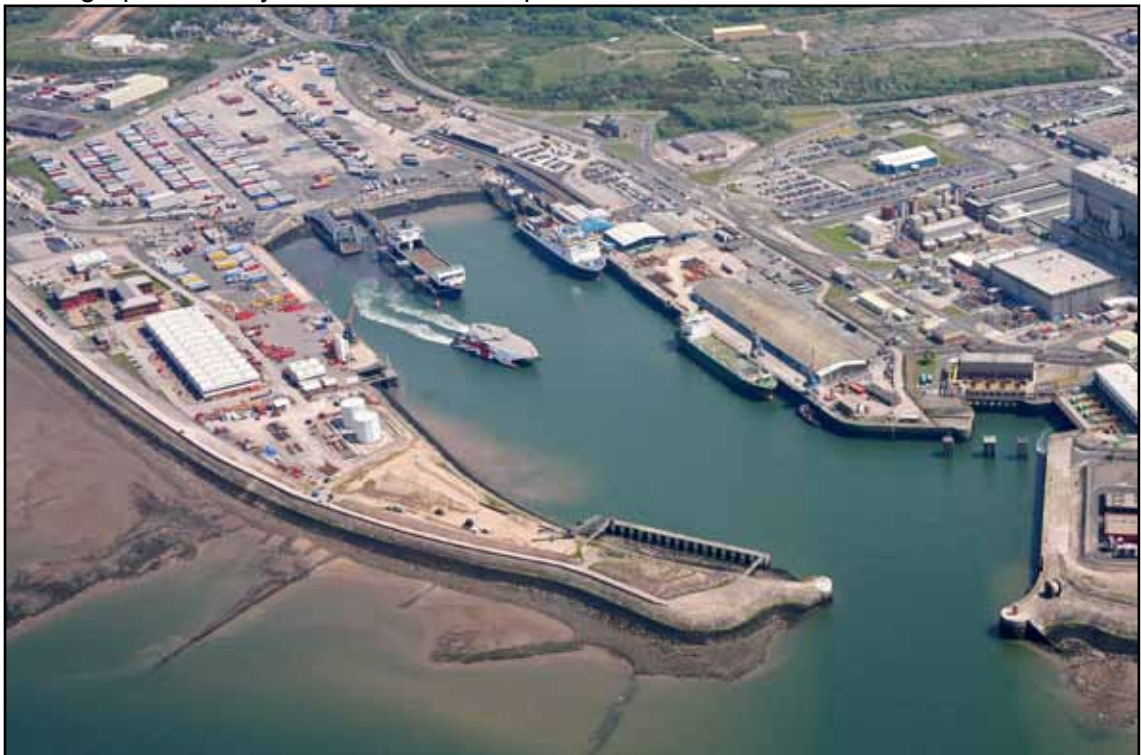
Figure 1

Heysham Port

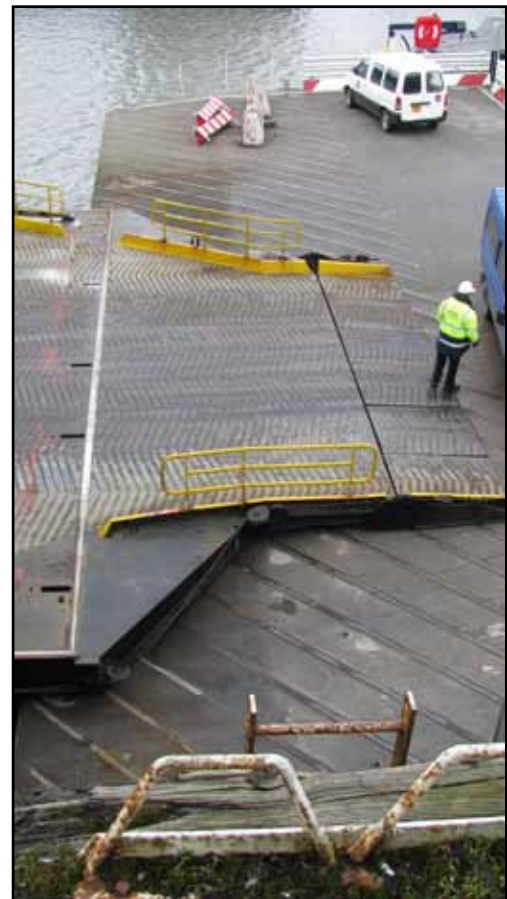
At the stern of the vessel, a charge hand (harbour employee) was supervising vehicle loading at the linkspan while the ship's second officer was talking to the trainee second officer. They all noticed the ship's movement when they heard the stern ramp scrape along the linkspan (**Figure 6**). The second officer ran into the ship and raised the stern ramp, closing it completely, thereby preventing vehicles from embarking.

Stern ramp on linkspan

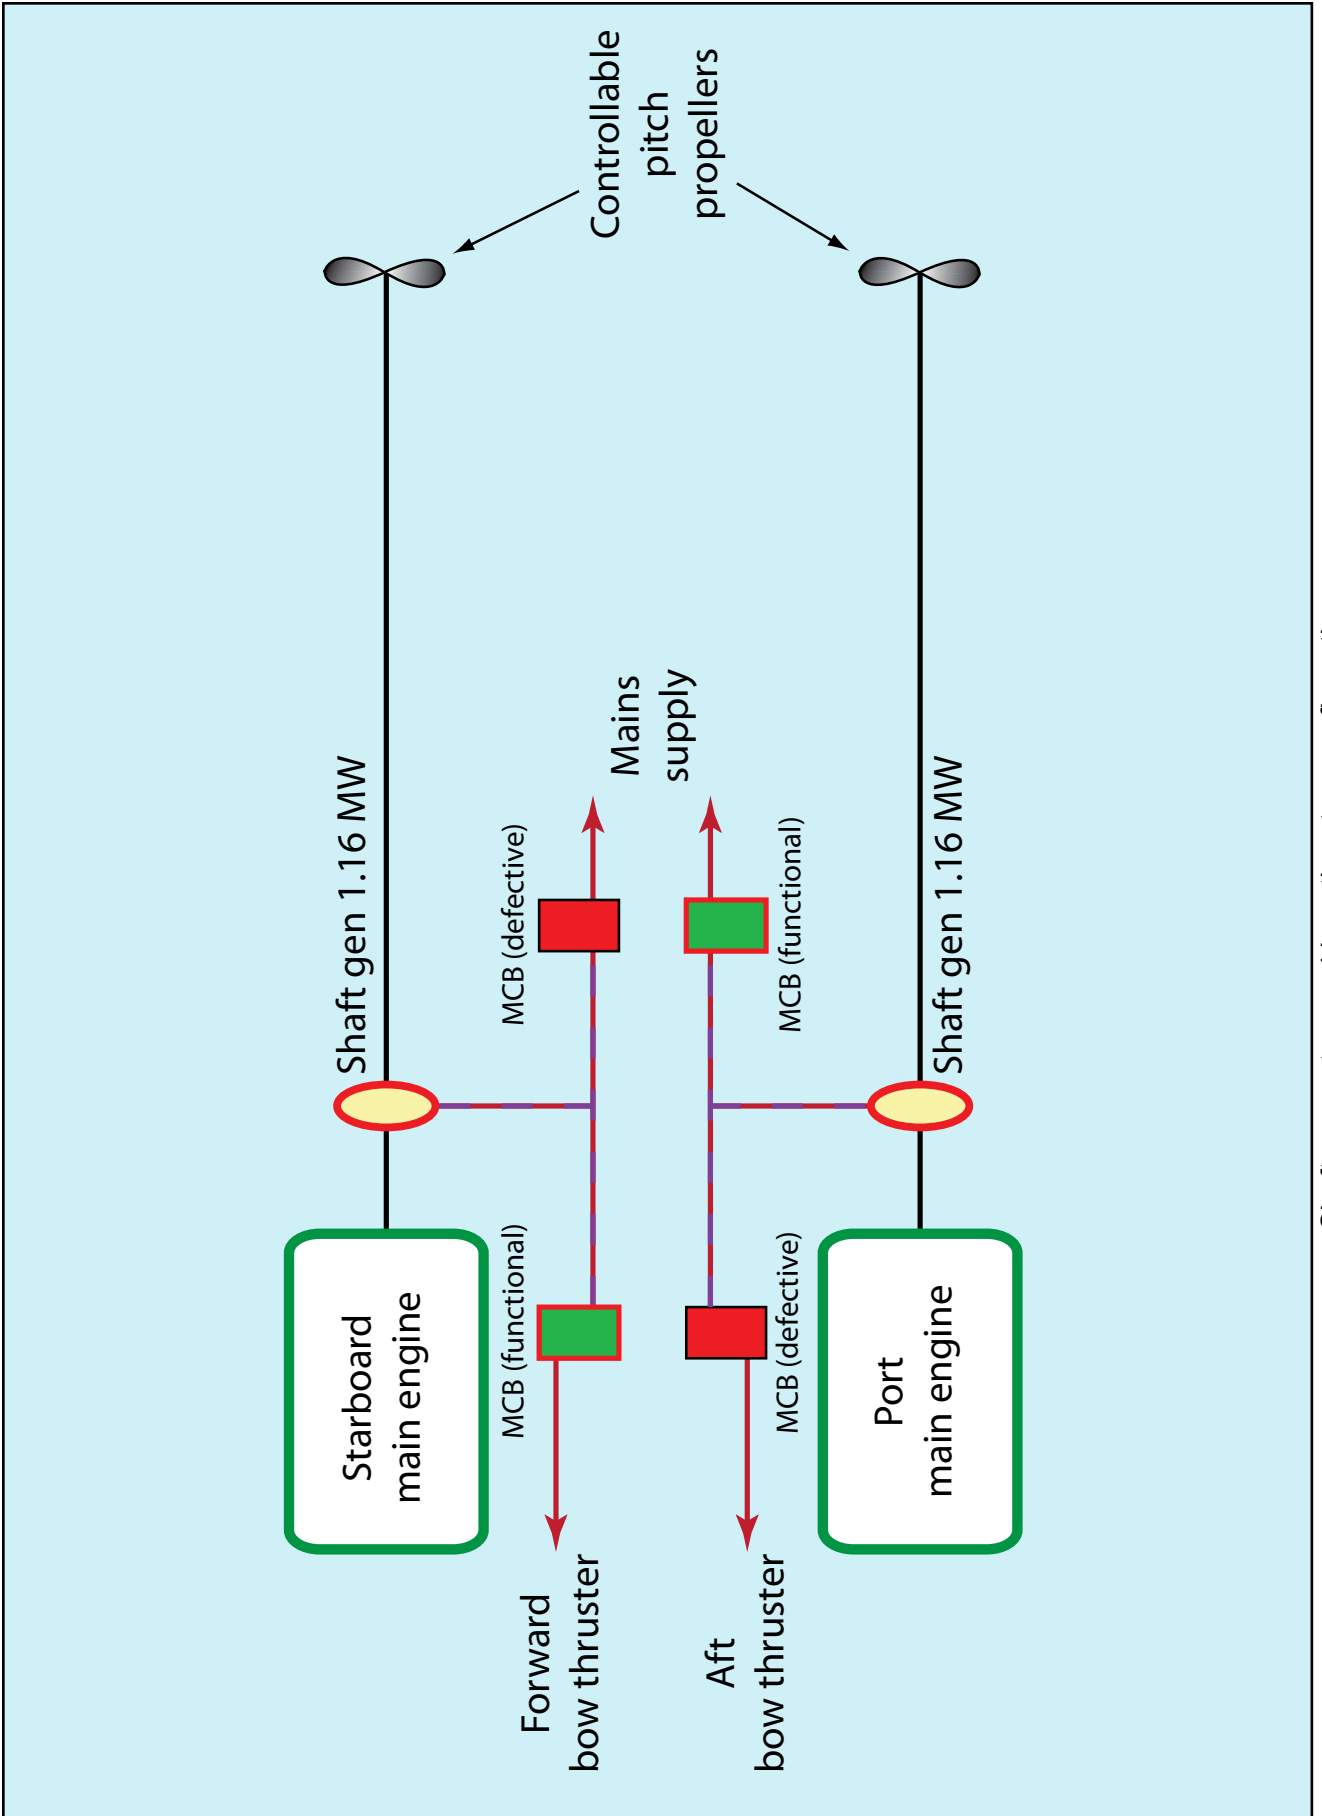
Shaft generators and bow thrusters configuration
