Tension Technology International Ltd - Test Report

Chain inspection and testing for MAIB

TTI-IMLR-2010-663R

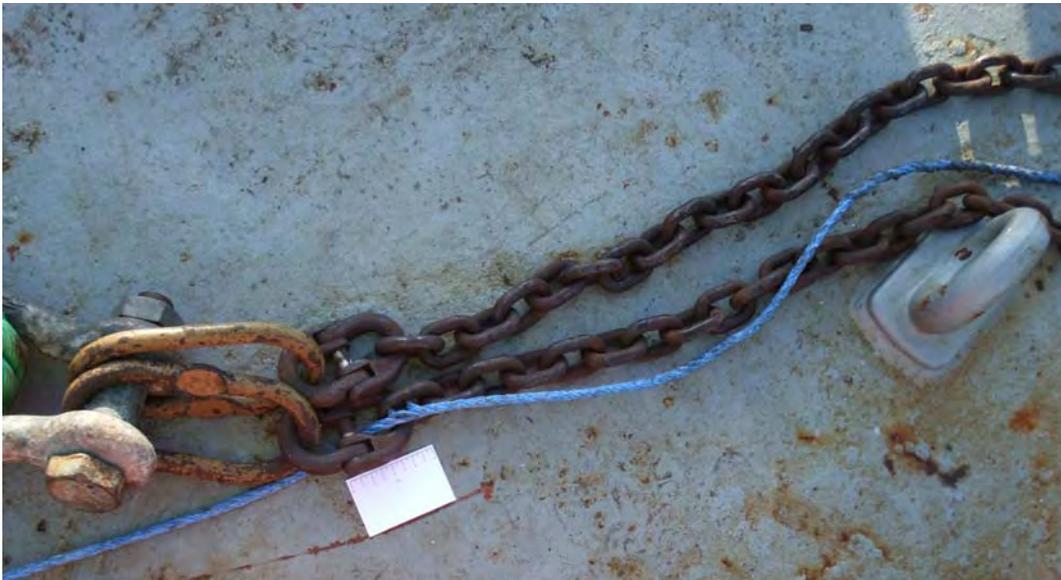
TTI Testing (the testing subsidiary of Tension Technology International) was contracted by the MAIB to undertake a review of a chain sling failure (see Figures 1 and 2 below). These Figures show the sling shortly after the failure: Figure 1 shows the chain with its two master links connected by a bow shackle, whilst Figure 2 provides a close up of the failed link.

Figure 1: Section of the un-failed chain.

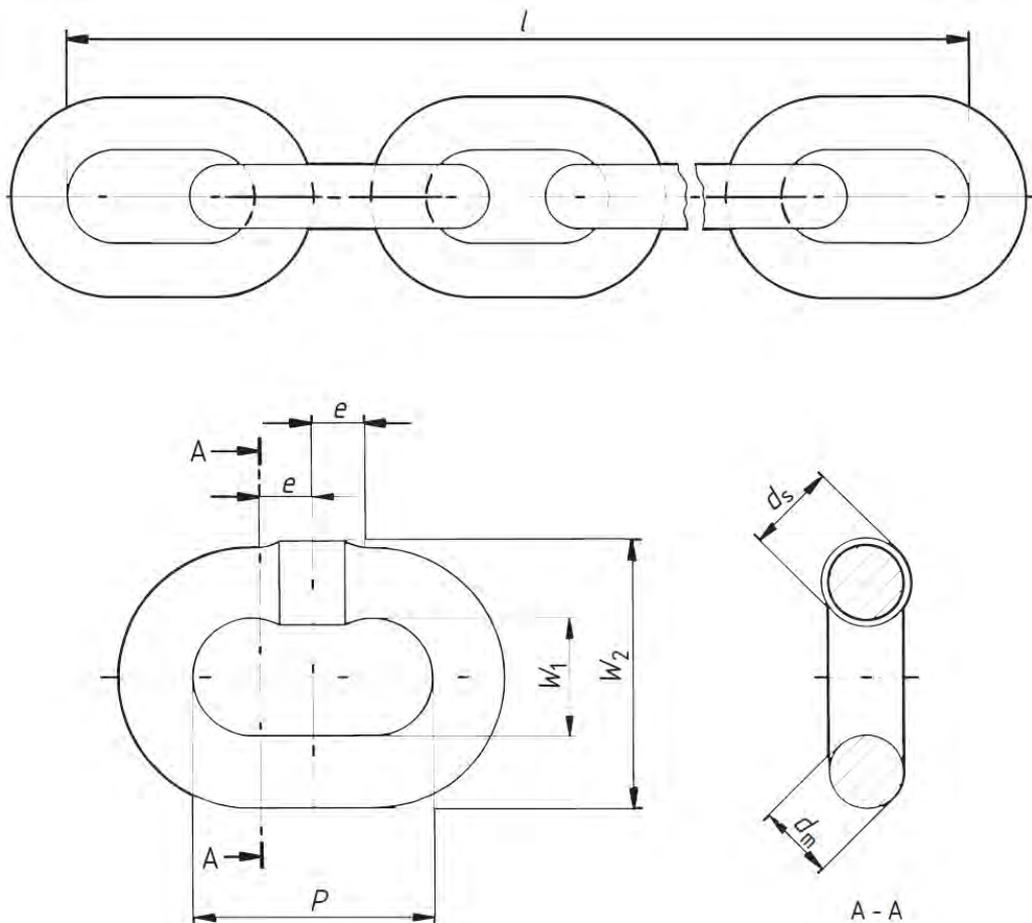
Measurements of the geometry (refer to Figure 8 for notation) were made on links 1-5. These results are presented in Table 1. It can be seen that the link geometry was in accordance with BS EN 818-2.

Figure 8: Notation used to define link geometry, from BS EN 818-1

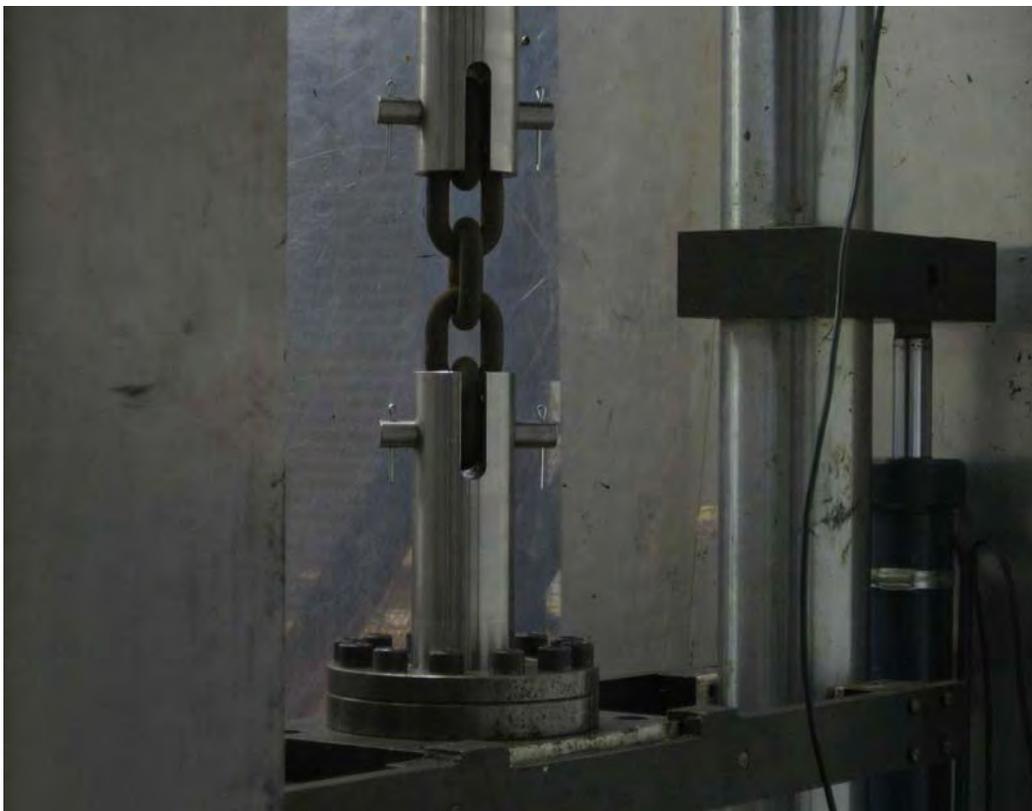
Figure 9 shows the sample in the 250 kN testing machine at TTI Testing's facility in Arbroath. A calibration certificate for this equipment is presented in Appendix A.

Figure 9: First 13 mm chain sample (links 1-5) ready for strength measurement.

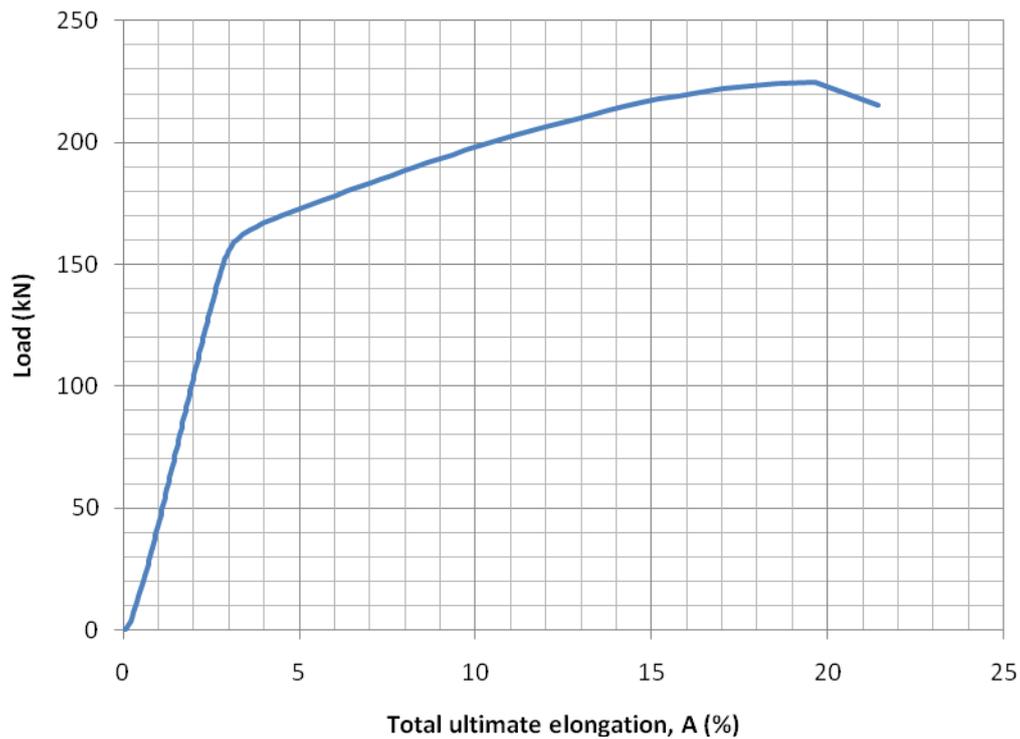
Figure 10 shows the typical load-elongation relationship, in this case for the second breaking load test. The graph is characterised by a bilinear 'curve'. The first part of the graph is the 'elastic' section up to approx. 160 kN load (if the load is reduced before exceeding this limit the load-elongation characteristic will return back along this initial line). The second shallower gradient line is associated with plastic deformation. Thus beyond the load of 160 kN the chain would suffer permanent deformation (distortion) if subsequently unloaded.

Figure 10: Load-elongation relationship for second breaking load test (links 7-11).

Figure 10 shows the load-elongation plot for the 13 mm chain when tested to failure. It may be seen that at 75% of the breaking load (168 kN) the chain has only just entered the plastic region (this is marked by the change of slope on the graph). Review of the graph shows that the permanent plastic elongation would be 1% at most at this load (the difference between the total elongation and the elastic recoverable elongation) – which equates to 0.39 mm for a 13 mm (39 mm pitch) link. This level of permanent deformation is very low, and well within the ± 1.2 mm allowed by BS EN818-2. It is therefore difficult to conclude anything concerning the chain loading history other than to say that it is possible that the other chain links could remain within geometrical tolerance at the loads thought to have caused failure of the link on the pin.

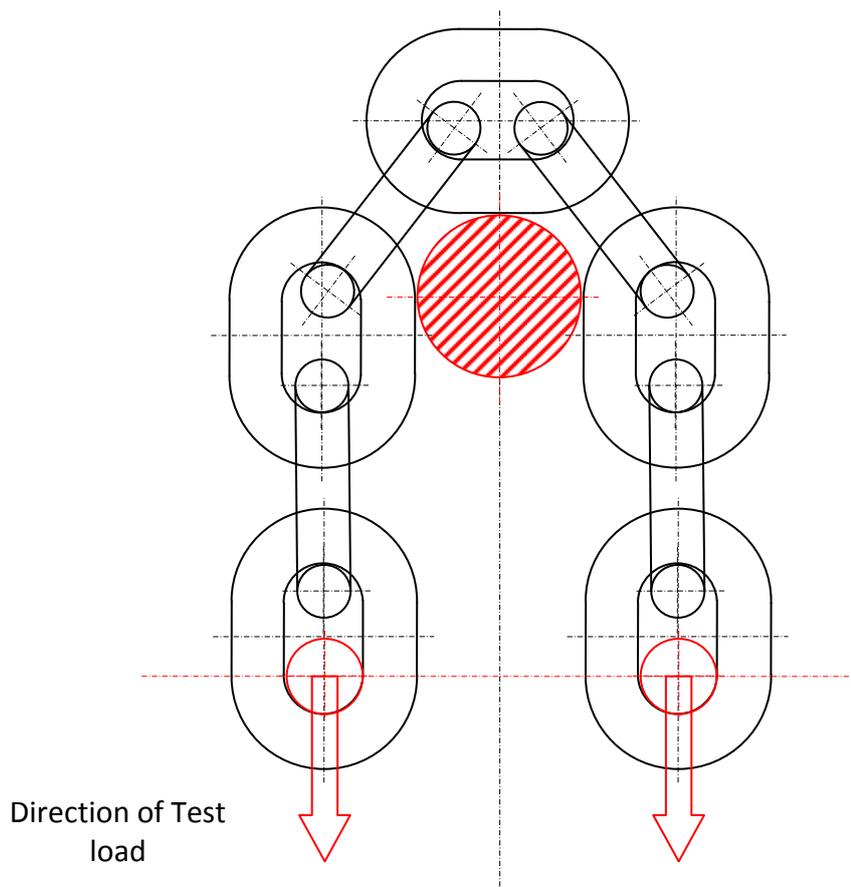
Figure 12: Agreed test configuration for the 'bent over pin' test.

It should be noted that the test geometry shown in Figure 12 was selected to try to model the loading configuration of the failed link based on the post failure examination, and in particular the transverse loading evident in the plane of the link. If a chain is doubled over a bar there are clearly a number of configurations which the chain might adopt: with the centre link in any position from vertical (as shown) to horizontal or any angle in between. As the load is applied to the chain it will tend to straighten along its axis, in that adjacent links will tend to align with their axes mutually perpendicular (this assumes that there was no pre-twist in the chain which would complicate things further).

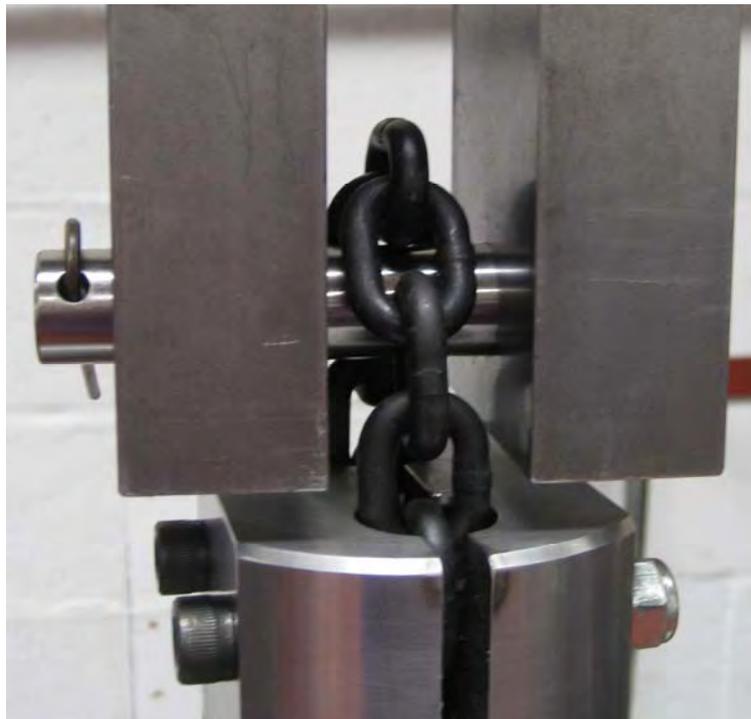
The test set up used for the breaking load test over a pin is shown in Figure 14. The samples were 9 links long (as shown in Figure 12) and arranged so that the weld of the middle link was at the top (i.e. clear of the pin).

Figure 14: Sample MAIB06 in the machine ready for testing.

Two breaking strength tests were conducted in this configuration. The results are presented in Table 4. It can be seen that the average breaking load of the chain in this configuration was 48.94 kN. Comparing this average to the results shown in Table 3, it can be seen that there was a strength loss of 25%.

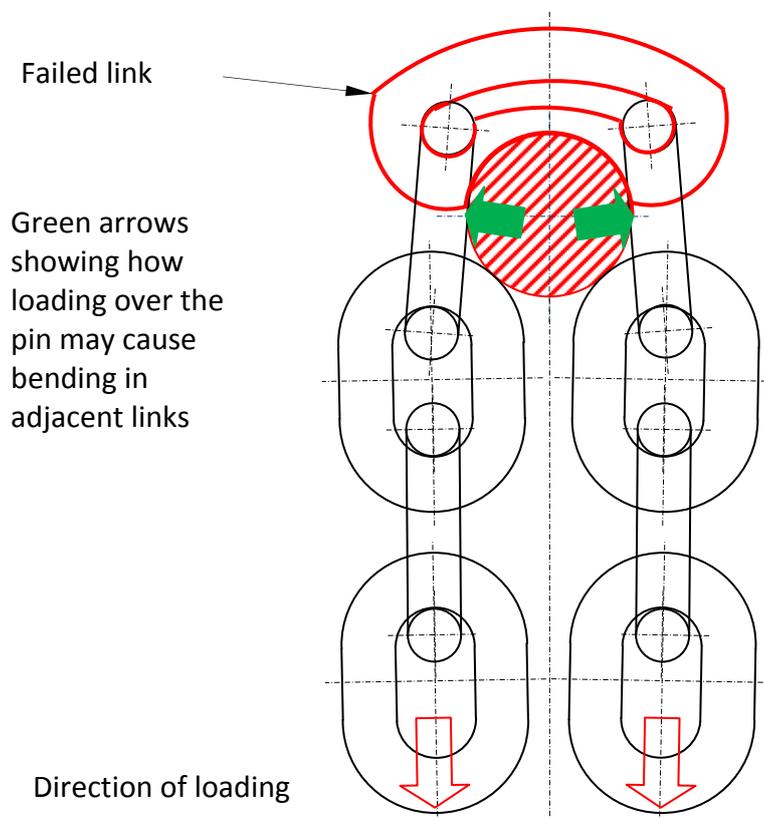
An examination of the chain sling, particularly in the area of the failure showed that the failed link had been subject to considerable plastic deformation. In the tests which were subsequently conducted on some 7 mm chain of the same geometry and grade, very similar features were found on both the failed link, and in respect of the out of plane bending on the two links either side of that. Figure 17 below is a schematic diagram showing how the features on the failed link and also the bending to the links either side may have occurred.

Figure 17: Schematic diagram showing how the failed link and adjacent links would be affected by the action of the pin.

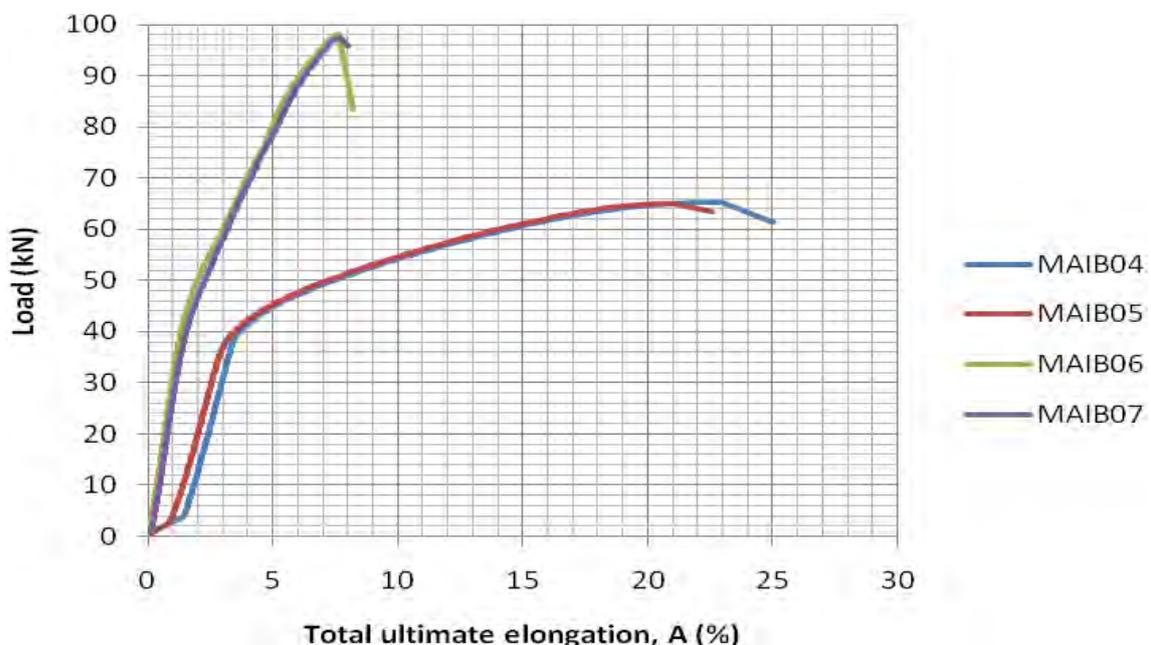
The observation that the majority of the chain links in the bent over pin test were not loaded sufficiently to cause appreciable plastic deformation leads to an important point. This point is best illustrated by consideration of the load-elongation plots for the two types of 7 mm chain tests, Figure 18.

Figure 18 shows the two pairs of results for the straight chain (MAIB04 and MAIB05) and those doubled over the pin (MAIB06 and MAIB07). The straight chain test relationship has a bilinear shape very much like that for the 13 mm chain (Figure 10), which is to be expected.

The energy at failure in the chain is given by the area under the curve – it can be seen that even though the failure load of the bent over pin assembly is higher than the straight chain, the area under the curve is far less. (This area would be lower still for the longer chain where the relationship tends to a straight line of the initial gradient.)

Hence, although the bent over pin configuration is *prima facie* at least as strong as (even stronger than) a straight chain configuration, it is also much more vulnerable to dynamic shock overloads. For otherwise identical configurations, in a displacement driven loading environment (such as the marine environment) a stiffer sample will experience much higher peak loads.

Figure 18: Load-elongation relationship for the two pairs of 7 mm chain breaking load tests: straight and bent over a pin.
