Report on the investigation of
the grounding and subsequent foundering of
fv Kerloch (J235)
at Crow Rock, off Linney Head, Wales
on 20 February 2010

Report No 12/2010
October 2010

SYNOPSIS

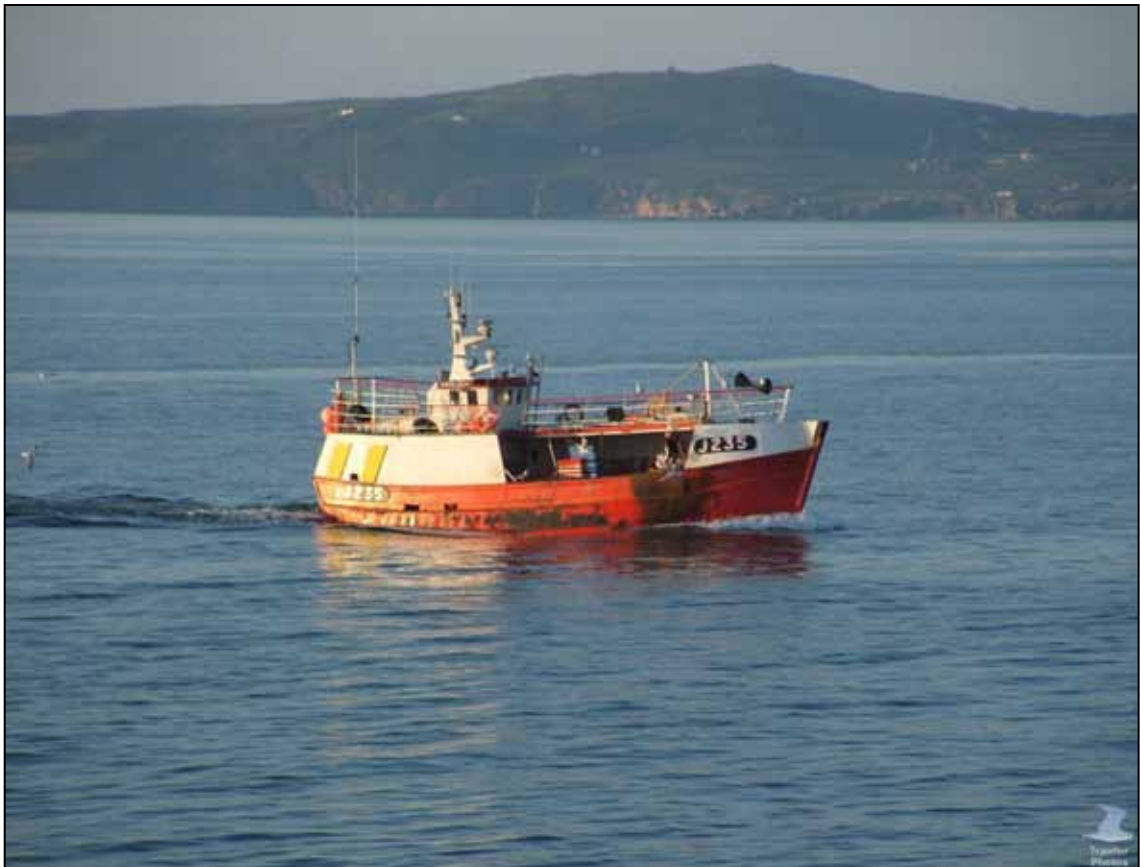
Figure 1

Kerloch was a Jersey-registered vivier¹ crabber, as depicted at **Figure 1**. Operating out of Milford Haven (**Figure 2**), she typically spent 2 to 3 days working the fishing grounds off Lundy Island, in the Bristol Channel, prior to returning to port to land, refuel and take on stores. The vessel normally then returned immediately to the fishing grounds.

Kerloch

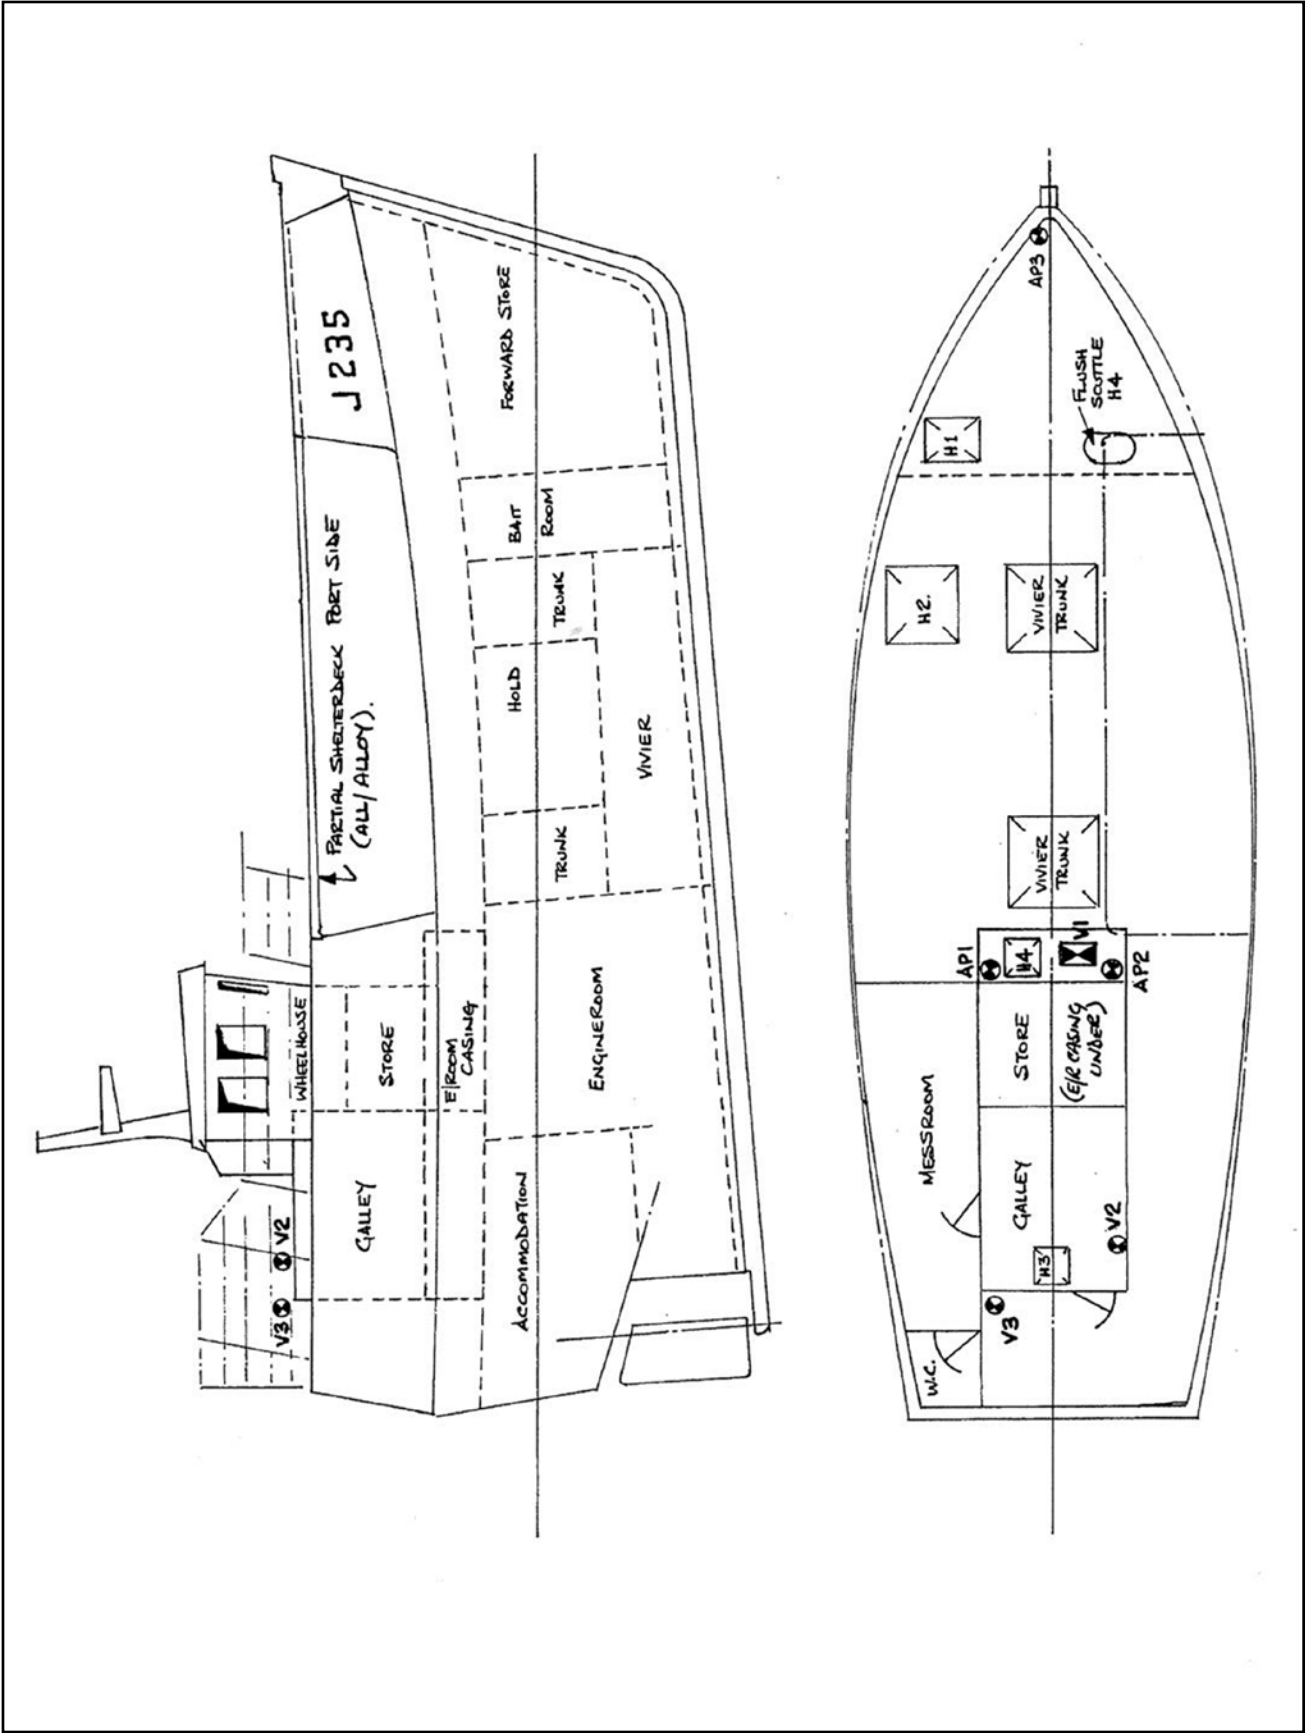
Figure 3

General Arrangement plan of Kerloch

The layout is depicted at **Figure 3**, and shows the central vivier tank for storing the live catch, aft of the bait room and forward store. The bulkheads below main deck were wooden, and not considered watertight.
