Report on the investigation of
the grounding and subsequent foundering of
fv Kerloch (J235)
at Crow Rock, off Linney Head, Wales
on 20 February 2010

Report No 12/2010
October 2010

At 1725 on 20 February 2010, the Jersey-registered crabber *Kerloch* (J235) was returning to port when she ran aground on Crow Rock, off the Pembrokeshire coast. The vessel began to sink rapidly and all four crew donned their lifejackets, then deployed and got into the liferaft. The crew were recovered from their liferaft by another fishing vessel and subsequently transferred to the Angle ALB and then ashore. There were no injuries and no pollution.

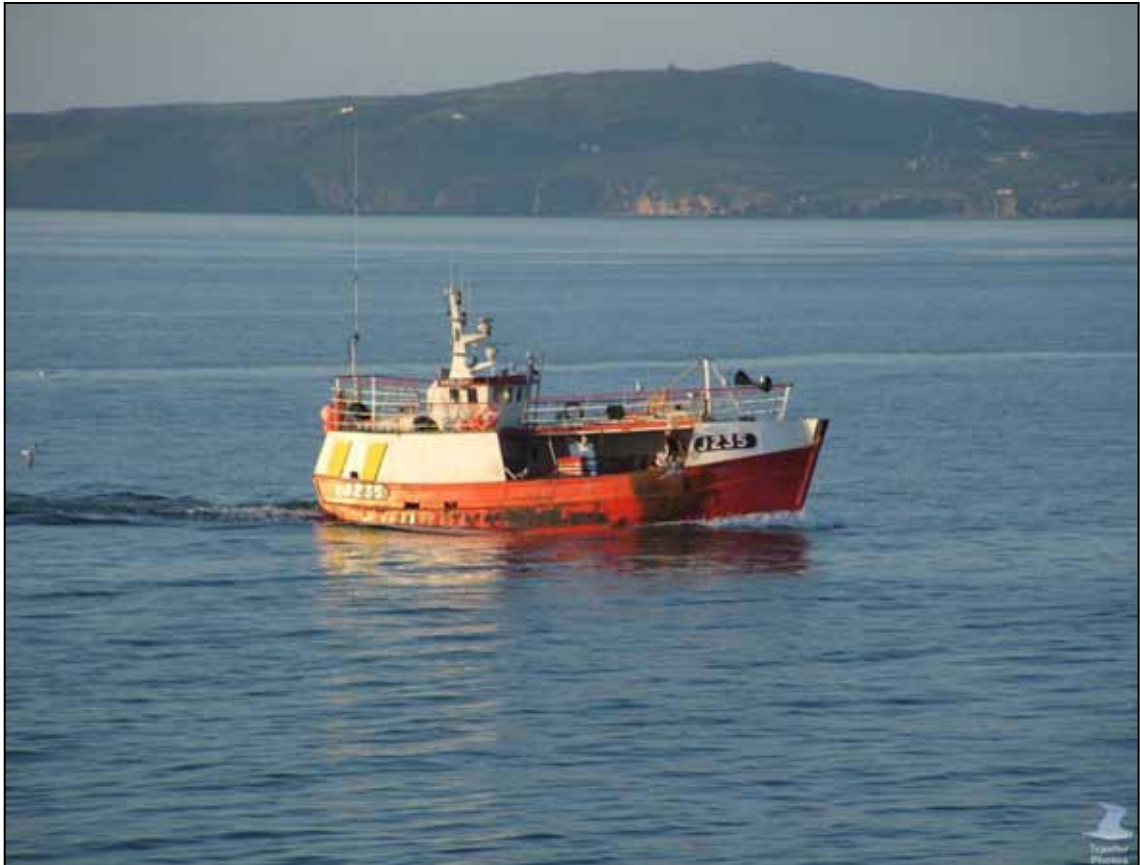
Figure 1

Kerloch was a Jersey-registered vivier¹ crabber, as depicted at **Figure 1**. Operating out of Milford Haven (**Figure 2**), she typically spent 2 to 3 days working the fishing grounds off Lundy Island, in the Bristol Channel, prior to returning to port to land, refuel and take on stores. The vessel normally then returned immediately to the fishing grounds.

Kerloch

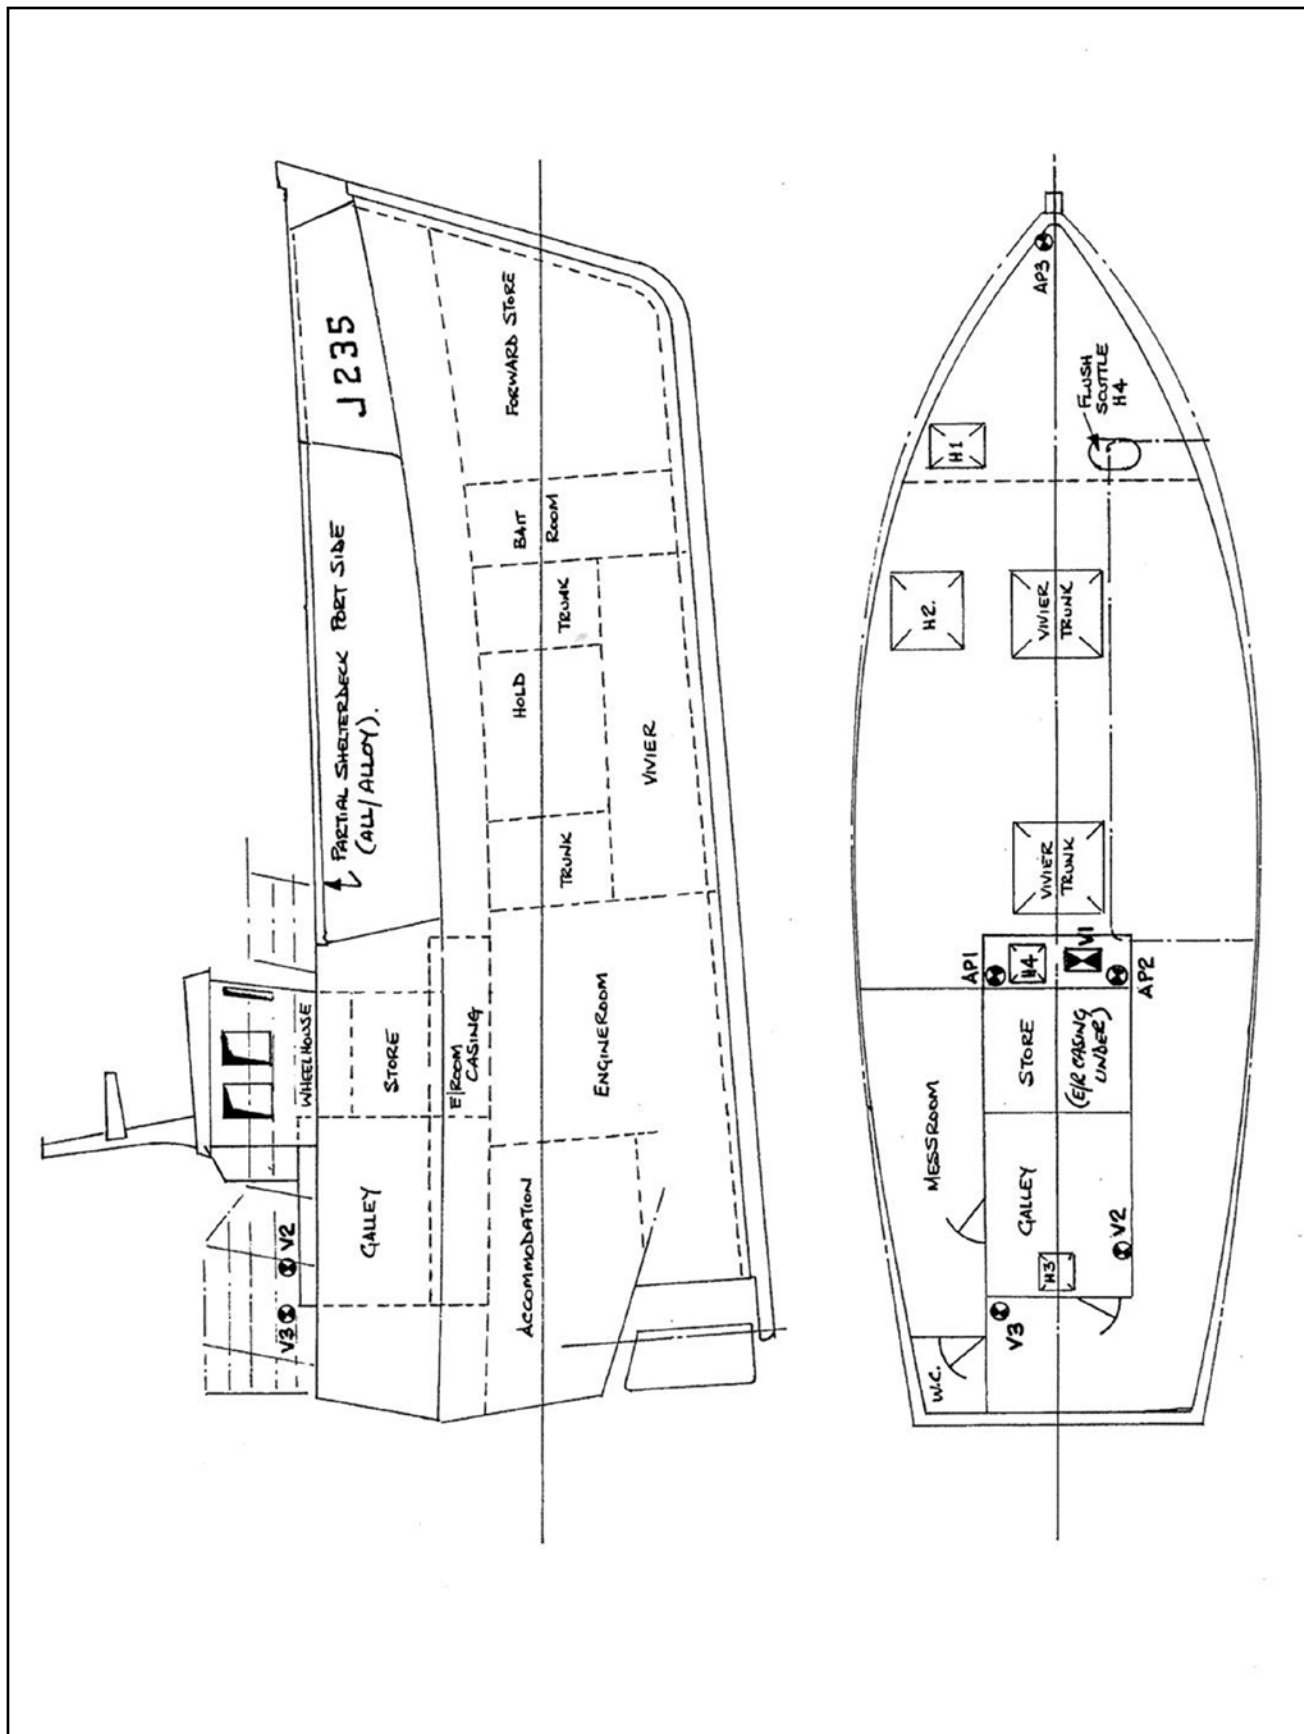
Figure 3

General Arrangement plan of Kerloch

The layout is depicted at **Figure 3**, and shows the central vivier tank for storing the live catch, aft of the bait room and forward store. The bulkheads below main deck were wooden, and not considered watertight.

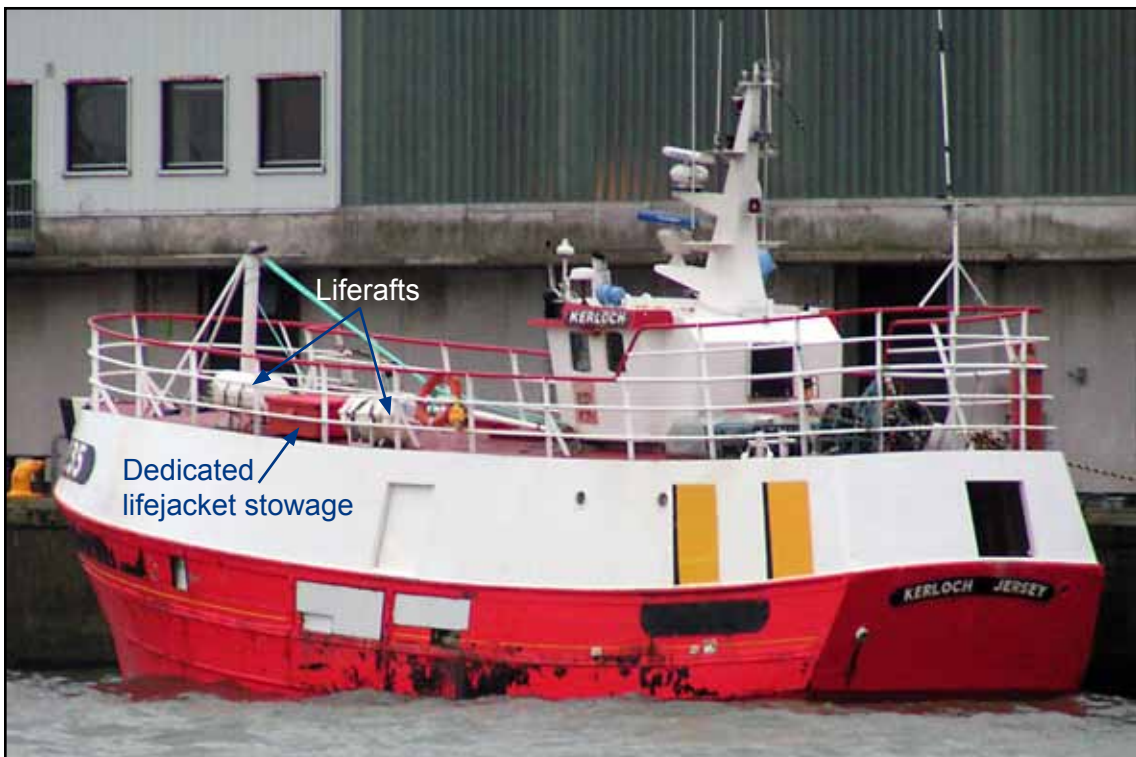
Figure 7

They each donned a lifejacket (**Figure 7**), then the skipper and one of the crew jettisoned the 8-man liferaft canister and started to deploy the painter. As the vessel continued to sink by the bow the crew became anxious about the time it was taking for the raft to activate, due to the length of painter that had to be pulled from the canister. However, the liferaft finally inflated upright (**Figure 8**), and the painter was then cut. One of the deckhands held onto the cut end, while the other two deckhands, then the skipper, jumped onto the liferaft, before boarding himself.

Photograph of *Kerloch* showing liferafts and dedicated lifejacket stowage
