Report on the investigation of
the fatality of a shore worker in No 2 cargo tank
on board the oil/chemical tanker

Bro Arthur

at the Cargill Terminal, Hamburg, Germany

Report No 9/2010
August 2010

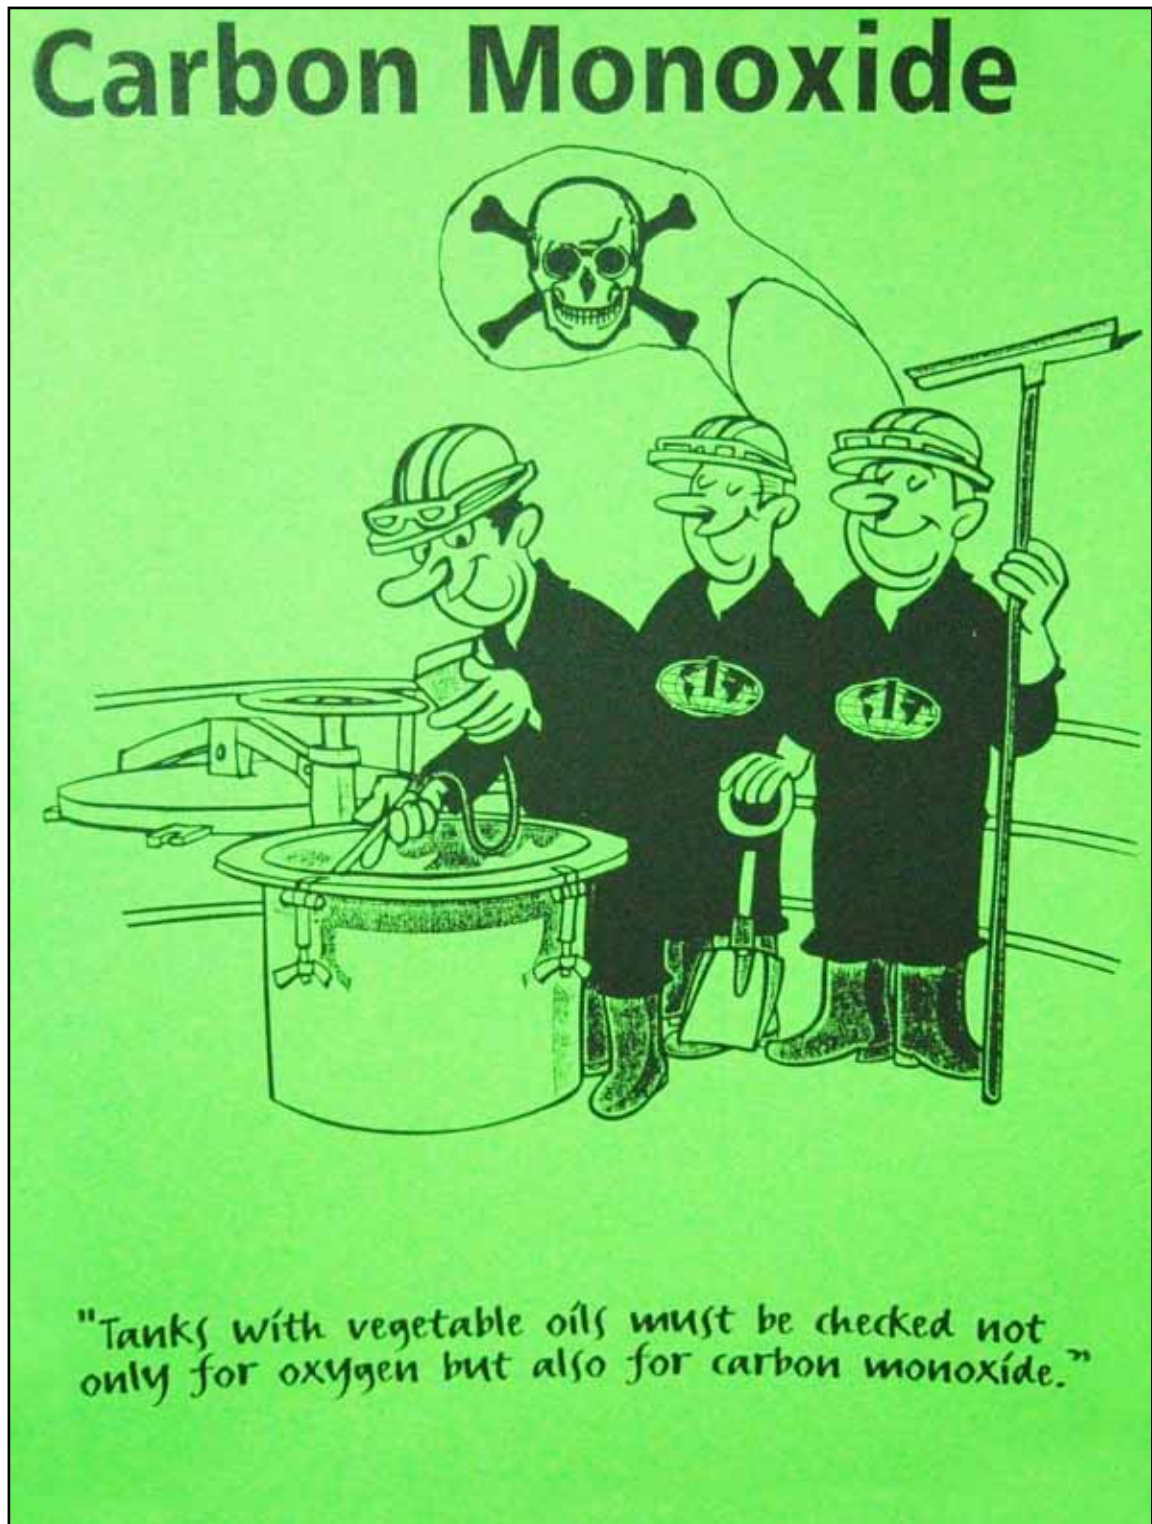
Figure 2

cargoes, there was nothing in the MSDSs which raised his concern or which required any special precautions to be taken. However, the supplier also passed a warning poster (**Figure 2**) to the chief officer. It advised that tanks containing vegetable oils should not only be checked for oxygen levels before entry but also for the presence of carbon monoxide (CO).

Vegetable oil warning poster supplied by P.T. Sari Dumai Sejati

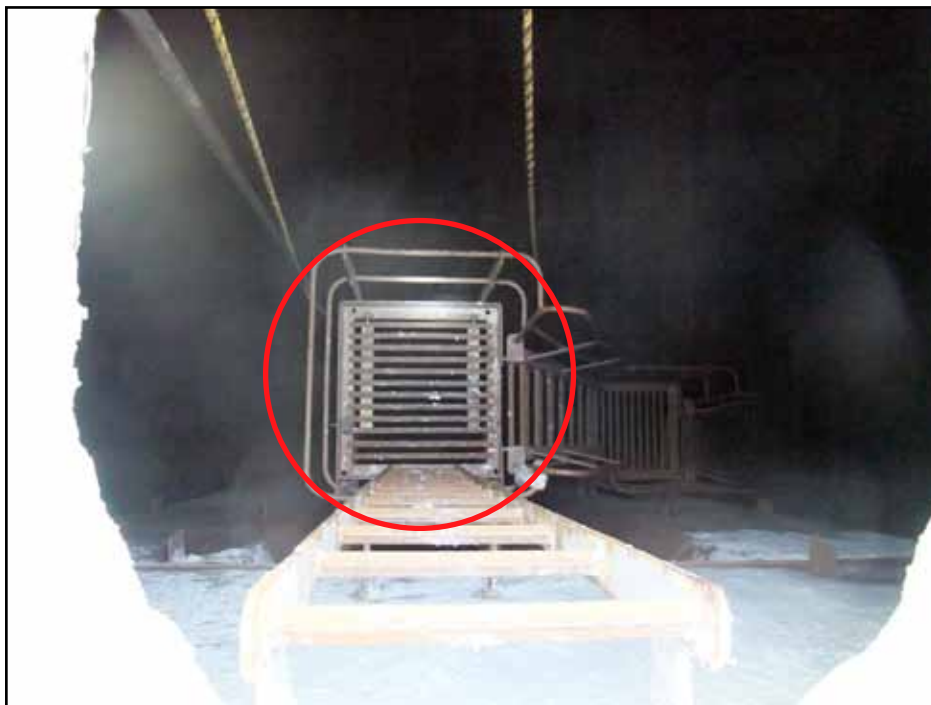
Figure 6

As the three “sweepers” descended the first vertical ladder, the supercargo followed and remained on the top resting platform (**Figure 6**) to act as communications link with the chief officer who was at the hatch coaming on the main deck. As the “sweepers” descended the three angled ladders to the bottom of the tank (**Figure 7**) the supercargo once again noted that “Sweeper” 1 was assisting “Sweeper” 2, but this did not cause him sufficient concern to abort the operation.

No 2 cargo tank - top resting platform

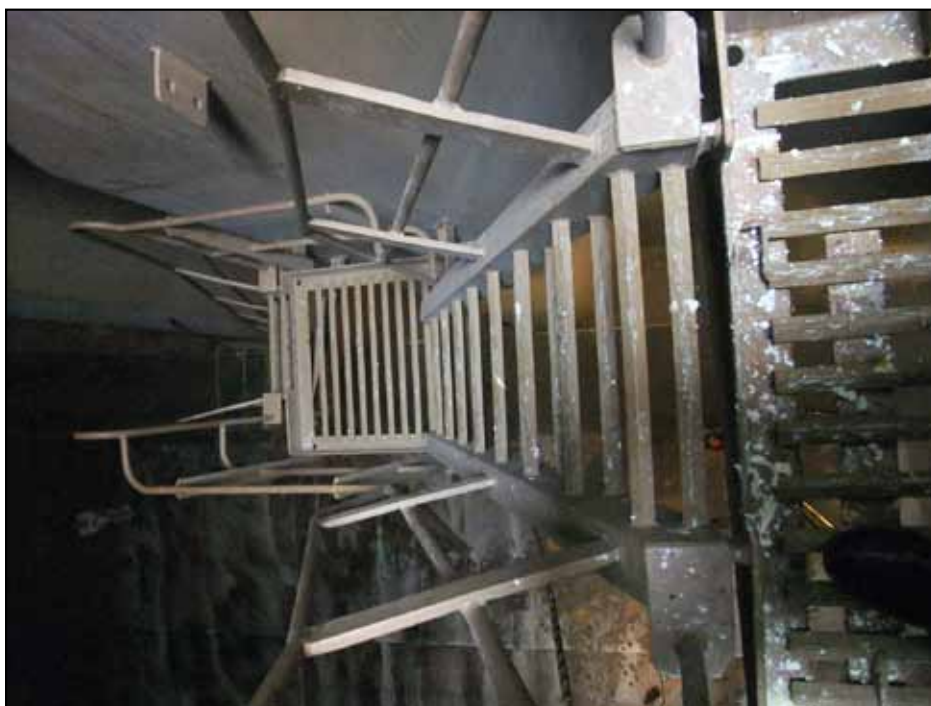
Figure 7

No 2 cargo tank - angled ladders

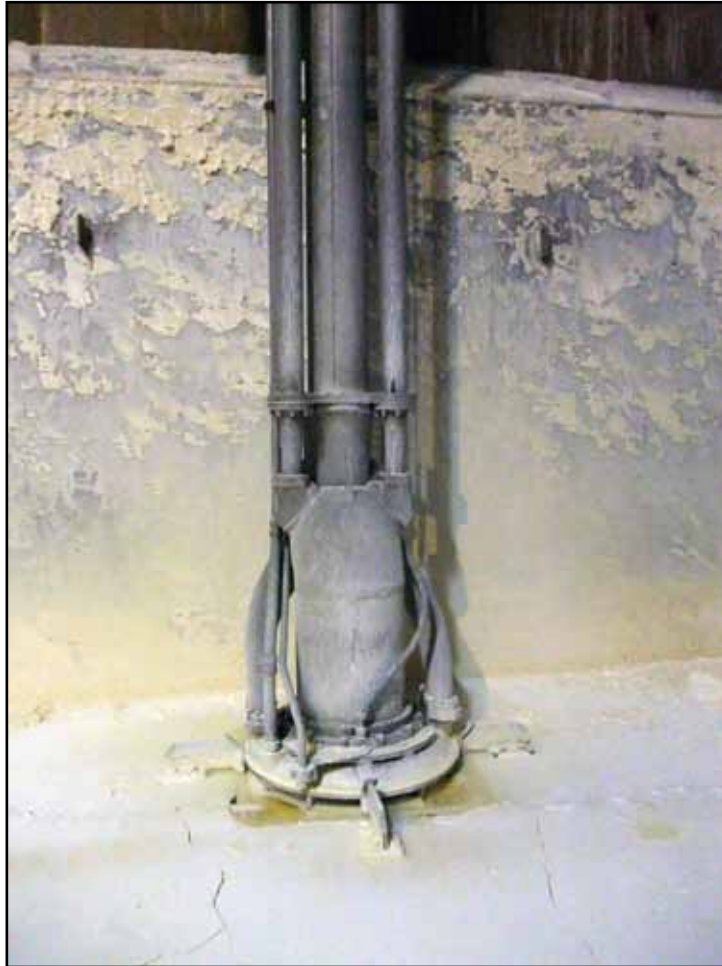
Figure 8

From his prominent position, and because of the lighting levels, the supercargo was able to easily monitor the cargo being “swept” into the pump suction well (**Figure 8**). At 2255 the supercargo called to the “sweepers” that he was satisfied, and indicated they should leave the tank. The supercargo saw the “sweepers” heading towards the first angled ladder as he exited the tank.

No 2 cargo tank - cargo pump section well

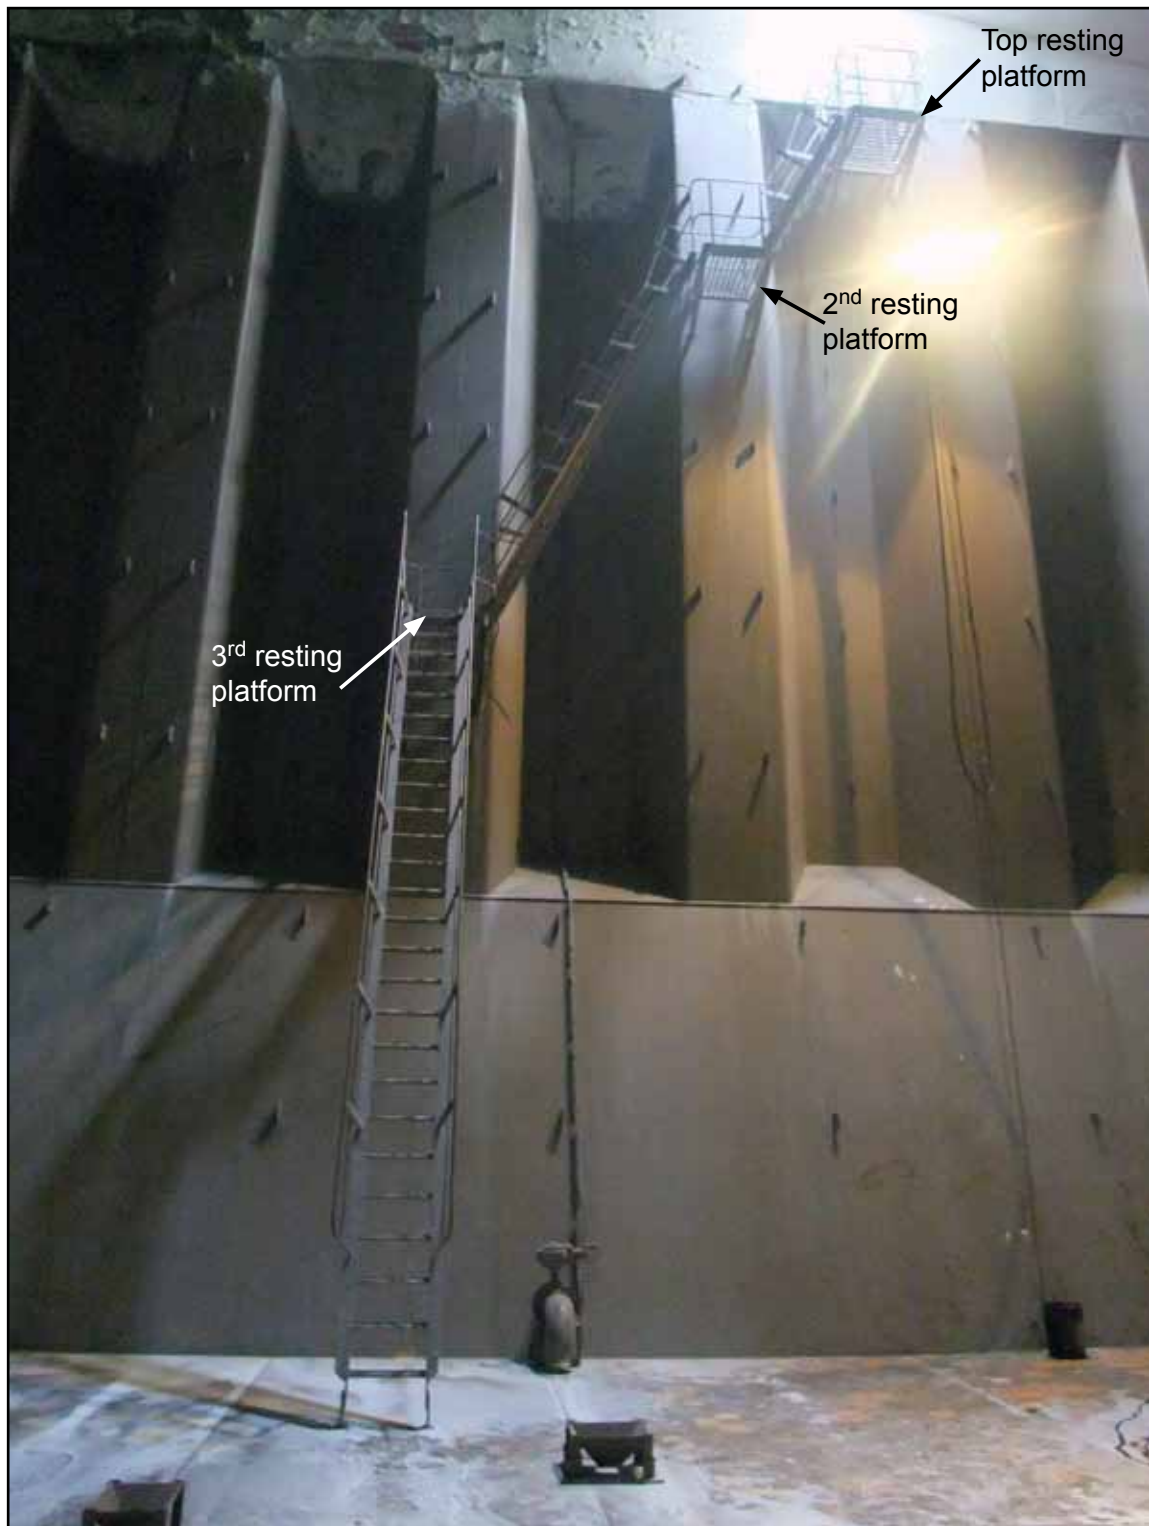
Figure 13

No 2 cargo tank was accessed directly from the main deck through a 1.1m diameter round hatch and 1m deep hatch coaming fitted with two internal and two external rungs. The 3.45m vertical ladder (**Figure 9**), which was not fitted with any back restraining hoops, led to the 0.8m² top resting platform (**Figure 6**). The platform was fitted with a central hinged access for casualty evacuation purposes. The access was secured with two drop nosed pins.

General arrangement of No 2 cargo tank access system

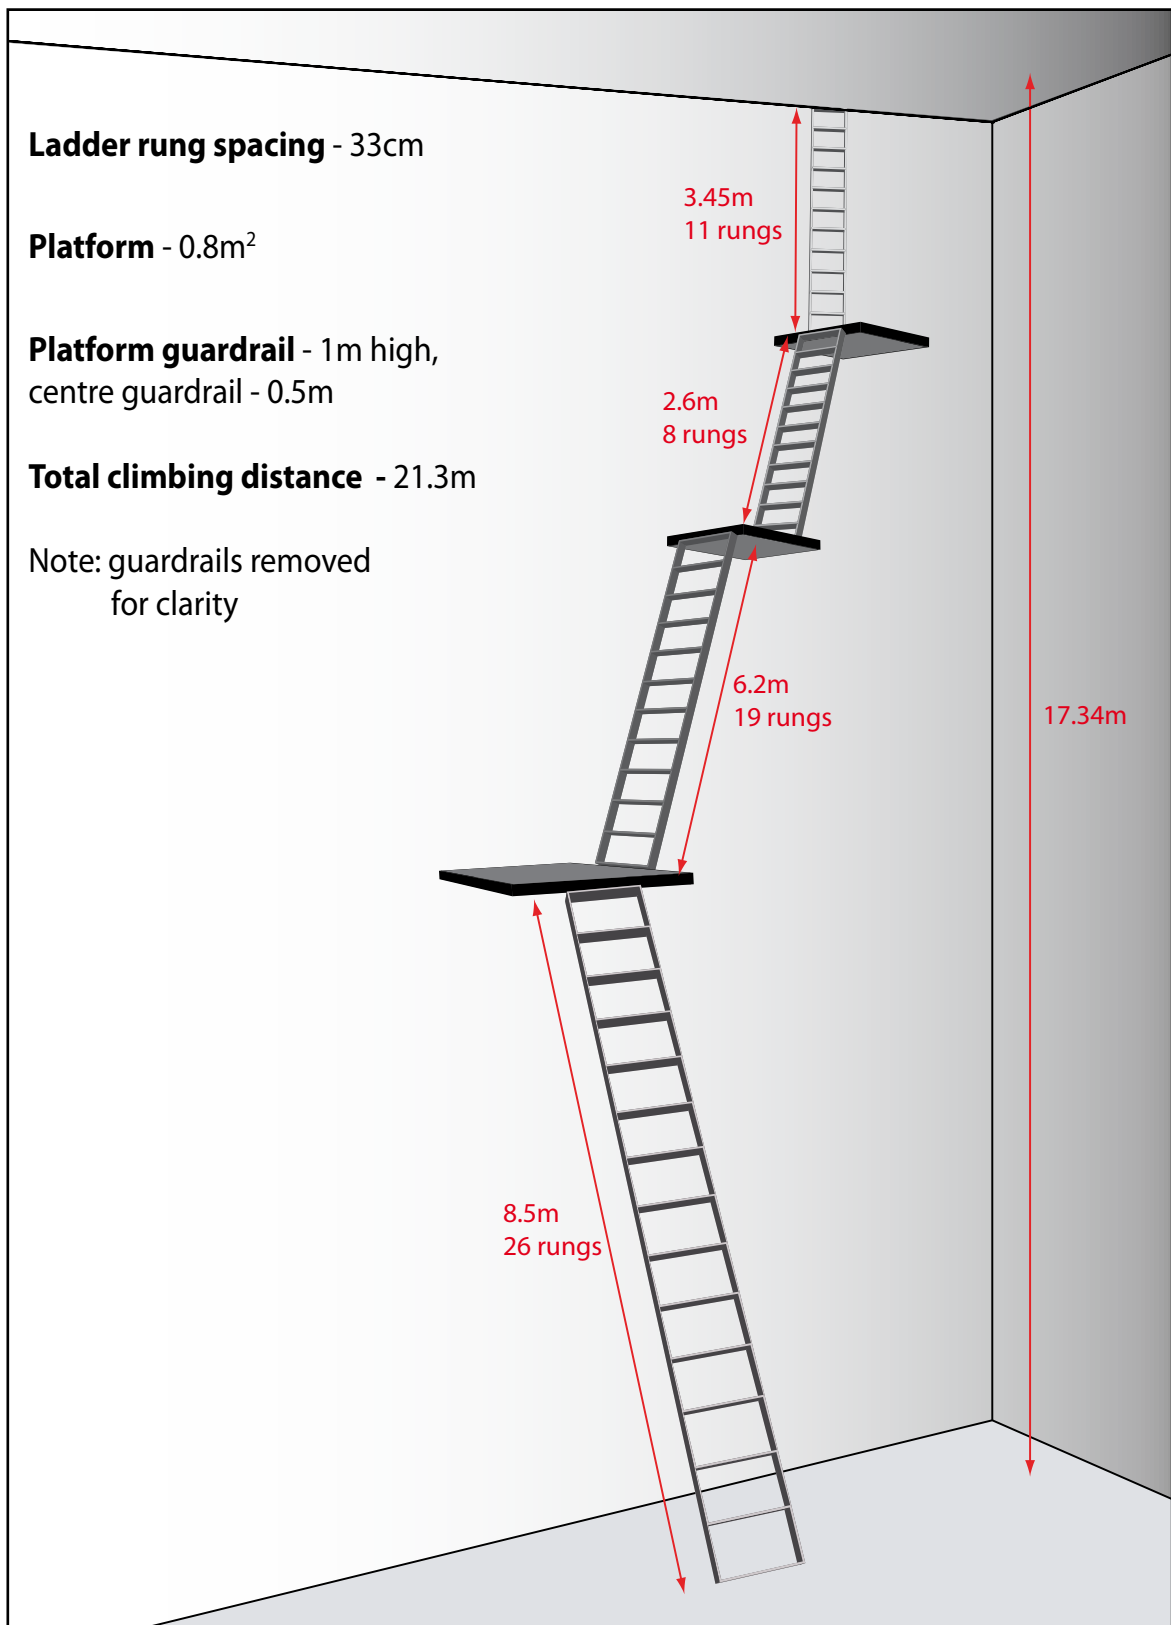
Figure 14

No 2 cargo tank vertical and angled ladder dimensions

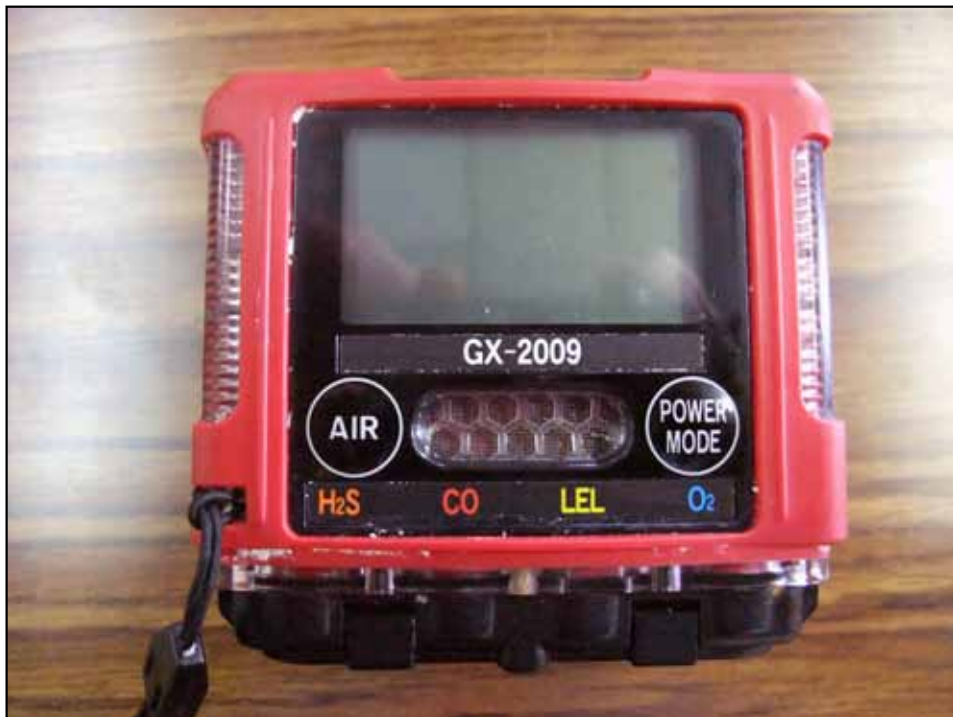
Figure 16

- Two Riken Keiki, GX-2009 (Ex Type A) PGMs with a 10m sampling extension hose (**Figure 16**), for measuring combustible gas, O₂, H₂S and CO levels.
- Two Gastec GV-100S (**Figure 17**) gas sampling hand pumps with a selection of detector tubes for measuring toxic gases including CO, H₂S, benzene and total mercaptan. No sampling extension hoses were delivered with the units. However, since the accident, two 20m hoses have been supplied to the ship.

Riken Keiki GX-2009 (Ex Type A) Personal Gas Monitor
