Report on the investigation of
The machinery space fire on board

Oscar Wilde

In Falmouth Bay

Report No 3/2011
March 2011

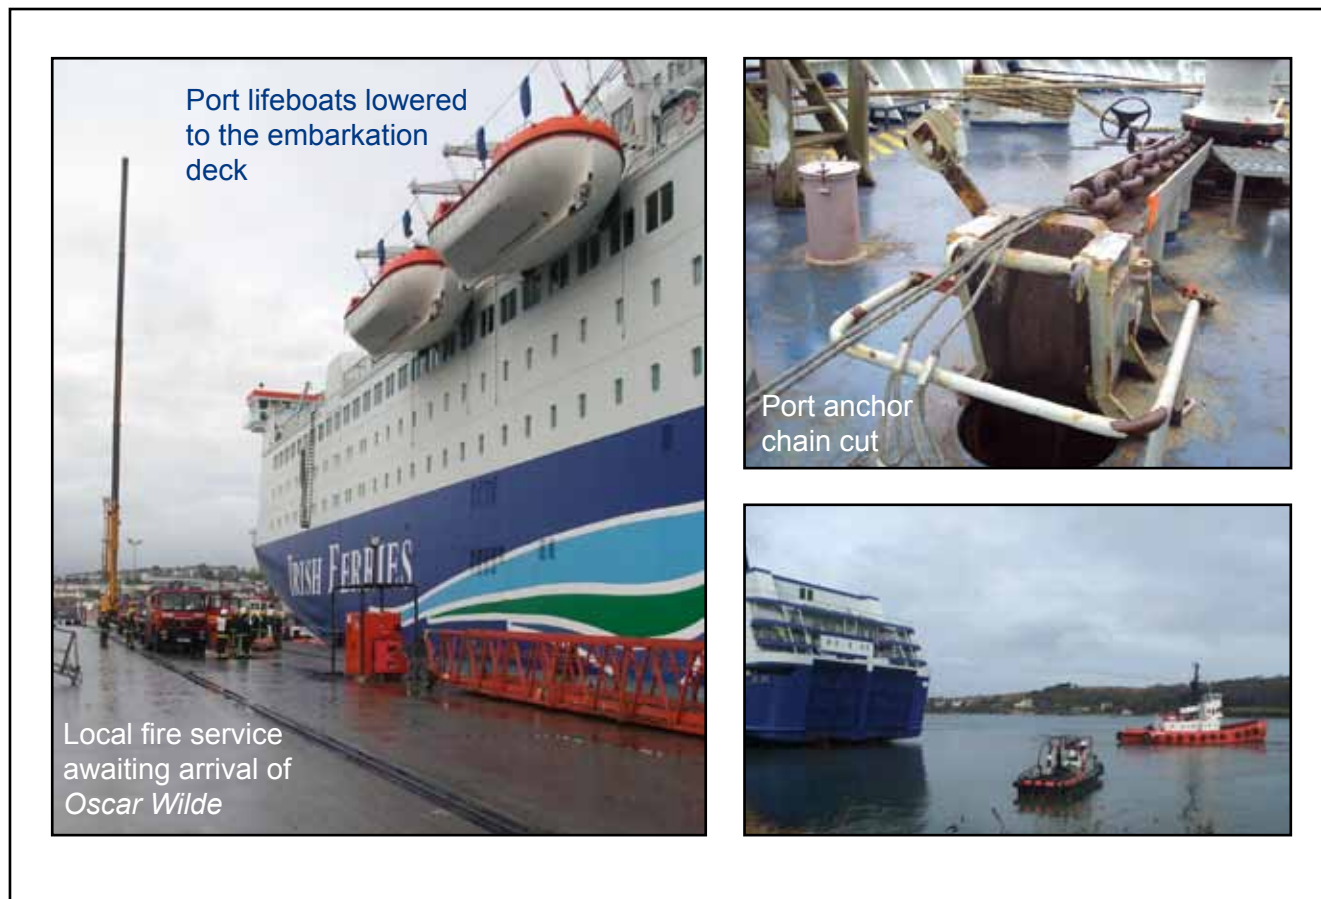
Figure 9

Due to the extent of the fire damage it was not possible to restore main electrical power to the vessel. Therefore, the anchor could not be recovered. At 0555 the following morning, the port anchor chain was cut to allow the vessel to be towed back to Falmouth (**Figure 9**).

Oscar Wilde towed back to the Falmouth ship repair yard

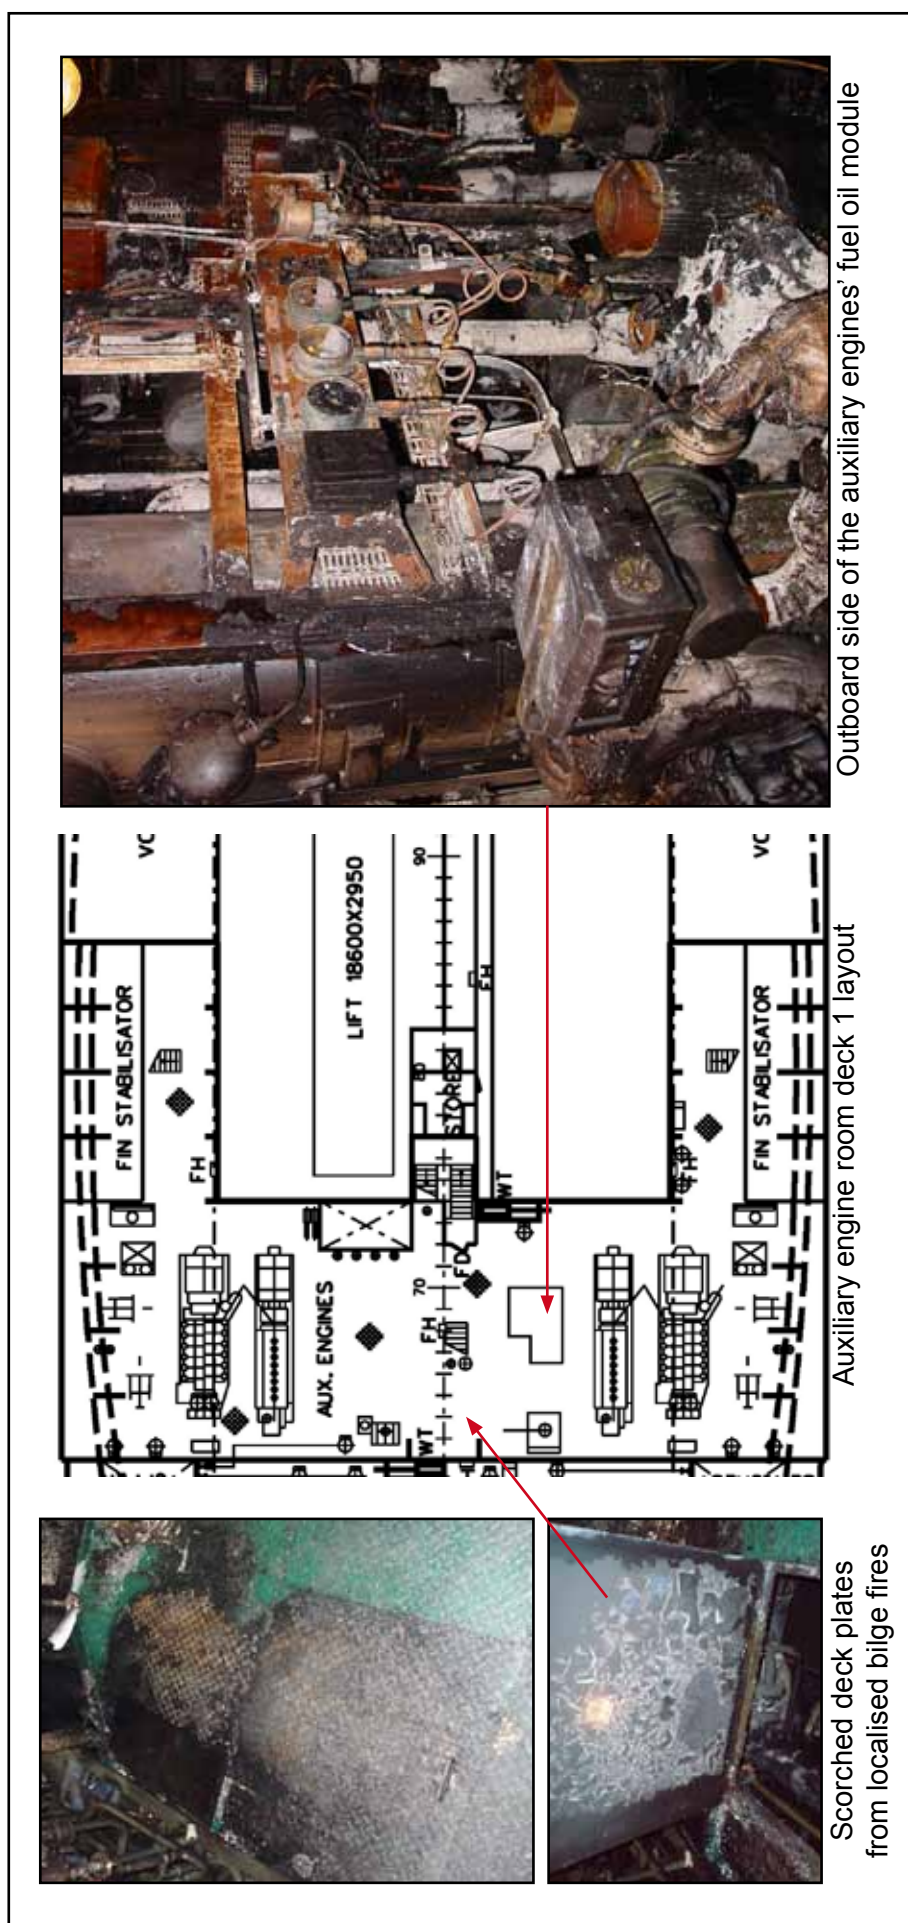
Figure 10

- on the outboard side of the auxiliary engine fuel module (**Figure 10**)
- in the AER bilge adjacent to WTD2 (**Figure 10**)
- in the corridor between the port aft ECR door and deck 2 lobby area (**Figure 11**).

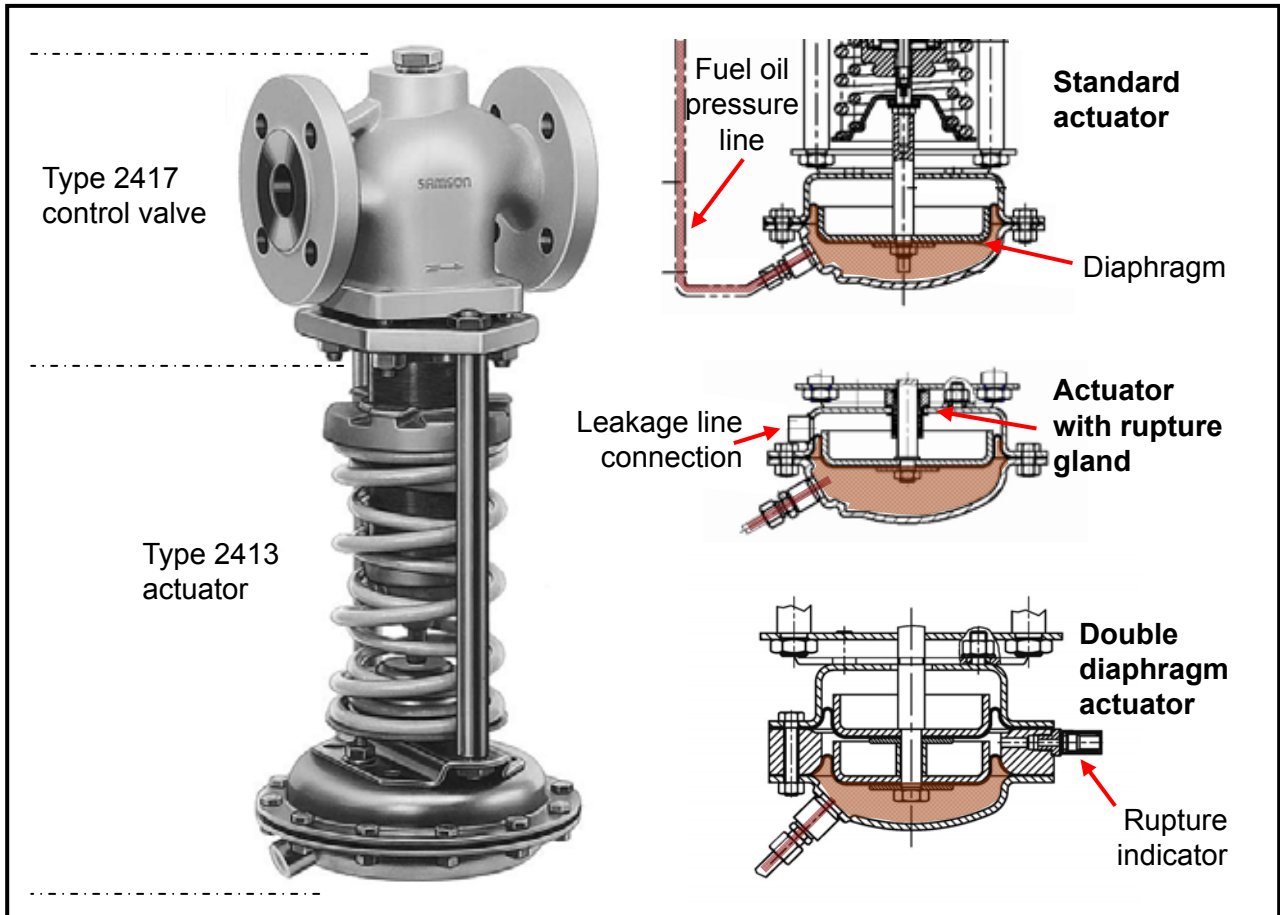
Figure 21

The excess pressure regulating valve fitted to the auxiliary engines' fuel module was a type 41-73 self-operated back pressure regulating valve manufactured by Samson Controls Ltd (**Annex A**). The regulating valve comprised two main components: a type 2417 control valve and a type 2413 actuator (**Figure 21**).

Samson Type 41-73 self-operated back pressure regulating valve

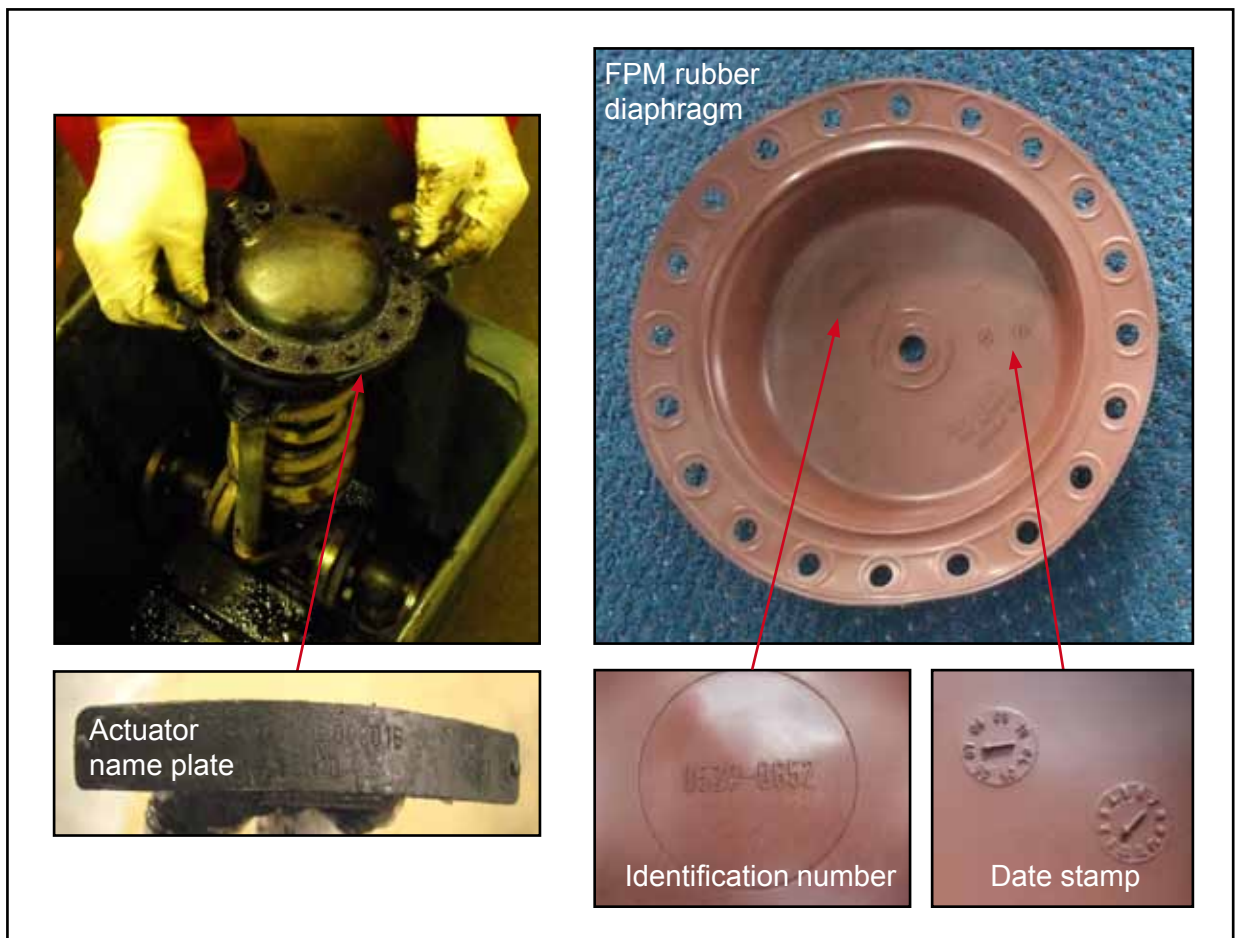
Actuator name plate and diaphragm markings

The test report on the diaphragm removed from the valve actuator identified deterioration of the rubber and a tear in its main flex region (**Annex B**). This damage was remote from the fire damage evident at its outer edge. The diaphragm was made from EPDM rubber and was therefore not suitable for use in fuel oil systems. The actuator had a diaphragm area reducing plate which increased the valves' operating pressure range to 4.5 to 10bar (**Figure 23**). The actuators fitted to the fuel modules on board *Oscar Wilde* were not fitted with any optional safety features.

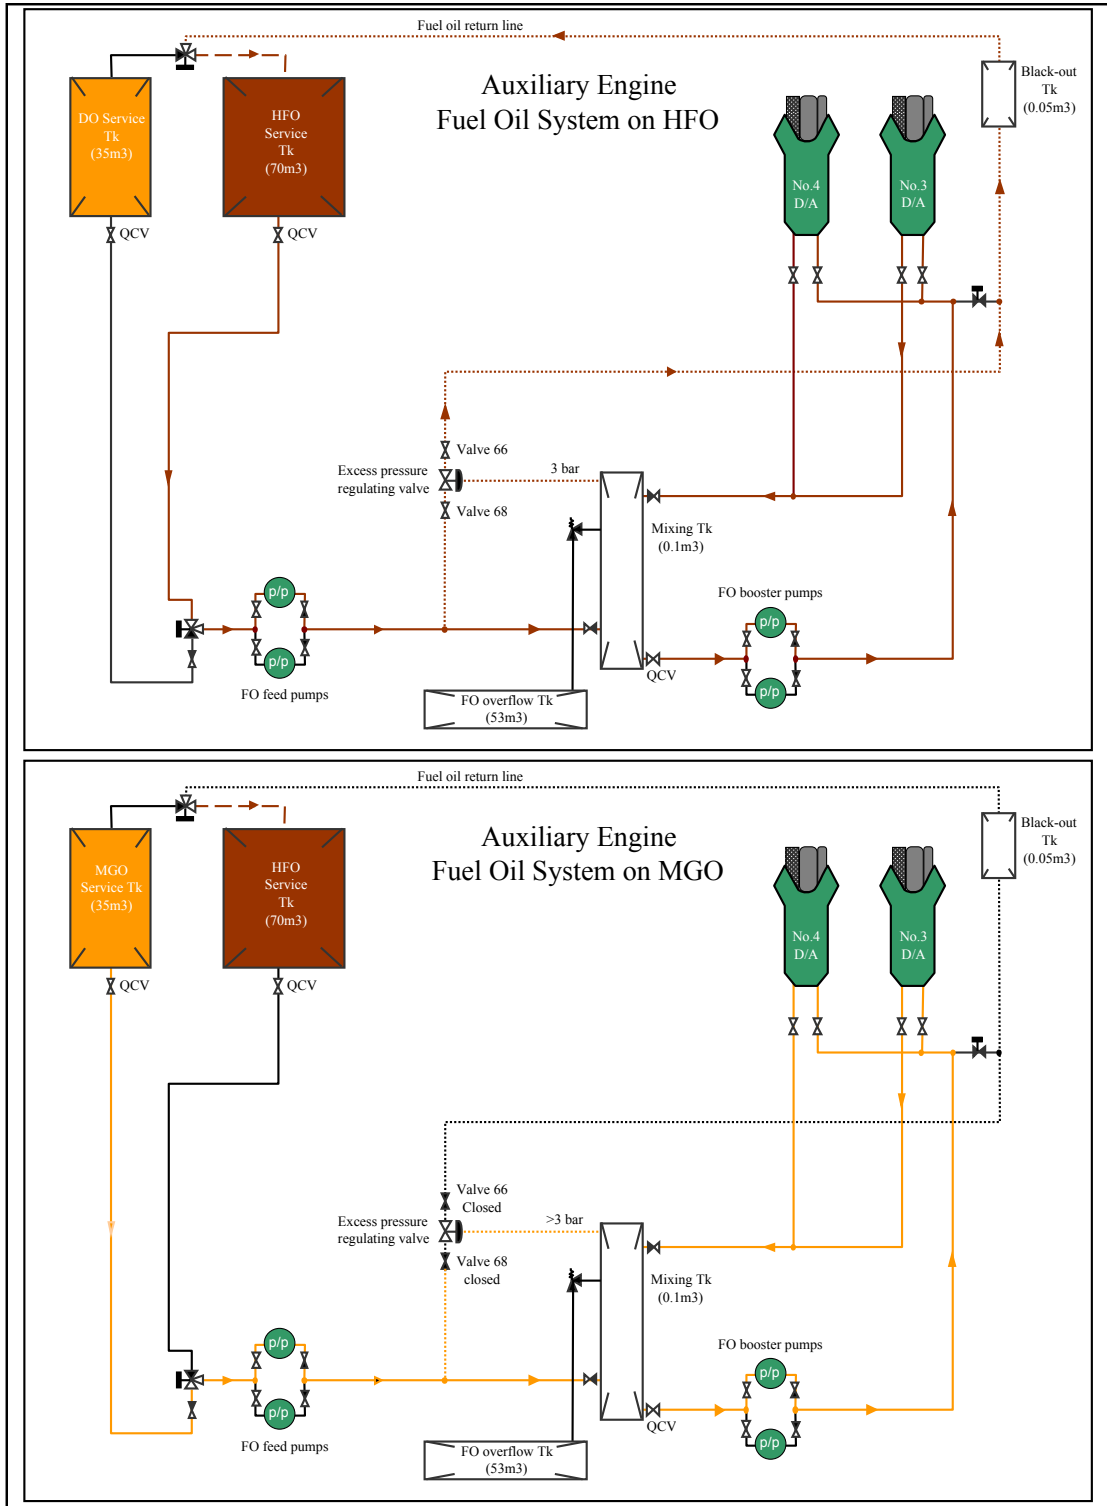
Figure 25

The change-over procedure adopted by DFM differed to the procedure developed by Wartsila. When using MGO, the DFM procedure required the crew to close valves V66 and V68 (**Figure 25**) in the AER in order to isolate the excess pressure regulating valve and prevent fuel returning to the service tanks. The regulating valve control line was not isolated and its actuator remained

open to the mixing tank. When the procedure was first introduced the system pressure increased sufficiently to cause the mixing tank relief valve to lift. To prevent this occurrence, the ship's engineers reduced the feed pumps' relief valve pressure settings.

Simplified illustration of the auxiliary engines' fuel oil system

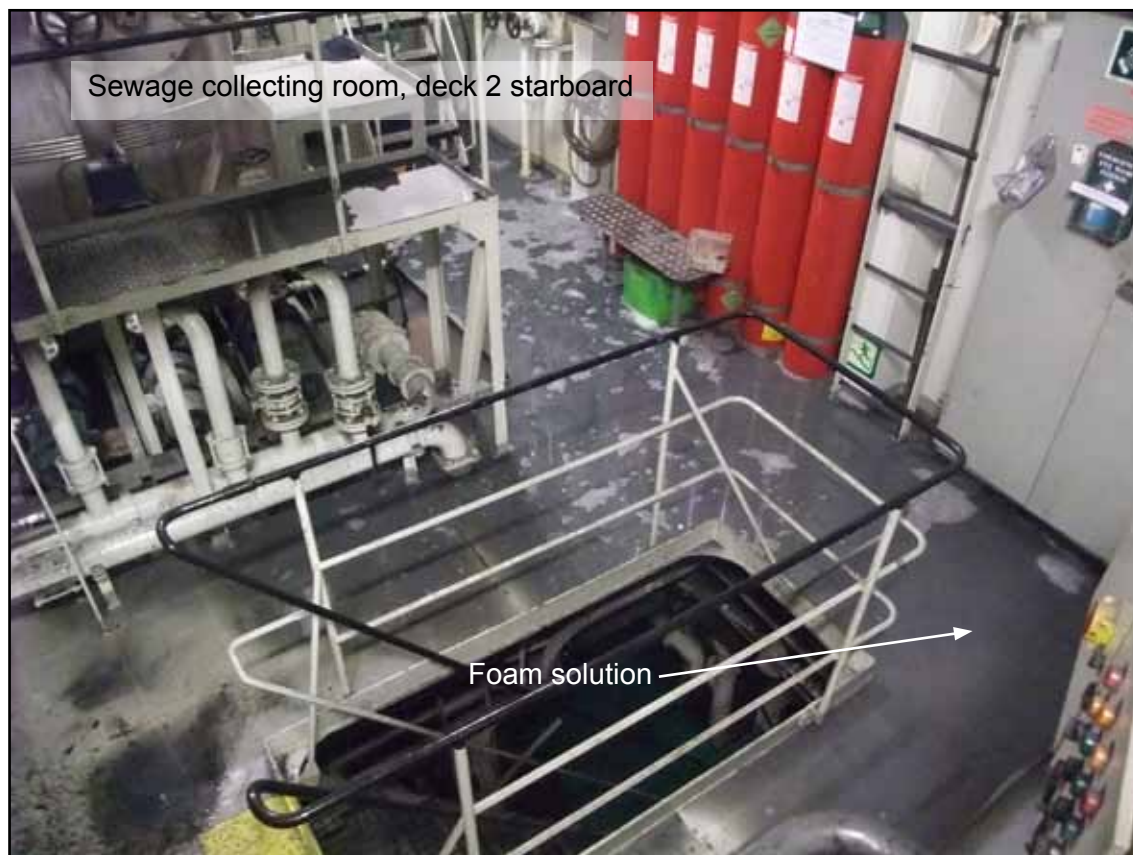
Following the fire, the system’s control valves were found to be in the correct position for a discharge into the AER. The foam storage tank was empty but no high-expansion foam was found in the AER. There was evidence that foam solution had entered the compartment via the foam generators. Liquid was dripping from some of the generator nozzles, areas of soot had been washed from the bulkheads immediately behind some of the generators, and soapy liquid was found in several machinery save-alls remote from any of the *Hi-fog* spray heads and fire-fighting efforts (**Figure 35**). Samples collected from the sewage treatment and collecting tank save-alls contained approximately 98% sea water and 2% *Hotfoam* concentrate.

Hotfoam solution delivered to the AER

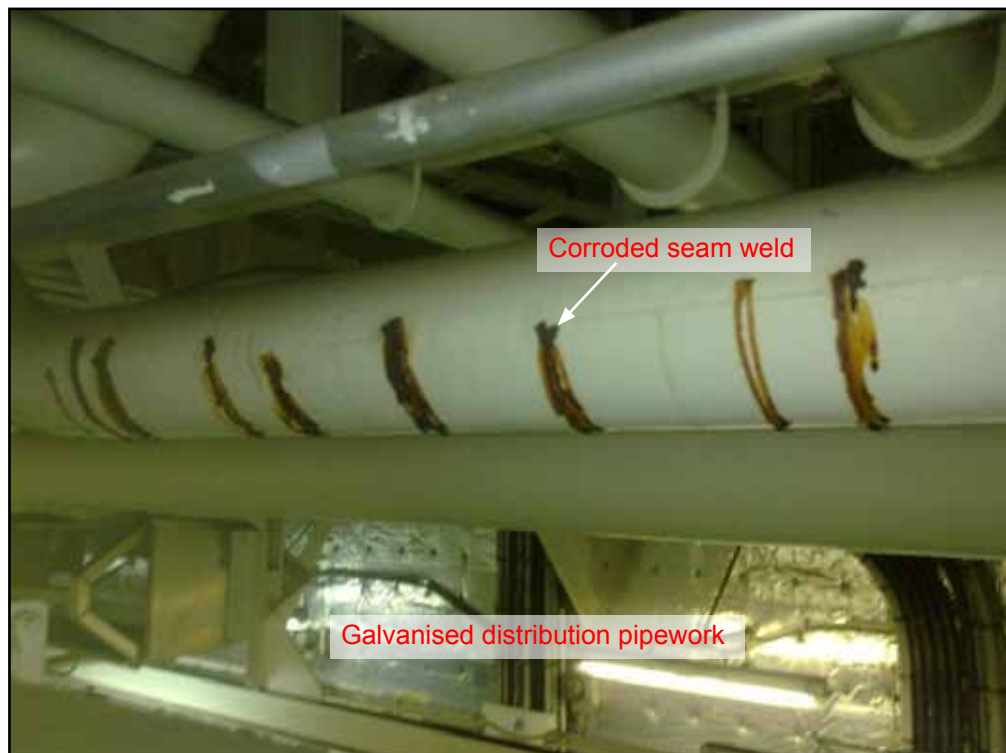
Figure 38

As a result of its findings on board *Oscar Wilde*, Wilhelmsen carried out several enhanced surveys of *Hotfoam* systems fitted to other vessels. Its service engineers closely inspected the distribution pipework and foam generator nozzles and identified that water traps were common, and that corrosion was prevalent within the dry pipe systems. They also found that welded seams within galvanised systems were particularly prone to corrosion (**Figure 38**). In addition, many foam generators could not be accessed to allow nozzles to be inspected, particularly on the larger tankers.

Hotfoam system survey on other vessels

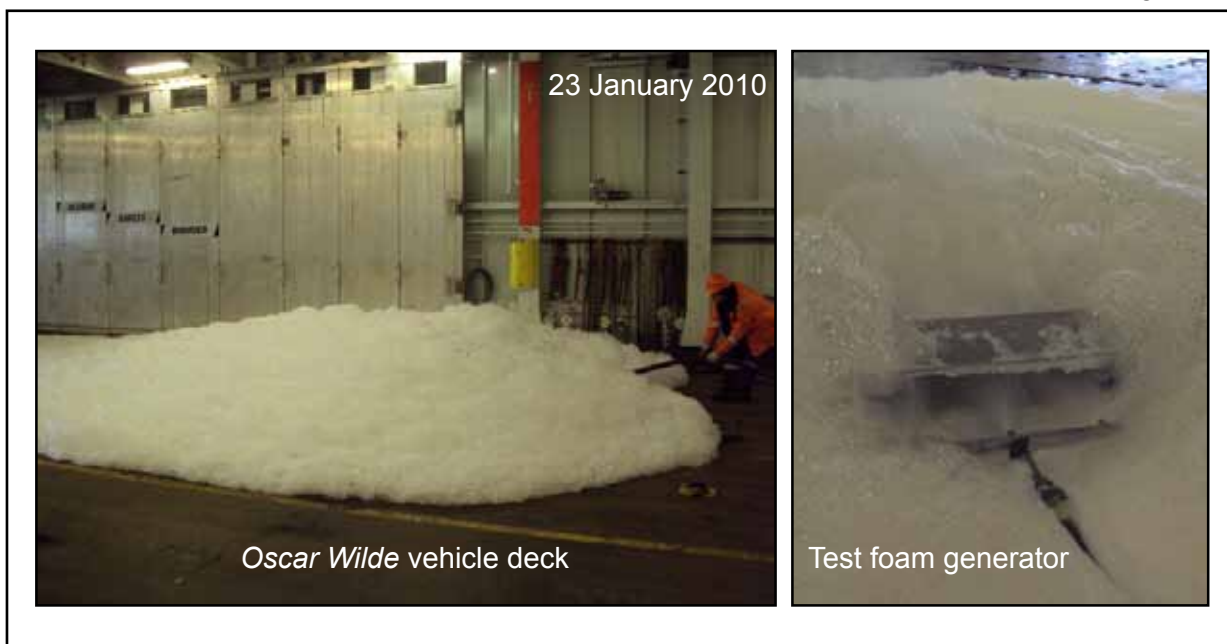
Figure 40

A Wilhelmsen service engineer last conducted the annual maintenance on 15 May 2008; again no defects or shortfalls were identified (**Annex H**). The foam concentrate test certificate stated that the foam tank had been filled in March 2002. The manufacturer recommended that the concentrate be renewed every 5 years.

Hotfoam system discharge test

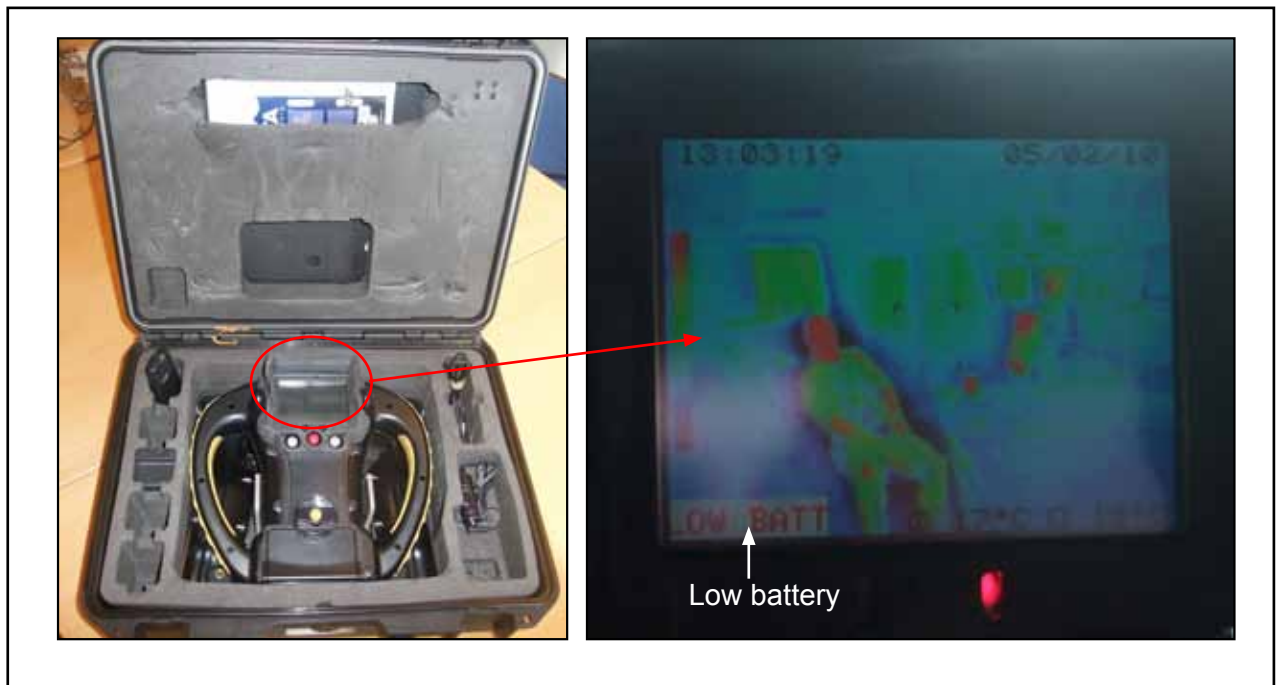
Figure 41

The ship held a thermal imaging camera which was located at the deck fire party's muster point. It was standard practice to take the camera to a scene of a fire. On this occasion, the fire party forgot to take the camera to the lower hold and it remained unused in the fire store throughout the incident. After the fire, it was found that the camera's battery had not been charged prior to sailing and only had sufficient charge to power the camera for 1 to 2 minutes (**Figure 41**).

Thermal-imaging camera
