Report on the investigation of the collision between
the bulk carrier
Alam Pintar
and the fishing vessel
Etoile des Ondes
15 miles north of the Cherbourg peninsula
on 20 December 2009
resulting in one fatality
and the loss of the fishing vessel

Marine Accident Investigation Branch
Mountbatten House
Grosvenor Square
Southampton
United Kingdom
SO15 2JU

Report No 11/2010
September 2010

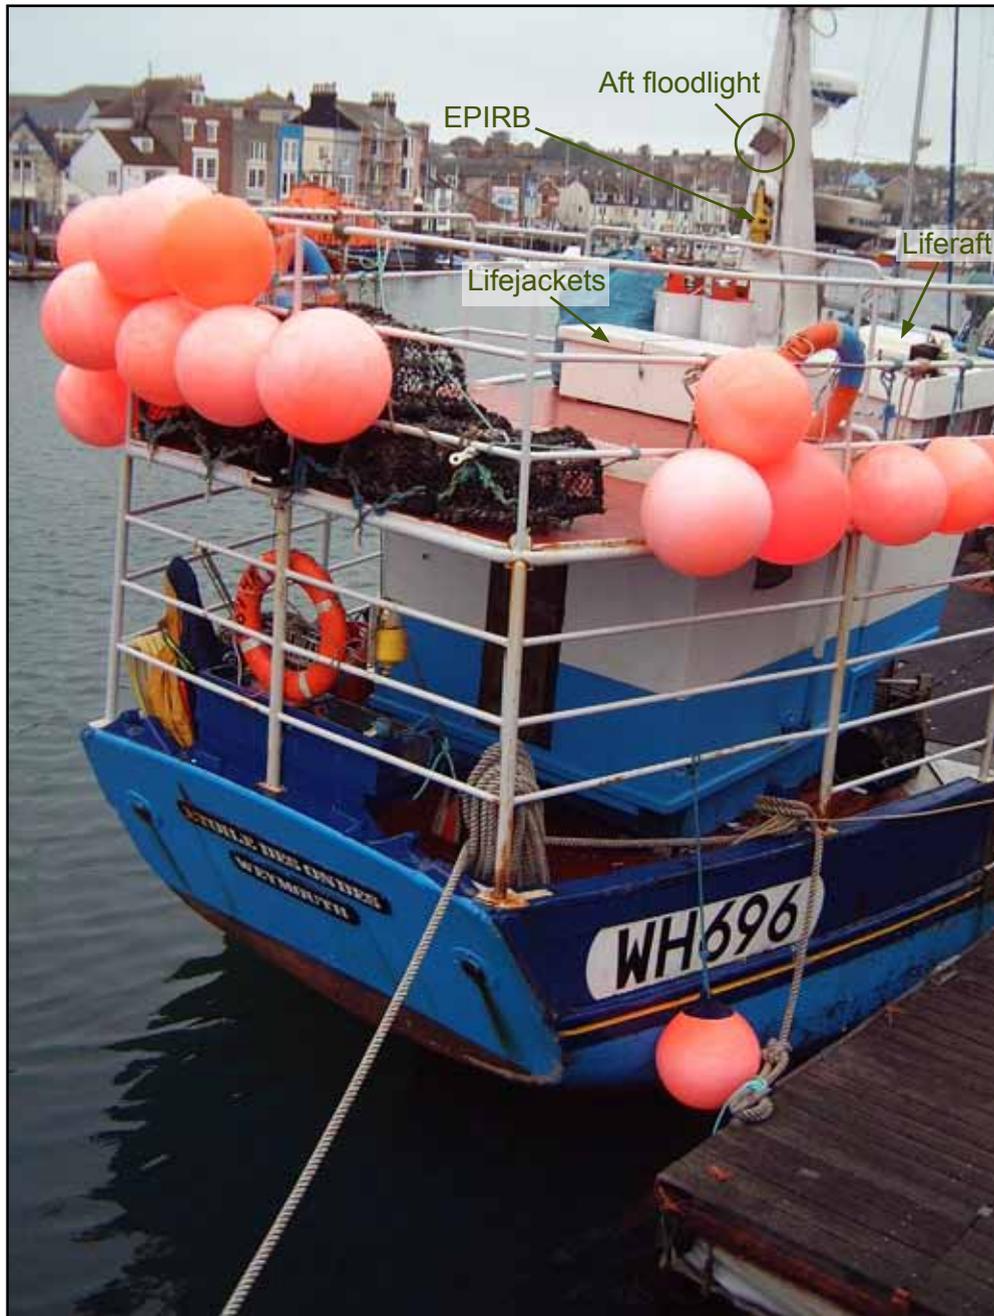
General overview of *Etoile des Ondes*' wheelhouse top and quarter deck (deck shelter omitted for clarity)

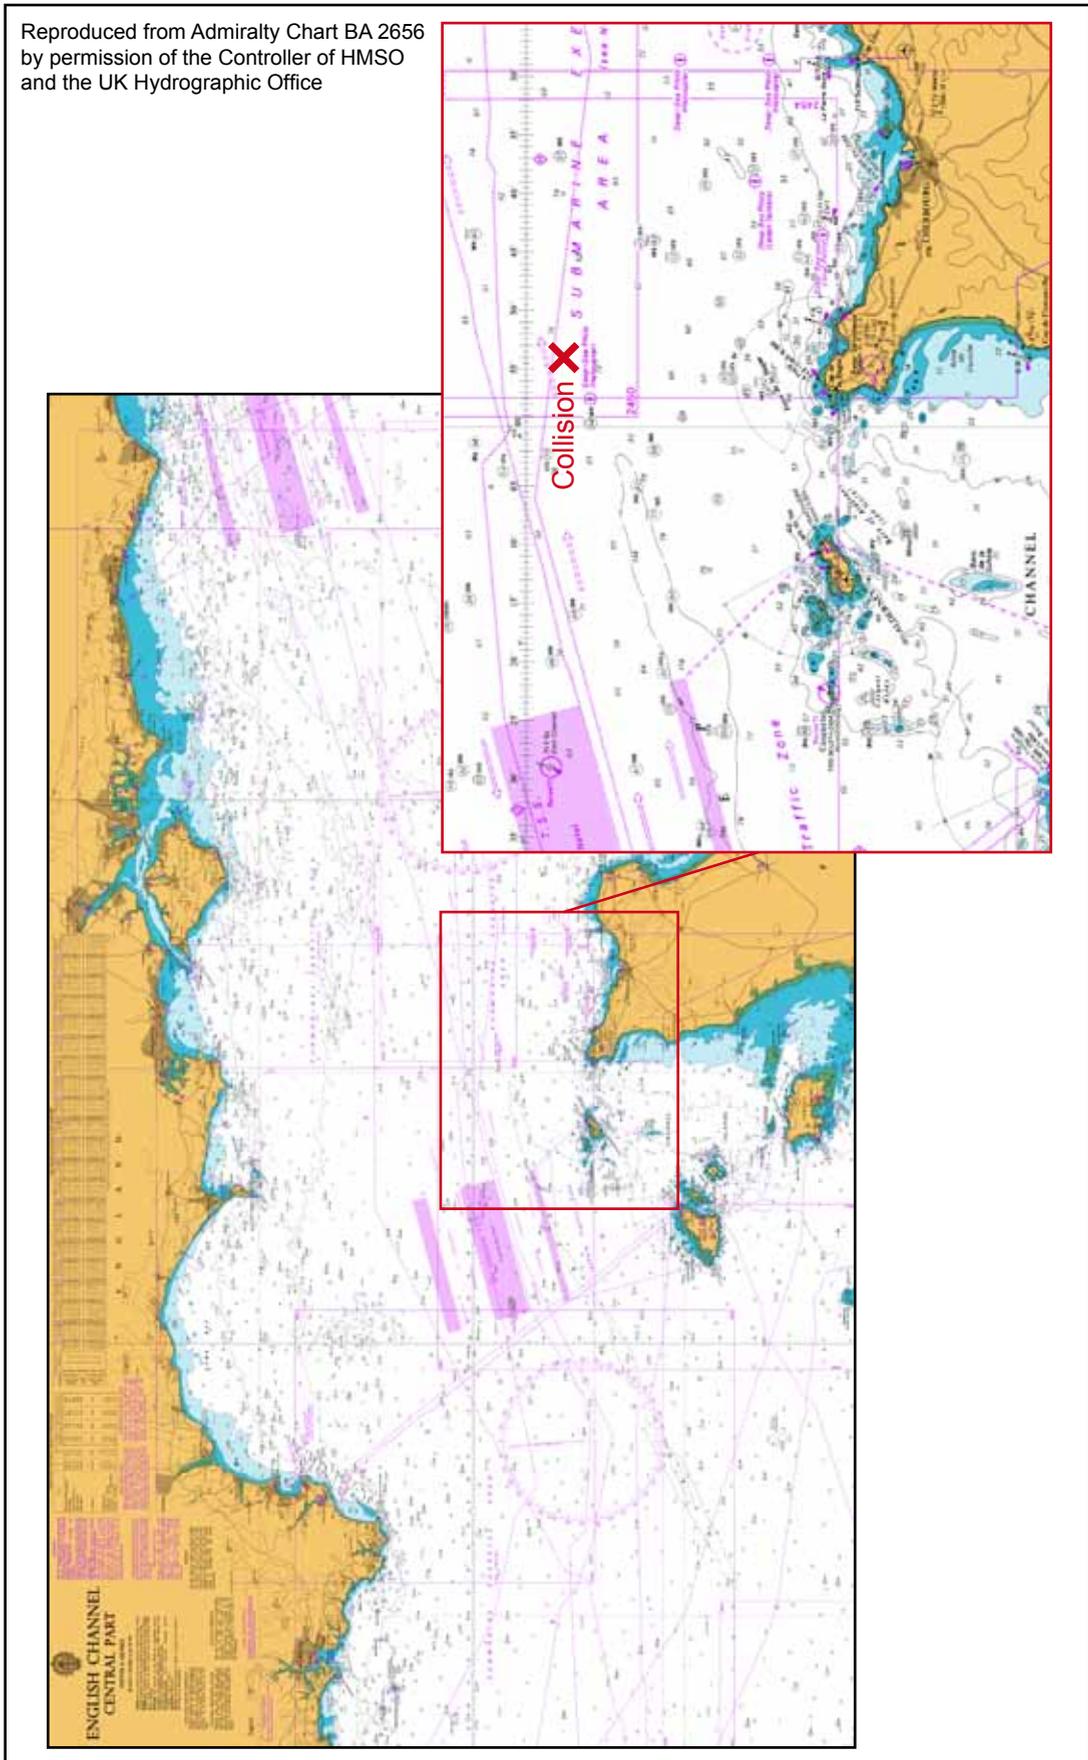
Figure 11

The area north of Cherbourg was used regularly by the skipper of *Etoile des Ondes* (**Figure 11**). The area is deep, 75 to 80m, and subject to strong tidal streams, which effectively restricted shooting and hauling to around the turn of tide.

Etoile des Ondes fished with strings of 70 to 80 pots, each of which was about a mile long. On the day of the accident these strings were being laid out in a north to south pattern, which was across the general direction of traffic flow. Although the skipper had fished these grounds for several years, he had never conducted a risk assessment to identify the additional dangers posed by the heavy traffic in this area.

Overview chart of the fishing grounds and detail of the area of collision

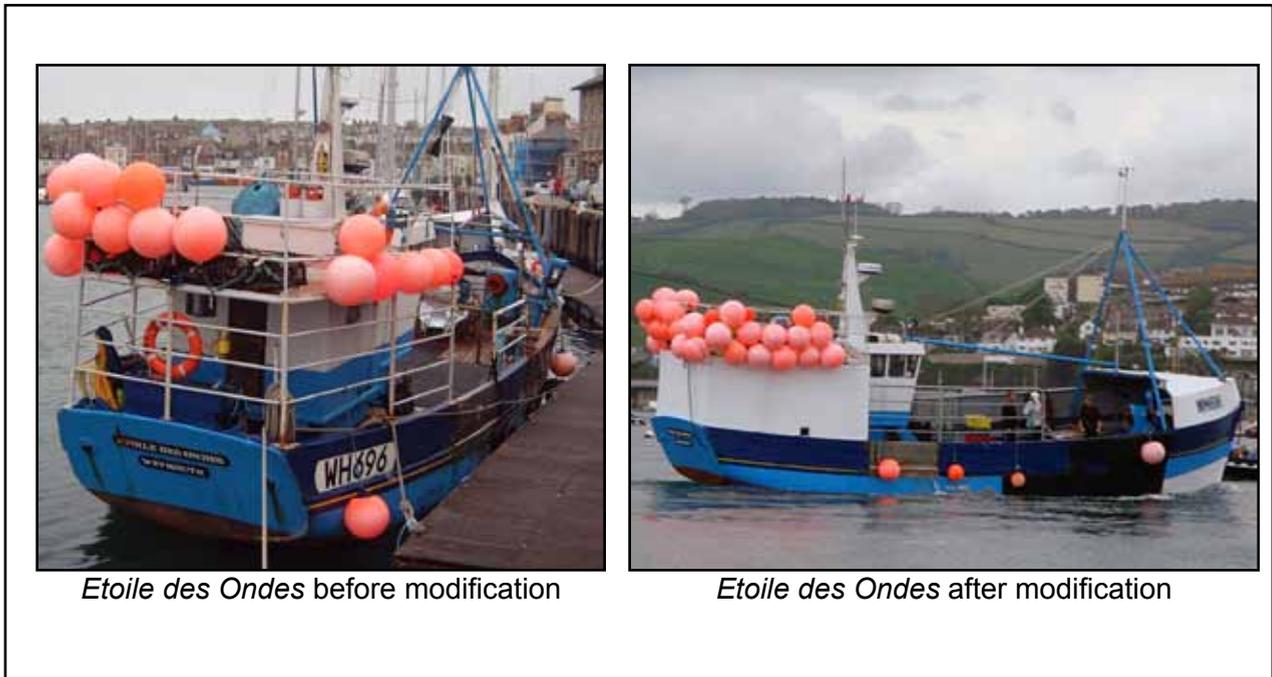
Figure 13

During *Etoile des Ondes*' last refit her bow and quarter areas had been enclosed with ply board sheets to provide shelter to the crew when on deck (**Figure 13**). These modifications restricted the view astern from the wheelhouse and it now required the lookout to make a positive effort to look astern. This area was also used to stow any spare fishing buoys that were not deployed.

A risk assessment should also be conducted whenever structural modifications to vessels are being planned. Although there were valid reasons for enclosing both the bow and stern areas of *Etoile des Ondes* (**Figure 13**), ie protection of the crew, they were made without considering the effect of the modification on the visibility from the wheelhouse. The ability to keep a good, all round lookout should be considered before undertaking any changes.

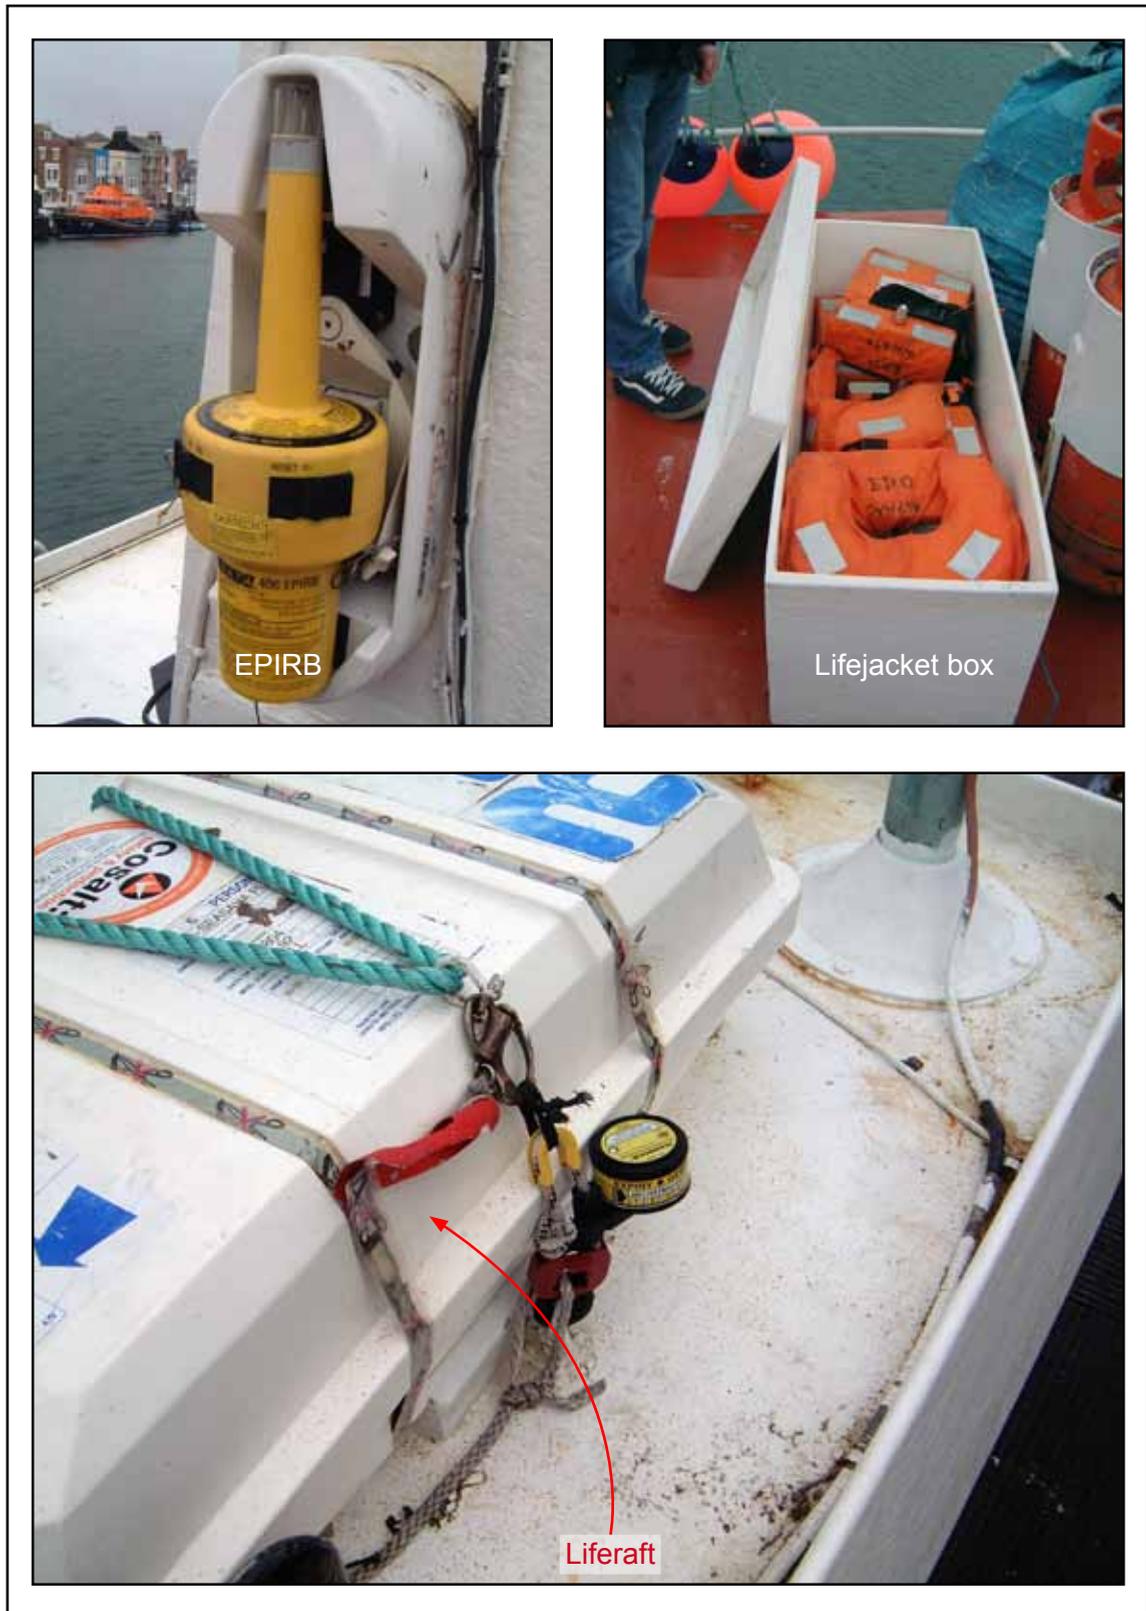
Etoile des Ondes' EPIRB, lifejacket box and liferaft
