Report on the investigation of the collision between  
the bulk carrier  
***Alam Pintar***  
and the fishing vessel  
***Etoile des Ondes***  
15 miles north of the Cherbourg peninsula  
on 20 December 2009  
resulting in one fatality  
and the loss of the fishing vessel

**Report No 11/2010**  
**September 2010**

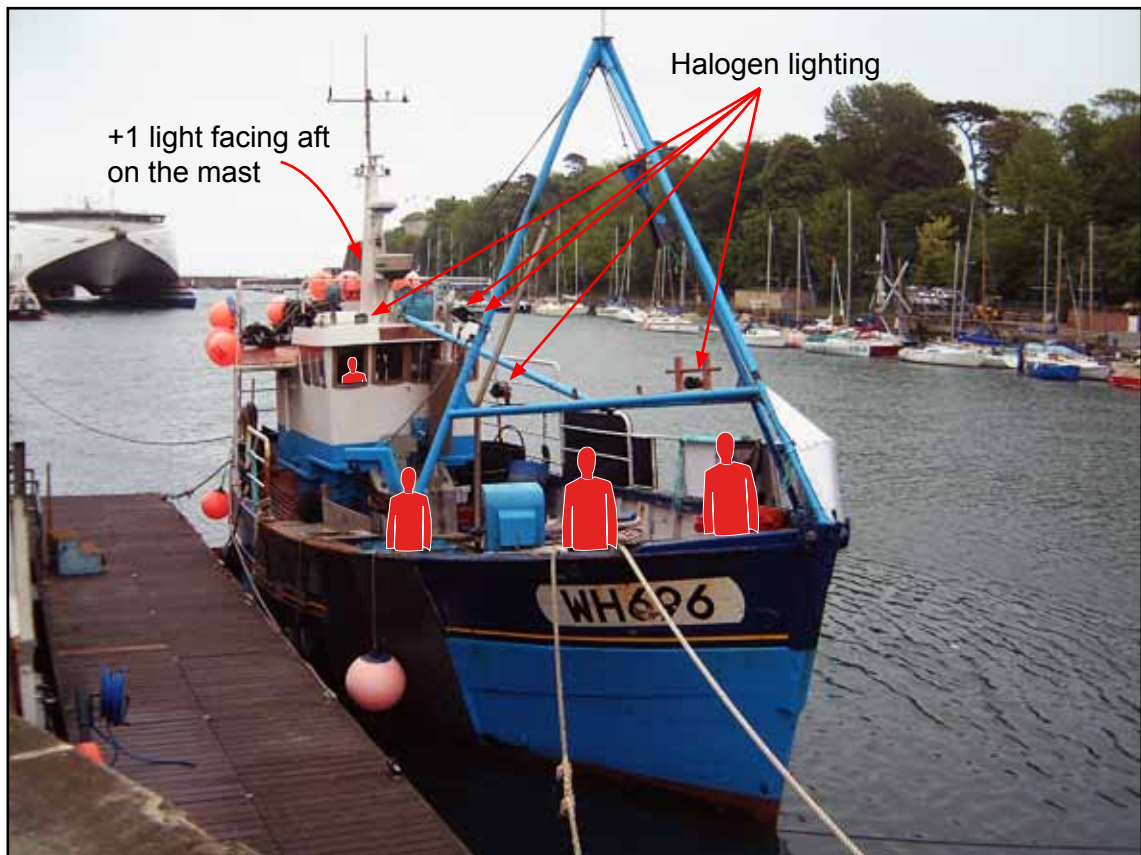
*Etoile des Ondes* - with halogen lighting and crew positions indicated  
(whaleback omitted for clarity)

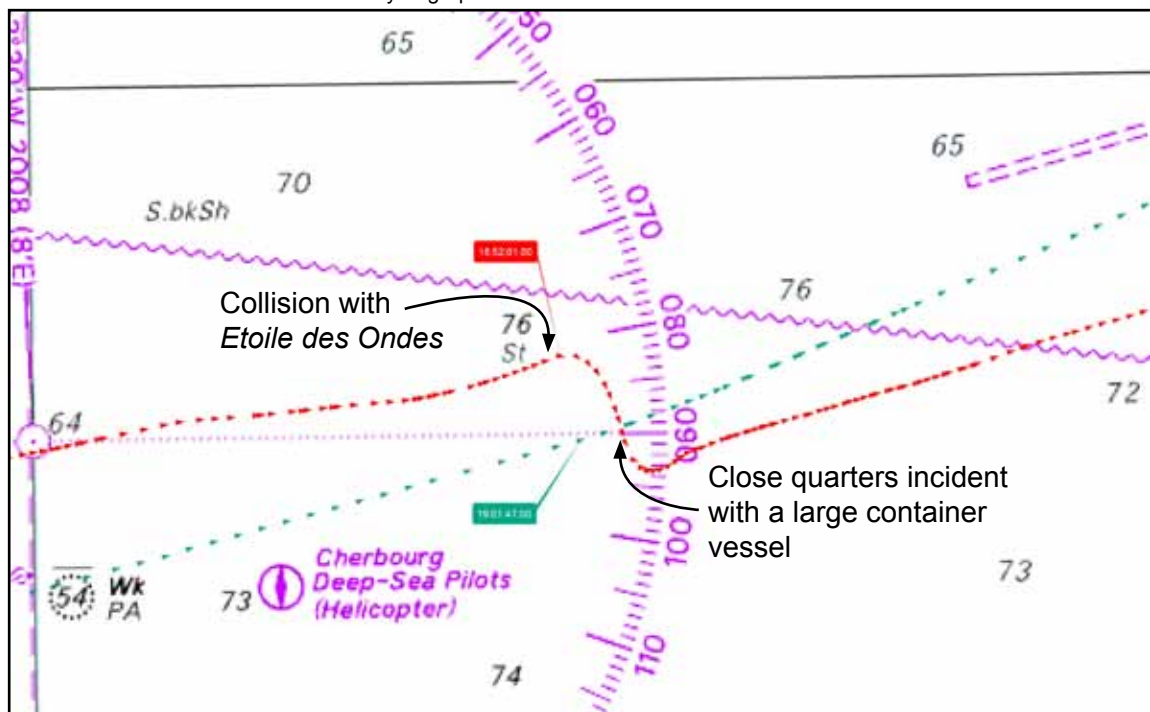
Figure 8

The main engine revolutions were increased to full sea speed, and the master ordered the helm hard-a-port, intending to return to the original course of 077° (G). He then noticed *Alam Pintar* had crossed the path of an overtaking vessel, and soon afterwards *Alam Pintar* was involved in a close quarters situation with a large container vessel as she passed by at a distance of 0.3 nm (**Figure 8**).

AIS track of *Alam Pintar* and a large container vessel

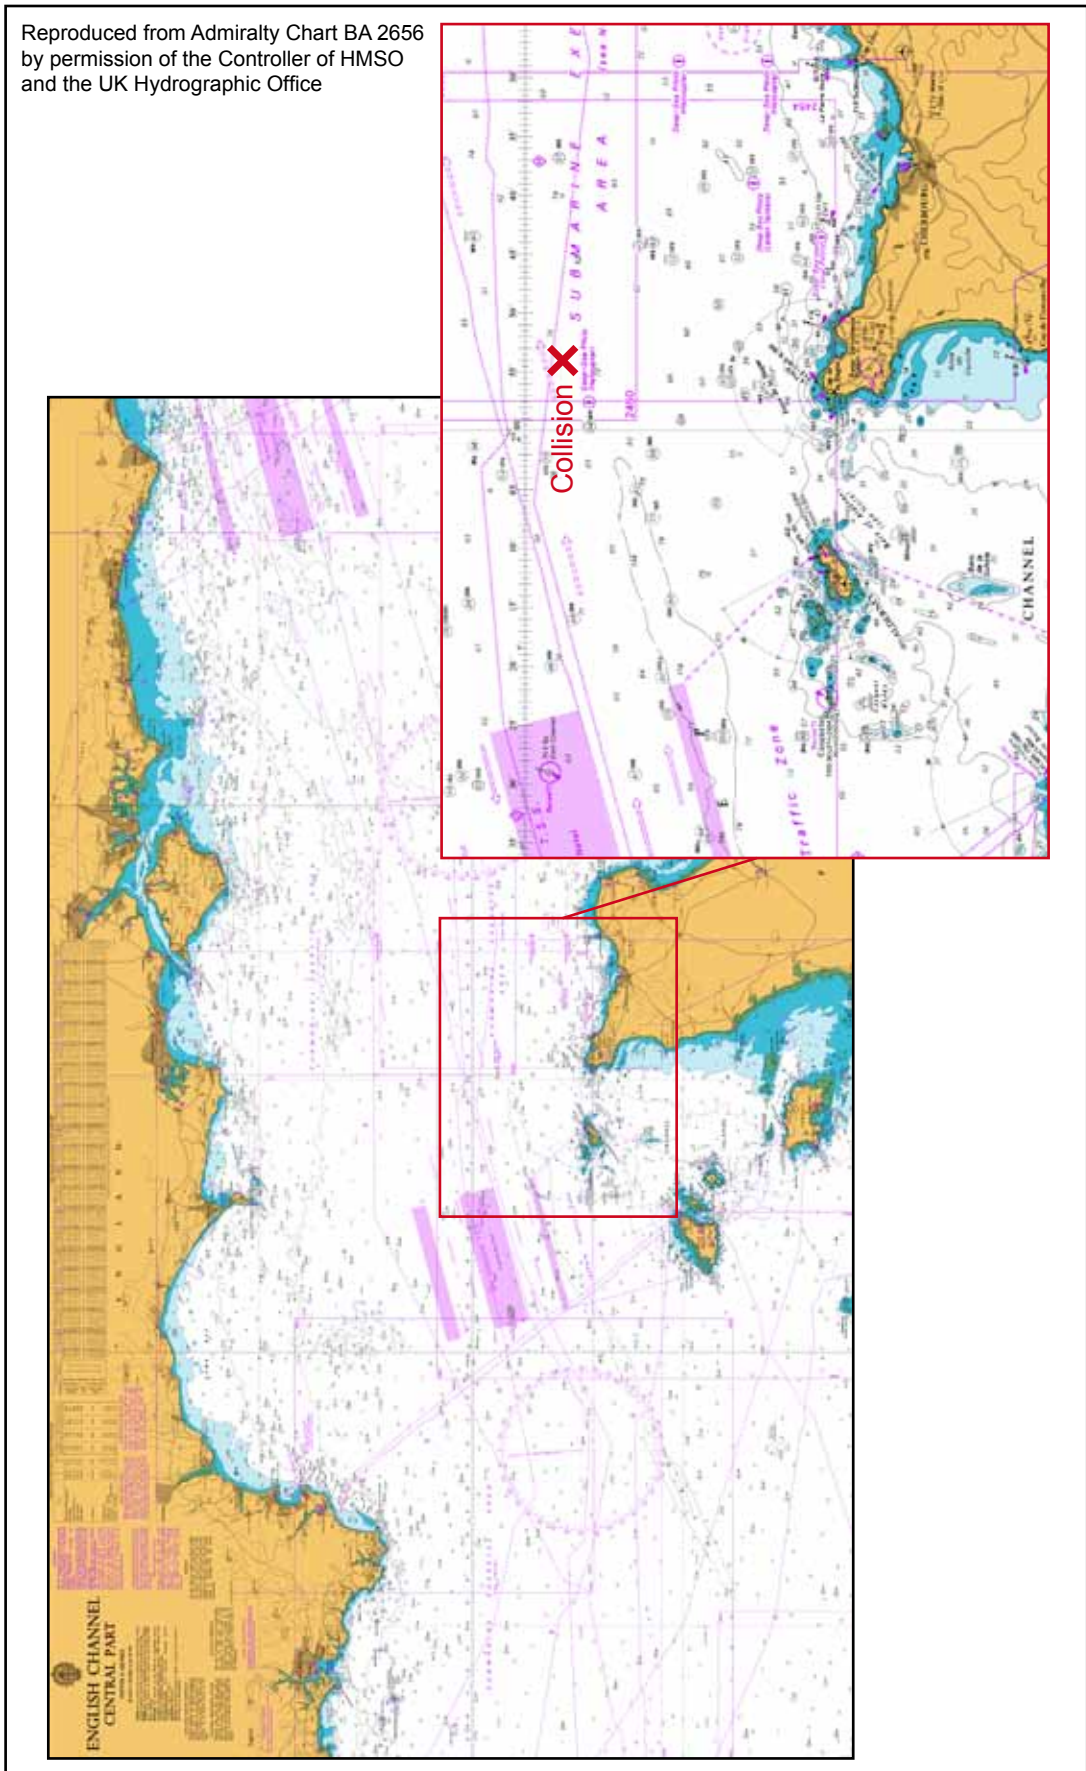
Figure 11

The area north of Cherbourg was used regularly by the skipper of *Etoile des Ondes* (**Figure 11**). The area is deep, 75 to 80m, and subject to strong tidal streams, which effectively restricted shooting and hauling to around the turn of tide.

*Etoile des Ondes* fished with strings of 70 to 80 pots, each of which was about a mile long. On the day of the accident these strings were being laid out in a north to south pattern, which was across the general direction of traffic flow. Although the skipper had fished these grounds for several years, he had never conducted a risk assessment to identify the additional dangers posed by the heavy traffic in this area.

Overview chart of the fishing grounds and detail of the area of collision

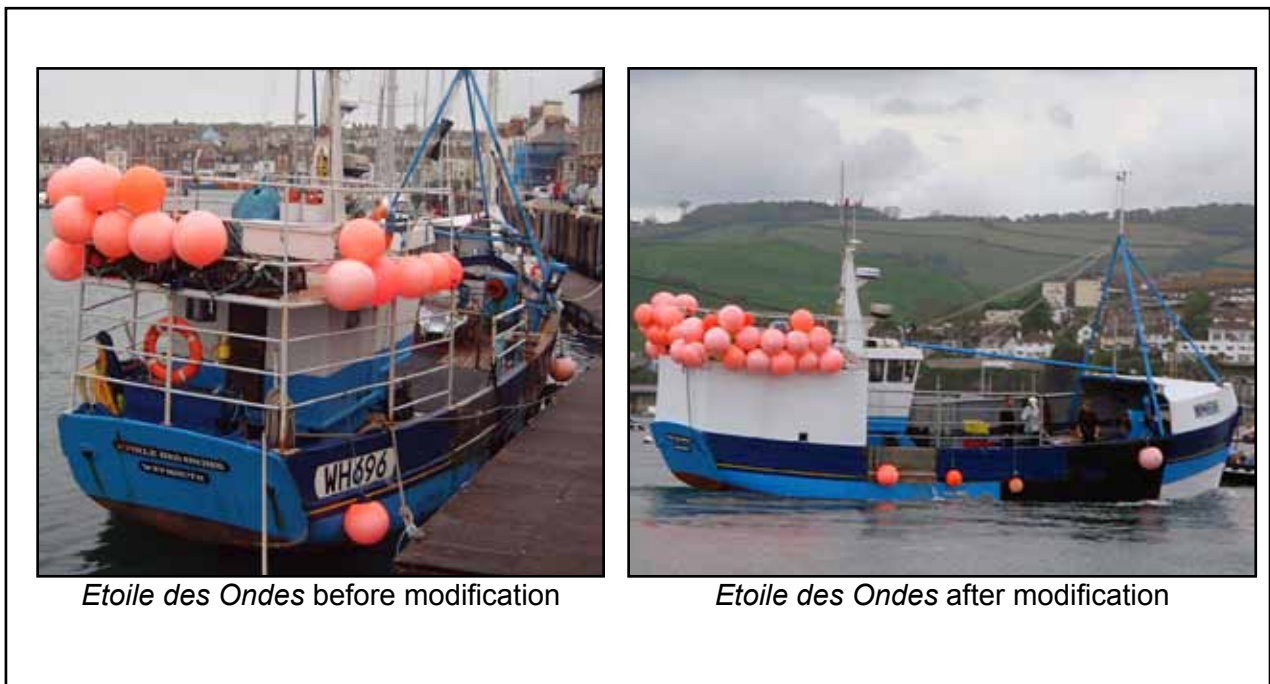
Figure 13

During *Etoile des Ondes*' last refit her bow and quarter areas had been enclosed with ply board sheets to provide shelter to the crew when on deck (**Figure 13**). These modifications restricted the view astern from the wheelhouse and it now required the lookout to make a positive effort to look astern. This area was also used to stow any spare fishing buoys that were not deployed.

A risk assessment should also be conducted whenever structural modifications to vessels are being planned. Although there were valid reasons for enclosing both the bow and stern areas of *Etoile des Ondes* (**Figure 13**), ie protection of the crew, they were made without considering the effect of the modification on the visibility from the wheelhouse. The ability to keep a good, all round lookout should be considered before undertaking any changes.
