Report on the investigation of the collision between
the bulk carrier
Alam Pintar
and the fishing vessel
Etoile des Ondes
15 miles north of the Cherbourg peninsula
on 20 December 2009
resulting in one fatality
and the loss of the fishing vessel

Marine Accident Investigation Branch
Mountbatten House
Grosvenor Square
Southampton
United Kingdom
SO15 2JU

Report No 11/2010
September 2010

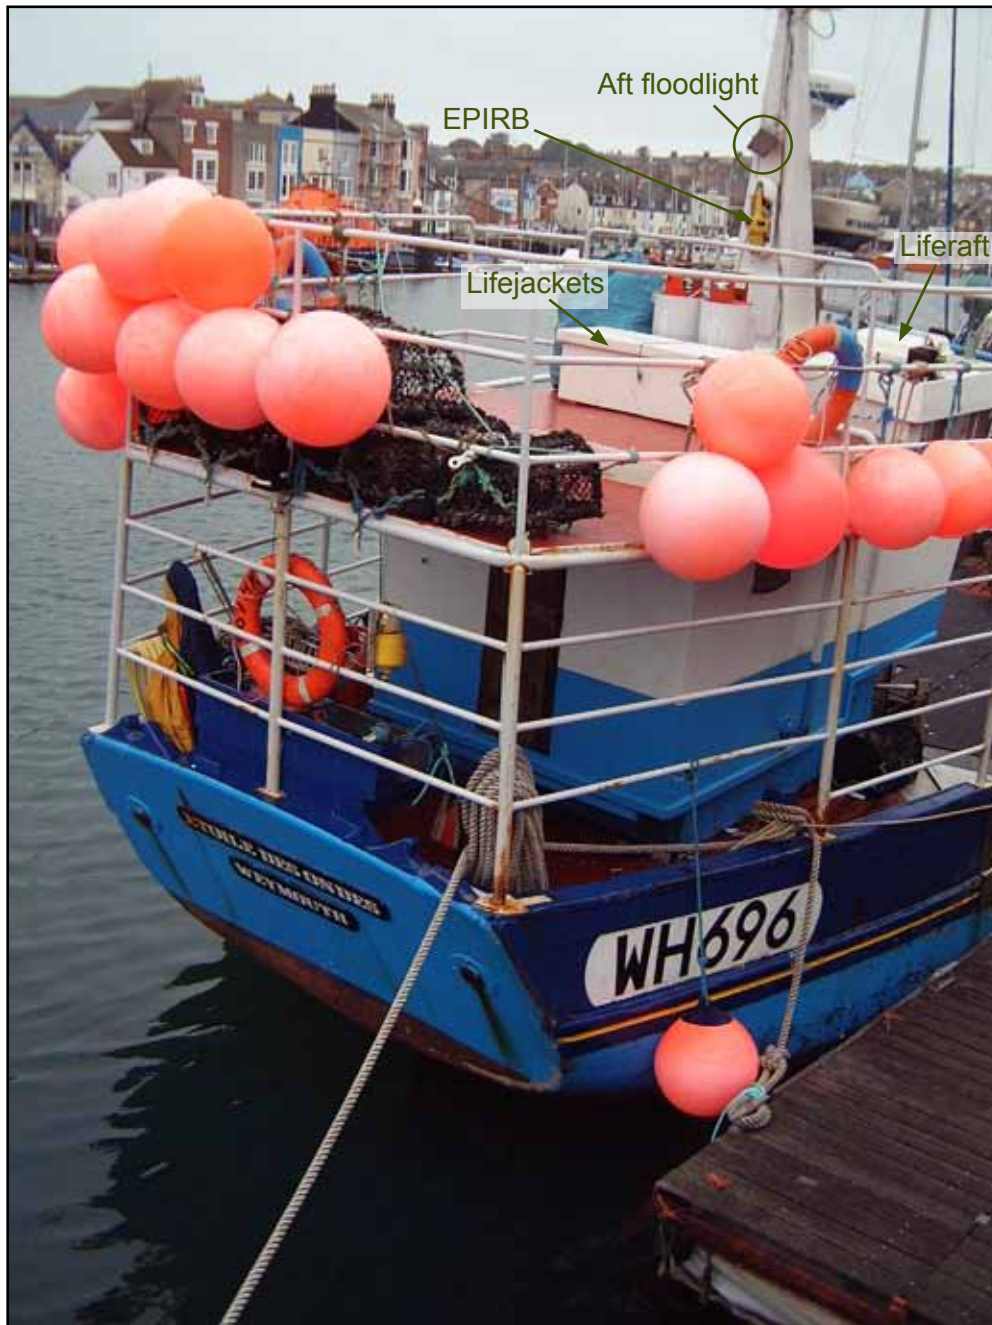
The skipper then climbed back on top of the wheelhouse to release the EPIRB. On returning to the liferaft he cut the painter, cleared away other loose rigging, and paddled the liferaft a few metres clear of the vessel. They circled around the vessel, looking for Chris, but sadly he was not seen again.

General overview of *Etoile des Ondes*' wheelhouse top and quarter deck (deck shelter omitted for clarity)

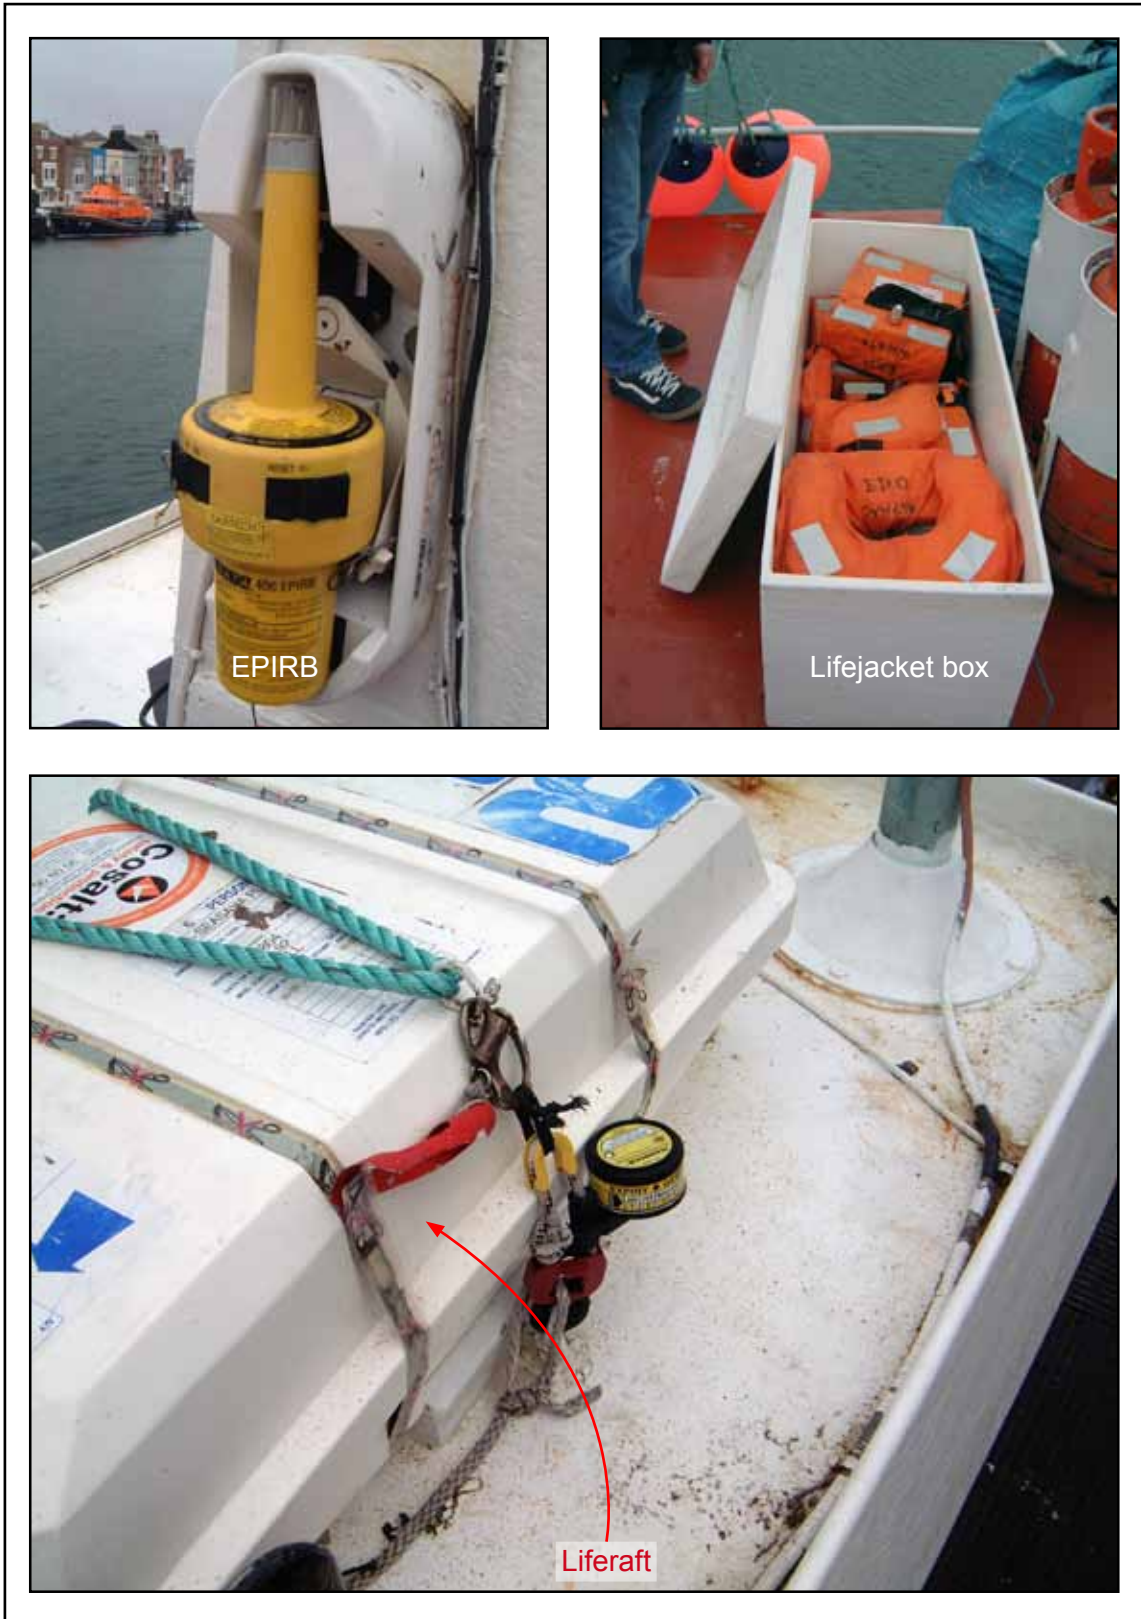
Figure 14

Etoile des Ondes was less than 15m in length, so was not required to carry an EPIRB. However, the owners had fitted one, and they had recently provided an additional unit as the batteries of the original EPIRB were close to expiry. Both EPIRBs were stowed on top of the wheelhouse, next to a six-person liferaft and a box containing six lifejackets (**Figure 14**). The vessel was not required to be fitted with an automatic identification system (AIS) unit, and did not carry this equipment.

Etoile des Ondes' EPIRB, lifejacket box and liferaft
