Nakano technical investigation report, *Ever Elite*

Investigation Report
on Potential Causes of M/V EVER ELITE Accommodation Ladder Fall Accident
and Preventive Measures of Recurrence

November 30, 2009
Nakano Seisakusho Co., Ltd.

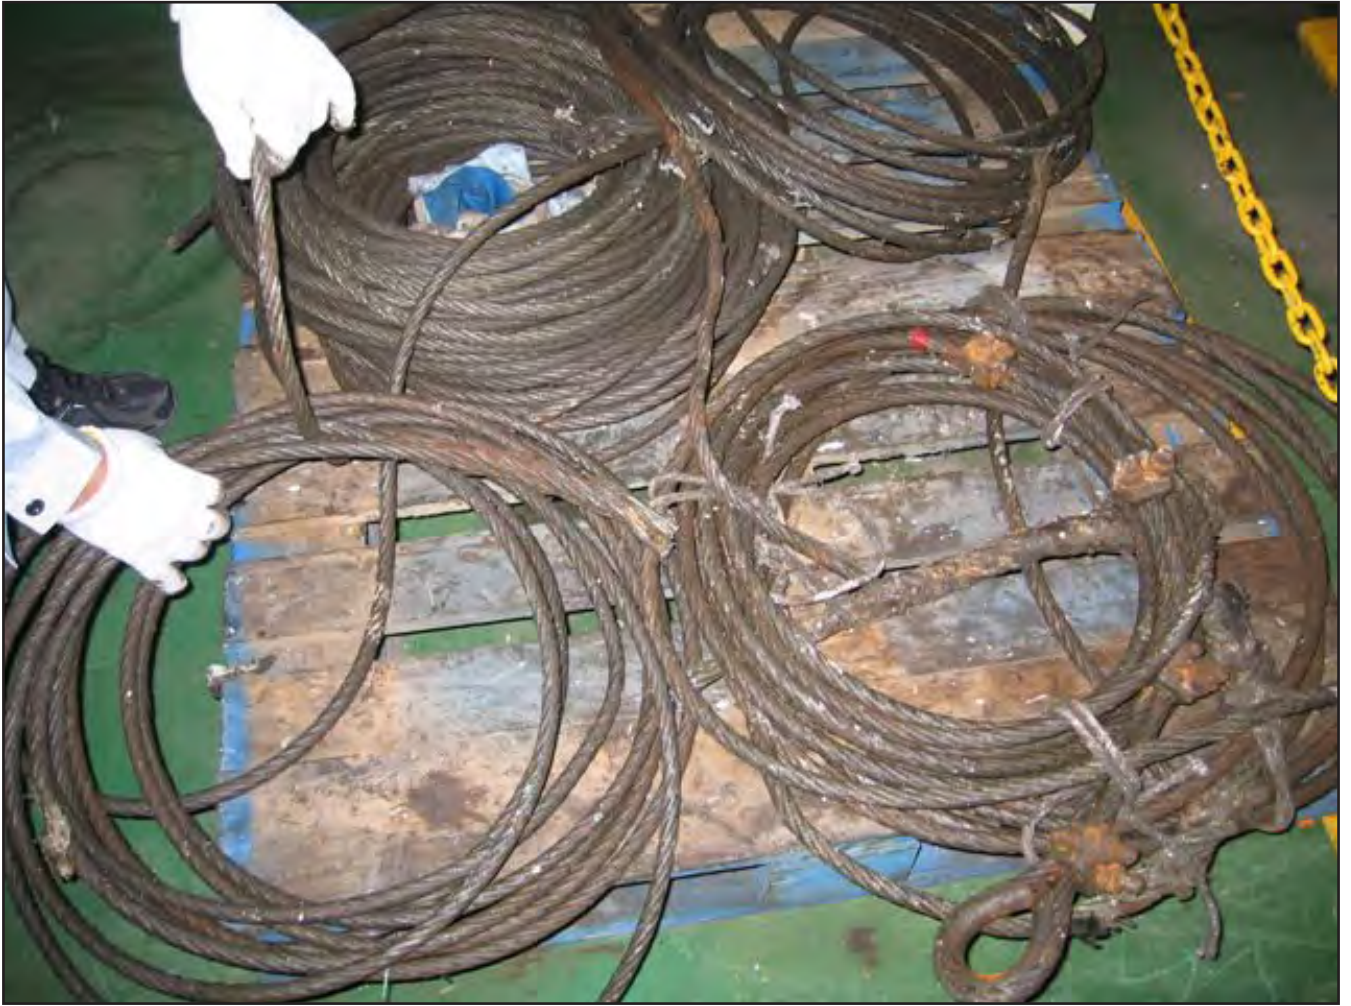
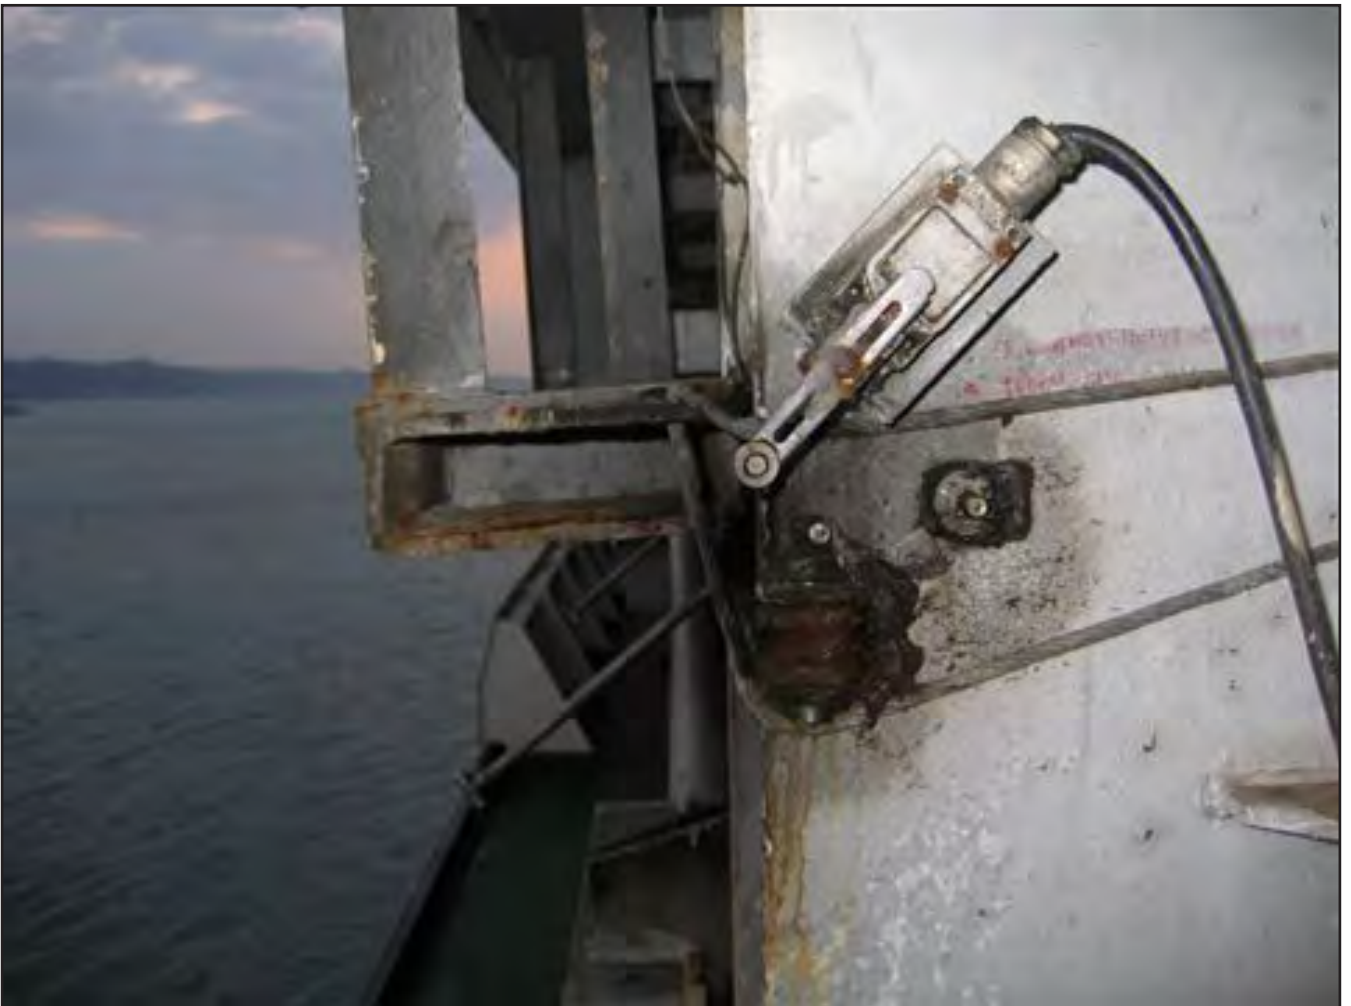
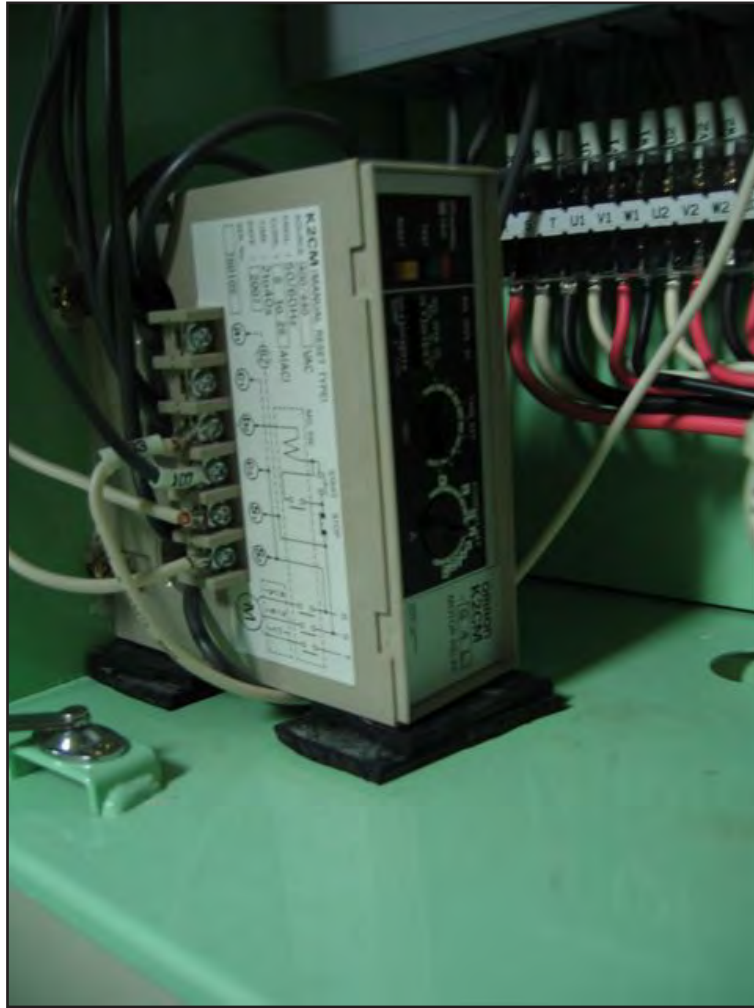
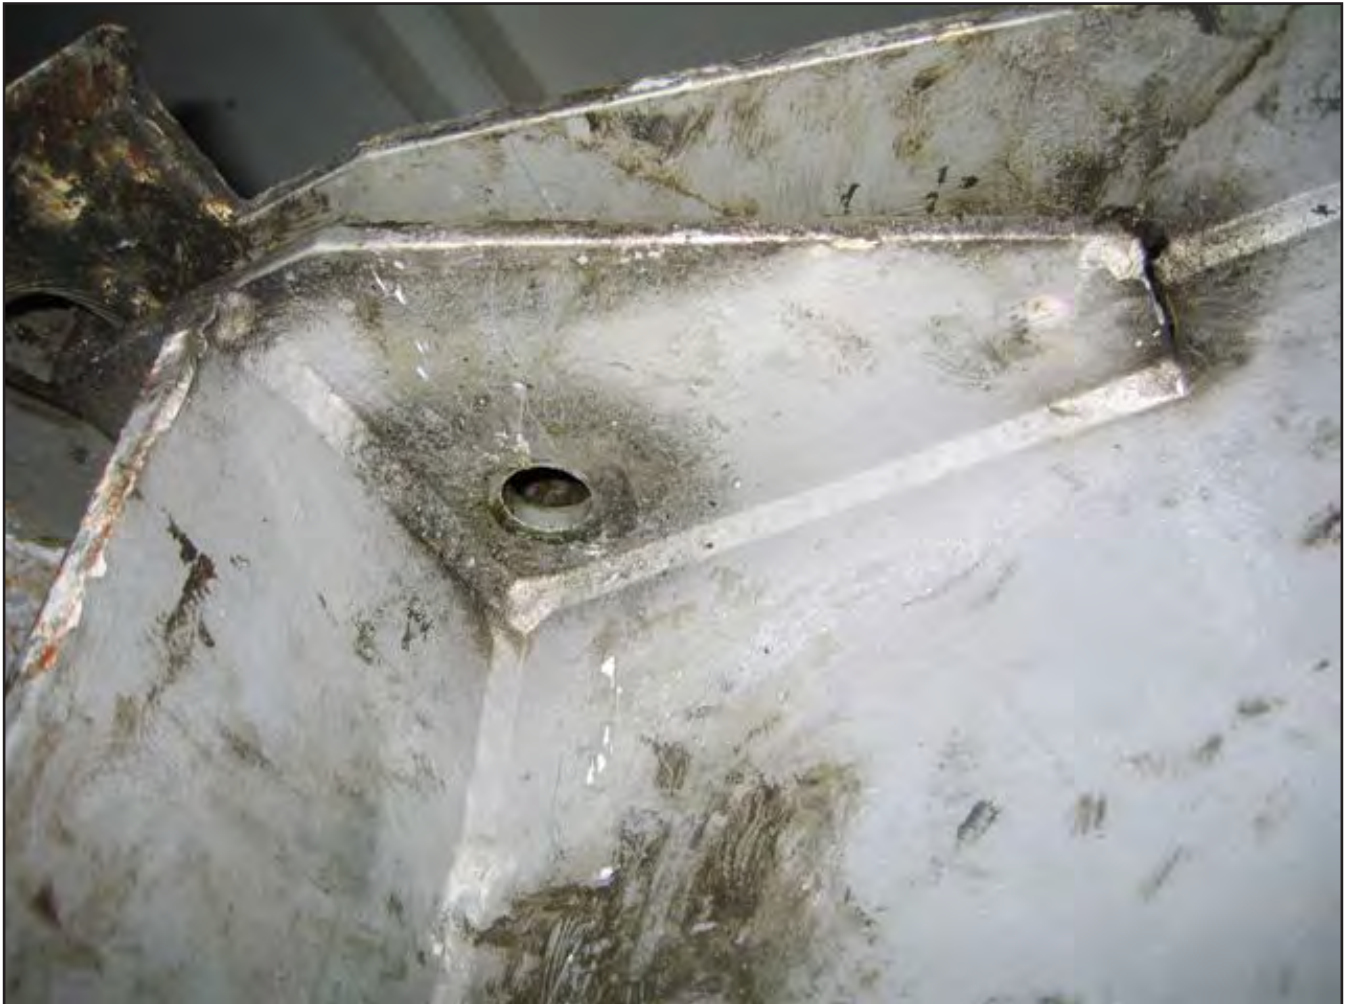
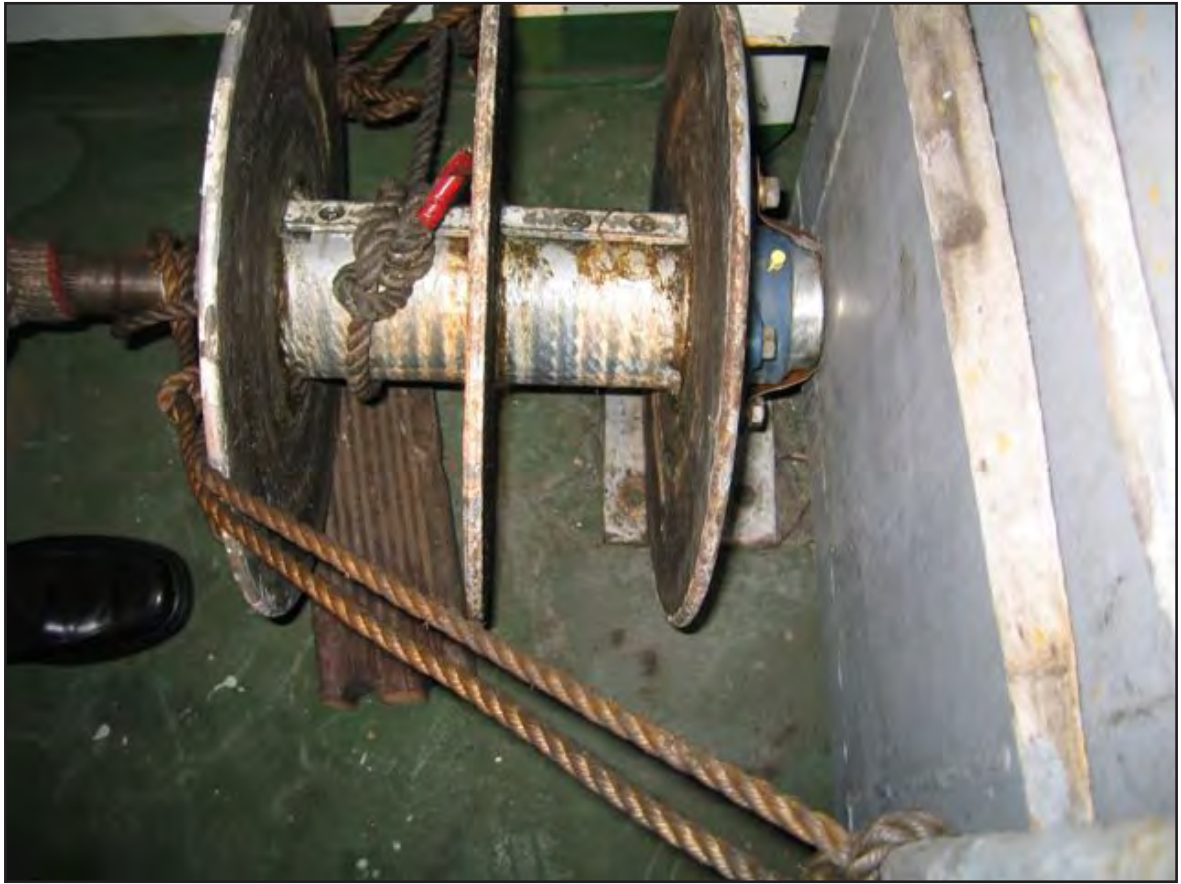
Investigation Result of Accommodation Ladder (Port Side)	
Subject	Investigation Result and Remark
Hoisting Wire	No problem (No trace of cut-off was found) (Appendix 1)
Stowing Wire	No problem (No trace of cut-off was found) (Appendix 1)
Sliding Wire	No problem (No trace of cut-off was found) (Appendix 1)
Limit Switch for Hoisting	Our original instruction was "ladder should be stopped 5-10 mm before davit." However, the installation condition at the port side of the vessel indicated that the ladder stopped after contacting the davit. Please check and readjust. (Appendix 2)
Motor Relay	We confirmed mounting of the motor relay provided in September, 2007 to the starter. Operation condition was not confirmed. (Appendix 3)
Sheave within Davit (dia 137)	One set of sheave and pin within davit was missing. We consider that the set was lost in the accident. Missing of the set is unlikely the cause of the accident. (Appendix 4)

Drum & Drum Shaft	No problem (Appendix 5)
Gear Box	<p>At the time of inspection, the bevel gear unit and vertical bevel gear had been replaced with new ones and the old ones used at the time of the accident were kept in the engine room. We conducted inspection of the old ones, and found the followings:</p> <ol style="list-style-type: none"> 1) Portion A of the bevel gear unit and Portion B of the vertical bevel gear were damaged. (Appendix 6 and 7) 2) Roller bearing C mounted on the vertical bevel gear was damaged. (Appendix 8) 3) Portion D of the bevel gear unit showed a trace of contact by Portion E of the vertical bevel gear. (Appendix 6) 4) Top bearing housing and intermediate bearing were replaced with new ones. The top bearing housing and intermediate bearing housing that had been used at the time of accident were not damaged. 5) Other parts and gear box had no problem. 6) The ship crew explained that the vessel had been overhauled in April, 2009.

Ladder	<p>Fall and loss of the lower ladder</p> <p>M16 Bolts (SUS304) securing each base plate of sheave set A and sliding roller set to the ladder frame were broken.</p>

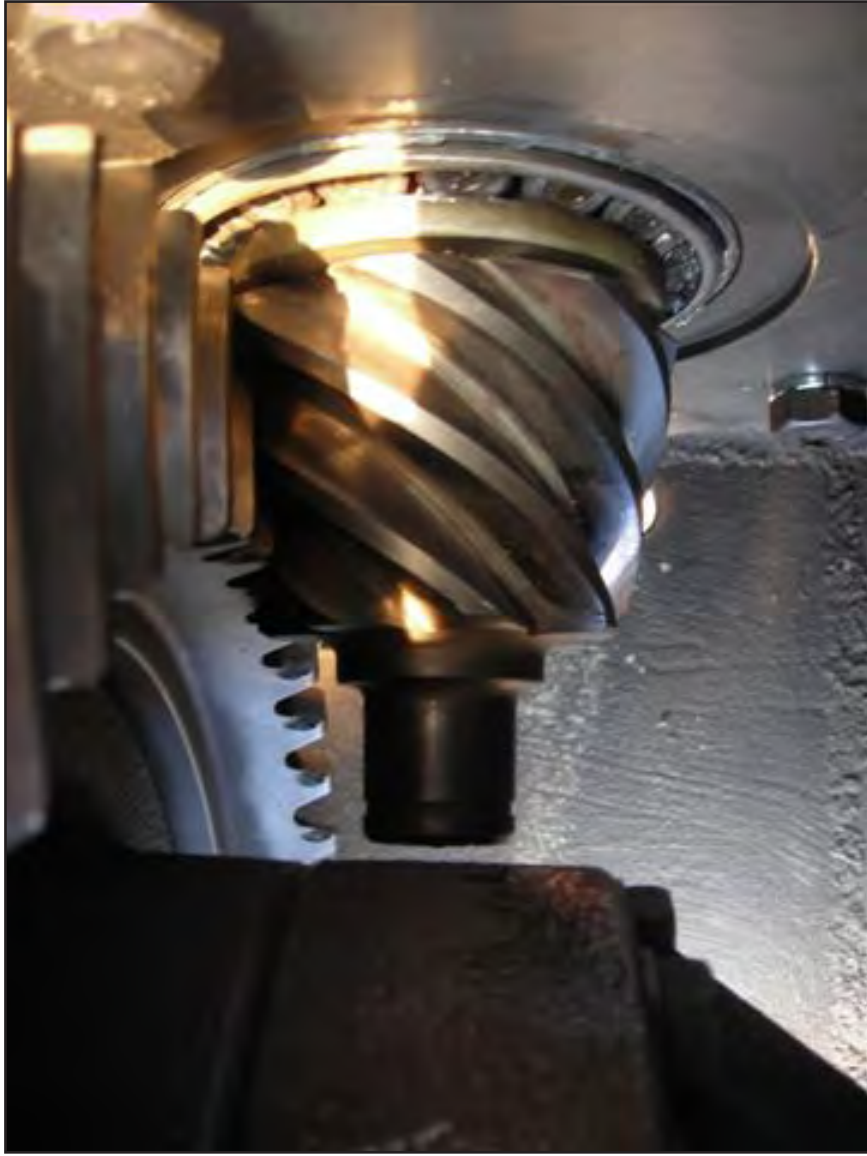
<Appendix .9>

As is in the Appendix A, Portion D of Bevel Gear Unit shows a trace of contact with Portion E of Vertical Bevel Gear (see Appendix 10: Inside photo of Gear Box of the same type at our factory; approximately 3mm gap between D and E). Hence, it is presumed that a gap of 3mm or more generated between F and G, Vertical Bevel Gear traveled to a lower position, Inside Ring of Roller Bearing contacted Bevel Gear Unit and was broken, then Roller Housing was broken, and disengagement between Bevel Gear Unit and Vertical Bevel Gear ensued. The possible cause of gap generation is foreign body intrusion, or fastening Nylon Nut where Spacer or Collar is not an authorized product. (See Appendix 11)
