Report on the investigation of  
the capsizing of the fishing vessel

***Aquila***

with the loss of three lives  
Bo Faskadale Reef, Ardnamurchan  
on 20 July 2009

**Report No 5/2010**  
**April 2010**

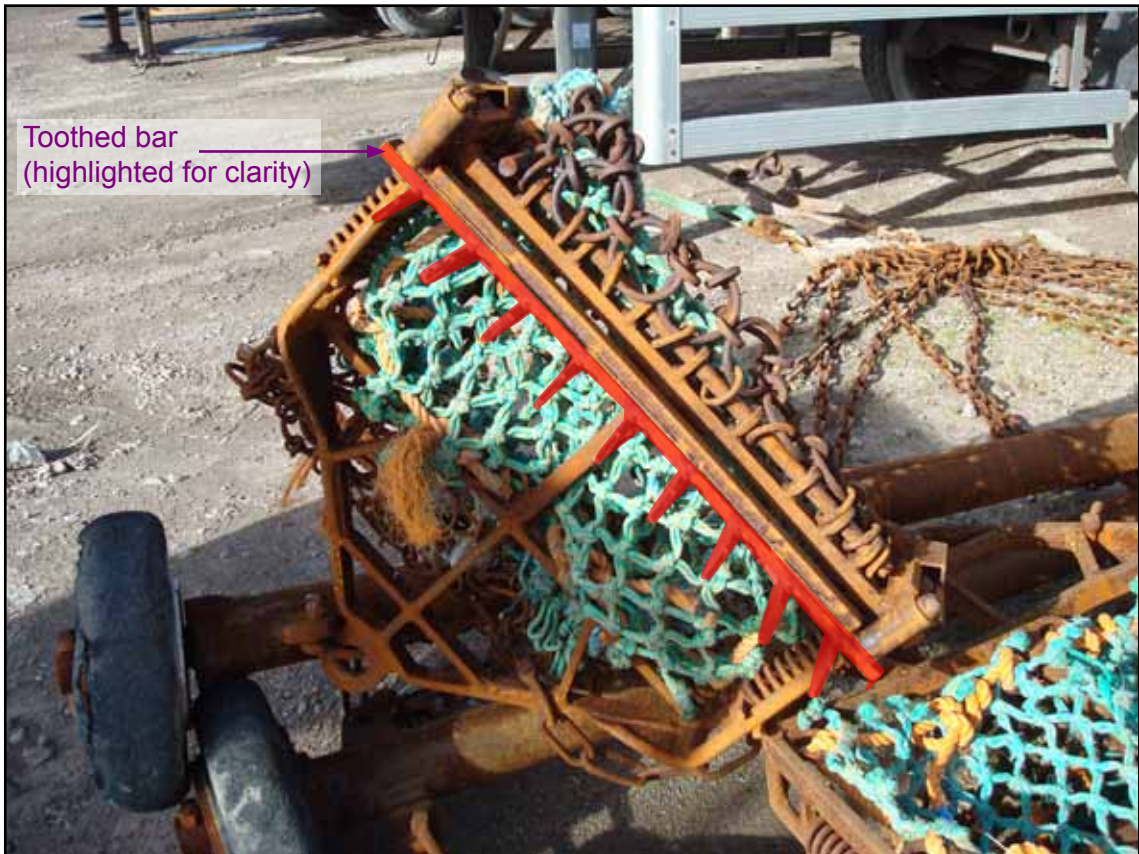
Dredge bag from *Aquila*, showing toothed bars

*Aquila* dredged for scallops by towing two wire warps, one from each side, attached to which were steel spreader bars which each held seven dredges (**Figure 9**). The dredges consisted of a frame with a toothed bar at the front, to dig the scallops out of the seabed, with a collecting bag behind it. The bag was made of chain links forming a chain mesh on the bottom with netting on the top (**Figure 3**).

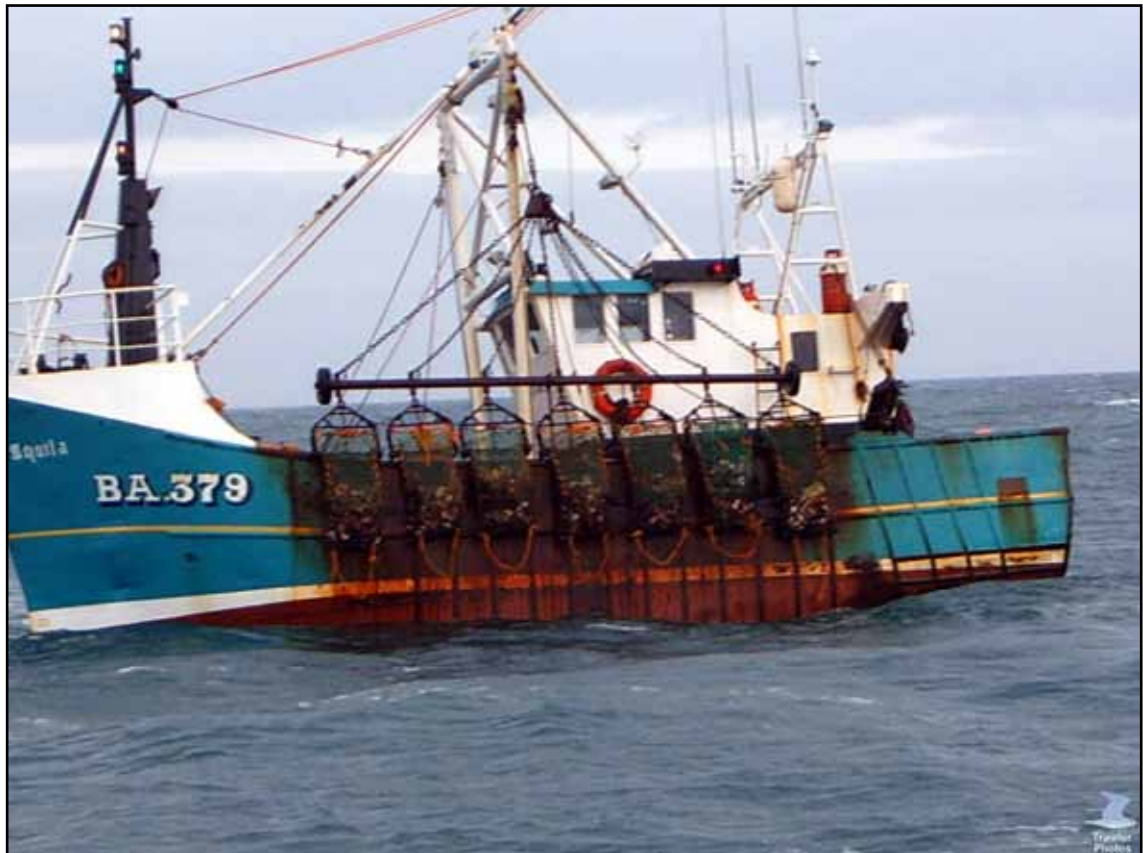
Figure 9

*Aquila's* seven dredges

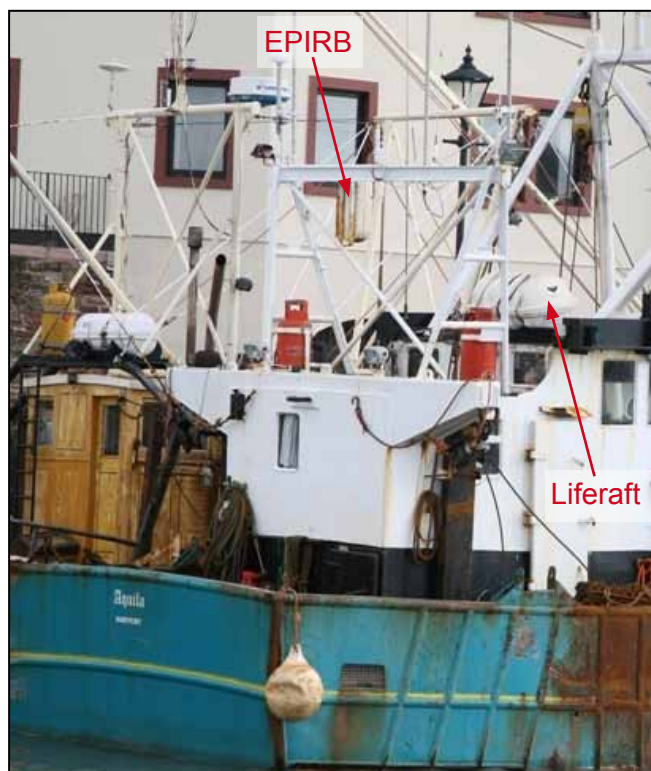
Figure 14

In this case, due to the speed of capsize it is difficult to identify an alternative location from which float free and activation of either of these important items of safety equipment would have been guaranteed (**Figure 14**).

EPIRB and liferaft stowage positions  
on *Aquila*
