Report on the investigation of  
the capsizing of the fishing vessel

***Aquila***

with the loss of three lives  
Bo Faskadale Reef, Ardnamurchan  
on 20 July 2009

**Report No 5/2010**  
**April 2010**

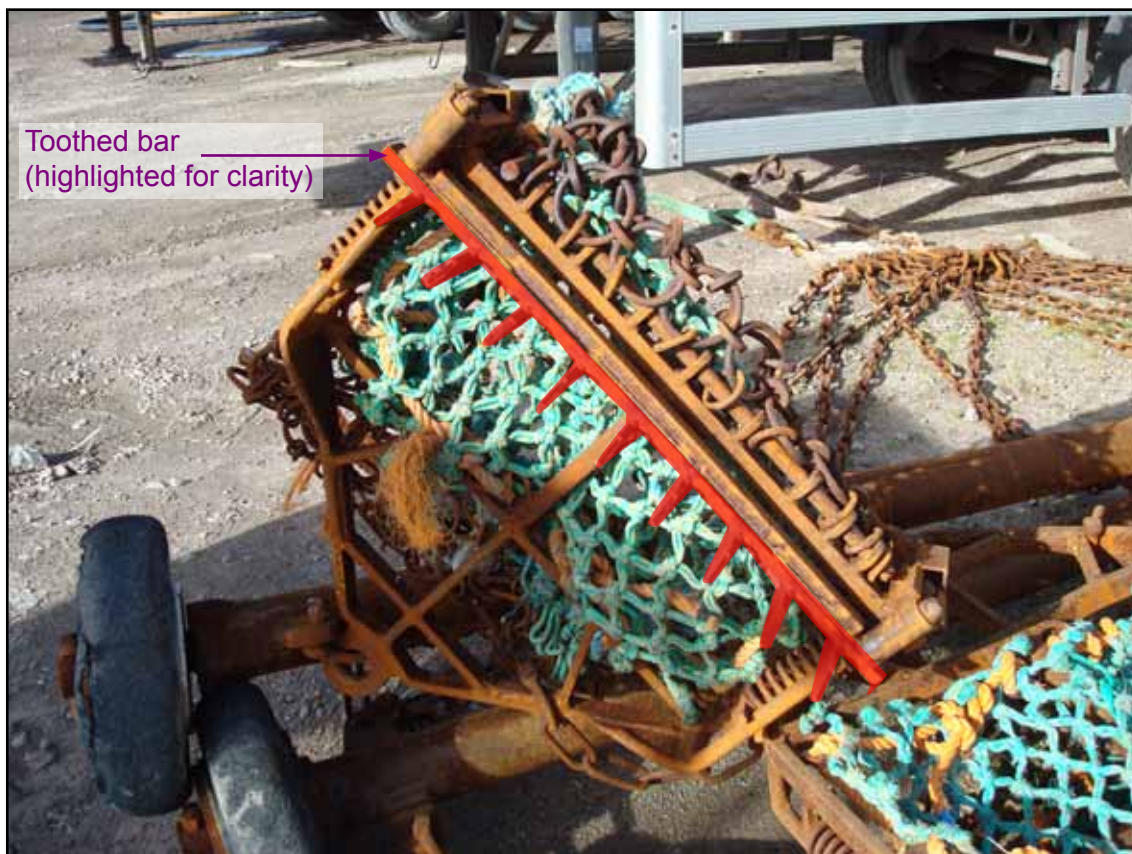
Dredge bag from *Aquila*, showing toothed bars

*Aquila* dredged for scallops by towing two wire warps, one from each side, attached to which were steel spreader bars which each held seven dredges (**Figure 9**). The dredges consisted of a frame with a toothed bar at the front, to dig the scallops out of the seabed, with a collecting bag behind it. The bag was made of chain links forming a chain mesh on the bottom with netting on the top (**Figure 3**).

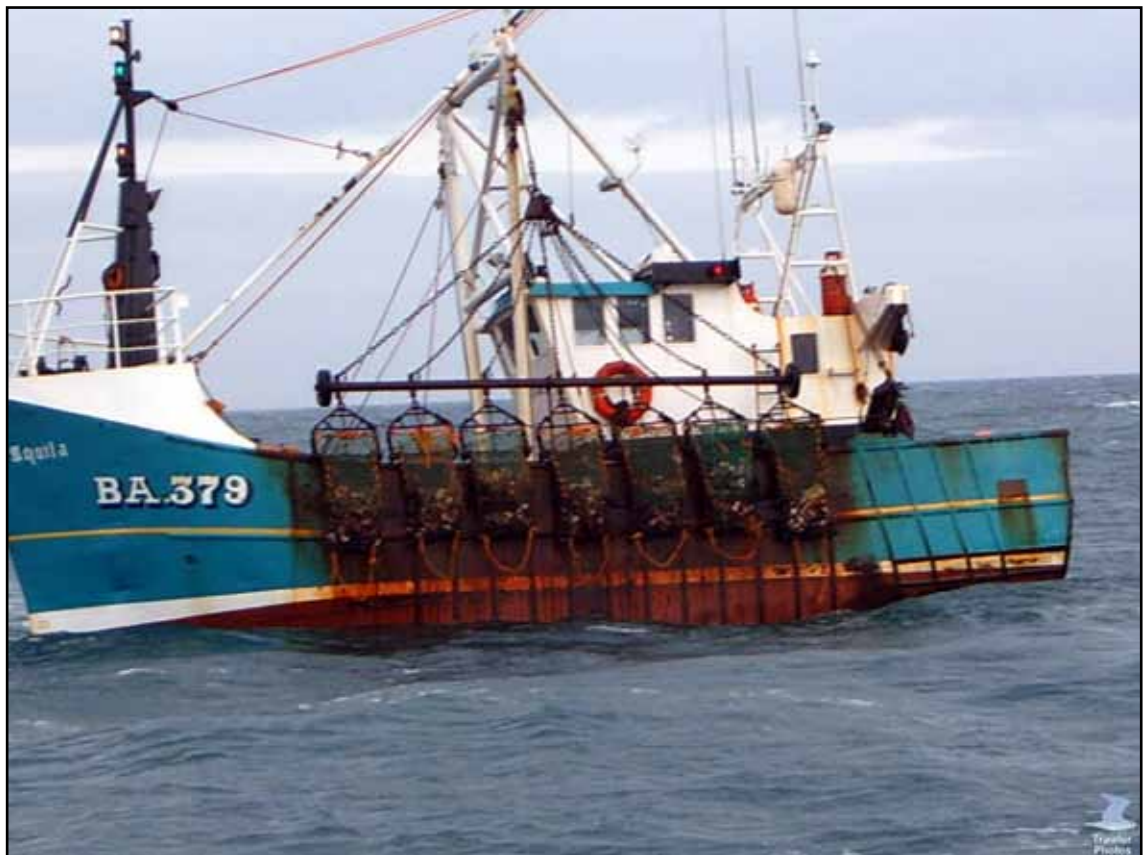
Figure 9

*Aquila's* seven dredges

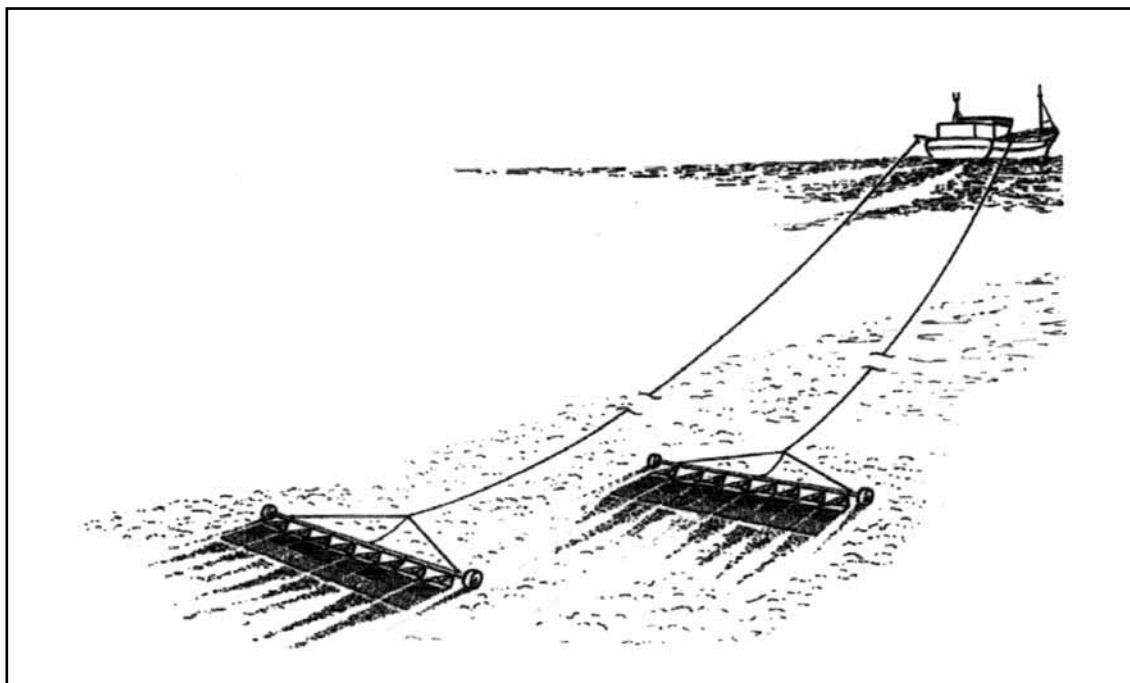
The dredges were towed astern of the vessel by two warps, which were set at differing lengths to avoid the steel bars fouling each other as they were dredged across the seabed (**Figure 10**). On *Aquila*, at the time of the accident, the starboard warp was set to be 20m longer than the port warp.

Drawing of scallop dredges
