Stability Assessment
Investigation into capsizing of MFV 'Aquila'
Marine Accident Investigation Branch

December 2009

Report on Stability Investigation - FV 'Aquila'

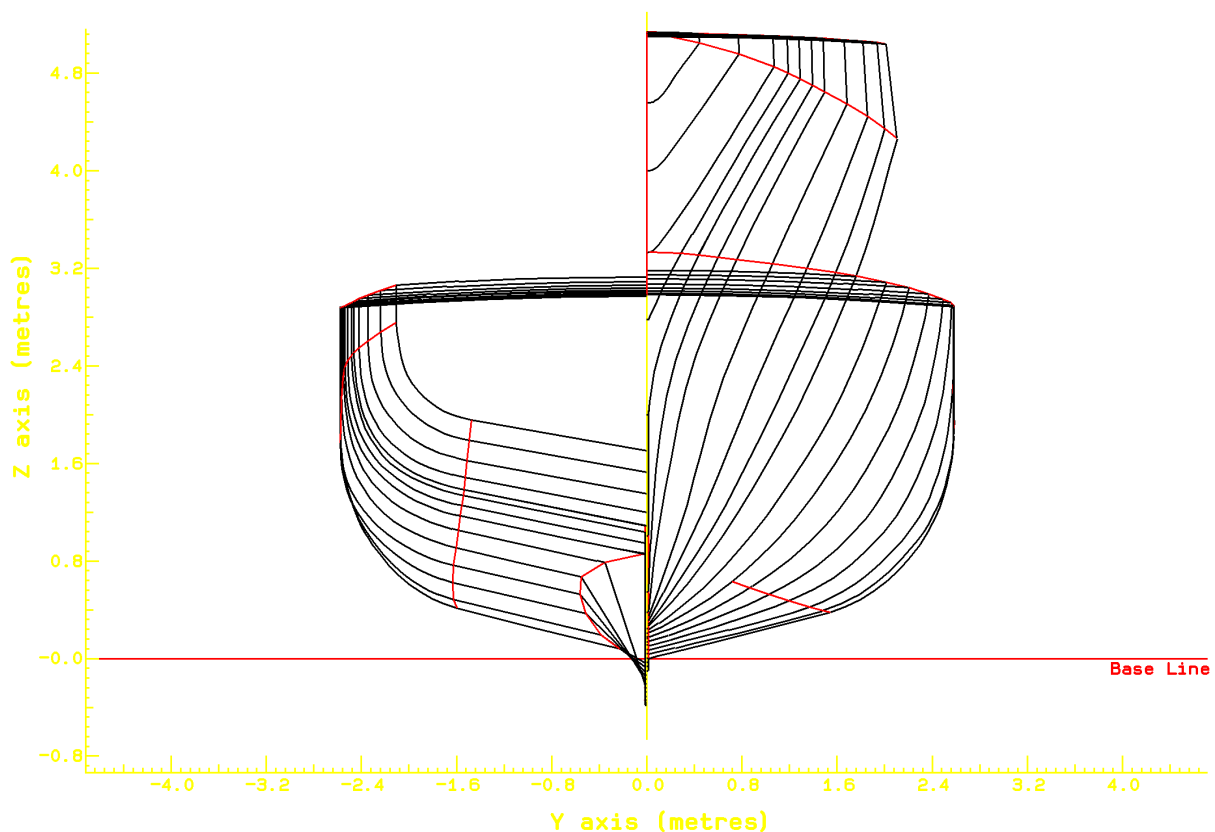
Diagram 1 – Hull sections of fishing vessel 'Aquila'

The shape of the vessel's hull and its compartments and tanks were defined by measurements taken from the lines plan and the hull. Half breadth and height dimensions for 16 transverse sections through the hull were recorded on the computer to create a coordinate model of the hull shape. An additional 22 sections were interpolated automatically from the input section data to refine the model – see diagram 1 below. Appendix 1 is comprised of section, plan, profile and isometric views of this hull model.

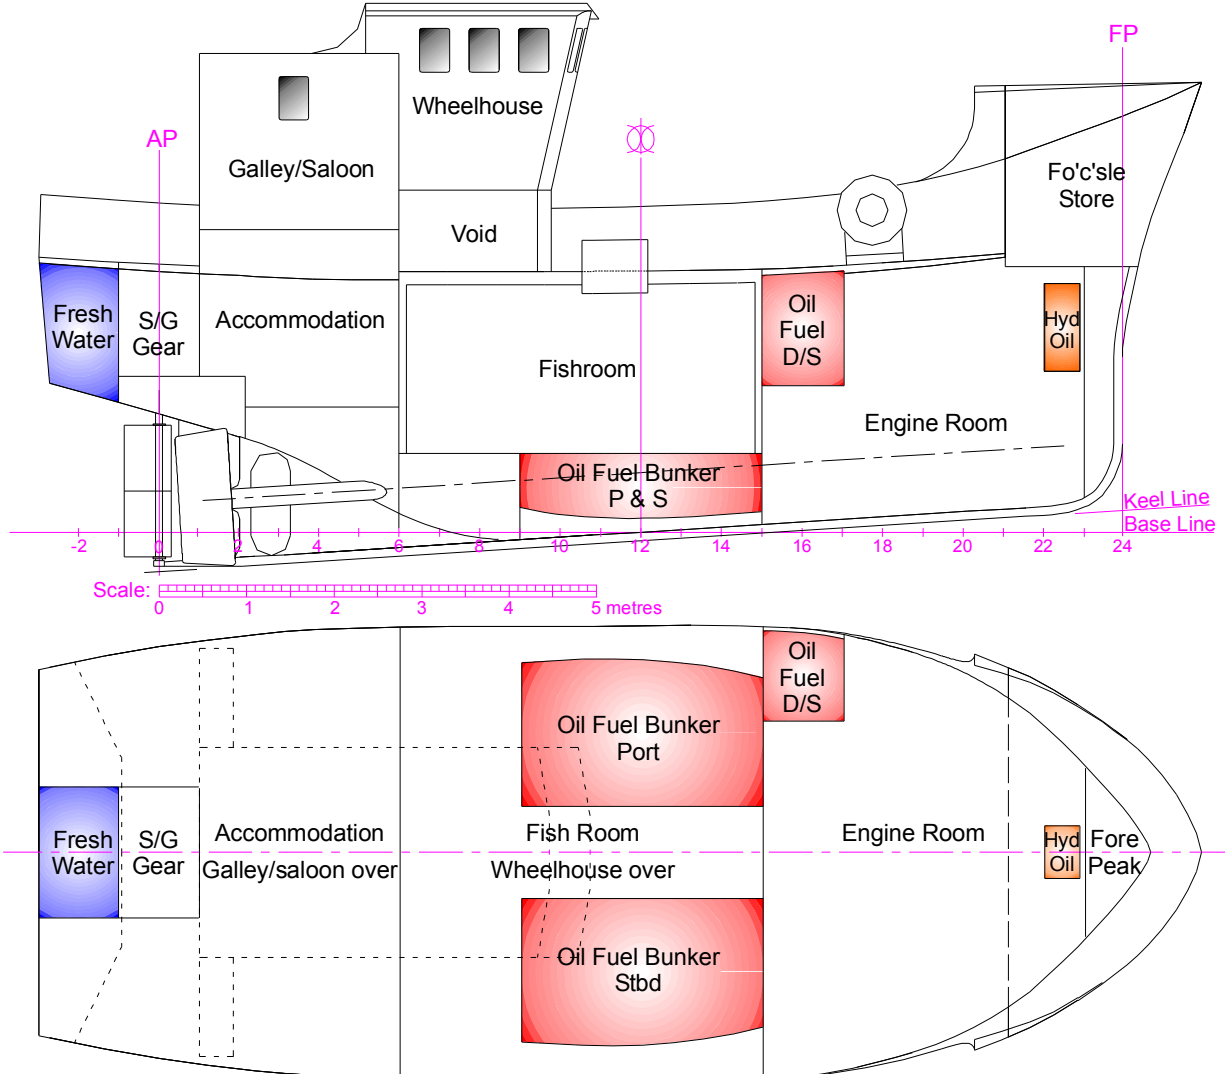
Diagram 2 – General Arrangement of fishing vessel ‘Aquila’

All longitudinal dimensions are taken about an Aft Perpendicular (AP) located at the rudder stock. The Forward Perpendicular (FP) is located 11.00 metres forward of the AP at the intersection of the stem with the datum waterline. All vertical dimensions are taken about a moulded Base Line passing through the the intersection of the keel and bottom plating at midships on the LBP. The same horizontal and vertical datums were used in the 1988 SIB. These datums are shown on the general arrangement drawing below.

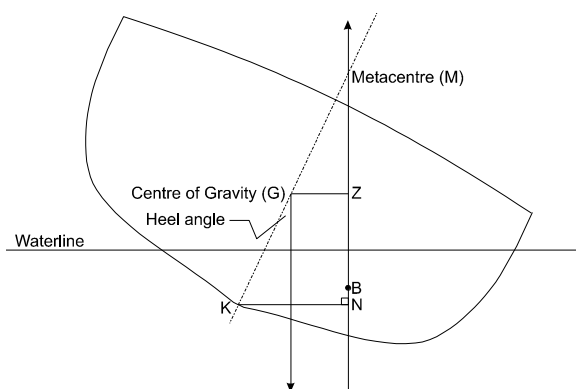
Diagram 3 – Relationship of KN to righting lever (GZ)

Appendices 2 and 3 are comprised of hydrostatic and free-trim KN data computed from the hull model for this report. The diagram below illustrates the relationship between KN values and righting levers (GZ):

It should be noted that the KN data used for the calculation of the stability data discussed in Section 6 of this report includes the volume of the hull below the foredeck (i.e. including the fo'c'sle) and the main deck but excludes the volume of the deckhouse and wheelhouse. This is normal practice in compiling a stability booklet for submission to the MCA as these latter volumes may not be watertight – flooding through open doors and windows, for example, will remove any additional righting lever that might have been obtained. In the 1988 SIB the deckhouse was included in the KN data.

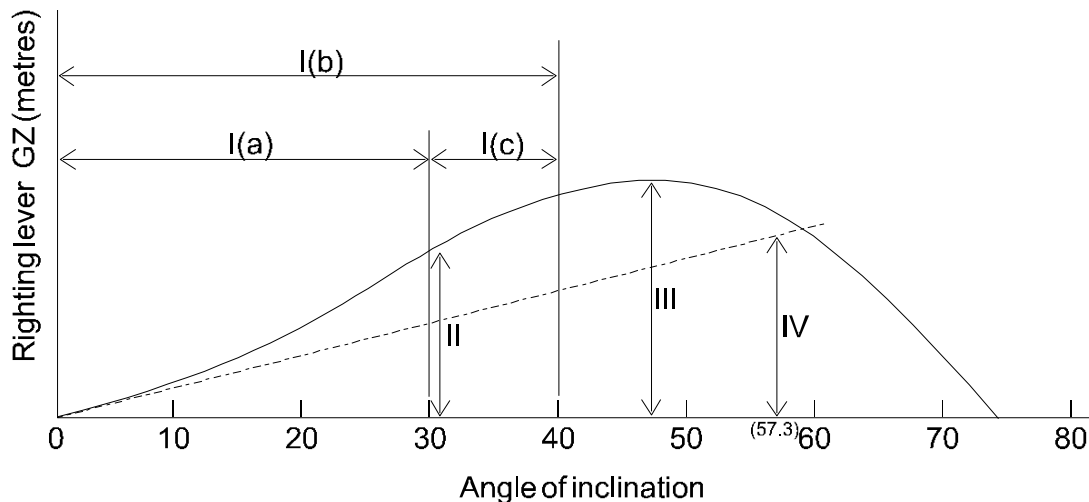
Diagram 4 – Example of righting lever curve with requirement key points

- I) The area under the righting lever curve (GZ curve) shall not be less than:
 - (a) 0.055 metre.radians up to an angle of 30 degrees;
 - (b) 0.09 metre.radians up to an angle of 40 degrees or such lesser angle of heel at which the lower edges of any opening in the hull, superstructure, deckhouses, or companionways being openings which cannot be closed weather-tight are immersed;
 - (c) 0.030 metre.radians between the angles of heel of 30 degrees and 40 degrees or such lesser angle as defined in (b) above;
- II) The righting lever (GZ) shall be at least 0.20 metres at an angle of heel equal to or greater than 30 degrees;
- III) The maximum righting lever (GZ) shall occur at an angle of heel not less than 25 degrees;
- IV) In the upright position the transverse metacentric height (GM) shall not be less than 350 millimetres;

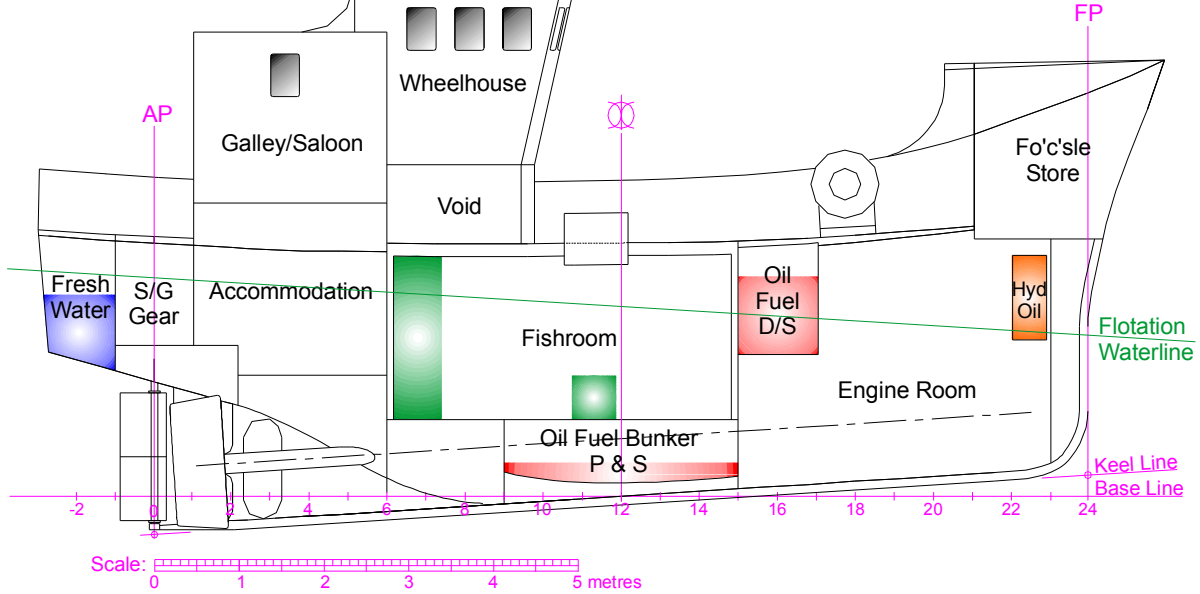
Vessel.....: FV Aquila
 Condition.: ACCIDENT CONDITION
 State.....: HULL INCLUDING MAJOR APPENDAGES
 Water SG...: 1.025
 Compliance: Vessel fails requirements in this condition

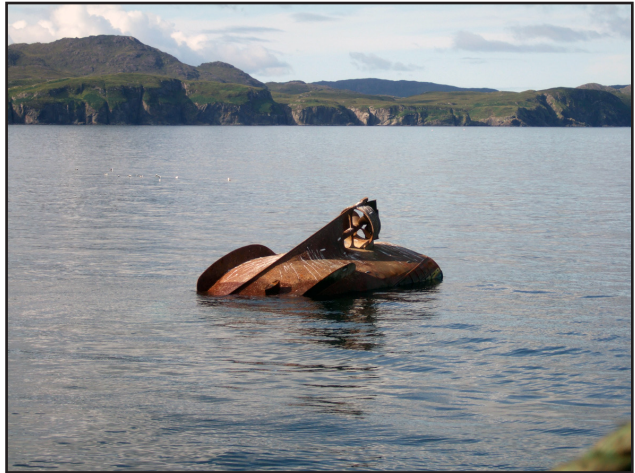
Photo: Sean McIlwraith

On 20 July 2009, at about 1540 UTC, the starboard warp of the scallop dredger *Aquila* became snagged on the seabed while she was trawling, downwind, in moderate to heavy seas near the isle of Eigg.

The vessel almost immediately veered and heeled over to starboard. The skipper was heard to pull the engine control back to neutral, but a succession of large waves then struck the vessel and she rapidly capsized. The three crewmen were initially trapped, and as water entered the mess room through the open accommodation door one of them dived down and out through the door to escape from the vessel.
