Report on the investigation

into the loss of the tug

Ijsselstroom

Report No 4/2010
April 2010

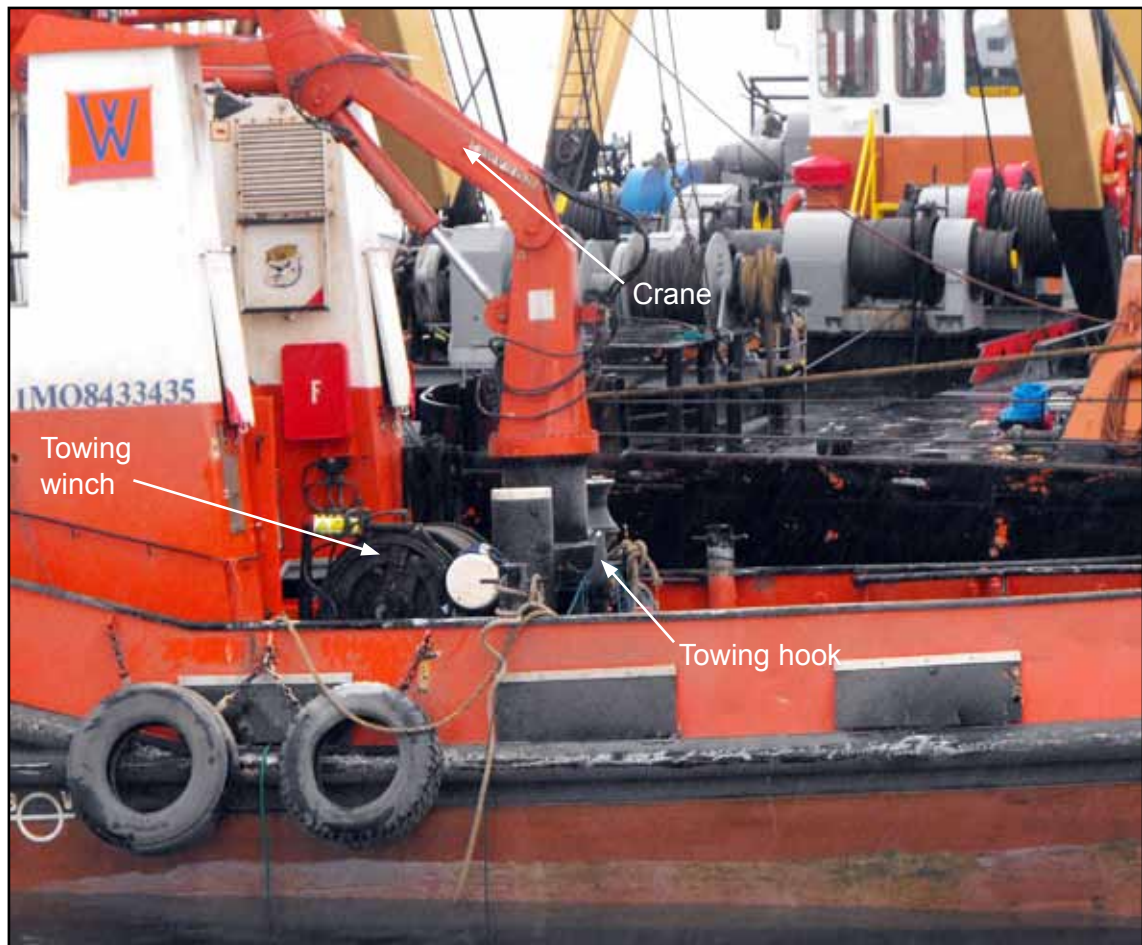
Figure 10

On deck, *Ijsselstroom* had a single drum towing winch, a quick release towing hook and a single hydraulic crane, all sited on the centre line just aft of the main accommodation (**Figure 10**).

Ijsselstroom aft deck gear

The hydraulic system of the winch brake was powered by a power take-off from the starboard shaft. If the starboard engine failed for any reason then the brake would be permanently applied. It is not known when the starboard engine stopped during *Ijsselstroom's* capsizing at Peterhead.

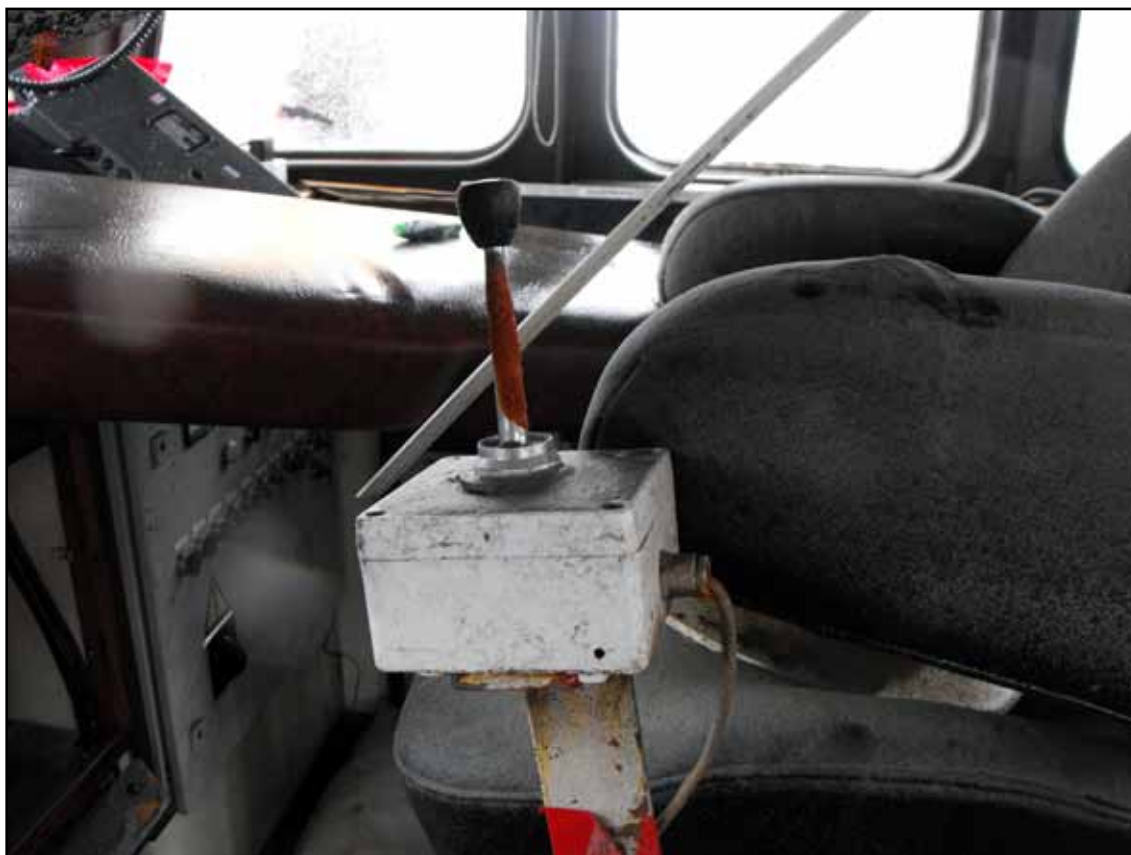
Figure 12

Ijsselstroom was conned from a swivel chair which had a joystick rudder control attached to the left arm (**Figure 12**). When the chair faced in the forward position the floor standing engine controls were just forward of the chair's right armrest (**Figure 13**). The winch control unit was attached to a chart table just abaft the engine controls (**Figure 14**). The VHF unit was mounted to the deck head above the bridge window and its handset suspended by a short line, within reach of the conning chair (**Figure 6**).

Joystick rudder control

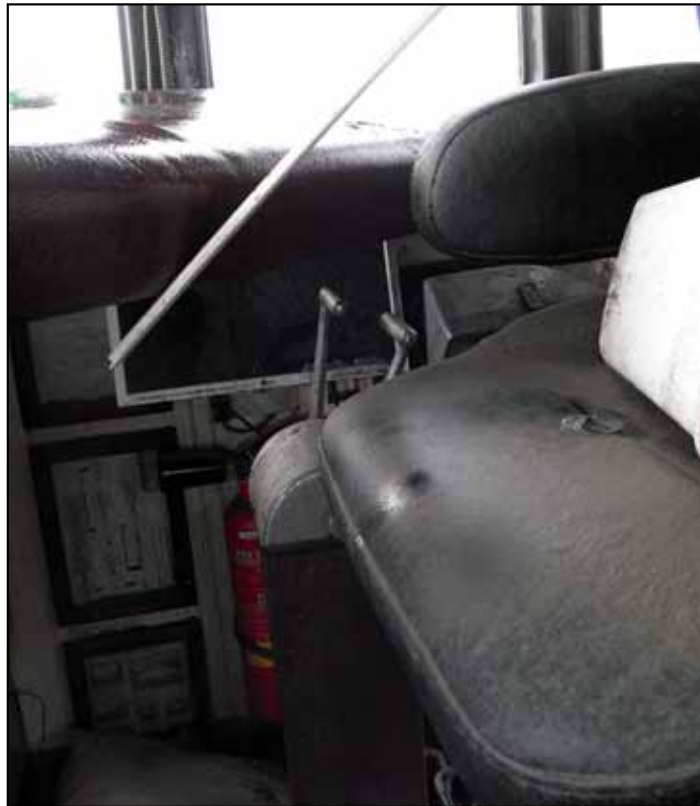
Figure 13

Engine controls

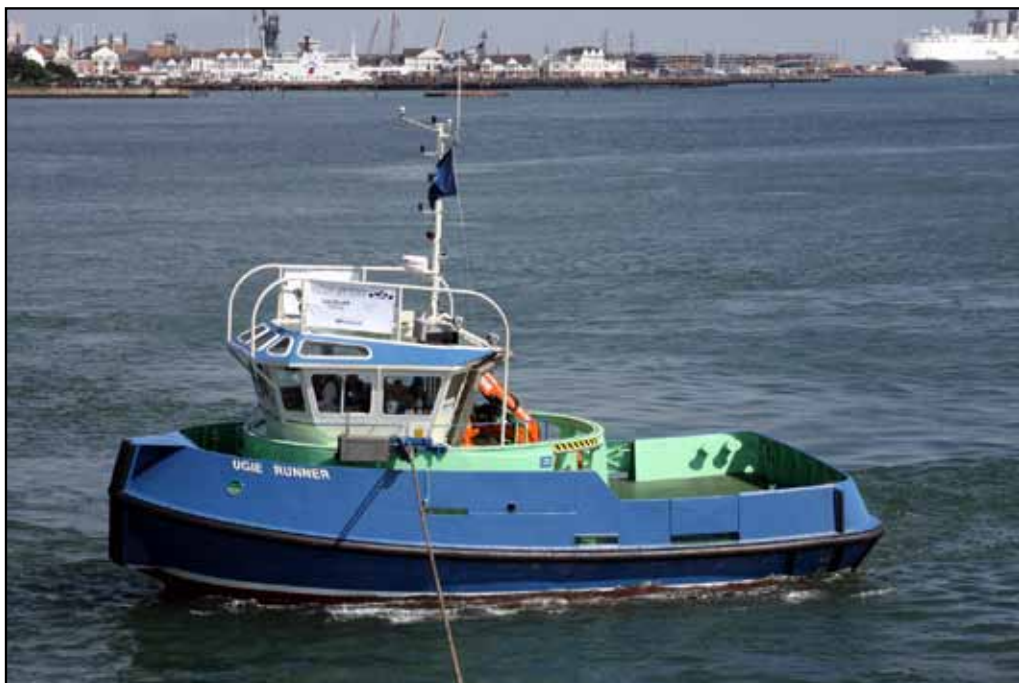
Figure 16

Ugie Runner

Ugie Runner has an 8.5t bollard pull and incorporates a dynamic oval towing system (DOTS), developed by Mampaey Offshore in the Netherlands. The system consists of an oval shaped rail integrated in to the vessel's structure with free moving carriages on the rail supporting the towing installation. This allows the towing point to move 360° around the vessel and therefore reduces the angle of heel when the tug is subjected to high athwartships towline forces. DOTS significantly reduces the risk of *Ugie Runner* girting.

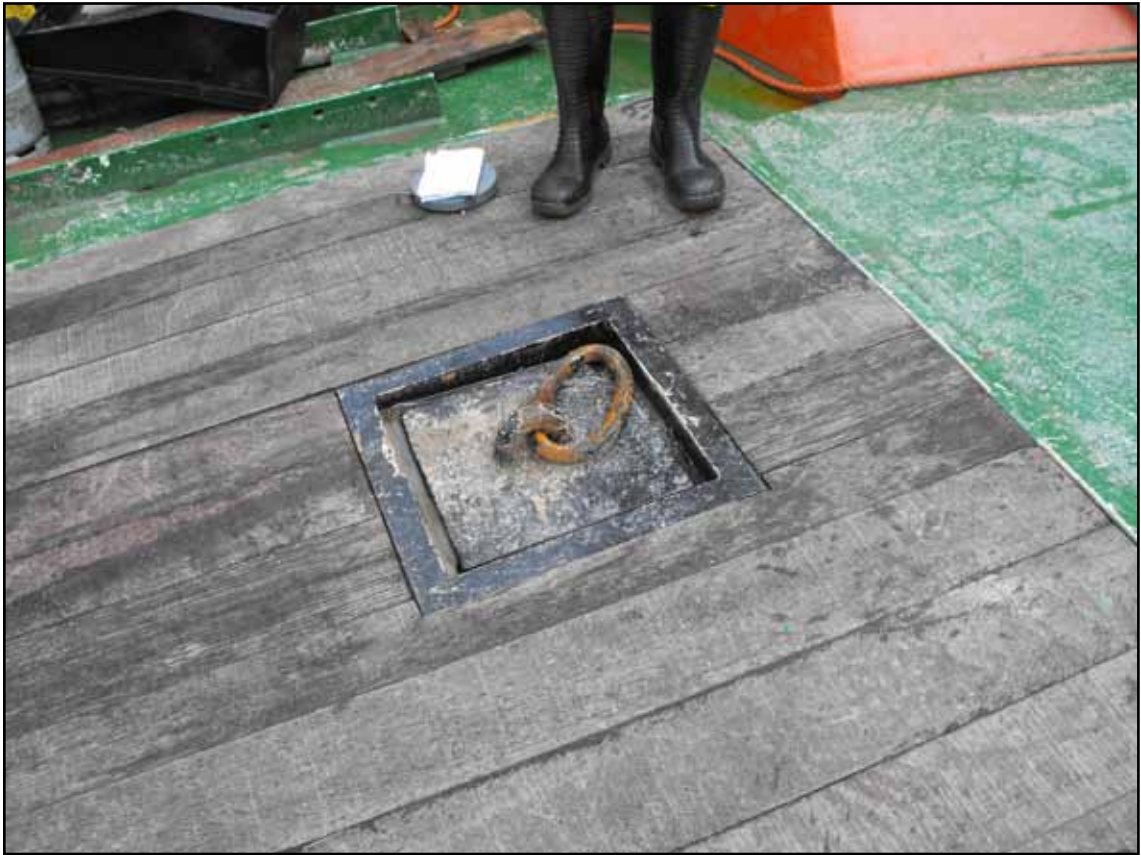
Figure 18

Ijsselstroom did not have a gob winch, centre line fairlead or H-shaped bollard, though she did have a ring through a centre line pad eye on the aft deck (**Figure 18**). However, it is not known if this had sufficient strength to support a gob rope, and it had not previously been used for this purpose. *Ijsselstroom*'s skipper never used gob ropes and felt that they would hinder his ability to handle the tug.

Centre line ring

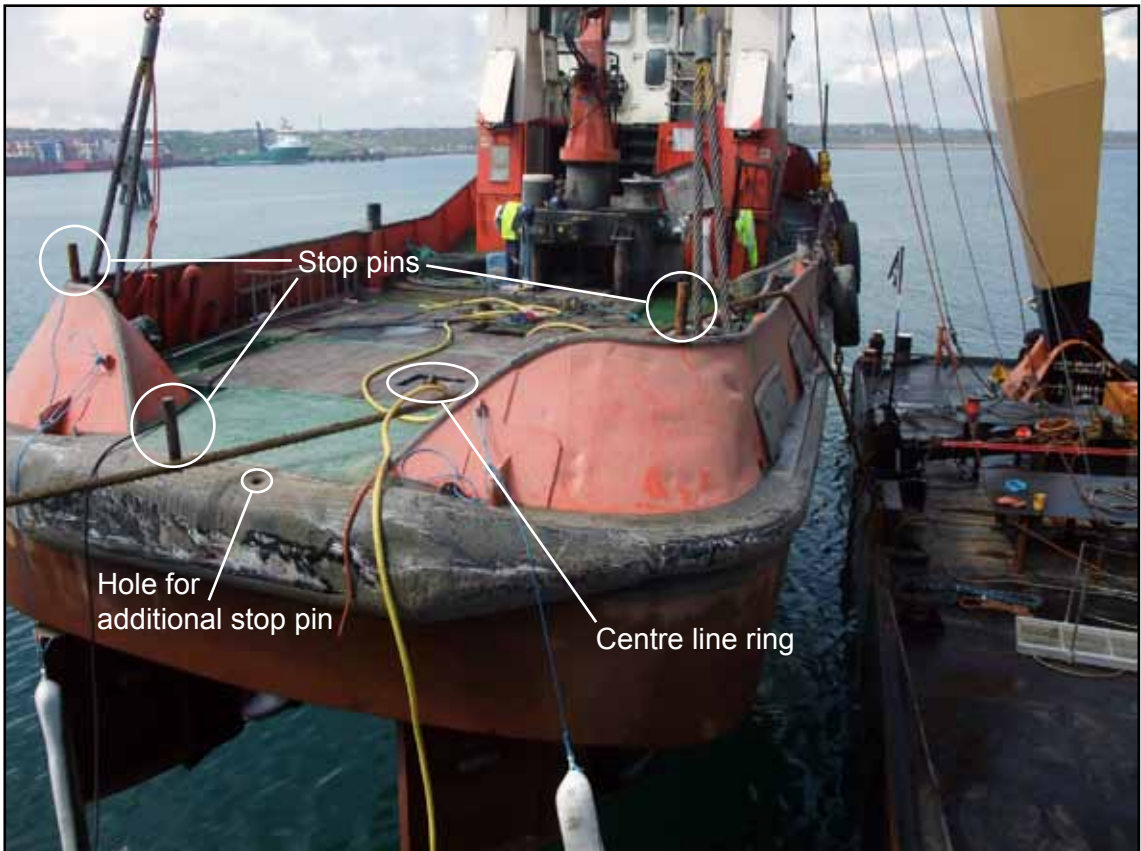
Figure 19

Another way to prevent a towing wire moving on to the tug's beam is by using stop pins. These are normally found on both quarters and either side of the centre line at the after end of the working deck. They can be fixed, removable or hydraulically raised and lowered. *Ijsselstroom* had removable pins, but none were in use for the arrival of *Tak Boa 1* because the skipper felt that the lead of the towline would be too steep to make them effective. **Figure 19** shows port and starboard quarter pins rigged and ready for use, and one removable pin fitted to port of the centre line.

Stop pins and centre line ring
