Report on the investigation of  
the grounding at high speed of the RIB

***Sooty***

Calve Island, Isle of Mull

**Report No 22/2009**  
**October 2009**

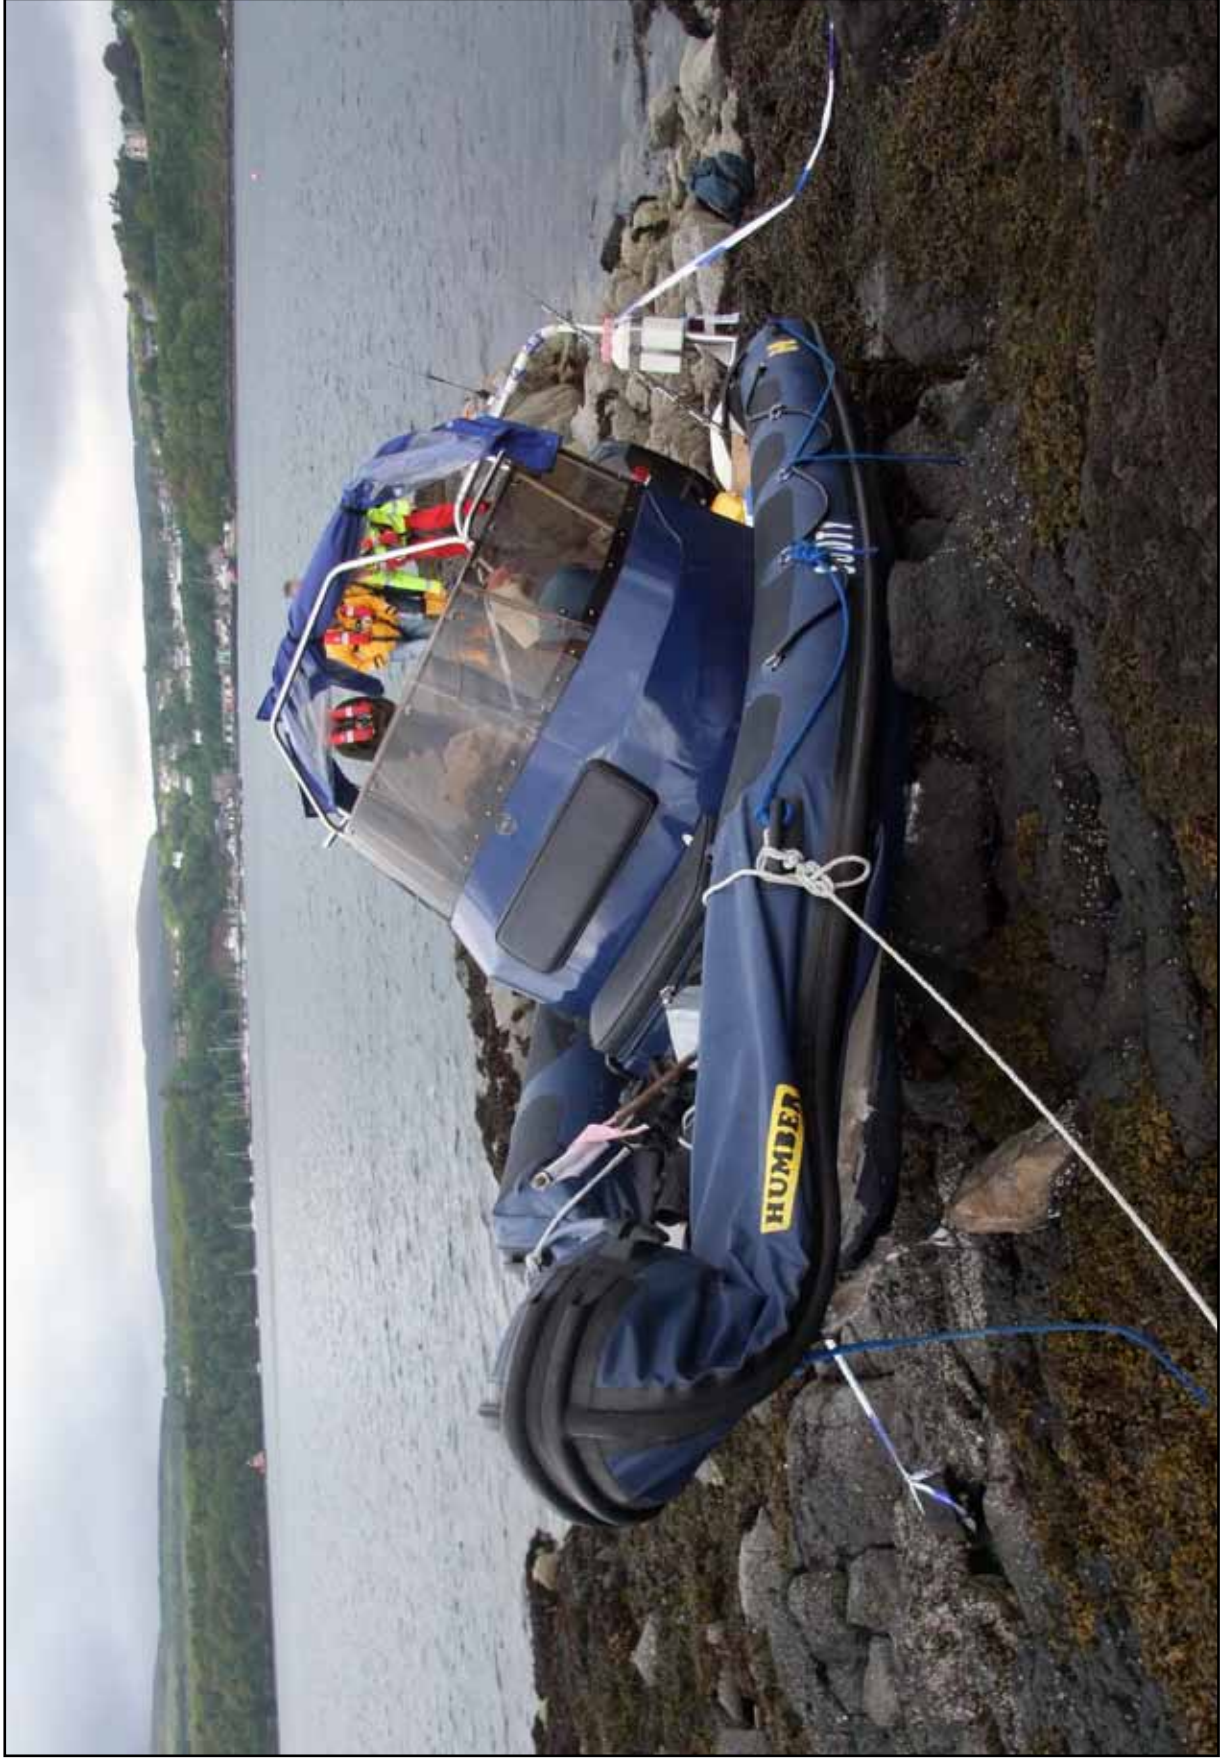
Sooty

Note: The height of tide shown is 1.3m less than that at the time of the grounding

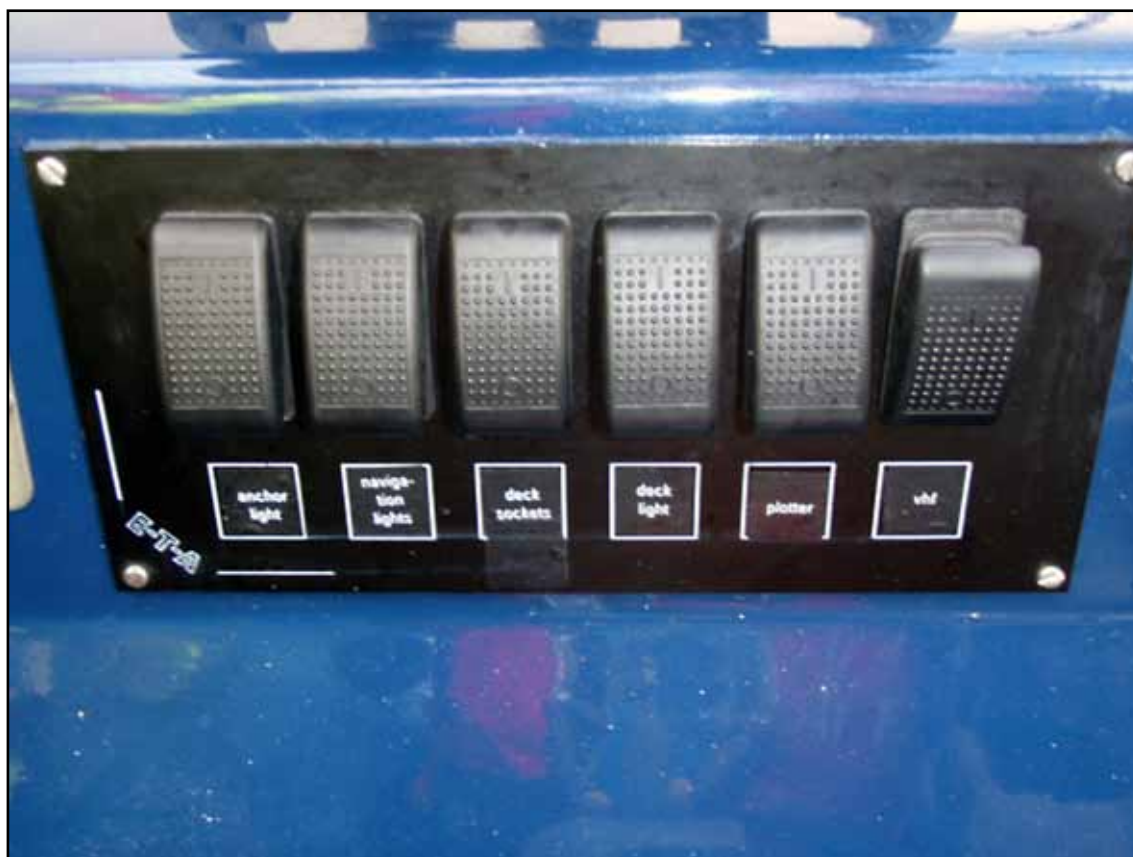
Figure 4

On their return to *Sooty*, the crew tidied loose diving equipment while the coxswain started the engine and switched on all six rocker switches (**Figure 4**) that supplied power to a deck socket, an all round white navigation light, sidelights, deck floodlight, mapping GPS and the VHF. It was reported that the coxswain then switched on the mapping GPS at the display unit and secured the engine kill-cord around his left leg.

Position of rocker switches

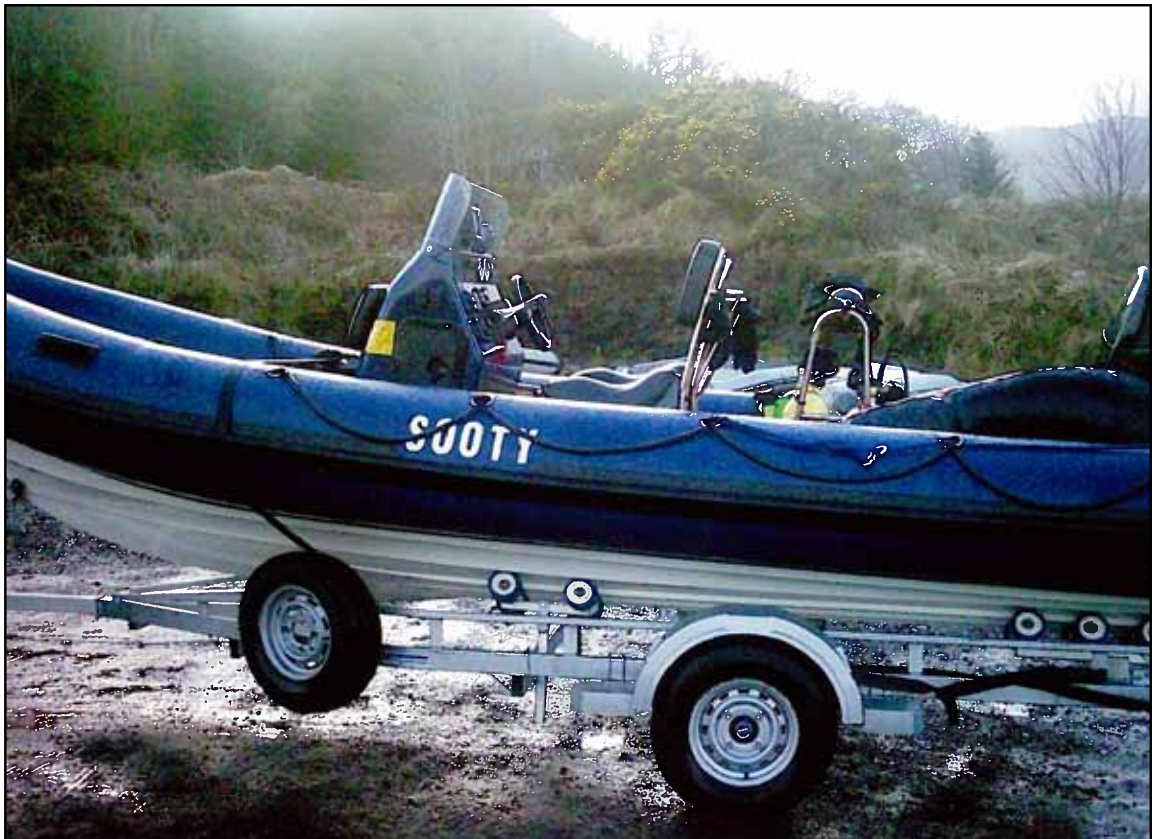
Sooty pre-modifications

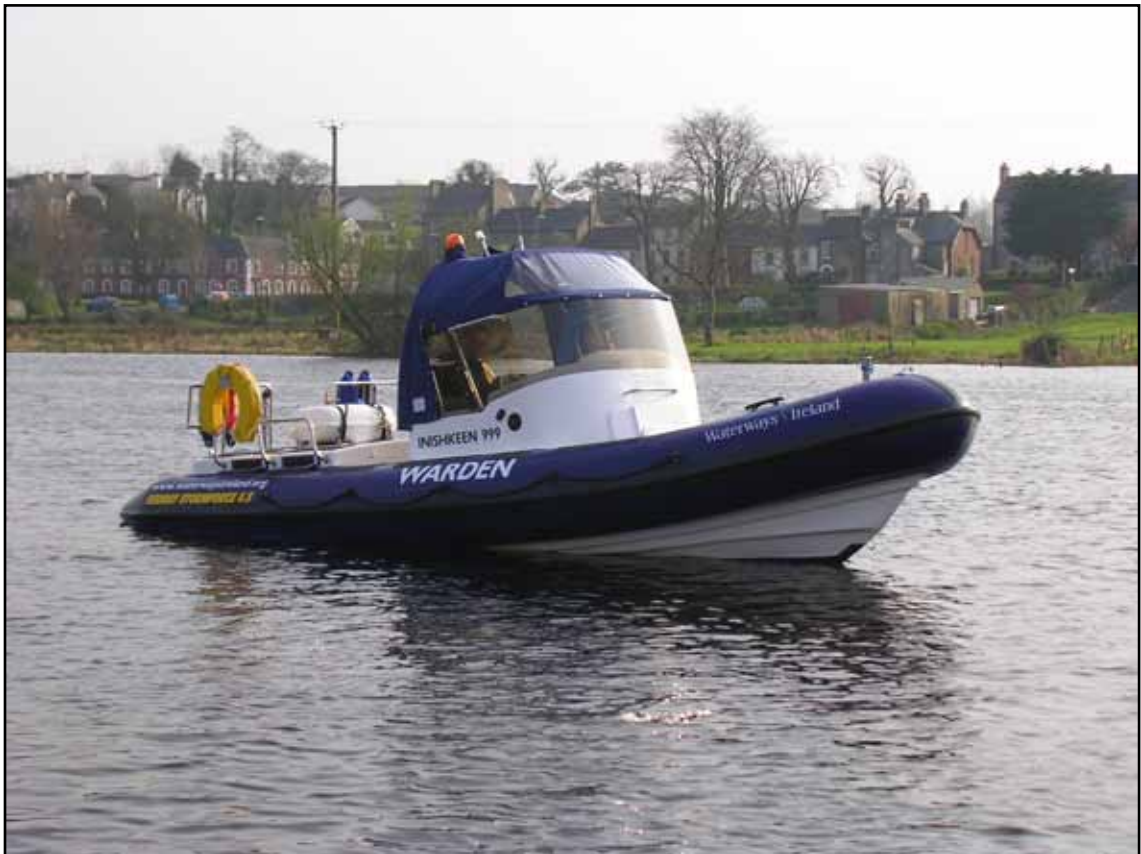
During the winter of 2007 / 2008, *Sooty* was modified to give greater protection from adverse weather and sea conditions. The modifications were copied from the design of another RIB, the Redway Boats Stormforce 6.5 (**Figure 8**) and included:

- A full breadth 'wrap around' console, moulded into the side tubes.
- A deeper visor following the lines of the modified console, with a bronze tint.
- A stainless steel frame over the console, complete with canvas awning and clear plastic inserts.
- The repositioning of an air bottle stowage from an athwartships line, to the fore and aft line.

Craft similar to Sooty post modifications
