Report on the investigation of
the grounding at high speed of the RIB

Sooty

Calve Island, Isle of Mull

Report No 22/2009
October 2009

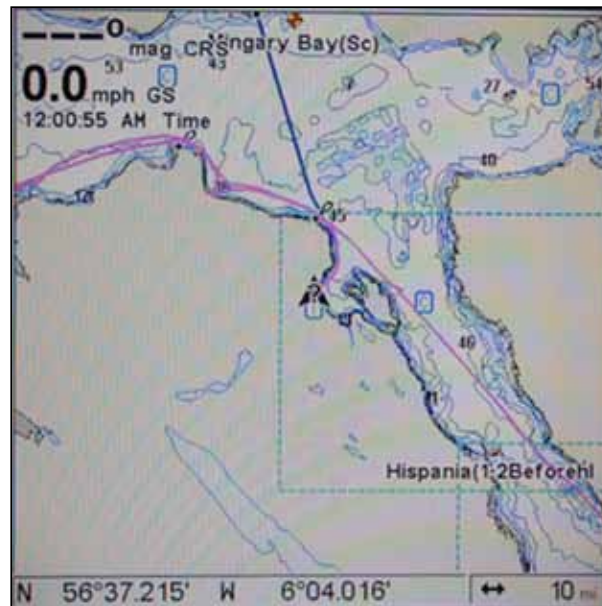
Figure 2

Passage was made from the north of Mull by following historic trails displayed on a mapping GPS¹ (**Figure 2**). In the vicinity of Tobermory Bay, course was adjusted to pass close to the north shore and the speed was reduced when passing the local RNLI station. By the time *Sooty* passed the buoys marking the designated fairway for local fishing vessels, speed had been reduced to about 10 knots. Half way along the fairway, course was altered to port and *Sooty* navigated through a number of craft secured to swinging moorings (**Figure 3**).

Historical track from GPS mapper 18 May 2009

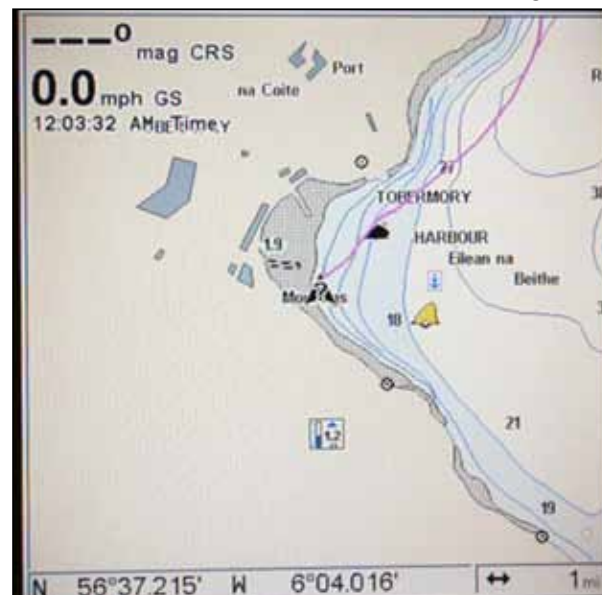
Figure 3

Entry into Tobermory 18 May 2009

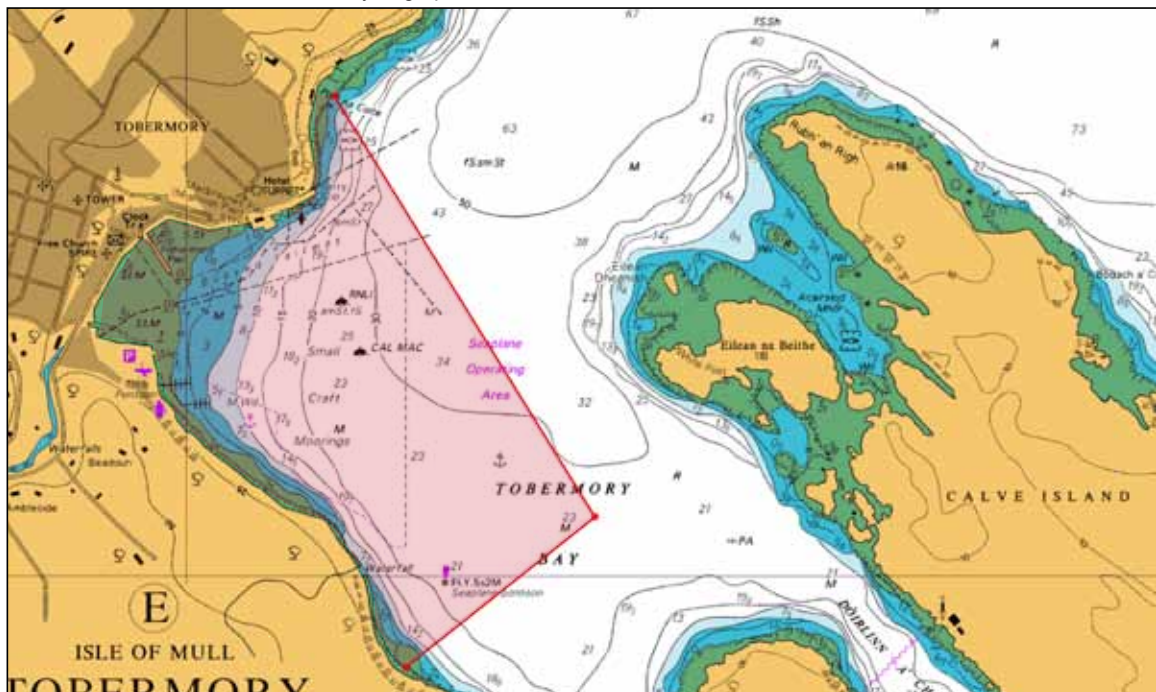
Figure 16

Control of the town's three piers is exercised independently by the RNLI, Caledonian Maritime Assets Limited (CMAL) and the Fisherman's Association. The THA limits were defined by the Crown Estate and are shown in **Figure 16**. This accident occurred 4 cables outside the THA area of jurisdiction.

THA limits of jurisdiction
