Report on the investigation of
the catastrophic failure of a windlass hydraulic motor
on board

Stellar Voyager

off Tees Bay
resulting in a major injury on
23 March 2009

Report No 25/2009
December 2009

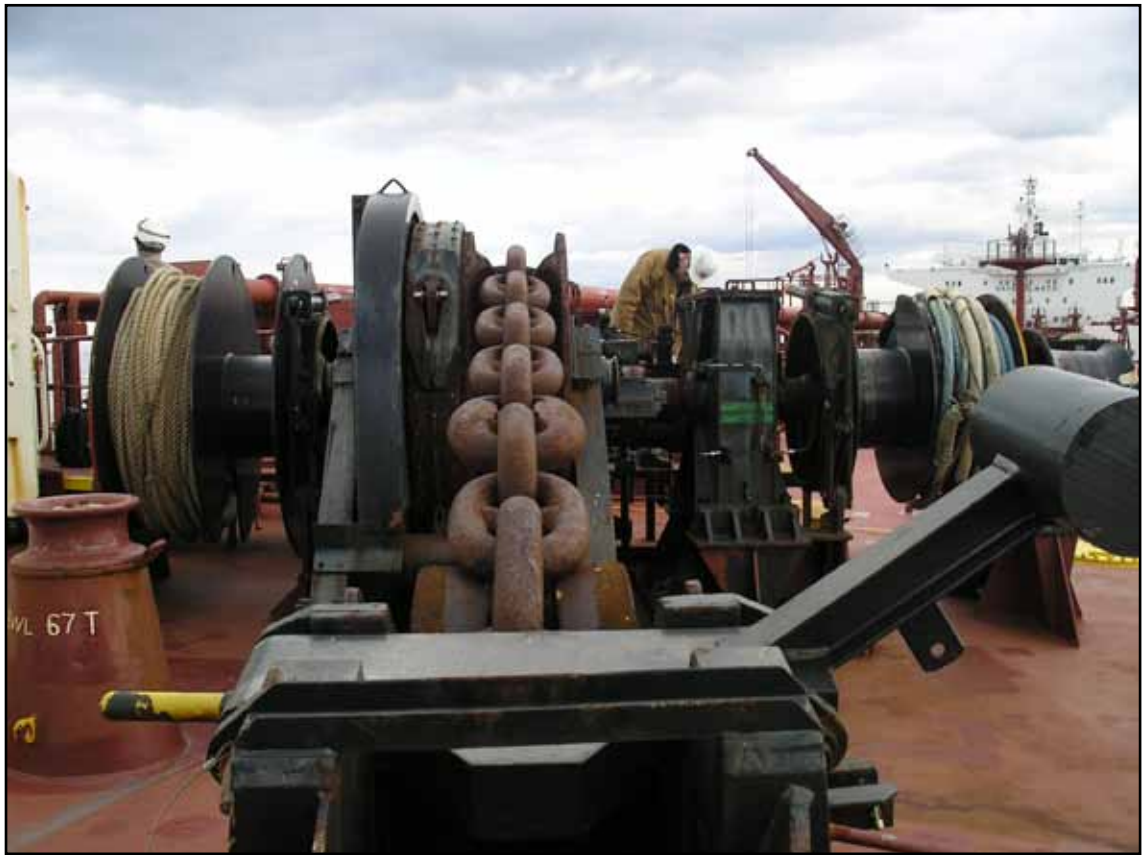
The anchor windlass system was supplied by Friedrich Kocks GmbH, Germany. It was electro hydraulically powered and fitted with two independent split drum winches on either side (**Figure 5**). The windlass was driven by a hydraulic motor manufactured by Bosch Rexroth AG, via planetary gears which drove a main gear wheel connected to the anchor chain gypsy wheel through a shaft and coupling arrangement. This double reduction gearing provided a speed ratio of 1168:1. Each windlass had a maximum capacity of 540kN and a nominal speed of 9m/min. The brake capacity was 2475kN.

Starboard winch-windlass

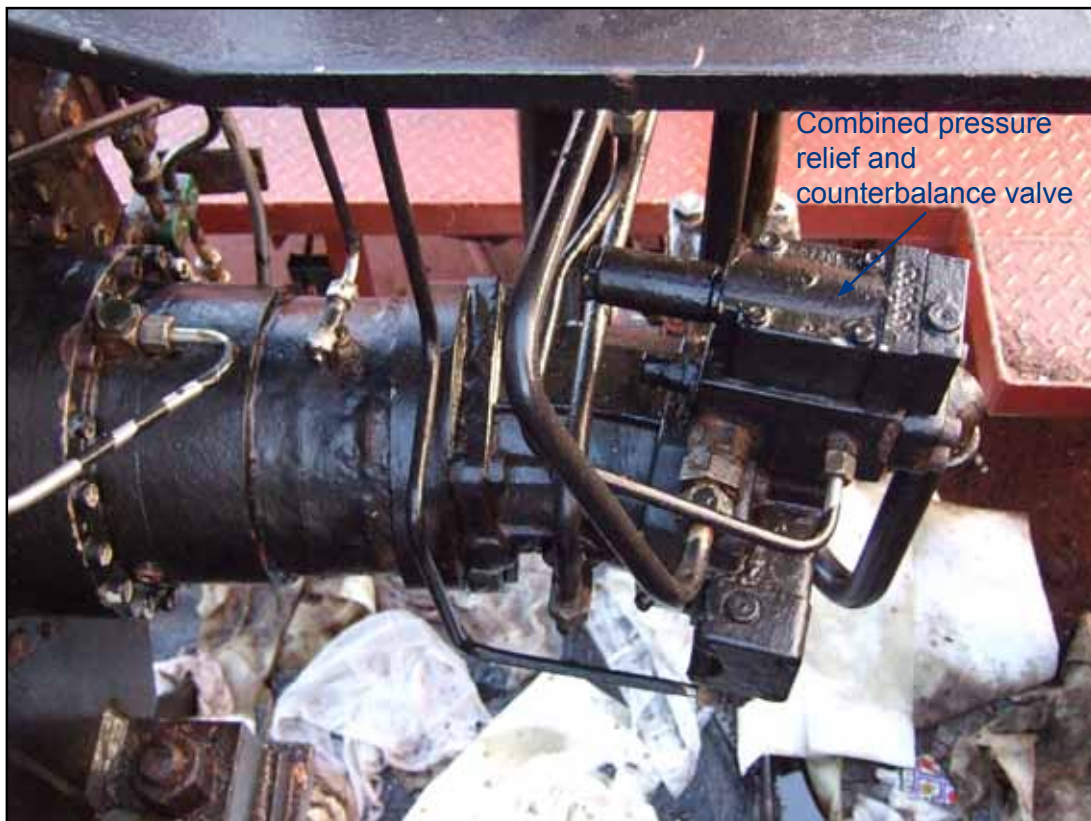
Figure 6

The hydraulic drive motor (**Figure 6**) was a bent axis axial piston variable displacement type. It was bi-directional and was capable of operating at maximum speeds of 3550rpm at 107cm³ displacement and 6300rpm at 0cm³ displacement, but had been adjusted to operate at maximum speeds of 1725rpm at 107cm³ displacement and 4325rpm at 43cm³ displacement. The oil flow was constant at 190 l/min. The motor output was adjusted by varying the position of a 'lens plate' which varied the stroke length of the seven pistons in the cylinder. The motor was therefore capable of achieving infinite combinations of torque and speed. The central bore of the cylinder carried a hollow spring-loaded pin which kept the cylinder aligned to its rotational axis. A diagram showing the internal components of the motor is at **Figure 7**.

The motor's components were made of normalised engineering steel and its outer casing was made of grey flake cast iron. The outer casing was not fitted with a pressure relief arrangement except for an open drain line to allow leaked oil to drain to a tank.

Hydraulic drive motor

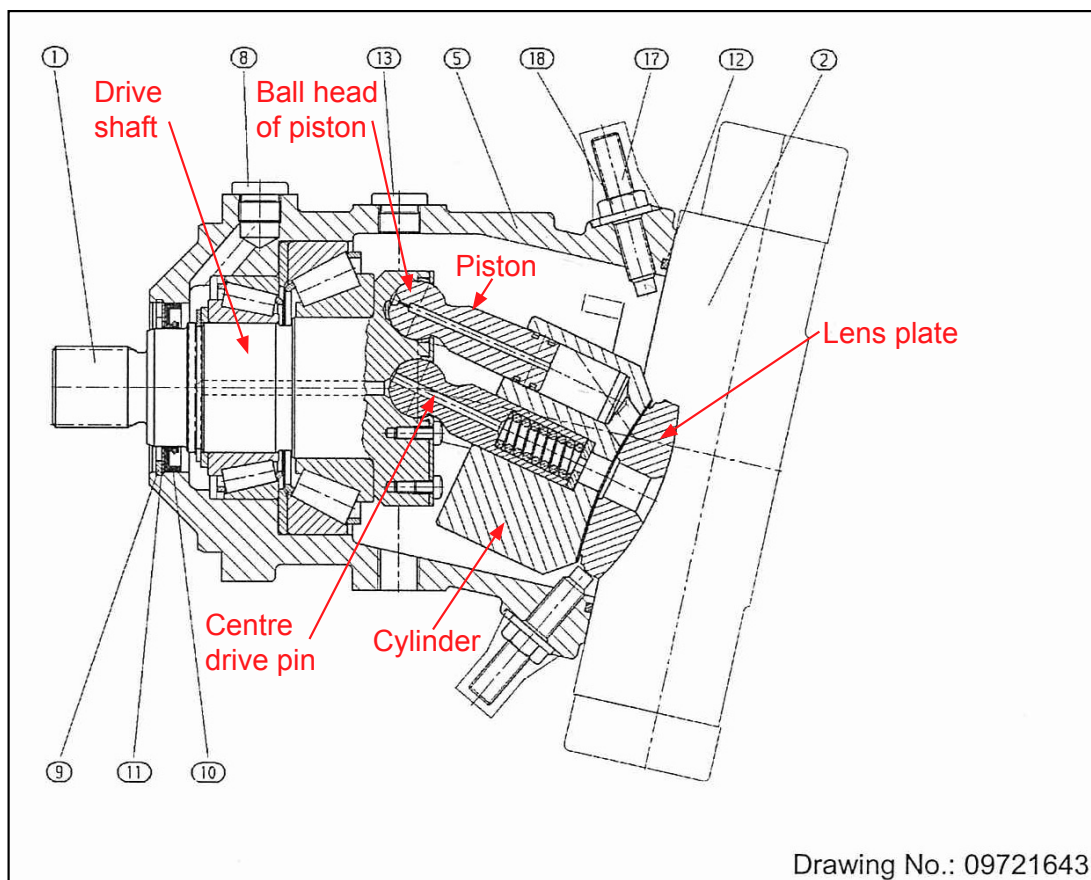
Figure 7

Bent axis axial piston displacement hydraulic motor
